# Pixmore Avenue, Letchworth Garden City Remediation Strategy

November 2025

**Project** HCE1473  
**Project Title:** Pixmore Avenue, Letchworth Garden City  
**Document** Remediation Strategy  
**Document** HCE1473.RS  
**Author:** Alex Large  
**Checked:** Hailey Tamblyn  
**Client:** Wedgewood Groundworks Limited  
**Initial Issue Date:** 03 November 2025

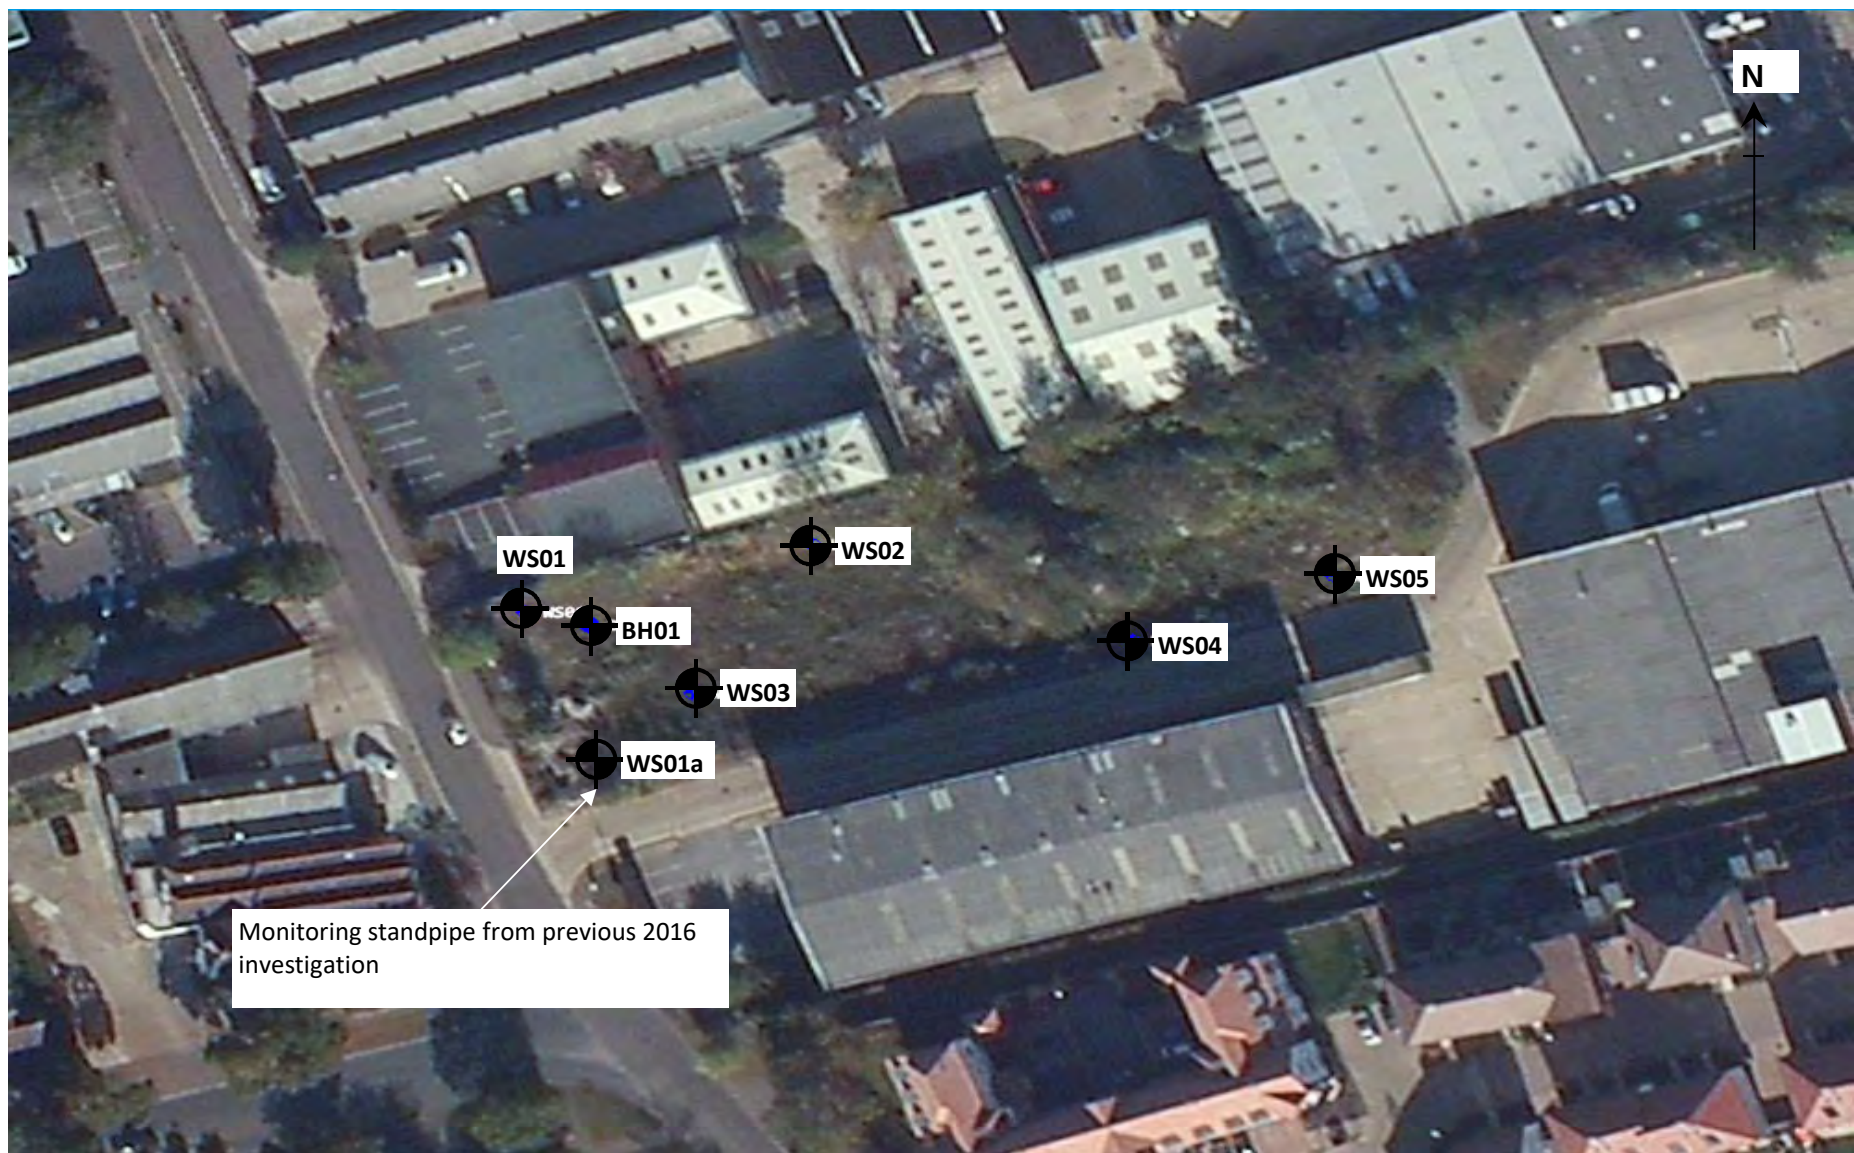
## Exploratory Hole Plan

| <b>Project:</b> | Pixmore Avenue, Letchworth | | | <b>Title</b> | Exploratory Hole Location Plan | |
