## HERITAGE, DESIGN AND ACCESS STATEMENT FOR PROPOSED WORKS AT JULIANS PARK

**RENOVATION TO VILLA ROOF & PROPOSED NEW ROOF ACCESS, EXTERNAL RENDER AND STONE REPAIRS & INTERNAL ALTERATIONS AT GROUND, 1<sup>ST</sup> & 2<sup>ND</sup> FLOORS.**

**EXTERNAL RENDER REPAIRS AND THERMAL UPGRADING TO MUSIC ROOM.**

**RENOVATION OF SERVICE WING TO FORM A NEW KITCHEN.**

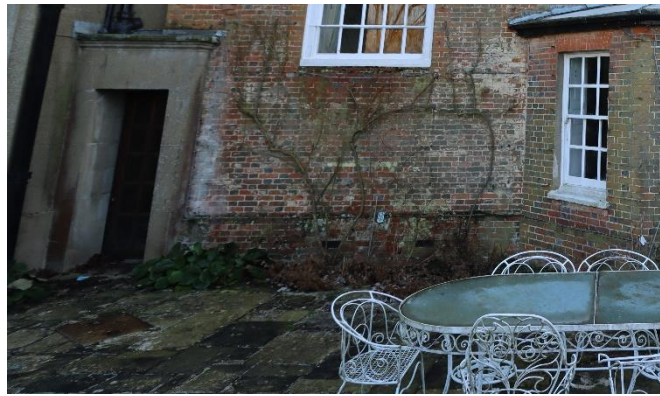
Location of infilled window at low-level

It is proposed that a cloakroom be installed within the former service corridor between the north-east Vestibule and the Dining Room, to serve this side of the house. The existing door off the Vestibule will be retained, and the low-level window on the north wall will be reinstated within the infilled opening.

- Remove infill to low level window at NE corner of Villa and install new lintel and slimline double-glazed timber window.

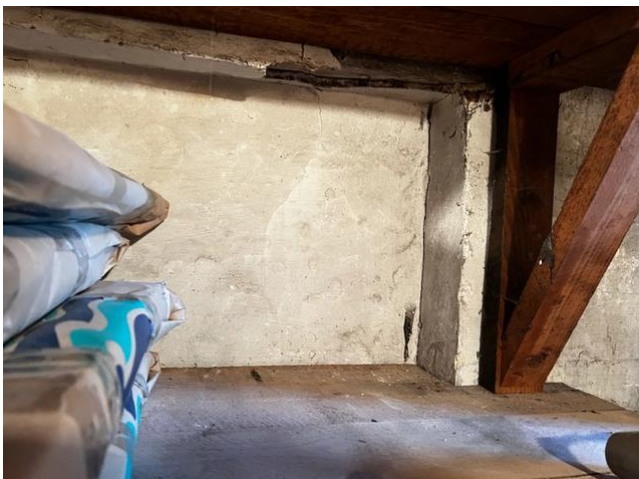
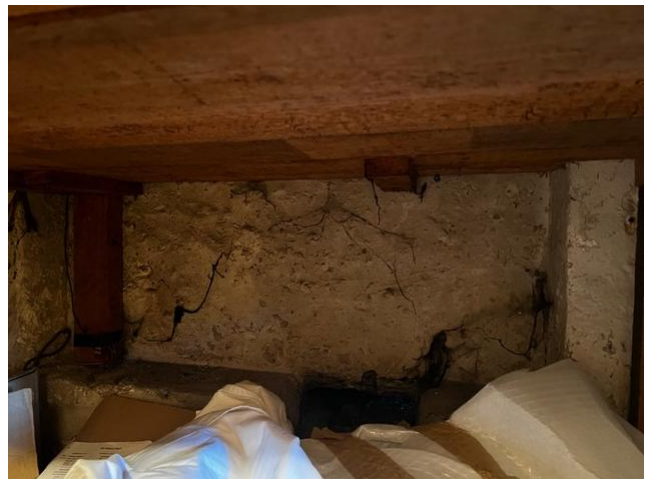
Evidence of infilled window from internal side of redundant service corridor

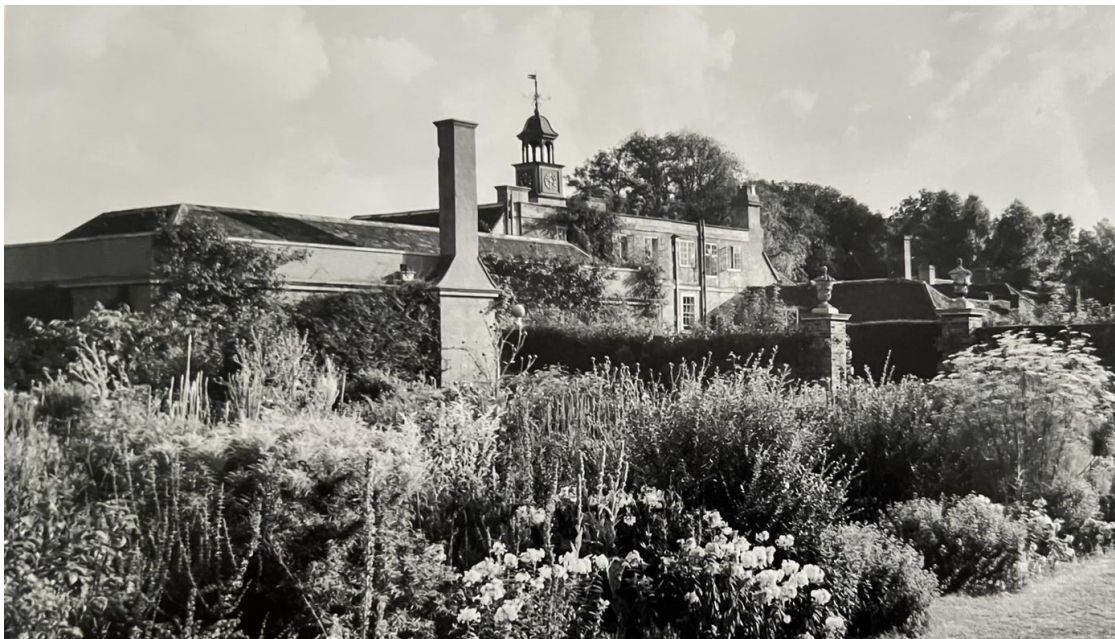
Original Music Room chimney stack

The original chimney stack has been reduced from its original height at some point, and this will be reinstated using photographic evidence.

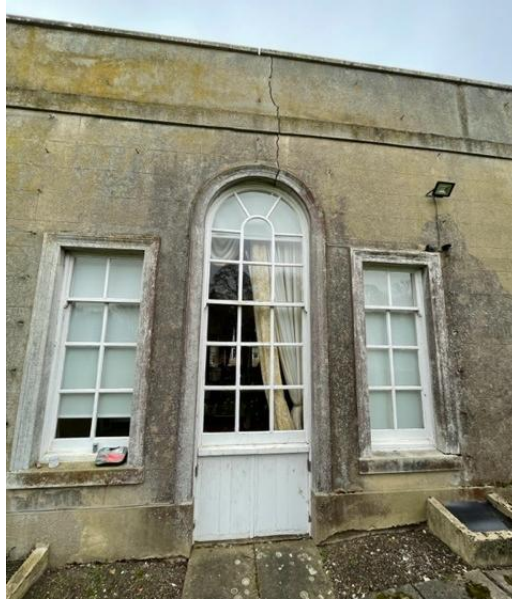
East Elevation of Music Room with vertical movement crack

Repairs are necessary to the render in several areas including to a large movement crack through the render and arched stone head to the door on the west elevation. The applicant has been advised that HeliBar repairs will be required to stitch the crack.

- Repairs to external render as necessary including crack to east elevation.
- Careful removal of existing floorboards, installation of insulation and underfloor heating to floor void. Replacement of existing boards with new finish to surface.
- Investigation of linings to external walls and installation of insulation if viable. Details to be confirmed.
- Reinstate chimney stack to full height using historic photographic evidence.

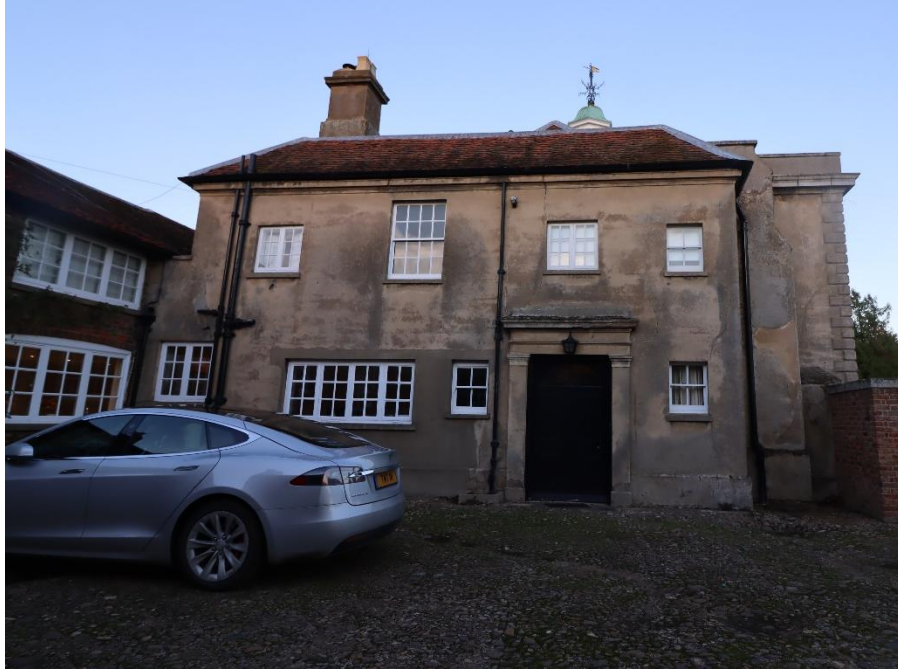
Existing drainage arrangement on west elevation of Villa. New sanitaryware installations at 1<sup>st</sup> floor will use existing routes

- New drainage to connect to existing drainage routes.

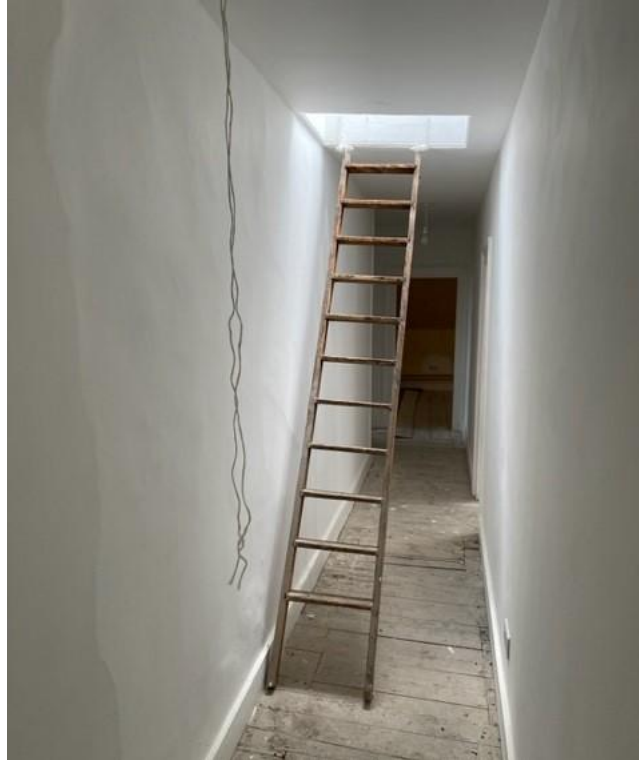
Existing MC20<sup>th</sup> fixed ladder to be removed.  
Construction materials of ceiling to be confirmed.

The existing roof access arrangement is via a timber ladder and a rooflight with a high kerb which is not considered to be safe. The ladder also obstructs the second floor corridor.

- Form opening in corridor ceiling as part of proposed loft ladder installation works (refer to proposed works to clocktower)
- Remove C20<sup>th</sup> ladder from second floor corridor.
- Remove existing C20<sup>th</sup> sanitaryware, door and partitions forming WC adjacent to north wall.
- Install 3no ensuites to be installed to serve bedrooms 6, 7 & 8, all within existing partitions. Replace sanitaryware to existing bathroom to west side.
- Generally, like-for-like repairs to walls, ceilings and floors throughout second floor as necessary and redecorate.

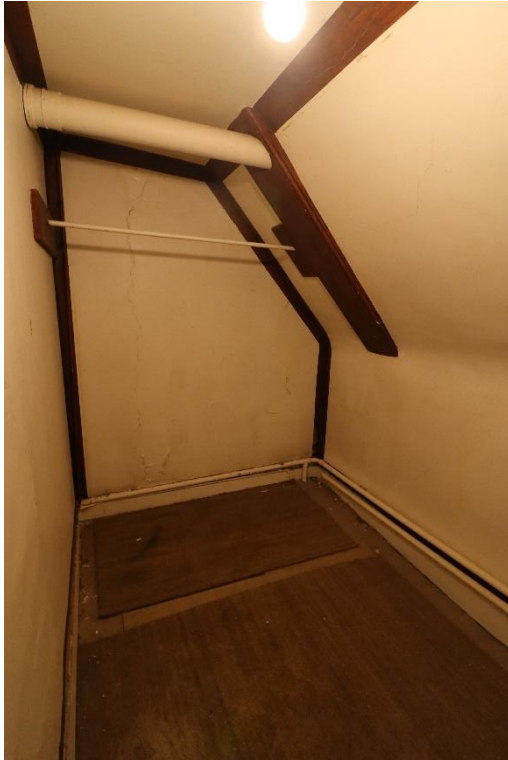
Ensuite bathroom proposed for Bedroom 6

The existing bathroom on the west side will be retained and upgraded using the existing drainage routes. The 2no proposed ensuite bathrooms in the north-east corner will connect to an existing external soil stack on the north elevation of the Villa.

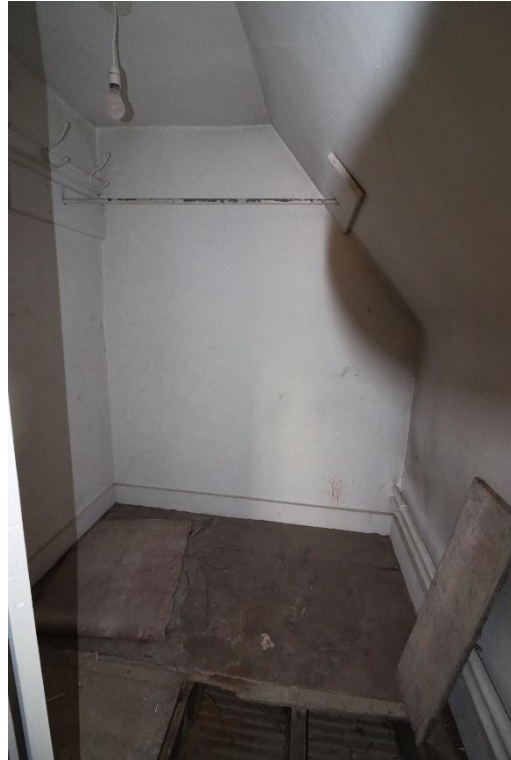
Ensuite bathroom proposed for Bedroom 7

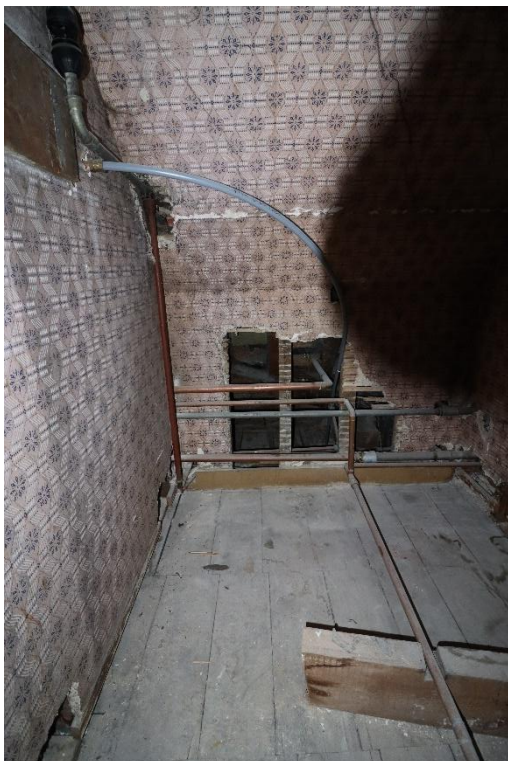
Ensuite bathroom proposed for Bedroom 8

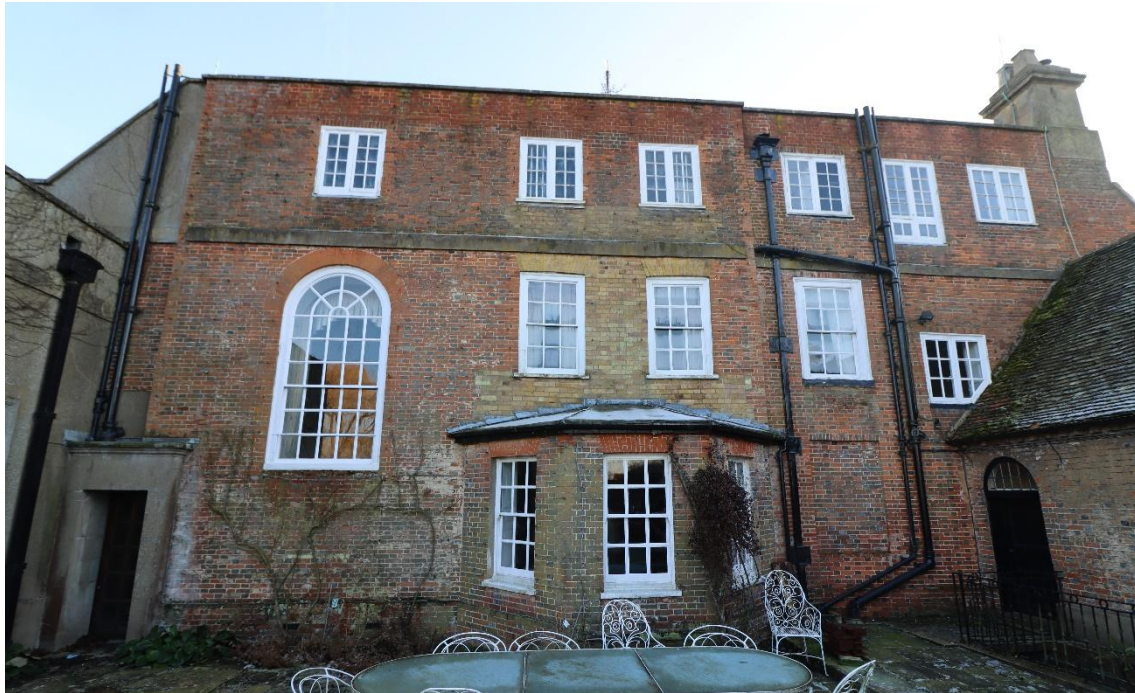
Existing drainage on rear (north) elevation of Villa (to right and left)

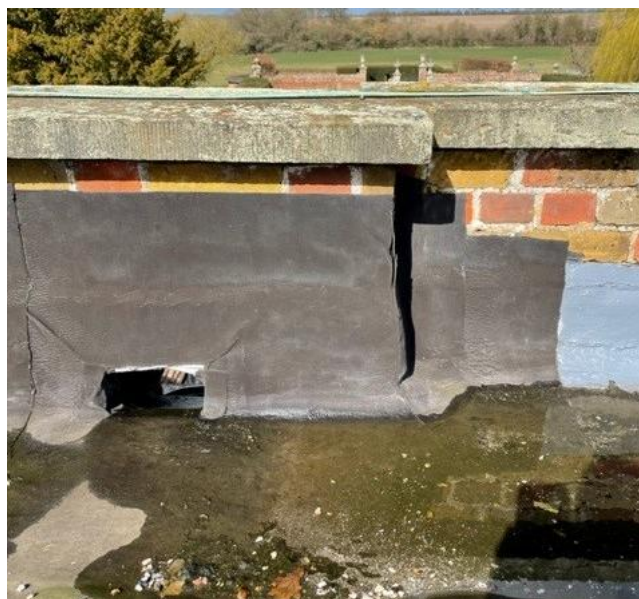
Villa flat roof outlet to north parapet wall

There is a parapet wall to the northside which is the location of the only rainwater outfall for the central flat section of roof. Opening up has been carried out to the ceiling below this area which possibly indicates that there has been failure of the asphalt. An overflow adjacent to the existing north parapet rainwater outlet will be installed as part of the proposed roof works.

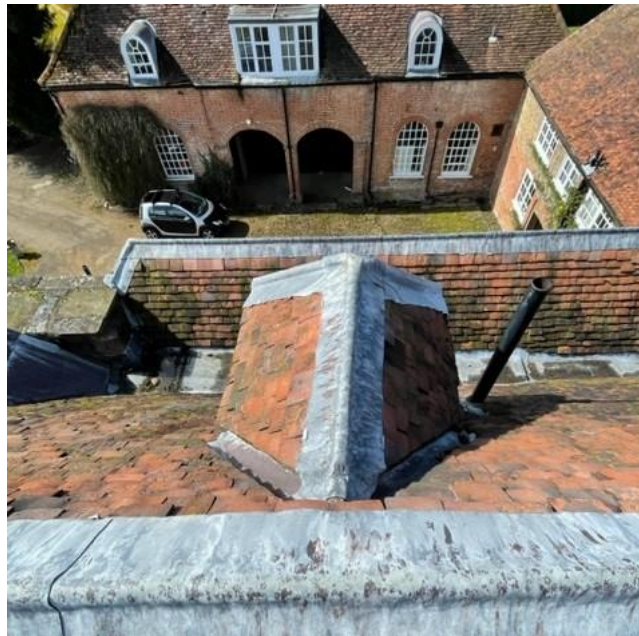
Dormer window to second floor west side bathroom

There are two curved lead clad dormer windows on the south slope to the east and west corner bedrooms, and a tiled hipped roof dormer with lead roll ridge, hips and lead clad cheeks to the west slope, which lights the second floor bathroom.

The lead to the hips and ridge will be removed along with the tiles and set aside for re-use where viable. The lead to the cheeks will be inspected and repaired/replaced as necessary. The existing timber rolls and battens will be inspected and repaired/replaced as necessary.

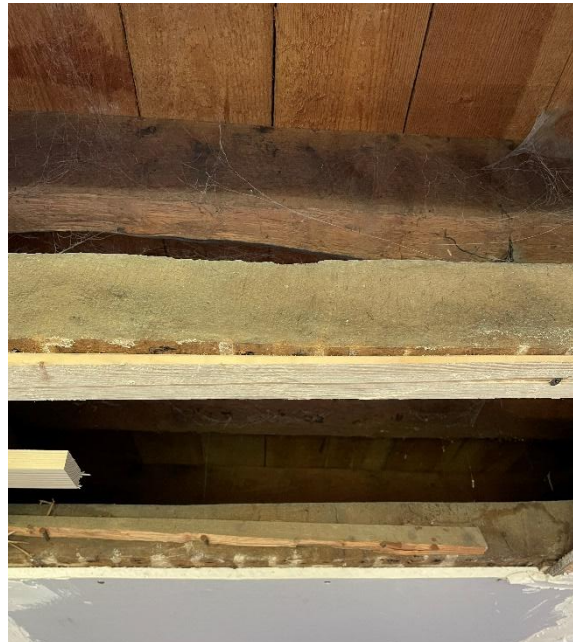
Photo taken in central north room indicating roof build-up.  
The lower timbers are assumed to be 1939 from works.

The proposal is to remove the existing C20<sup>th</sup> 3 layer felt roof covering, decking and timber firrings and the layer of timber boarding installed directly above the joists. Removal of these boards will provide access to the roof void for inspection of the structural timber and to carry out any necessary repairs. The roof void will then be insulated with sheep wool.

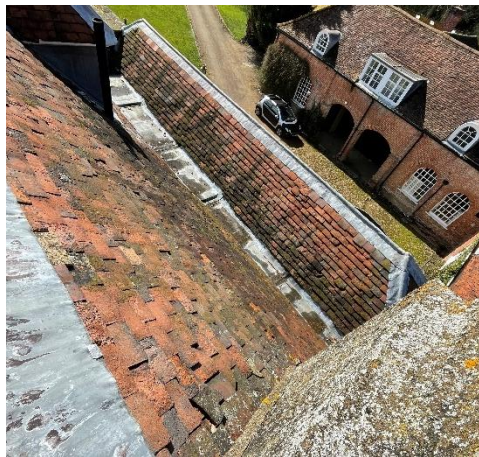
West side stepped valley gutter

The lead lined parapet gutters and outfalls to the north-east and to the south and the stepped valley gutter at the base of the west slope of the Villa, will be inspected and repaired/replaced as necessary.

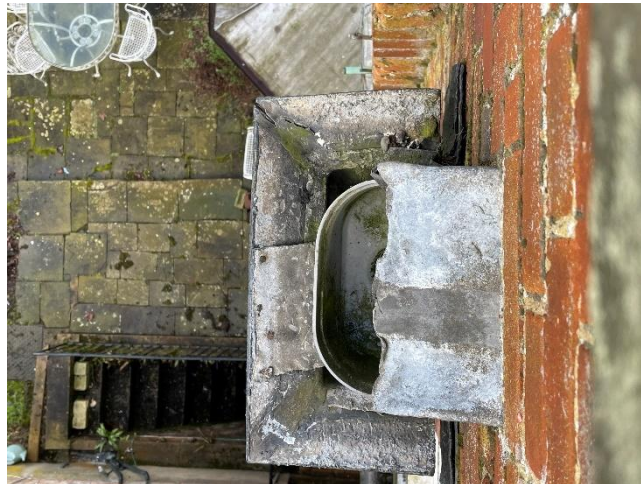
Rainwater outlet on north side from Villa flat roof

The north side parapet rainwater outlet discharges into a hopper which is connected to a square section cast iron rainwater pipe which will be inspected and repaired as necessary.

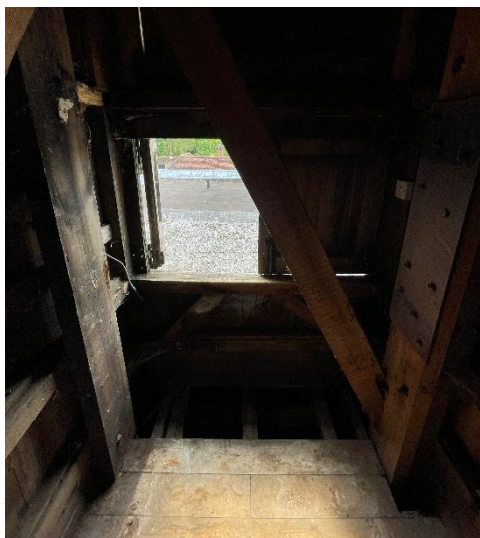
Bracing within the body of the clocktower

C20th timber bracing has been installed within the body of the clocktower which will need to be removed along with the floorboards and joists to allow installation of the ladder.

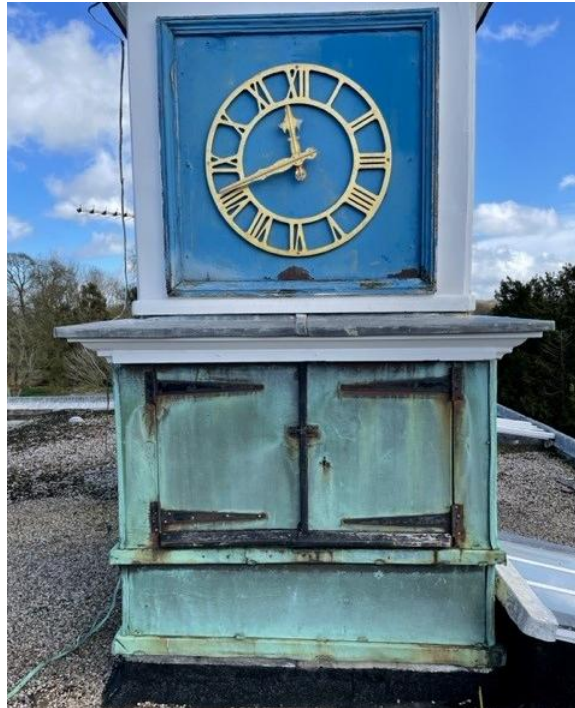
West face of clocktower.  
Existing doors to be increased in length to provide ease of access onto roof.

The existing doors on the west side will be adjusted to increase their length into the base of the clocktower thereby providing safe access onto the roof from the proposed automatic ladder, which will remove the necessity of climbing over a high kerb.

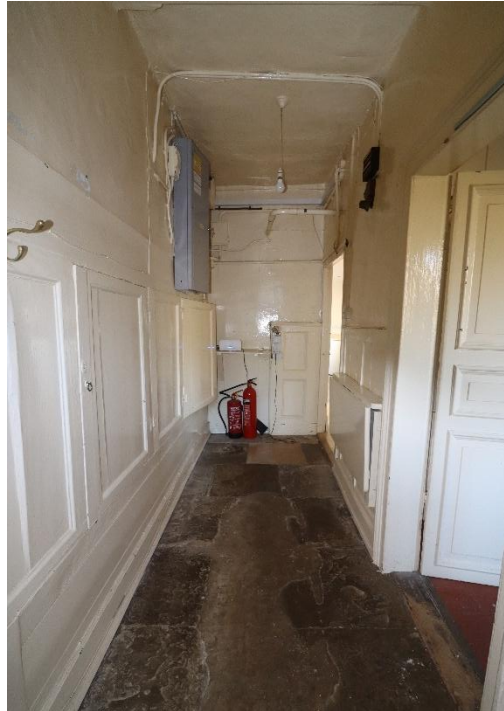
Butler's Pantry Service Corridor  
EC18<sup>th</sup> reclaimed cupboard doors concealing C17<sup>th</sup> fireplace to left side  
and worn flagstone floor

The C20<sup>th</sup> partition to the right, in the photograph above, the existing Butler's Pantry door D1 (Historic Recording p.24) and the existing door into the kitchen at the end of the corridor, will be retained in position.

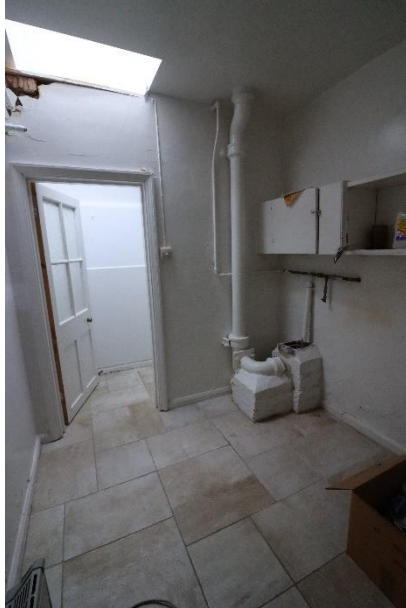
C20<sup>th</sup> door to WC to be removed

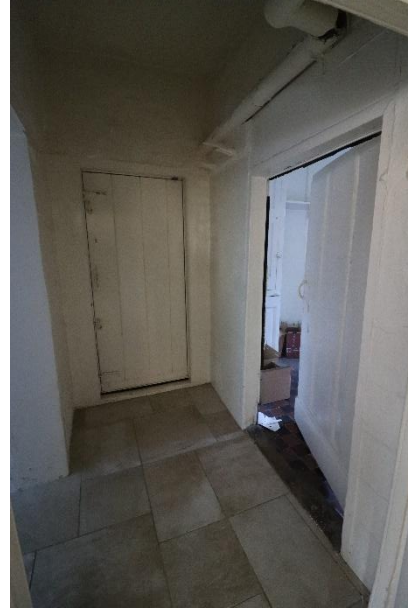
C20<sup>th</sup> door to store to be removed

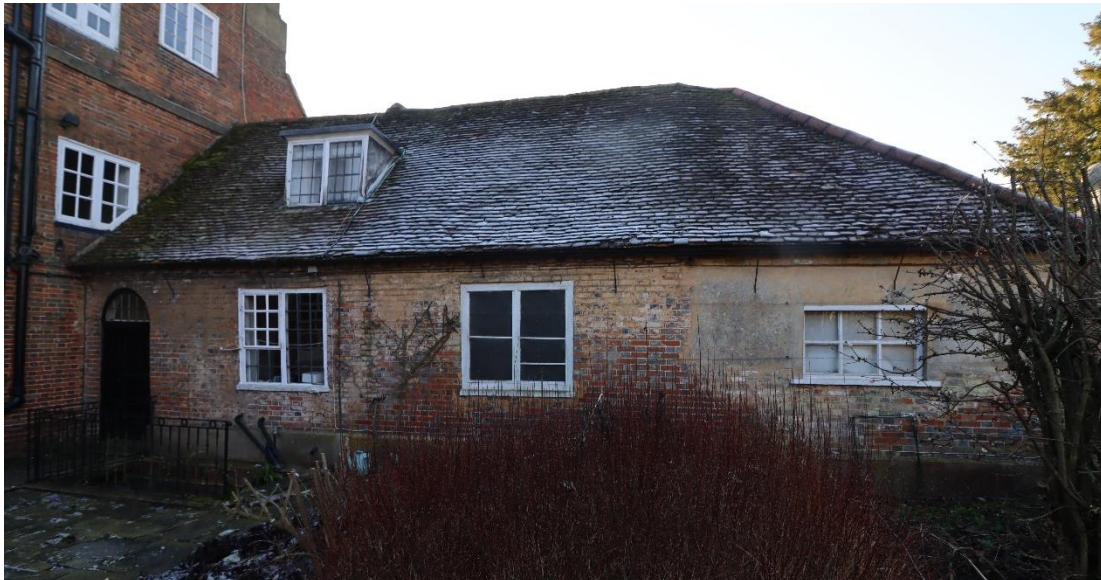
West elevation of service wing

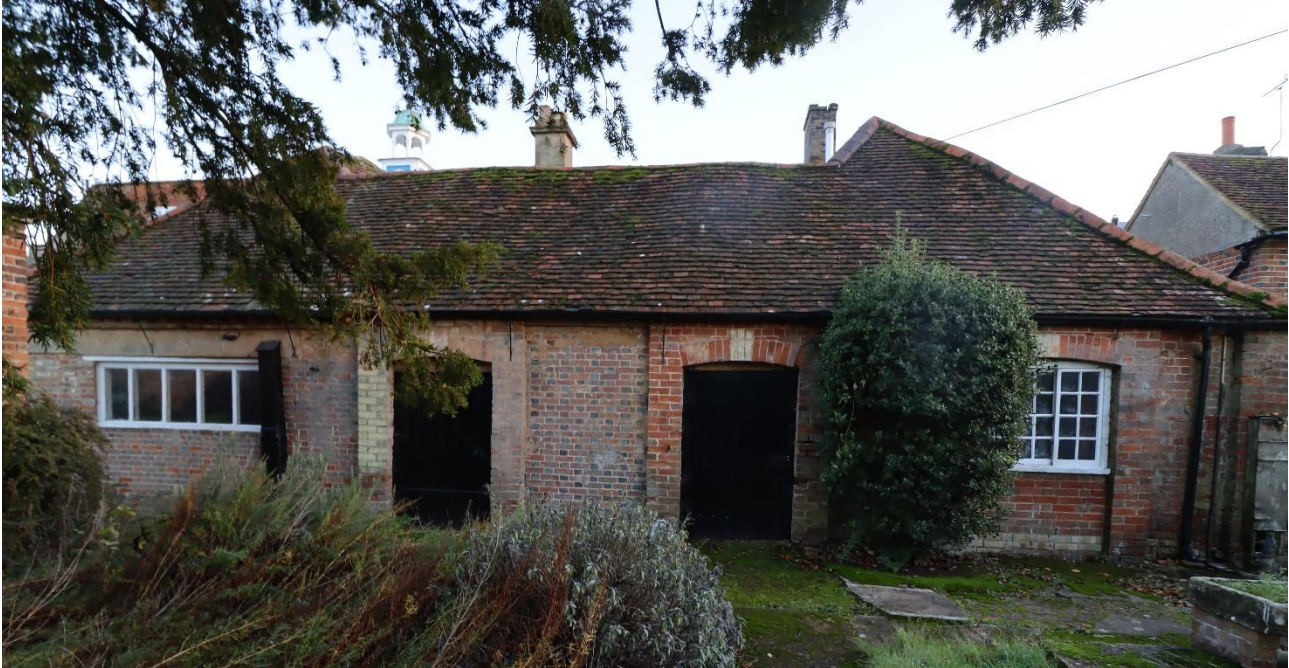
The C20<sup>th</sup> fixed light window to the north-west corner (lhs) will be removed and replaced to match with flush opening casements incorporated.

| 38 | Remove fixed light window to north elevation and replace with matching high quality timber window.<br><br>Remove 2no existing ledge and brace doors & frames and install 2no new part glazed multi-pane timber doors & frames in existing openings on north elevation. | Low<br><br>MC20 <sup>th</sup> window<br><br>MC20 <sup>th</sup> timber doors & frames will be re-used. | Low Impact | The existing fixed light window is MC20 <sup>th</sup> (Historic Recording p11) and is of poor construction without an external or internal sill. The replacement window will match the existing simple form but with opening casements added to the end lights to provide ventilation to the proposed Laundry Room. The new window will be fitted with slim-line double glazing and integral beads which will be thermally efficient. The new window will enhance the appearance of the elevation and will not affect the C18 <sup>th</sup> brickwork.<br><br>Re-use of MC20 <sup>th</sup> doors & frames in proposed garage block to CO approval. |

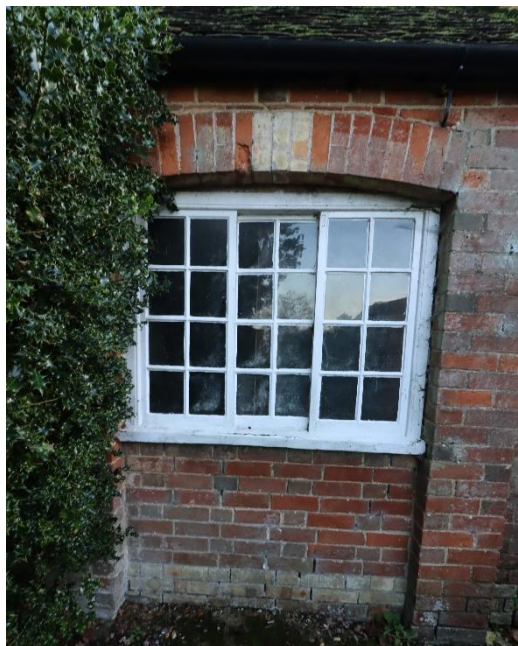
Replica MC20<sup>th</sup> sliding sash window and recessed brick panel below will be removed to provide an opening into the proposed link corridor

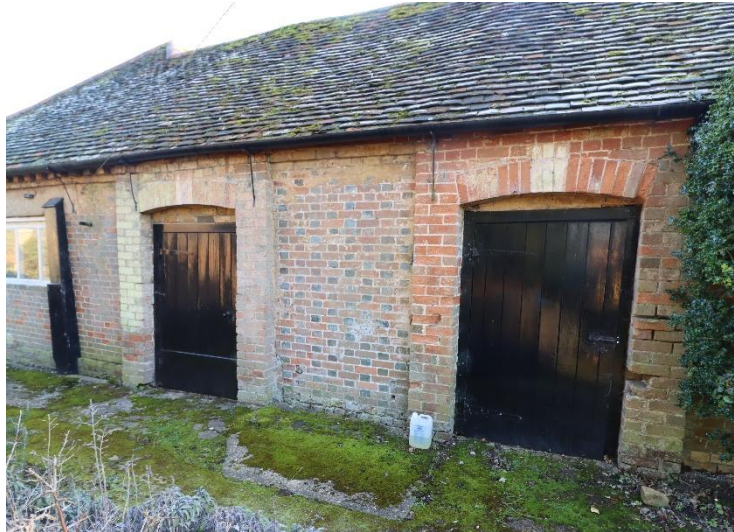
The 2no existing MC20<sup>th</sup> timber ledge and brace external doors and frames to the north elevation of the service wing store and plant room will be removed and re-used within the proposed garage block to the approval of the Conservation Officer. The existing openings will be fitted with new part glazed multi-pane timber doors and frames.

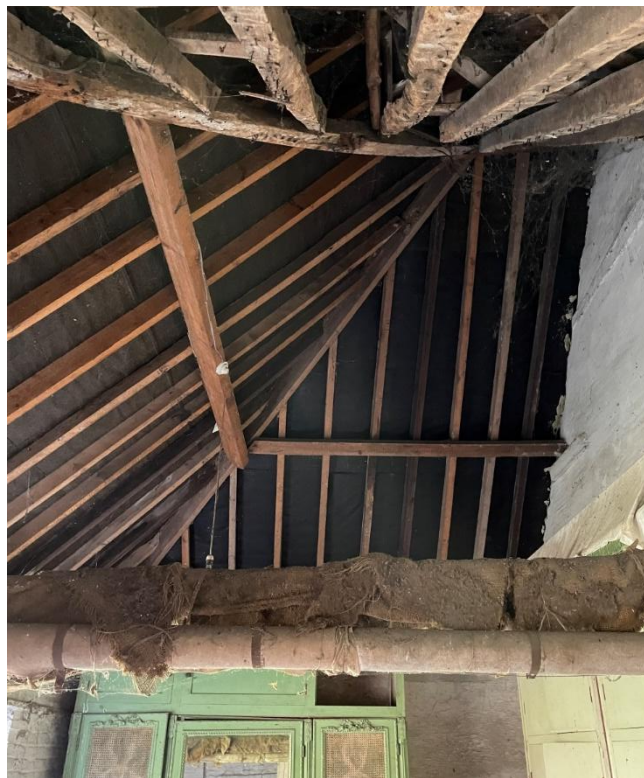
Location above existing store for new floor

The existing Store in the north-east corner of the service wing is open to the rafters, and it is proposed that as part of the conversion of this space to a Laundry, a floor is installed to support water treatment and hot water storage plant. Access will be via an opening to be formed in the MC20<sup>th</sup> plastered studwork partition which forms the back of the linen store at 1<sup>st</sup> floor, which can be seen on the right in the photo above. This will provide safe and convenient access to the plant room for maintenance.

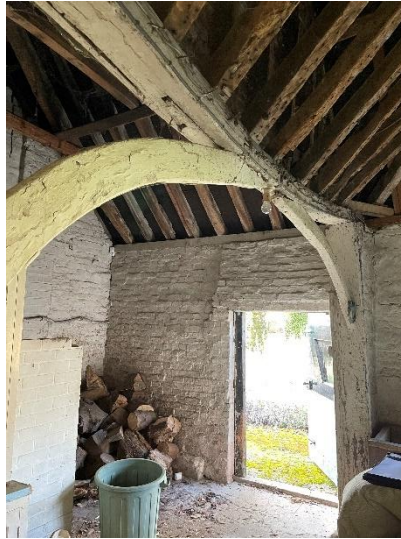
- Carry out structural repairs to existing roof timbers and beams and structural repair/remedial strengthening works to failing timber brace in Store (Historic Building Recording 26.05.23 p.33)

Timber brace to be repaired/strengthened

| 42 | Carry out structural repairs to existing timber brace in Store | High-Moderate | Low Impact<br><br>Benefit | Necessary repairs to structural timber brace (Historic Recording p32) A design for conservation structural repairs will be submitted for approval. Conservation benefit. |

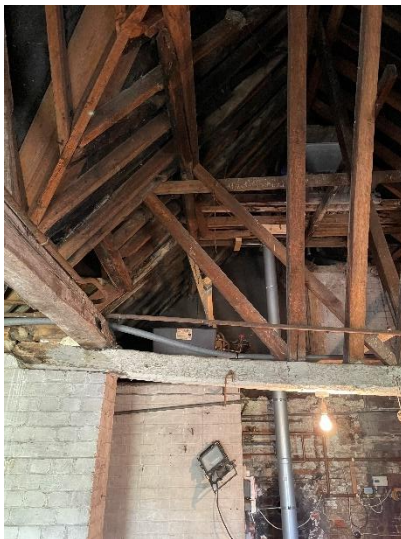
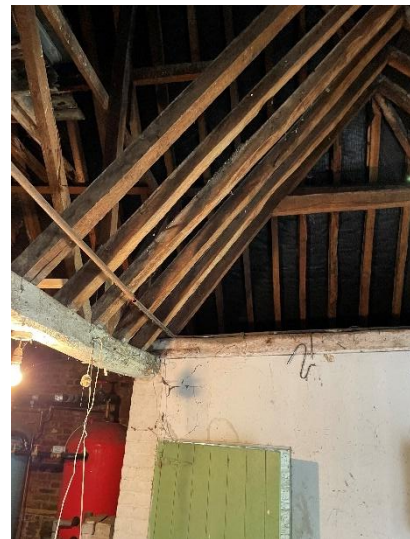
- There are 3no horizontal timber beams supporting the roof structure over the existing boiler room. These are likely to be C19th reclaimed beams used in the 1939 works. The deflected beam running east-west will be replaced with an oak flitch beam and will span from wall to wall following removal of the MC20th brick partitions currently supporting the existing beam.

Brick pier and workshop partitions to be removed

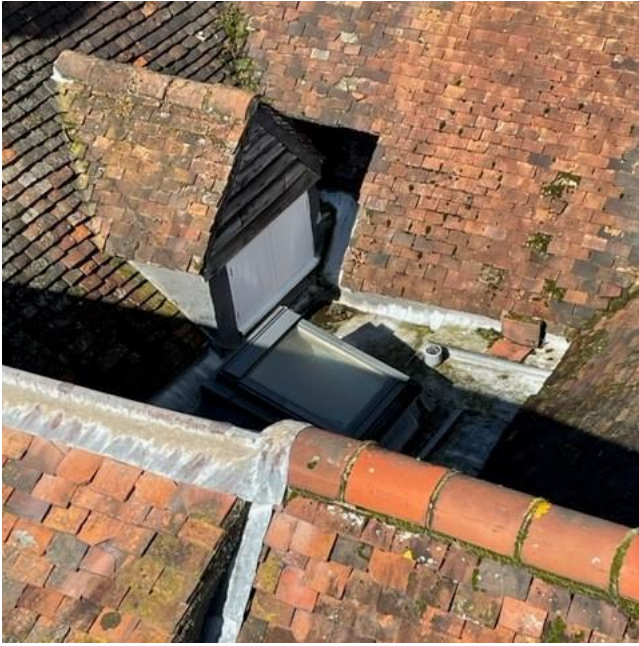
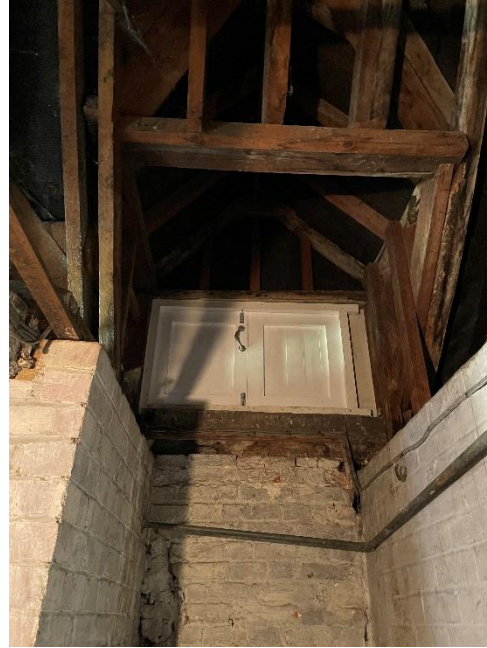
- The timber doors fitted to the hidden dormer on the internal west slope (photo below) will be replaced with a glazed access window and the dormer will be refurbished along with the roof works.

Dormer access hatch above Boiler Room - internal and external views

| 46 | Renovation to dormer window to central west slope and replacement of timber shutter with access window | Low<br>MC20 <sup>th</sup> dormer | Low Impact<br><br>Benefit and Enhance | <p>The dormer to the central west-facing slope has a timber hatch which will be replaced with a new slim-line double glazed opening casement window to provide access onto the flat roof. The new window will also provide daylight to the middle of the proposed kitchen accommodation. The dormer construction will be investigated and repaired as necessary and the tiles replaced along with the main roof works. Lead clad cheeks to be inspected and repaired/replaced as necessary to be confirmed. Conservation benefit.</p> |

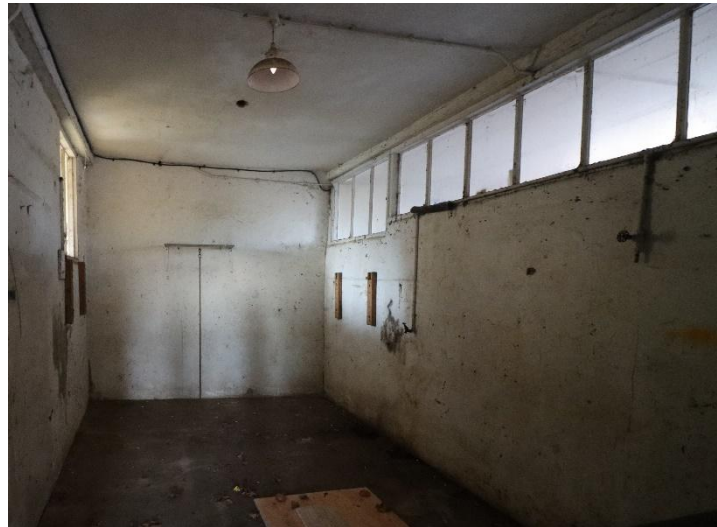
C20<sup>th</sup> partition to be removed (rhs)

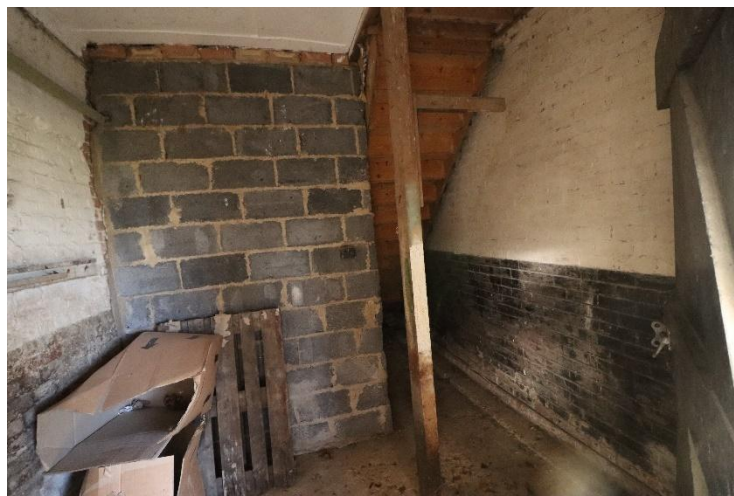
Blockwork partition to be removed and approx location for proposed new door opening (rhs)

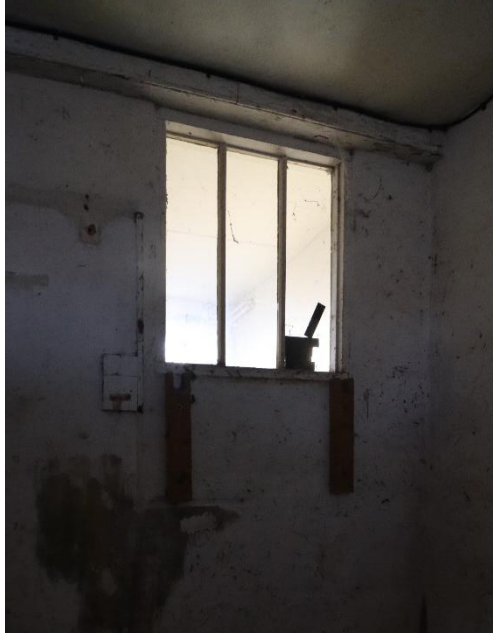
The existing glass in the internal window (photo opposite) which is located above the stair, will be removed and infilled to comply with Building Regulations.

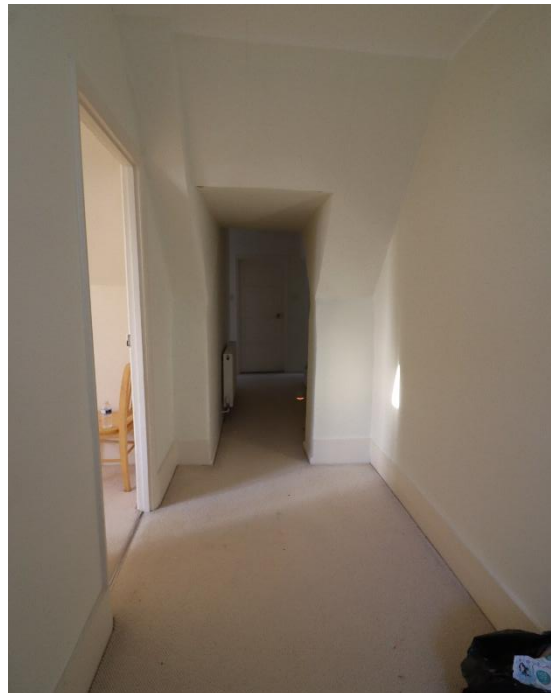
Division of 1<sup>st</sup> floor corridor will be located at far end  
(beyond radiator to lhs)

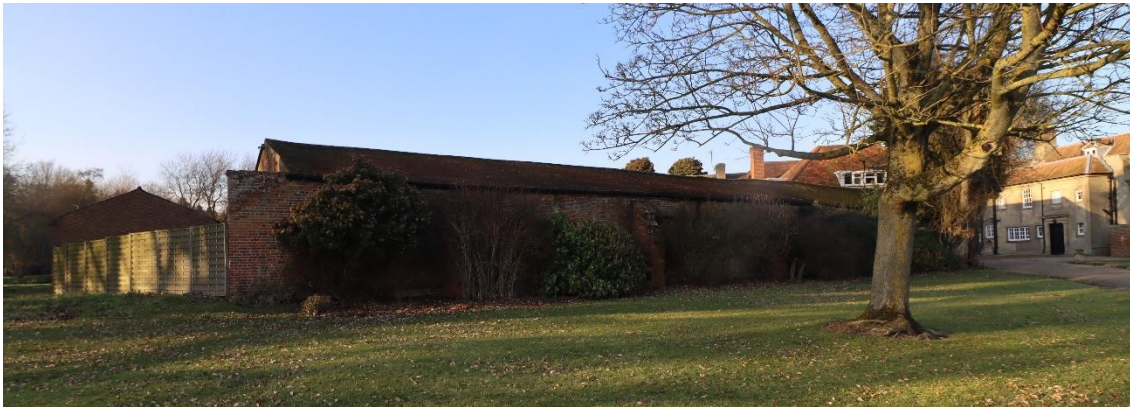
The brick wall which forms the south-east side of the main garage block, and running south-west from the former Coach House is all that remains of the pre-C20<sup>th</sup> structures (Historic Recording p.24)

South-east view and pre-C20<sup>th</sup> wall

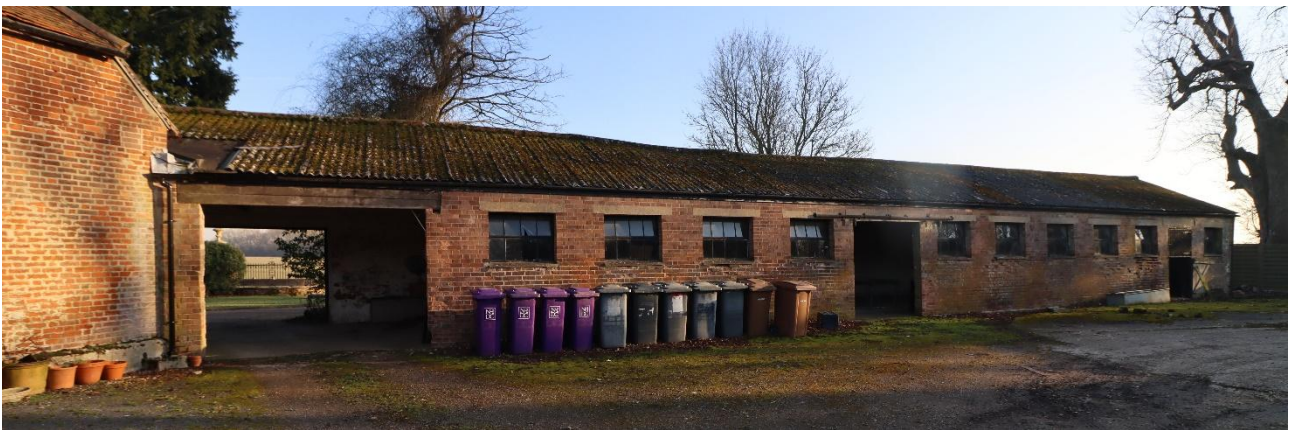
The roof slope on the south-east side is laid with plain clay tiles, and to the north-west side it is corrugated cement sheet.

MC20<sup>th</sup> garages (north-west elevation)

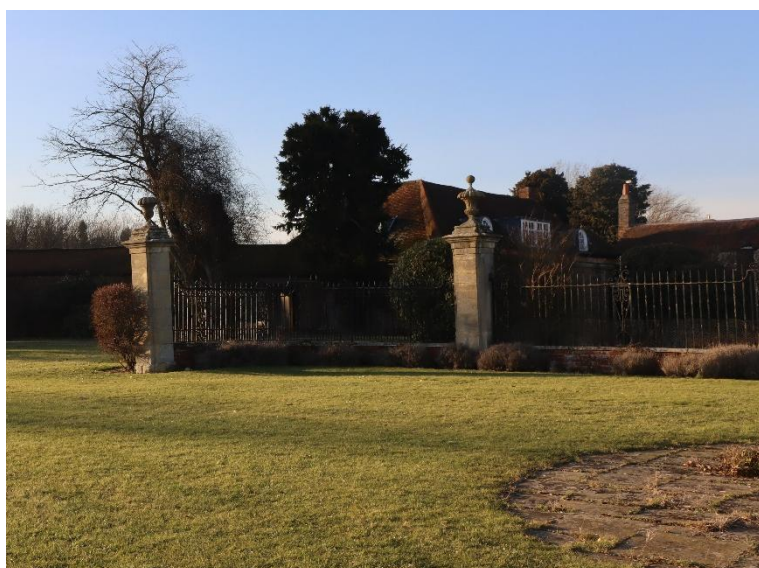
Later additions to the south wall of the Entrance Courtyard

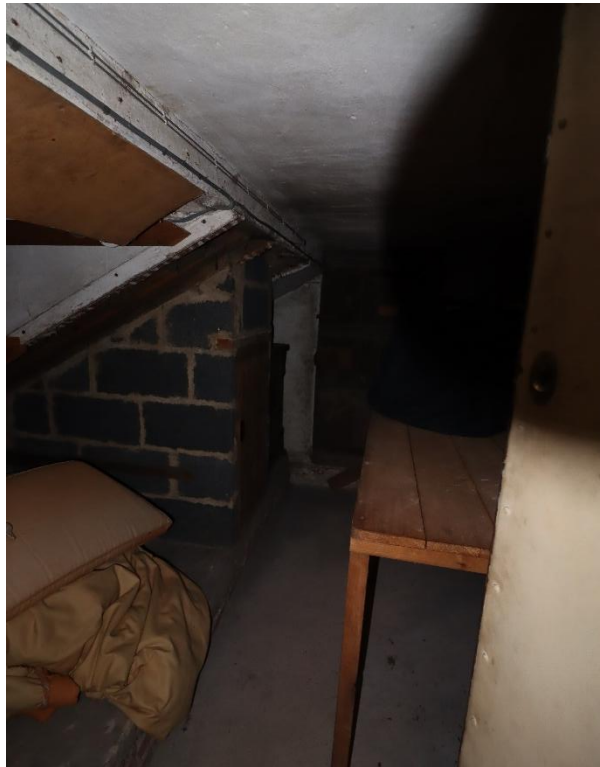
North-west service corridor to be converted to a Cloakroom

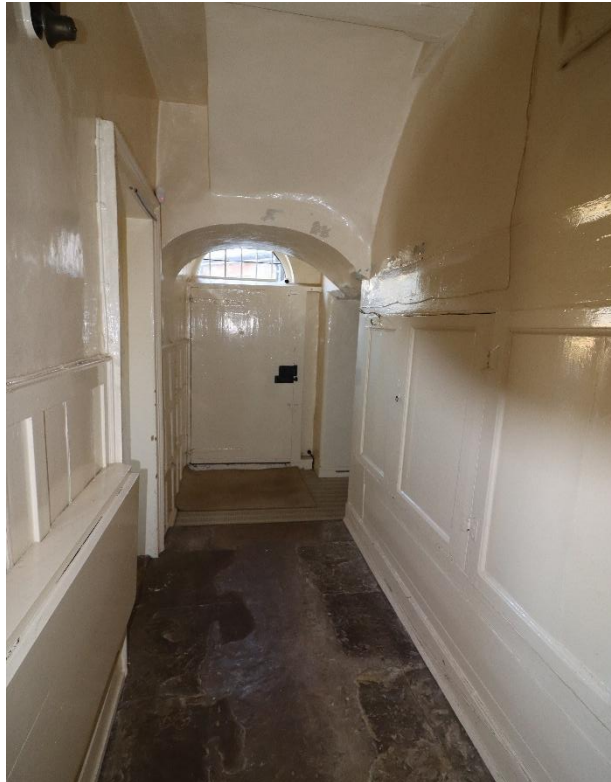
Service Corridor at rear of Main Villa. C17th fireplace behind cupboard doors (rhs)

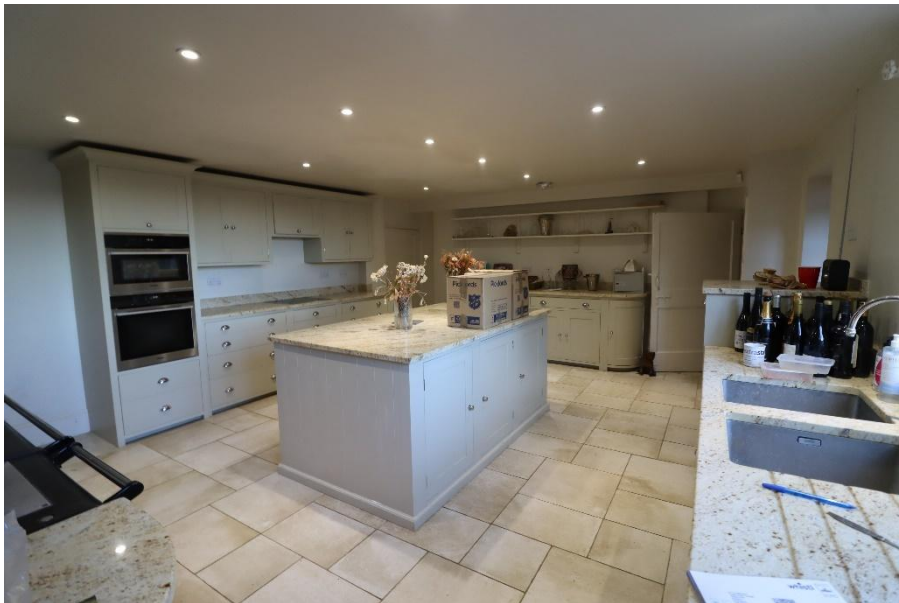
C20th kitchen to be removed and replaced

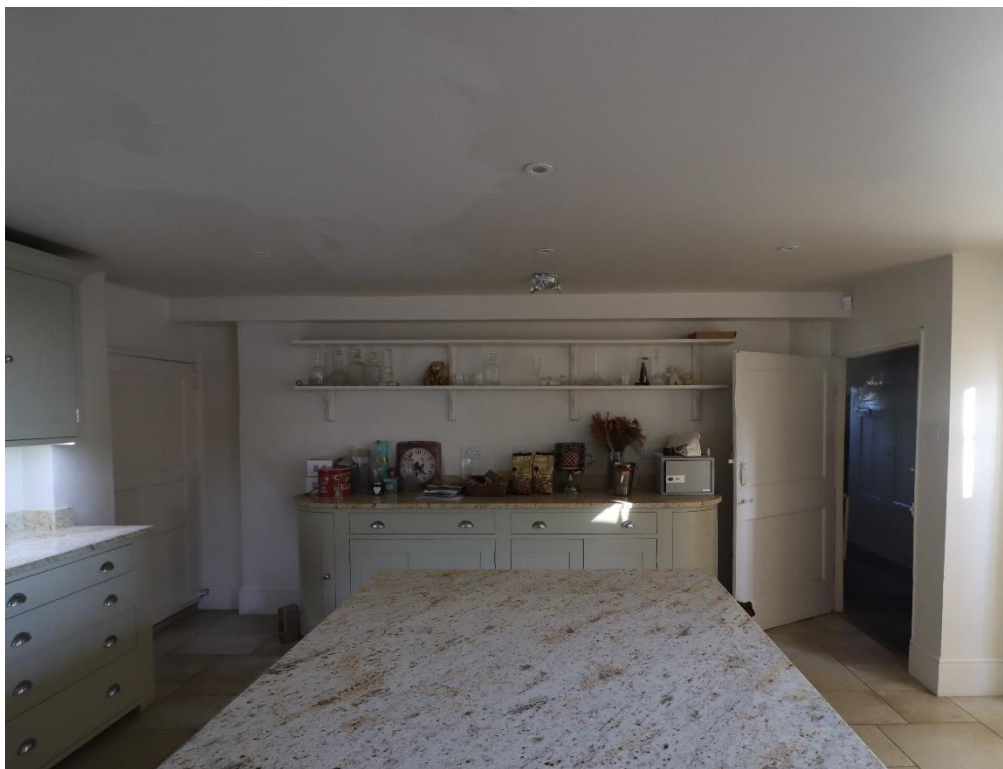
MC20th wall (forming Butler's Pantry) and shelving to be removed

| 27 | Removal of C20th partitions forming Butler's Pantry and Larder.<br><i>Note: The C20th partition and 2no doors separating the service corridor from the Butler's Pantry &amp; Kitchen will be retained.</i> | Low<br><br>MC20 <sup>th</sup><br>alterations | Low Impact<br><br>Benefit & Enhance | These partitions were constructed as part of the 1939 works. The harm caused by the loss of the MC20 <sup>th</sup> fabric is offset by the overall conservation benefit of the renovation of the service wing. The game hooks located in the ceiling beam in the cold store/larder (Historic Building Recording p.27) will be retained. Removal of the C20 <sup>th</sup> partitions will restore the kitchen to its former proportions. The doors from the fitted MC20 <sup>th</sup> cupboards in the Butler's Pantry will be re-used to form cupboards in the proposed Butler's Pantry and Pantry. |

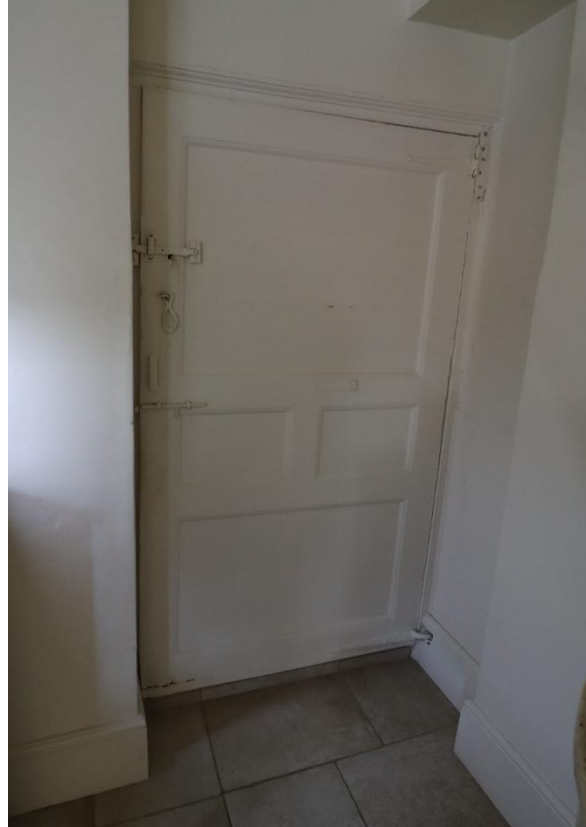
Georgian door (Historic Recording P20) to be relocated to form lobby to Master Bedroom suite

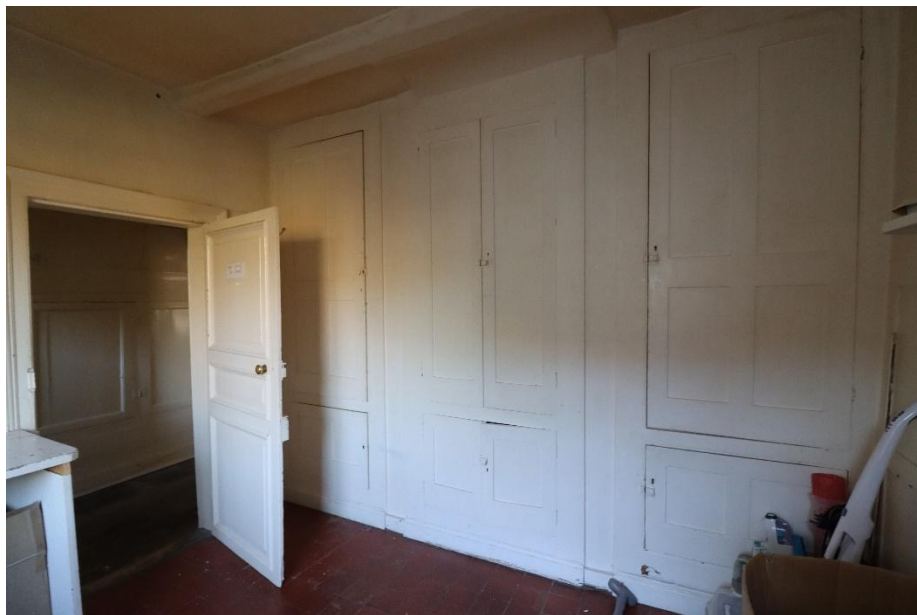
Butler's Pantry. Partition to corridor and existing door D1 to be retained.  
MC20th fitted cupboards to be relocated to new Butler's Pantry

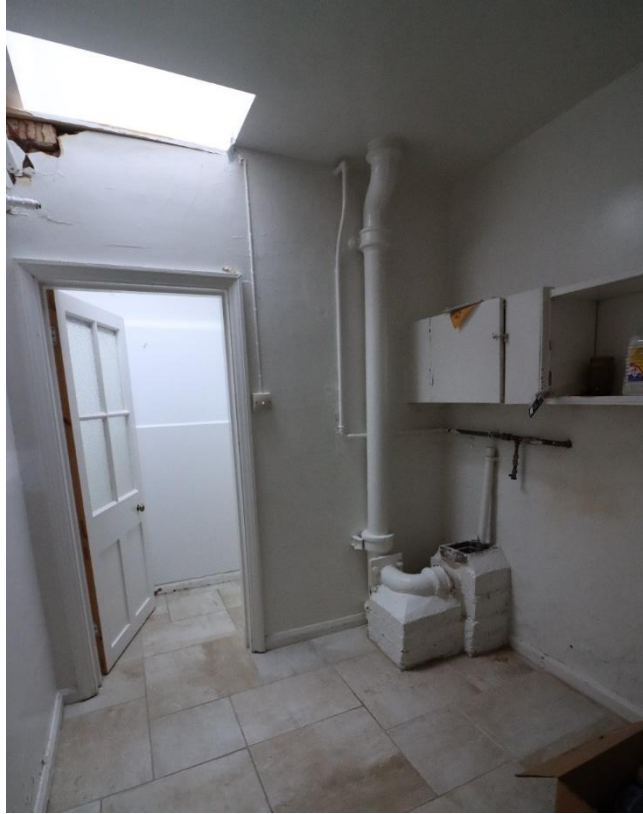
Lobby to Cloakroom. C18th walls to right & left to remain. MC20th door, partition and rooflight to be removed

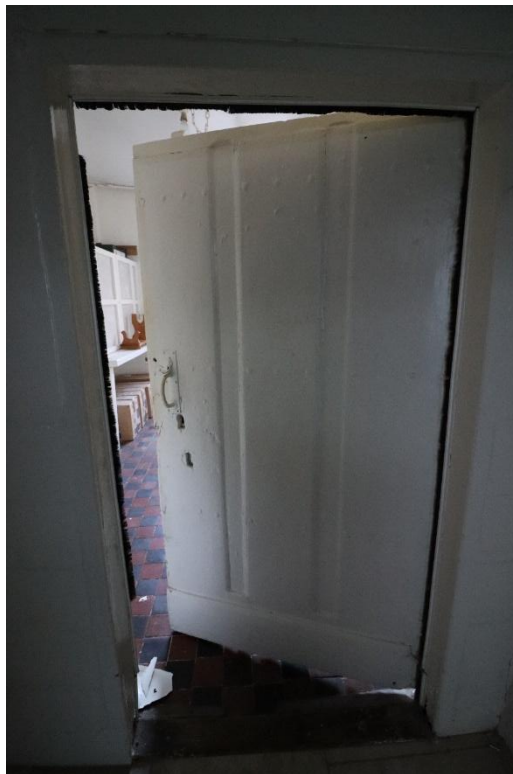
C17th style door to Cold Store to be relocated to new Laundry (Historic recording P 26-27)
