## HERITAGE, DESIGN AND ACCESS STATEMENT FOR PROPOSED WORKS AT JULIANS PARK

**RENOVATION TO VILLA ROOF & PROPOSED NEW ROOF ACCESS, EXTERNAL RENDER AND STONE REPAIRS & INTERNAL ALTERATIONS AT GROUND, 1<sup>ST</sup> & 2<sup>ND</sup> FLOORS.**

**EXTERNAL RENDER REPAIRS AND THERMAL UPGRADING TO MUSIC ROOM.**

**RENOVATION OF SERVICE WING TO FORM A NEW KITCHEN.**

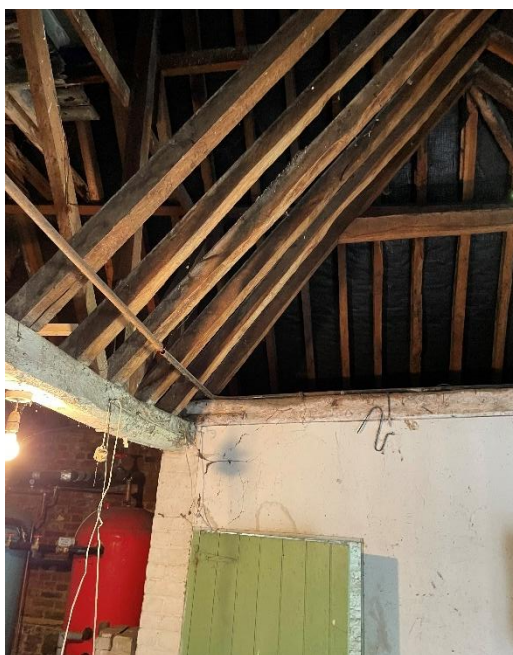
Existing Boiler Room. MC20th partition and door forming workshop to be removed. Historic rafters to remain.

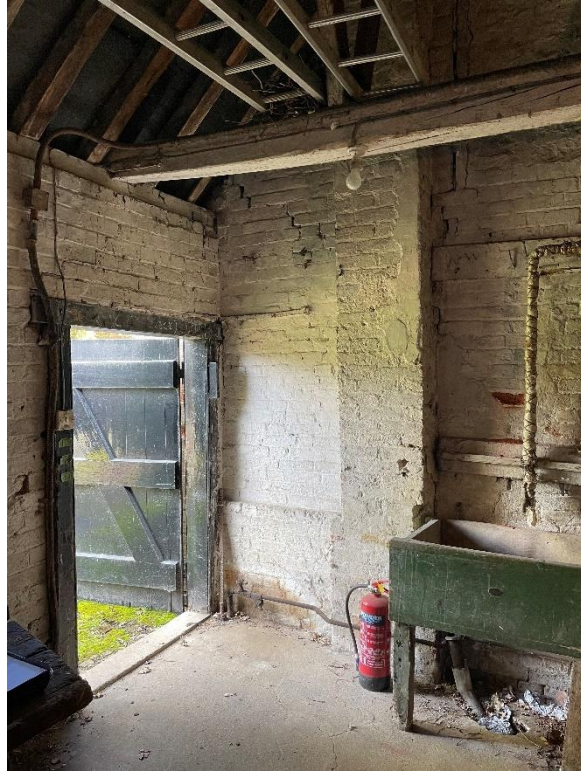
Boiler Room. Masonry flue and brick infill panel (rhs of MC20th door) to be removed

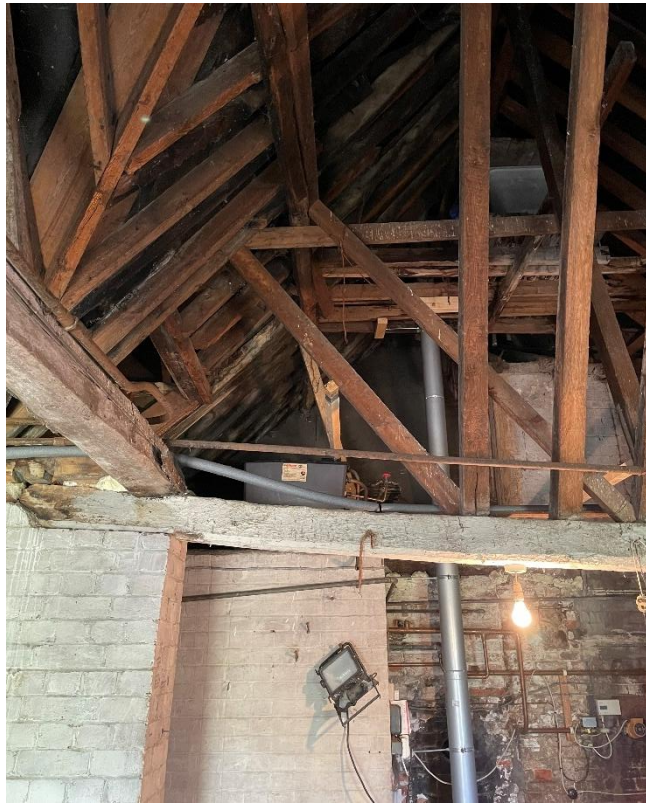
Structural solution for support of deflecting timber beam to be confirmed. MC20th corner to kitchen food cupboard behind pier

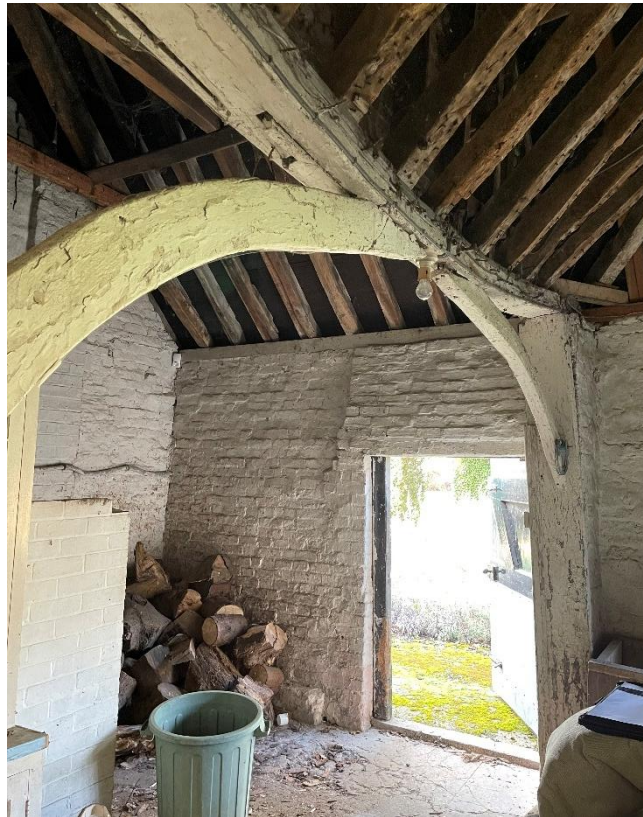
Store. Timber frame and spandrels with failing scarf joint to be repaired.

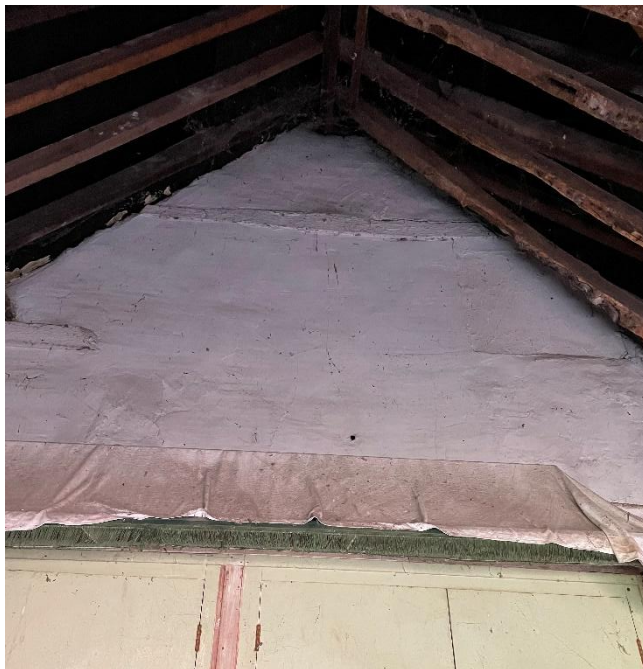
Opening to be removed in timber stud gable wall (from 1<sup>st</sup> floor Linen Room)

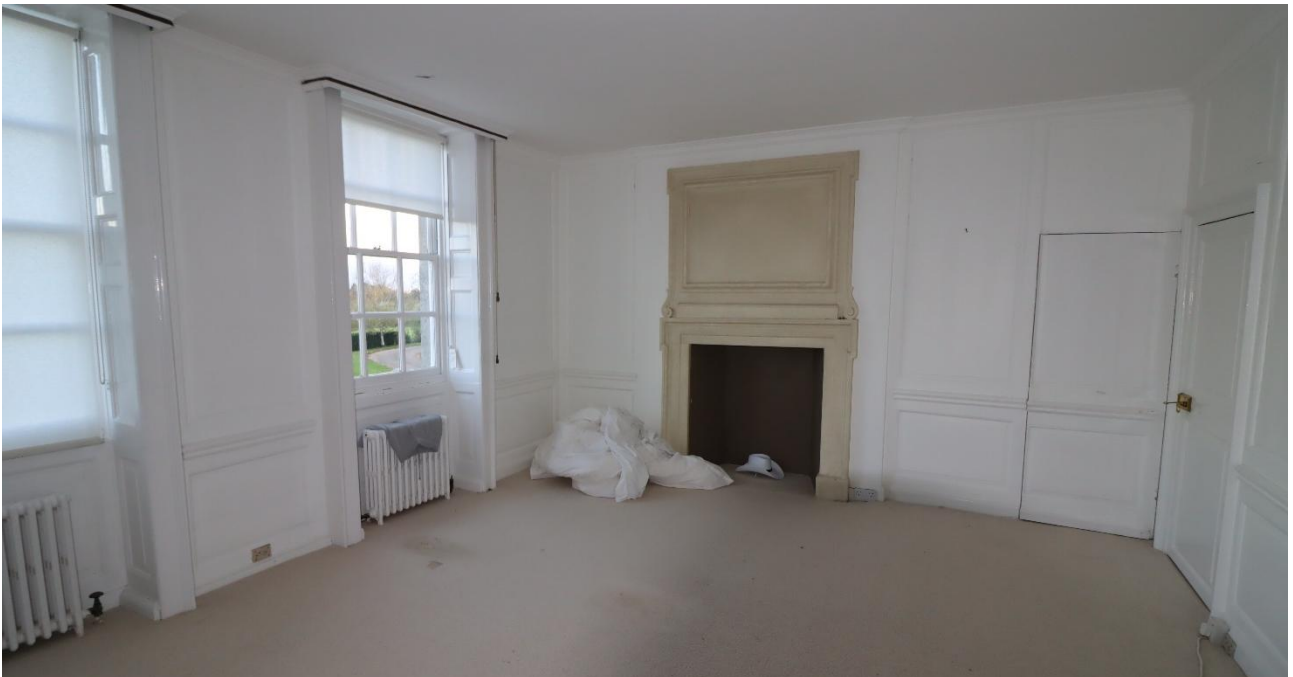
First Floor south-west bedroom to be converted to Master Bedroom Ensuite Bathroom  
2no doors (rhs) to be retained and fixed shut.

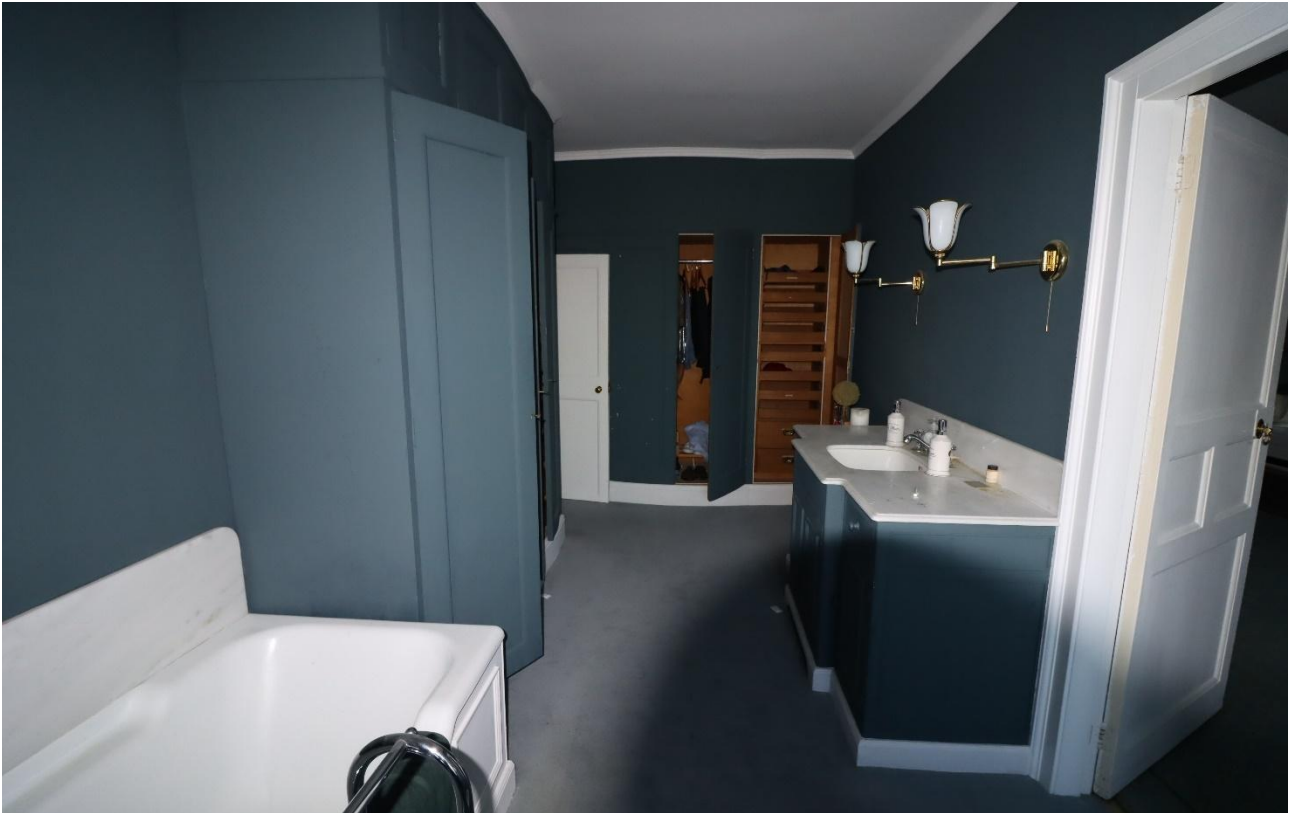
Existing ensuite bathroom to be converted to Dressing Room serving Master Bedroom Suite

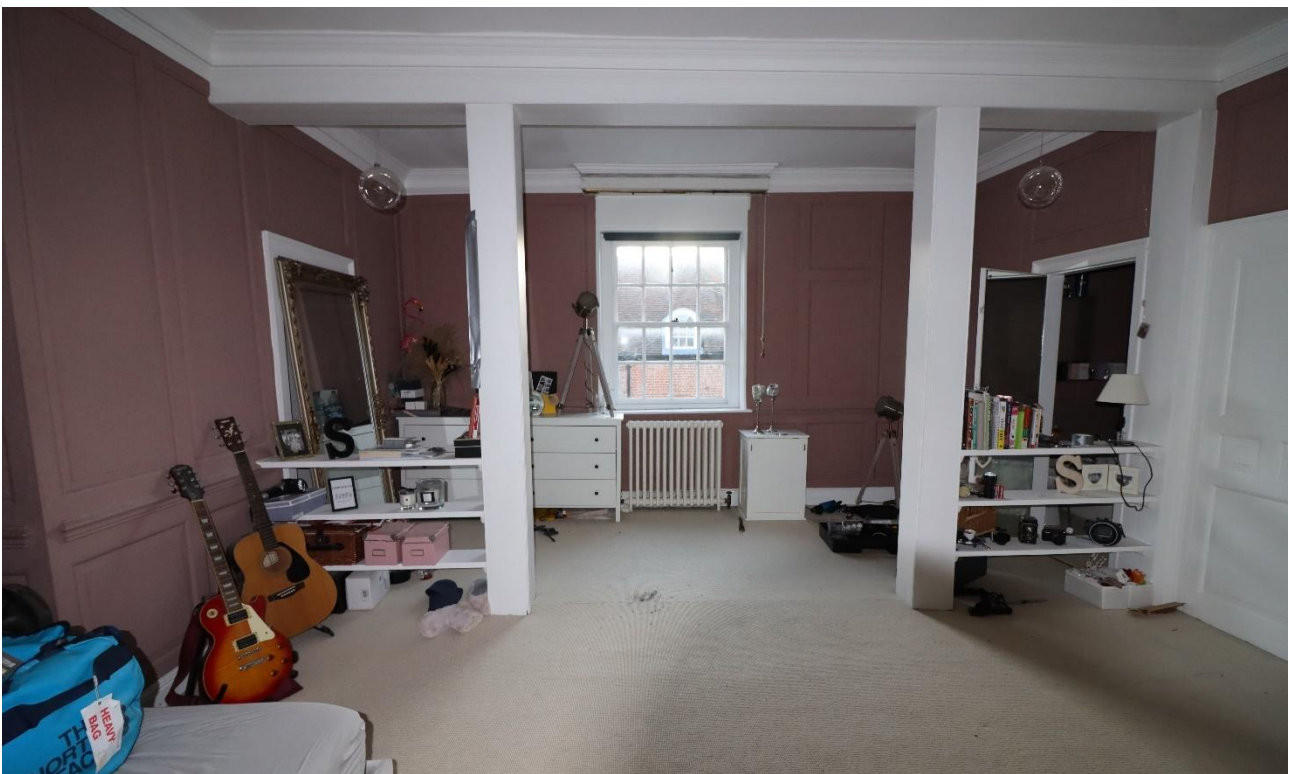
Bedroom 2 existing door (behind mirror lhs) to be opened up from bathroom side

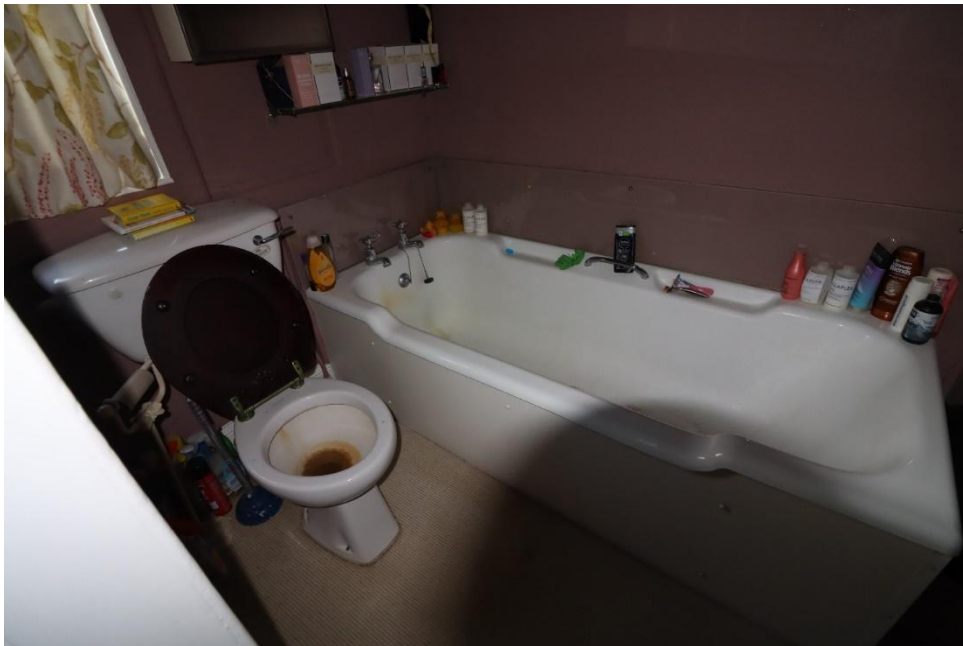
Existing ensuite to Bedroom 2. MC20th sanitaryware, plumbing and drainage to  
be removed. Room to be converted to a Dressing Room

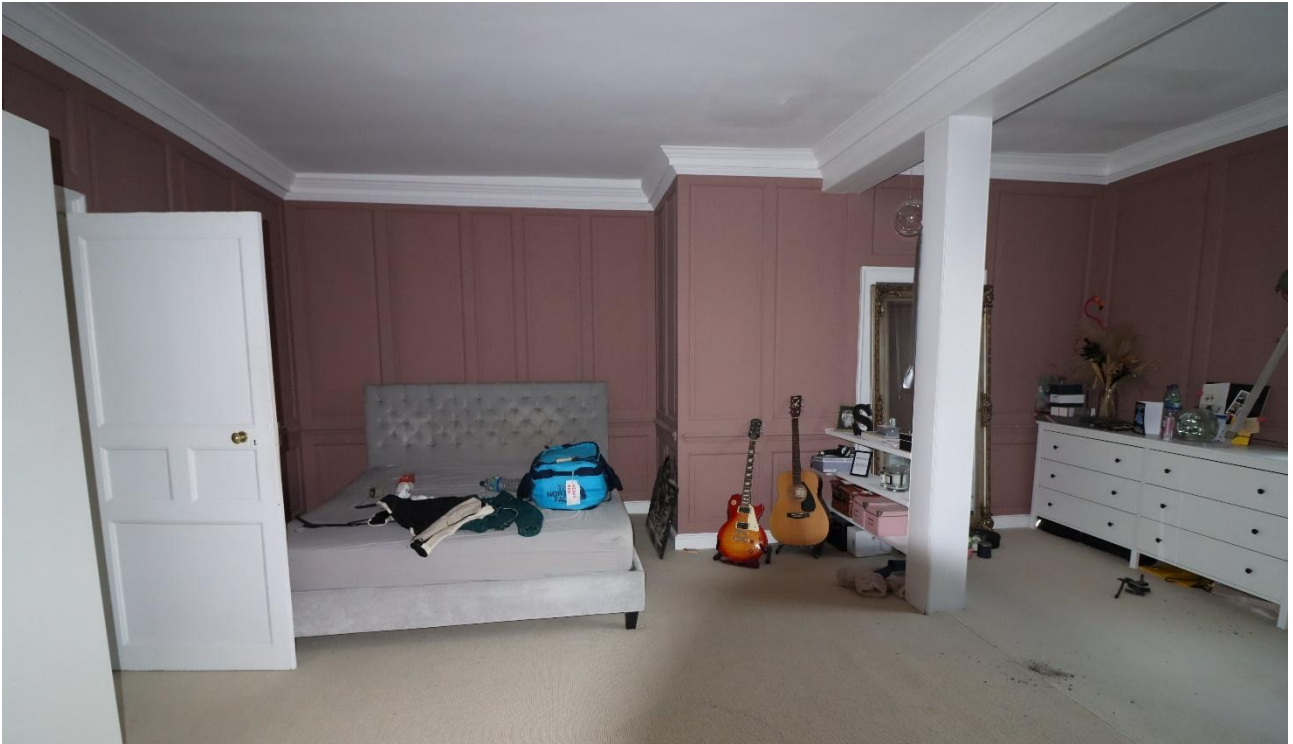
Matching door from kitchen to be relocated to form lobby adjacent to Bedroom 2 door

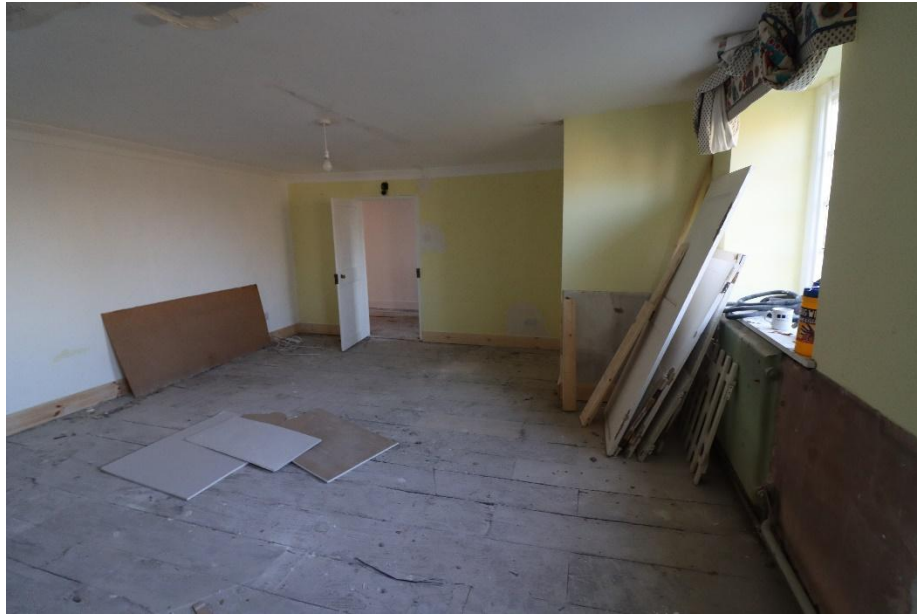
MC20th WC partitions to be removed (rhs)

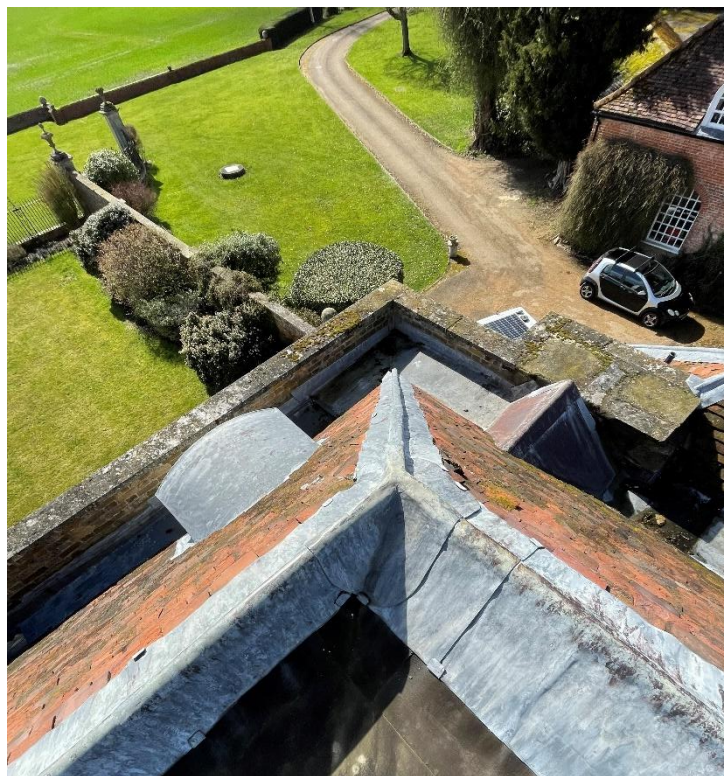
Top of west side lead clad dormer window

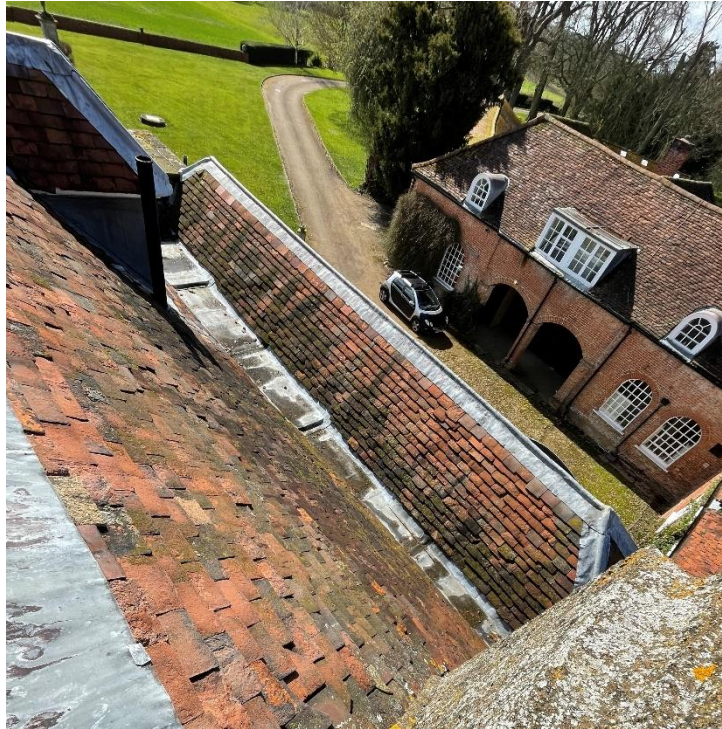
View to lead stepped valley gutter and tiled dormer window to 2<sup>nd</sup> floor bathroom (west side)

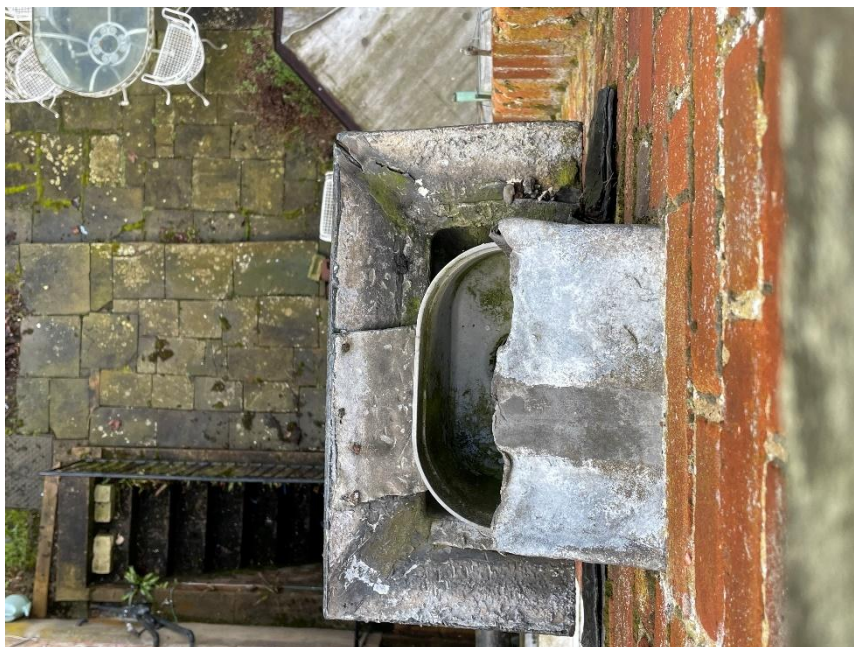
Existing rainwater outfall from flat roof to hopper (north elevation)

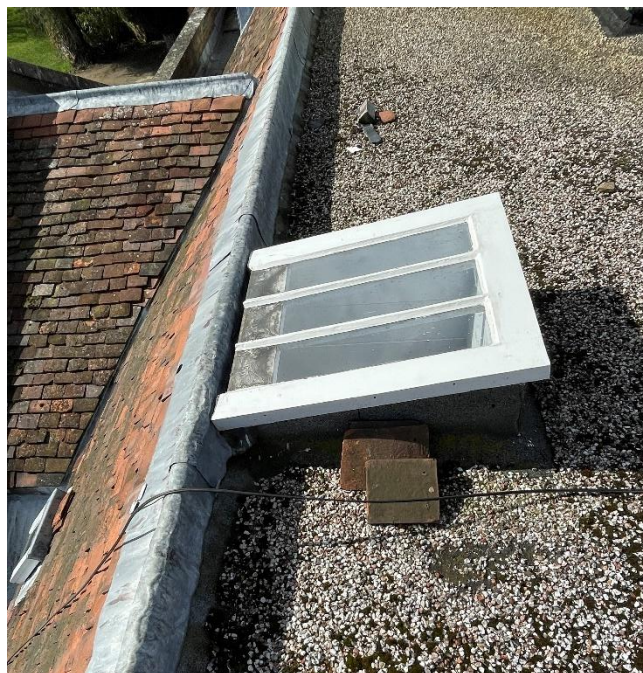
Rooflight R3 located against upstand kerb

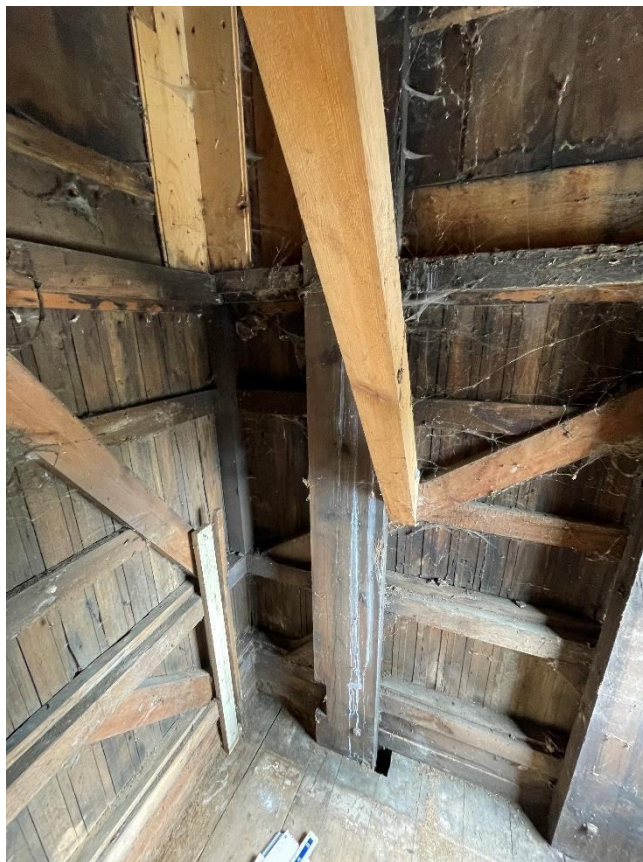
C20th bracing inside clocktower proposed to be removed to allow insertion of new ladder

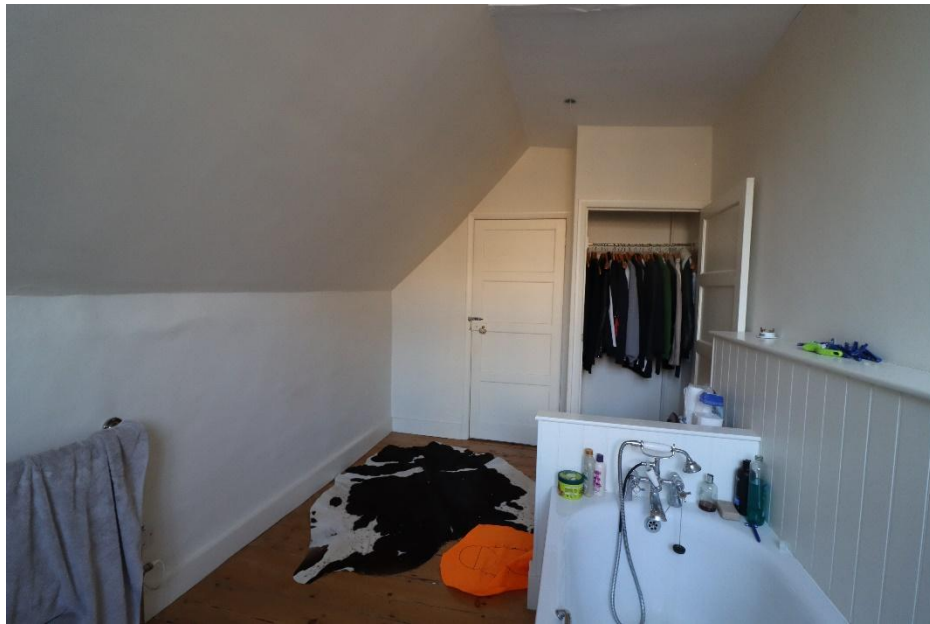
First Floor bathroom to Coach House to become part of proposed second annexe.

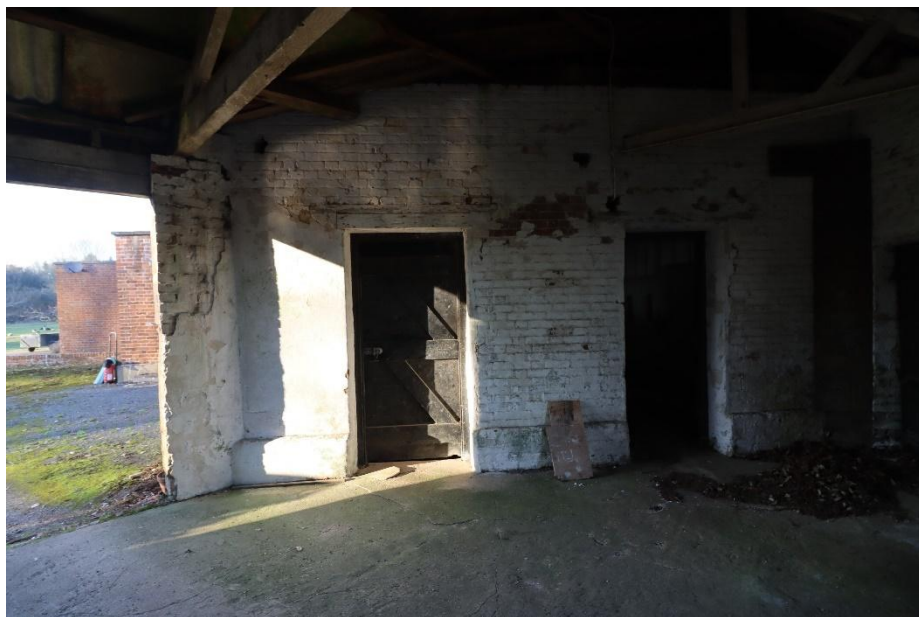
2no external ledge and brace doors (to be retained) to south wall of former Coach House. Door into Store (lhs) to be re-hung.
