# **Letchworth Golf Club**

## **Halfway House**

### **Tree Protection Plan**

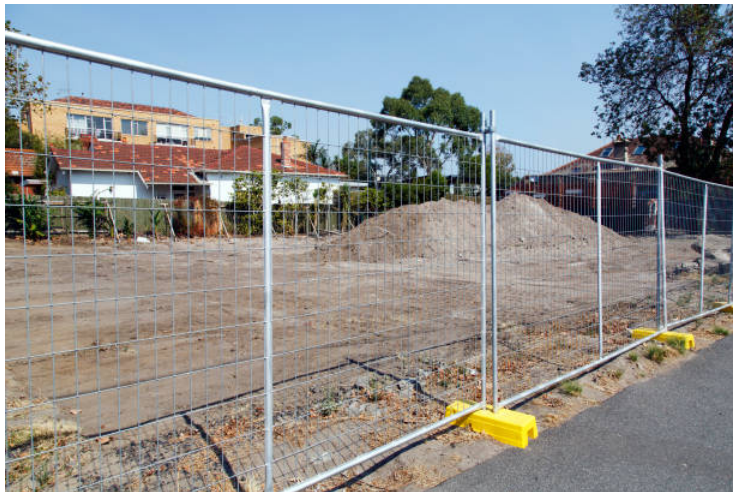
Heras Fencing Image.

The protective/enclosing fencing will be Heras fencing or equivalent (see attached photo) and will be installed prior to any site clearance, demolition or construction work.
