## Remediation Strategy

Proposed Residential Development

Greenside, London Road, Langley

Document no.: STX6902-R02-Rev\_B

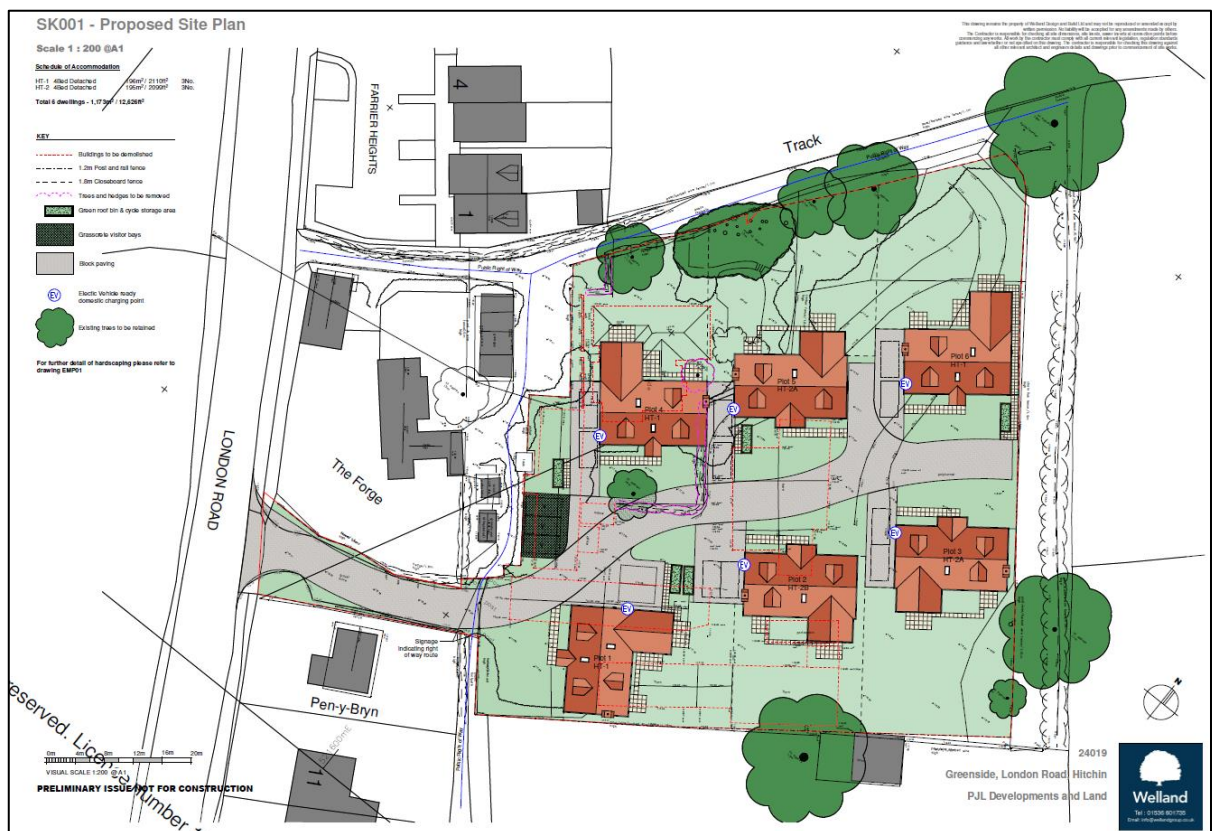
Figure 1-A: Snapshot of proposed development

- 1.1.1 The proposed redevelopment comprises the demolition of the existing dwelling and auxiliary outbuildings/workshops and the construction of six detached residential properties with private gardens, together with an access road and parking areas.
- 1.1.2 It is understood that the development is controlled under the North Hertfordshire District Council planning regime, under application reference 24/00671/FP.
- 1.1.3 A snapshot of the proposed development is shown below.

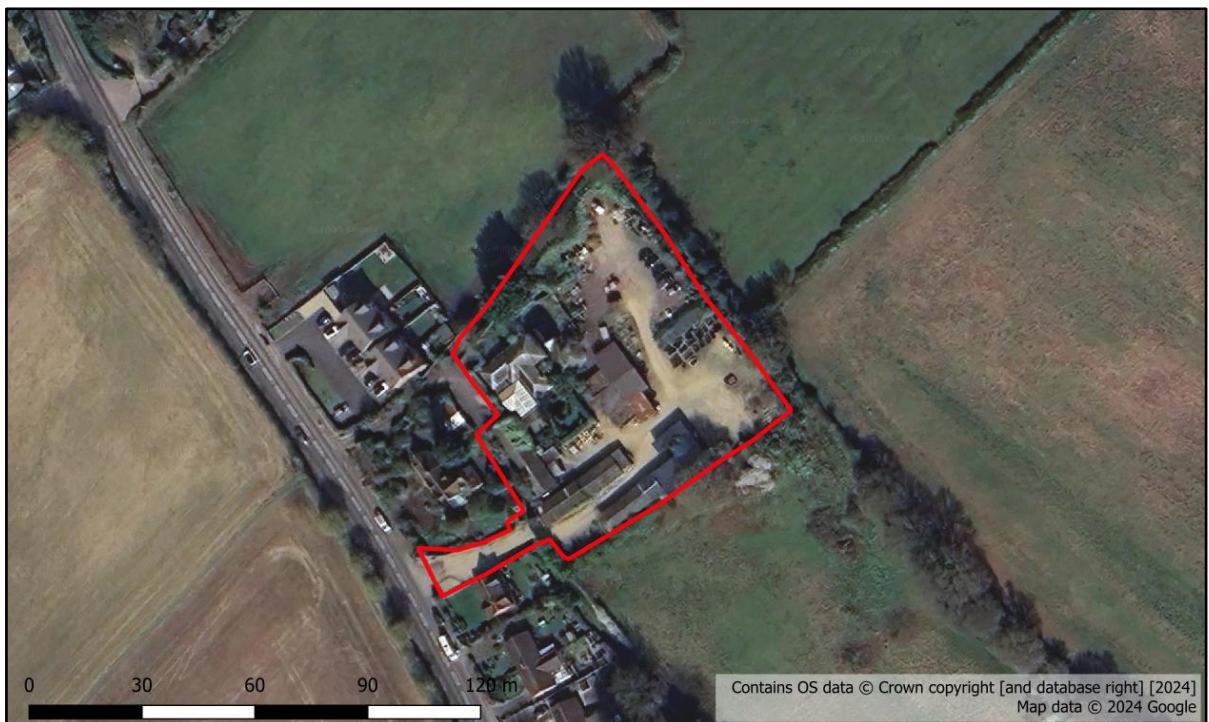
Figure 2-A: Aerial photograph and approximate site boundary

- 2.1.1 The site lies within the village of Langley, Hertfordshire at post code SG4 7PP. The site is accessed from London Road (B656) which lies adjacent to the site's south-western boundary.
- 2.1.2 The site (approximately 0.5 hectares in area) currently comprises a single residential dwelling, with the remainder of the site consisting of a yard and a number of outbuildings. An access driveway is present to the south-west of site. The surrounding area mainly comprises agricultural fields with a small number of residential dwellings to the west of the site boundary.
- 2.1.3 An aerial image showing the approximate site boundary is presented below.

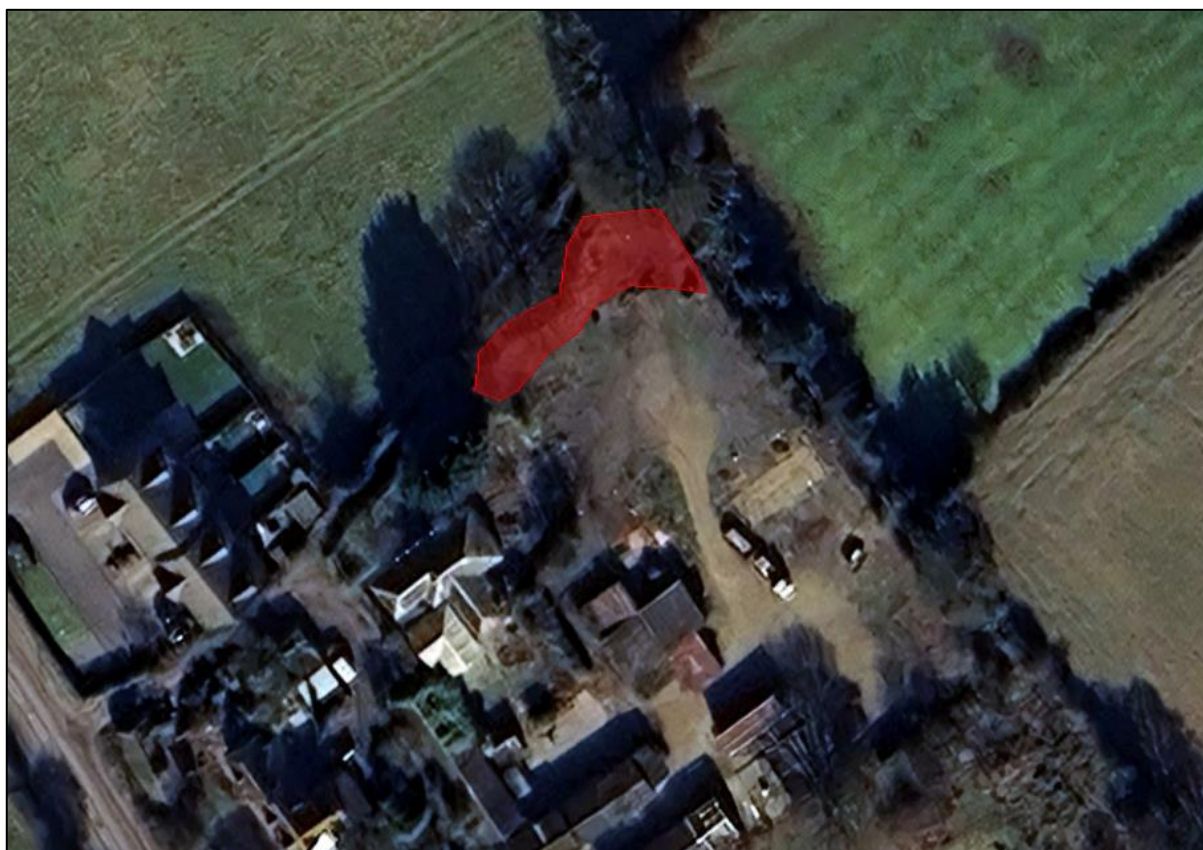
*Figure 3-A: Approximate location and extent of mound*

- 3.5.1 During the ground investigation, mounded material was noted in the northern corner of the site forming a bund between the edge of the yard area and the site boundary approximately 38 m long
- 3.5.2 Prior to commencement of construction works the material should be inspected and tested to characterised the material to help inform disposal costs or assess its potential for reuse.
- 3.5.3 The approximate location and extent of the mound is shown in the figure below.
