**Brainkind Neurological Care Centre, Stagenhoe Park, St Pauls Walden, Hertfordshire, SG4**

**8BY - Application ref 25/01385/LBC**

**Justification**

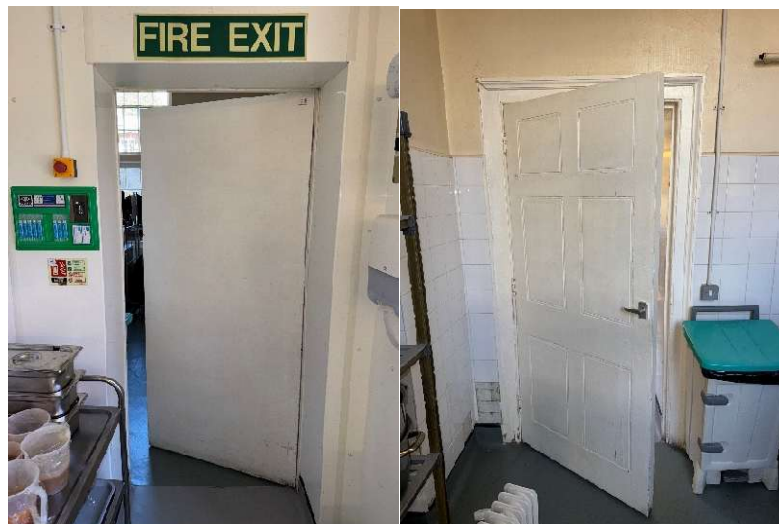
**Kitchen Store (8)**

This door is warped and does not fit within the frame. Because of this, it is beyond repair and will need to be replaced to ensure fire resistance.

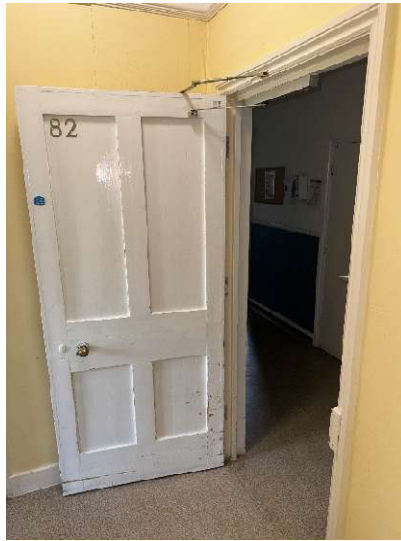
## Bedroom 82

The door is beyond repair due to damage at the bottom and a split on the side. As a result, the fire integrity of the door has been compromised, making it uneconomical to repair.

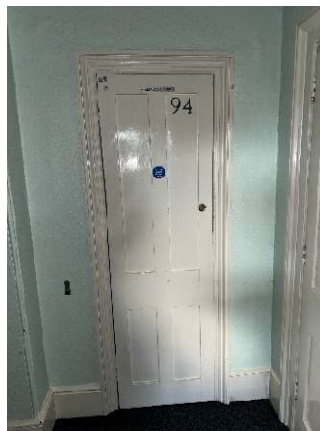
## Store Cupboard 94

Door currently isn't a fire door due to this being a store cupboard we would need to replace it. For this door compared with the others we could use the 2 Envirograf products mentioned above

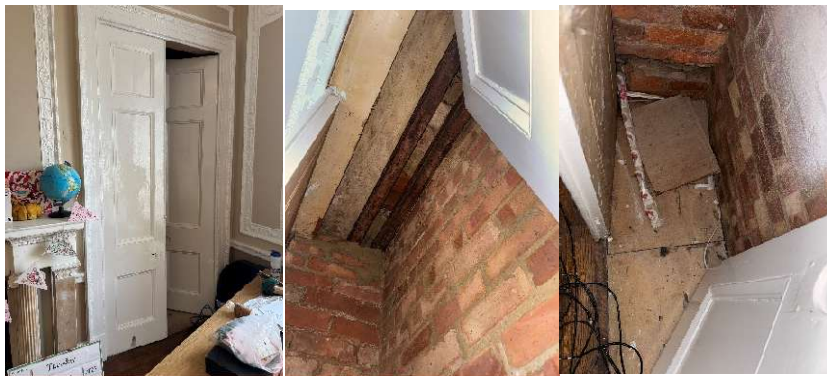
Item C (7.03)

Yes works to historic fabric. The original cupboard are not fire resistance and could allow a potential fire to spread upwards.

Frame out the soffit with timber battens, minimum 50mm x 50mm sections. Board frame with 15mm fireline plasterboard and seal gaps around the perimeter with Envirograf Intumescent Acrylic and Acoustic Mastic, Product 58. Apply mist coat and 2Nr coats of vinyl silk emulsion to new areas.

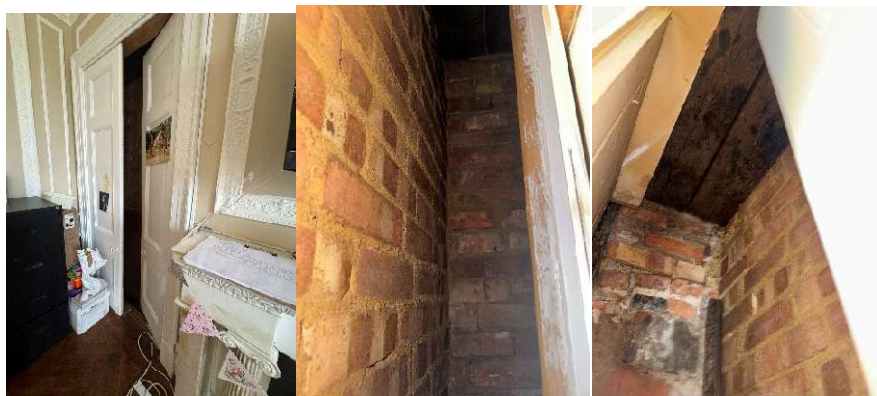
Item D (7.04)

Same as above item.

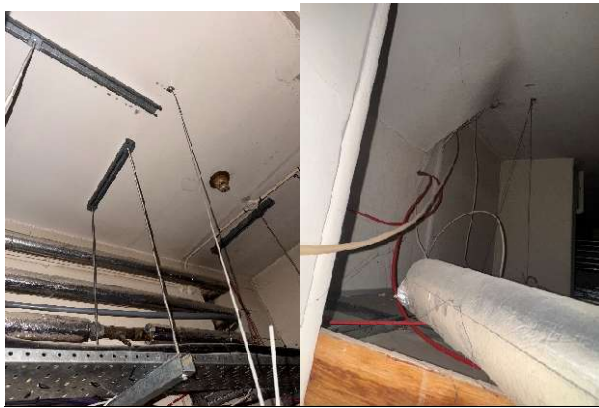
Item H

Yes works to historic fabric, holes within the original ceiling, these holes enable fire to breach the compartment

To approximately 10Nr areas of small damaged section so of plaster forming the original ceiling finish; square off cracks/holes assuming a maximising size of 200mm x 200mm. Overboard laths with fireline plasterboard securing fixed with mechanical fixings. Seal joints with Envirograf Buildfix Multi-Purpose Flexible Building Adhesive, Product 48.

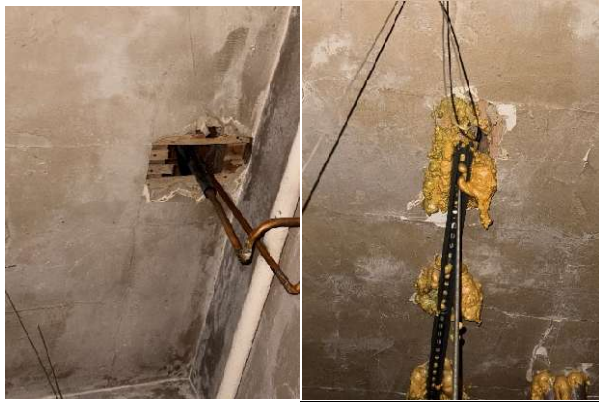
Item K (7.11)

Yes works to historic fabric, holes within the original ceiling, these holes enable fire to breach the compartment

Overboard laths and any structural beams with 15mm fireline plasterboard mechanically fixed to joists. Board joints, screwheads and abutments with walls to be sealed with intumescent filler and mastic sealant.
