## Design and access statement

28 St Albans Road, Codicote, Herts, SG4 8UT

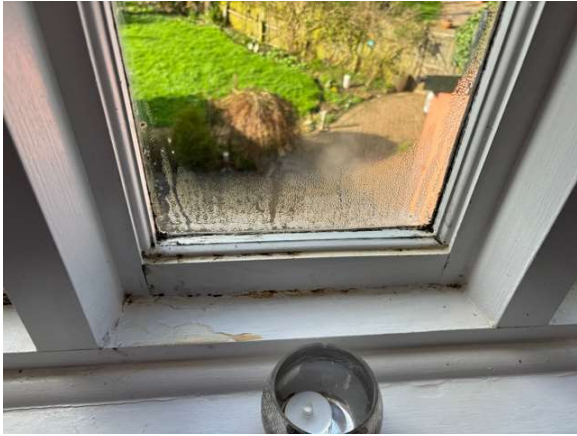
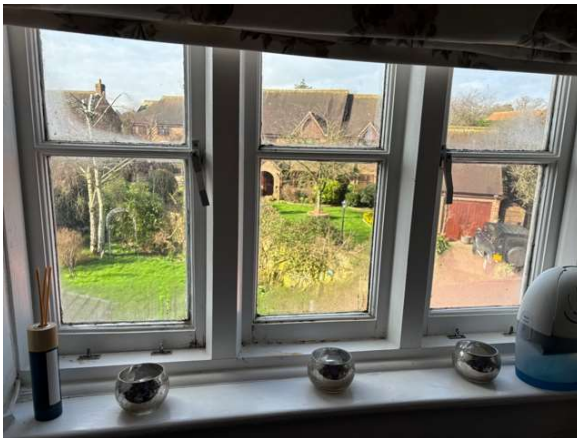
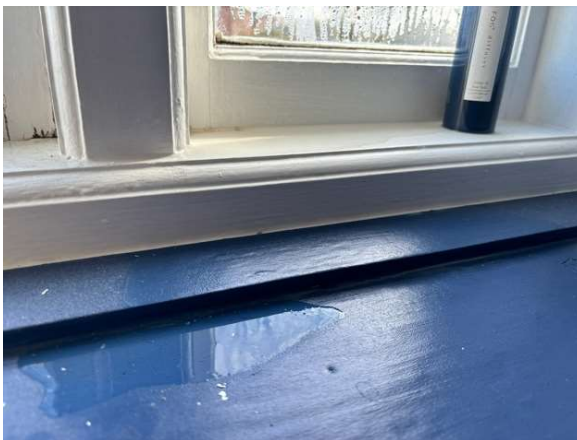
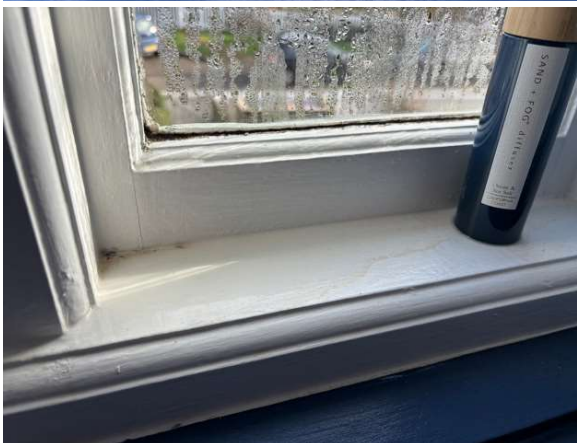
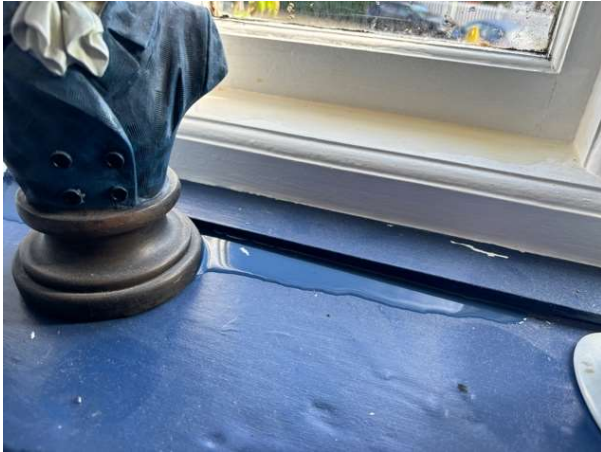
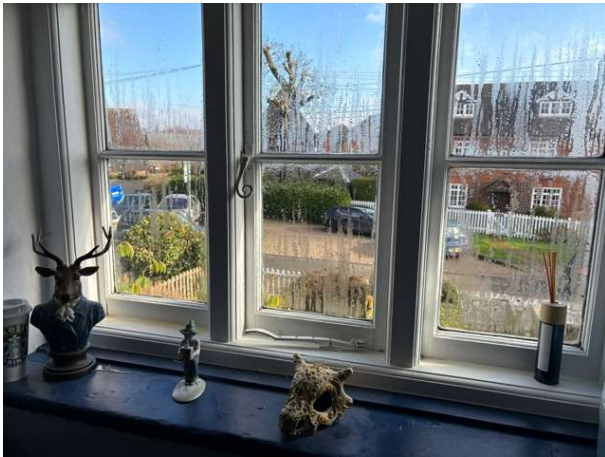
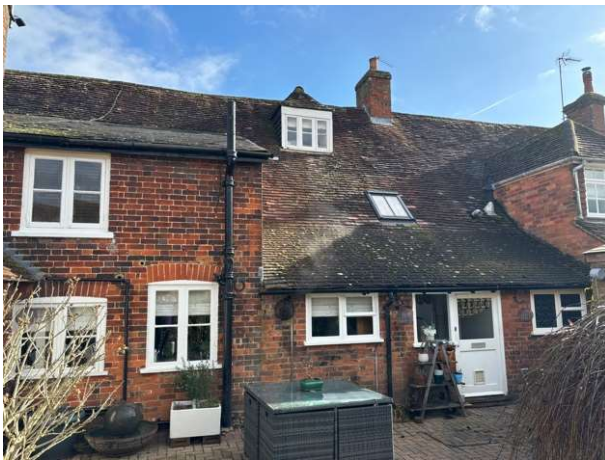
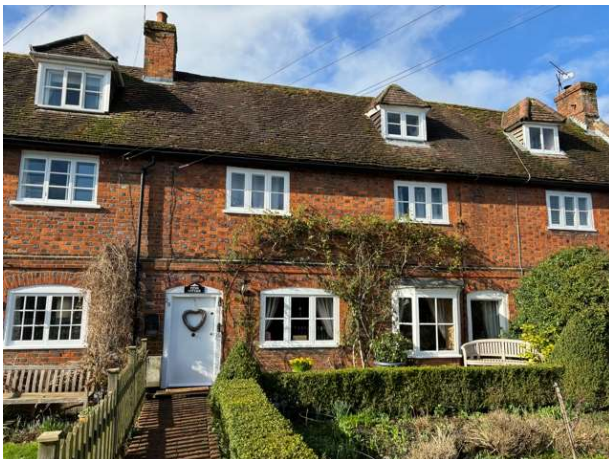
### Images of current condition of windows:

The property is in a good state of repair, however in order to bring the building back into future use, essential works are needed to the windows which are in poor condition. The proposals are for essential replacement works to increase the buildings life. The current condition of the windows results in condensation forming on the inside of the property. This is causing a build of mould as well as rotting the frames.

Below you will see the current condition of the windows. You can see that the frames are rotten and not fit for purpose. Furthermore, there is evidence of the condensation build up as well as the water pooling in areas around the windows. By replacing the windows, we will be preserving the historical interest of the property.

The proposal is to replace existing single glazed casements to the façade with new double glazing. New windows will have thermal, acoustic, operational and build qualities. Furthermore, there are currently no fire exit windows on the first or second (attic) floors. This is something that would be resolved as you can see in the detailed drawings of the proposal. Most importantly, this can be achieved without altering the original appearance of the windows. The proposed works are for the purpose of both protecting the important historic elements of the original part of the building whilst also bring the property in line with modern living needs.
