WG9

Drawing of proposed replacement casements/ fixed windows (within existing frame and with new central timber mullion between fixed windows)

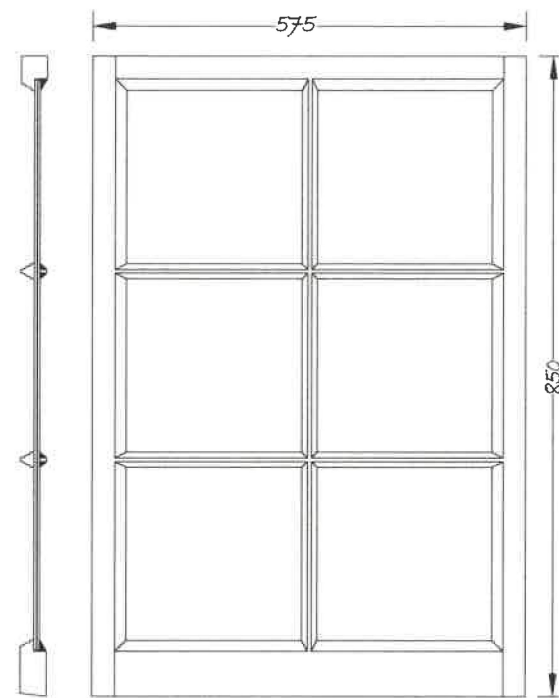
Drawing of proposed casement details

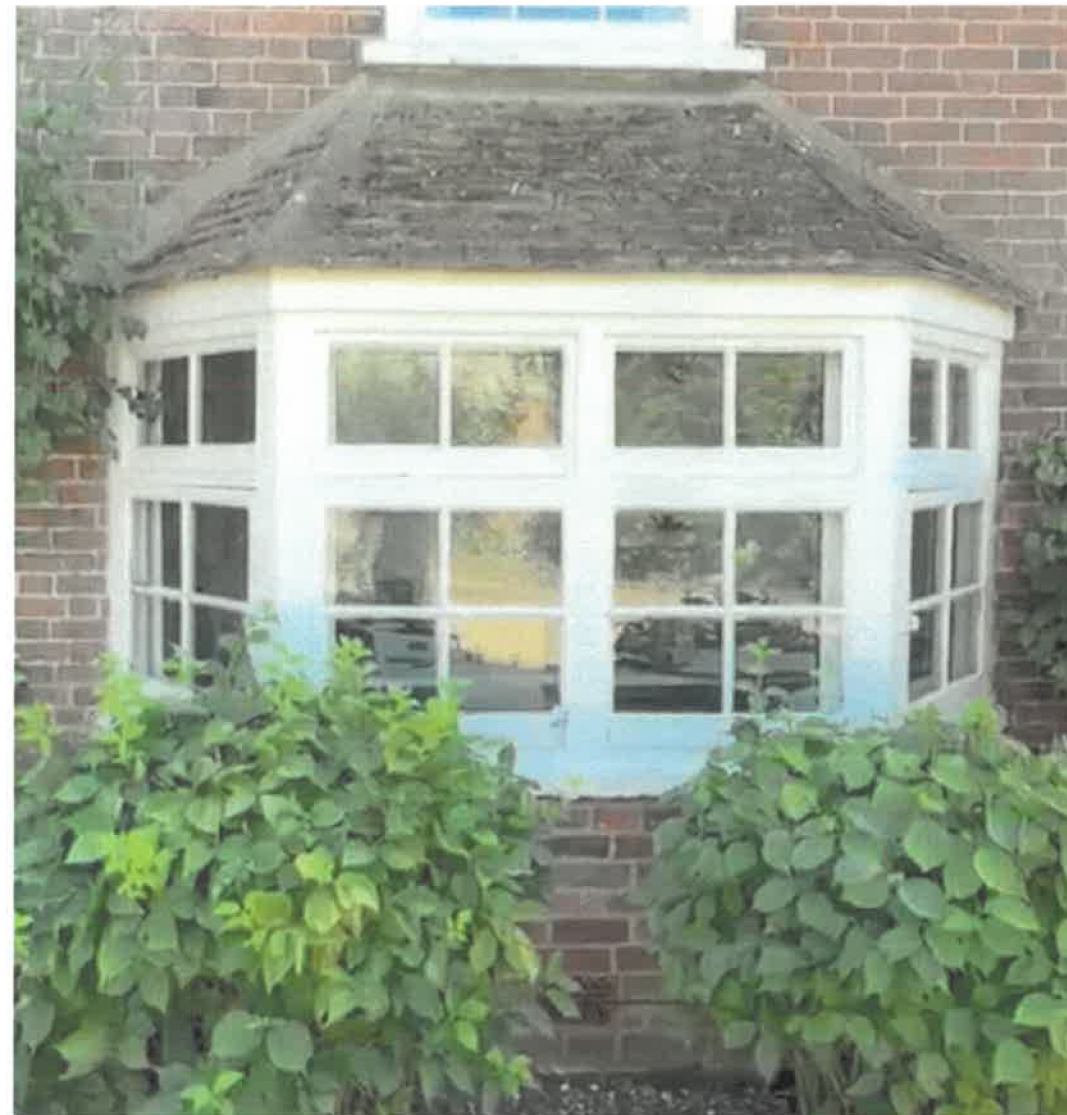
Photo of existing bay window

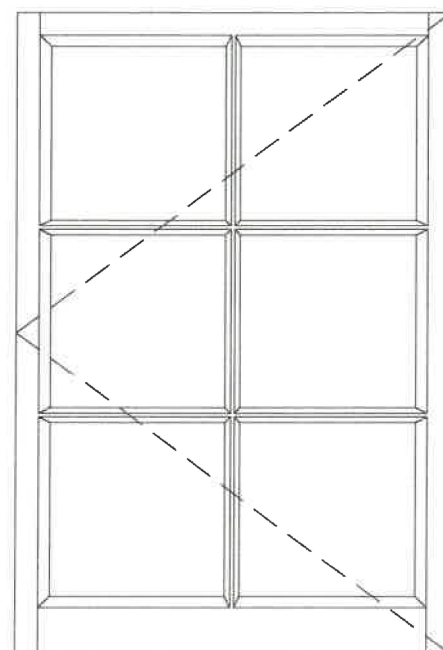
OPENING

FIXED
