Project **The Highfields School**

Title **Tree Constraints Plan**

Document Number  
**5297-RPS-XX-XX-DR-AR-9000**  
Project Code - Originator - Zone - Level - Type - Role - Drawing Number  
RPS Project Number  
**794-PLN-LAN-5297**  
**rpsgroup.com**  
Suitability  
**S3**  
Revision  
**P01**

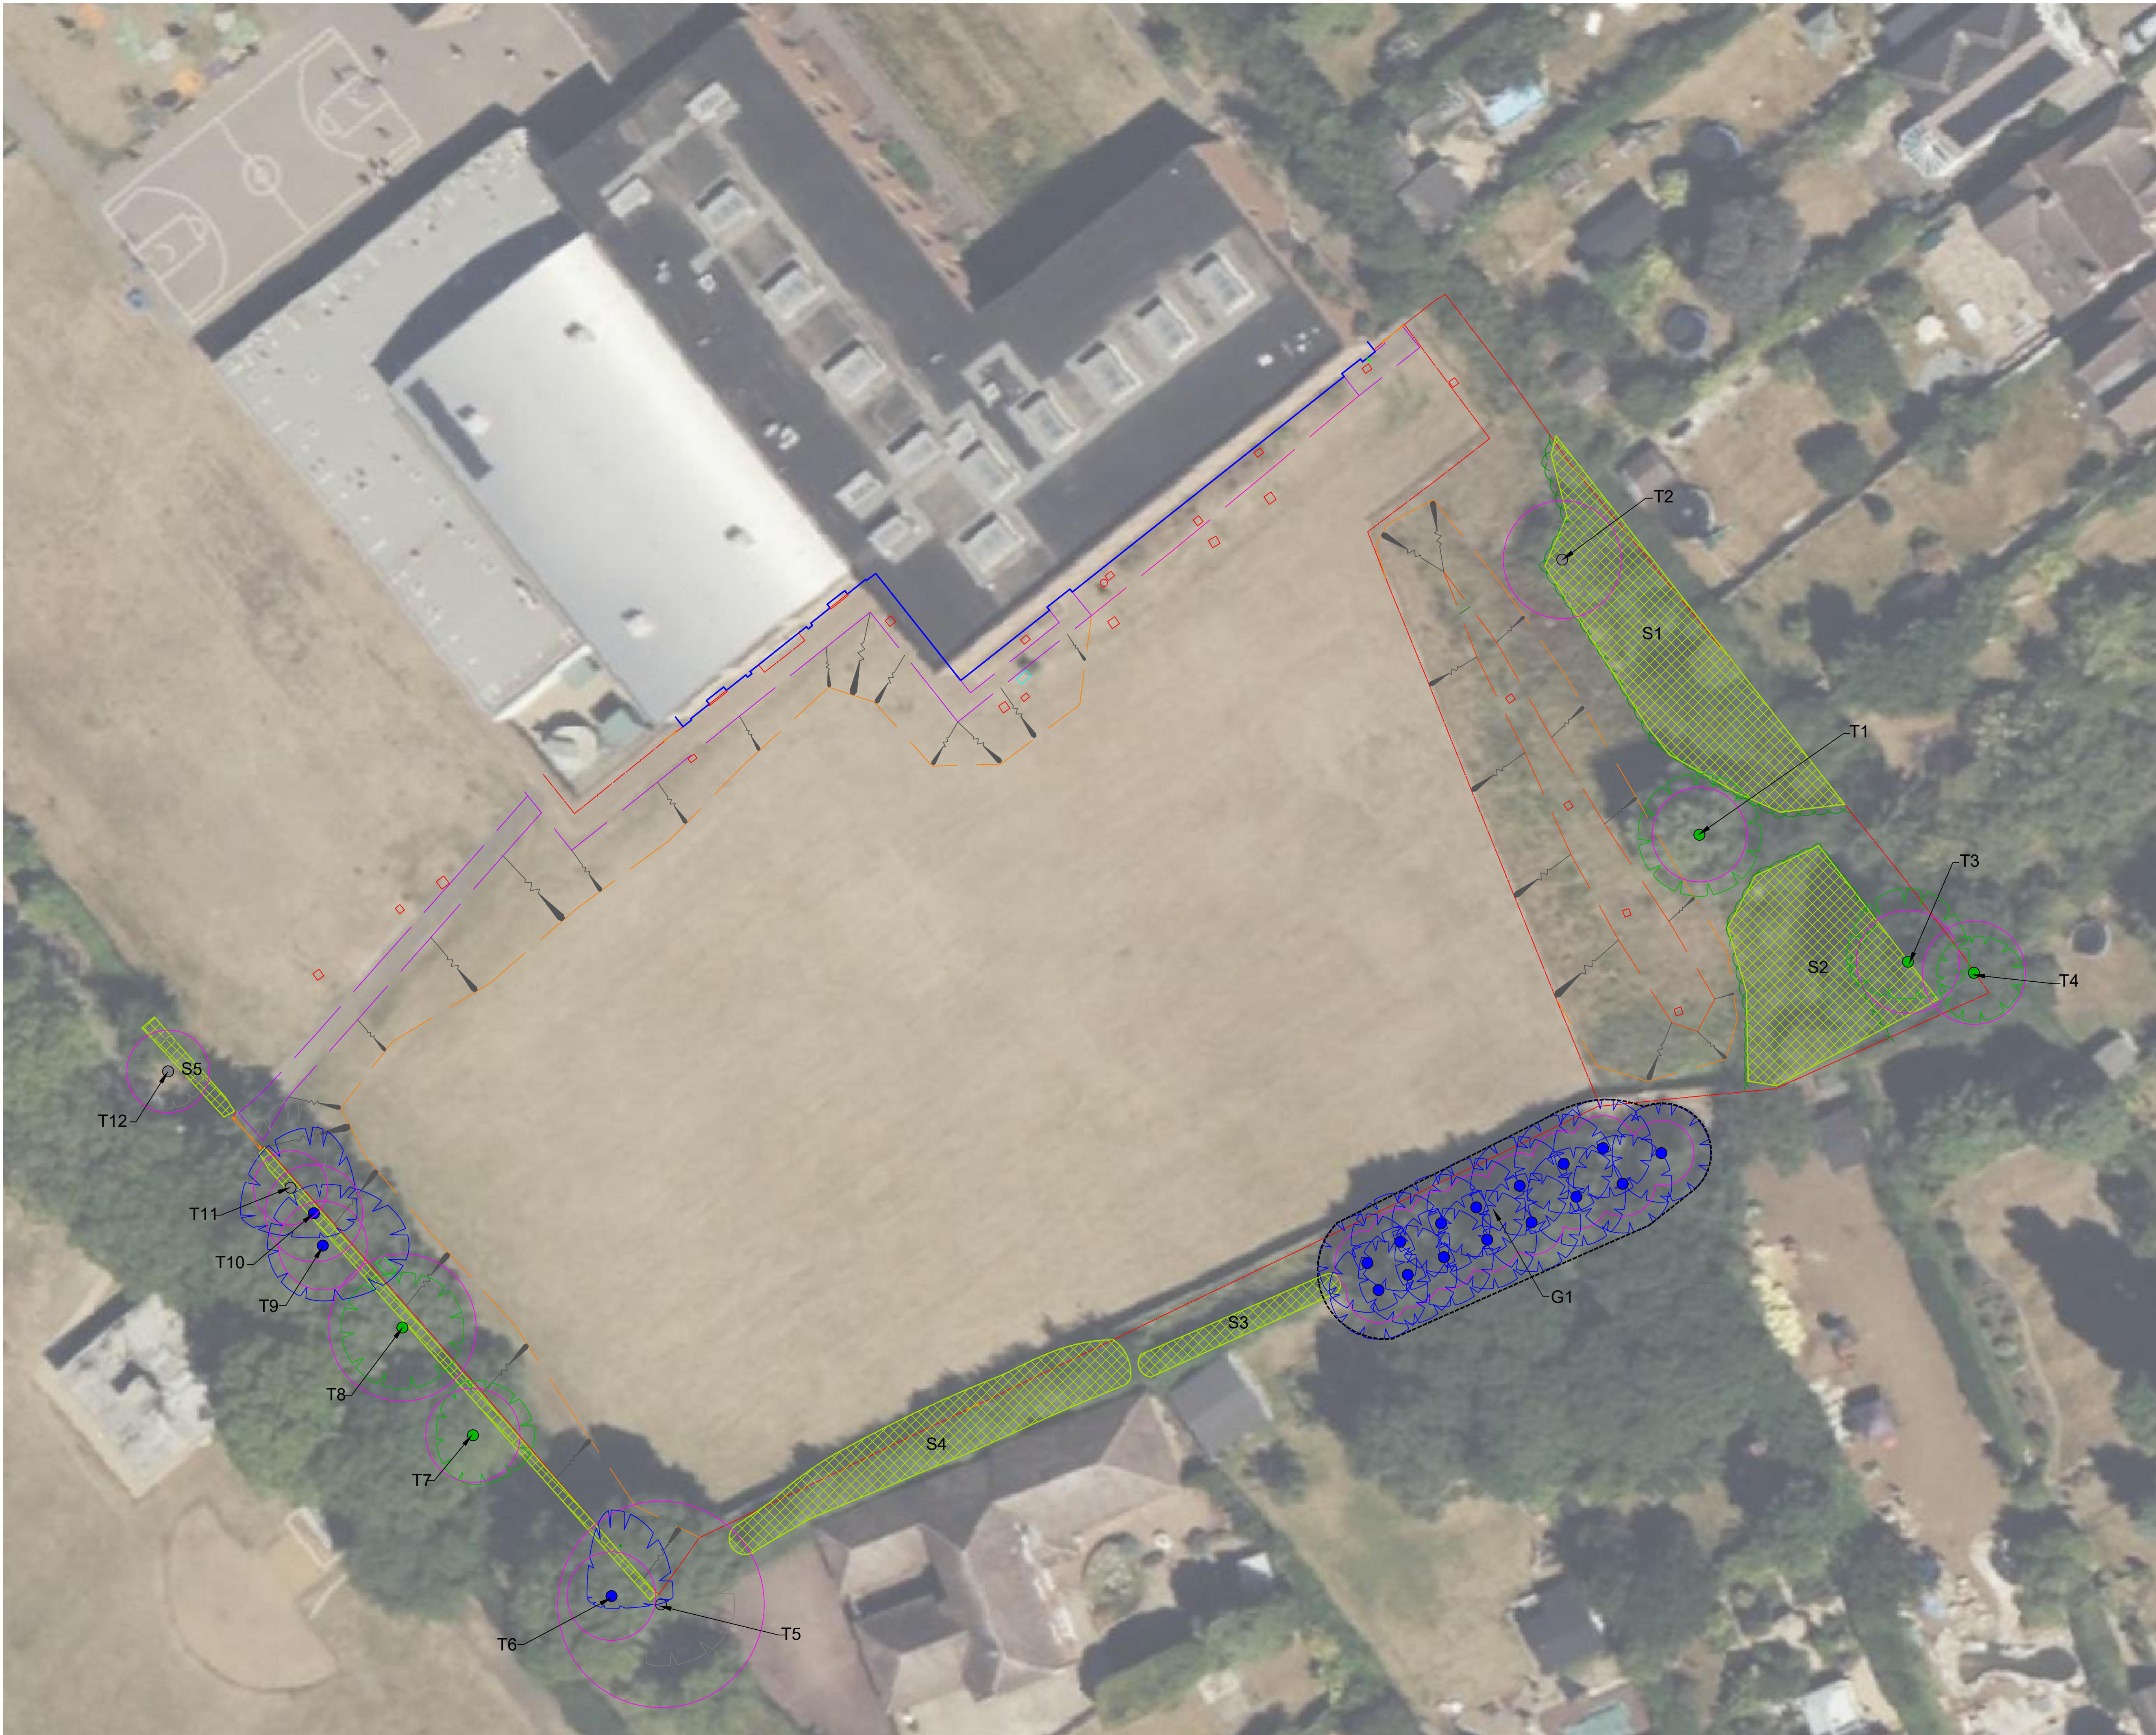
**NOTES:**  
• Refer to RPS Tree Schedule for further details.  
• Survey based on a visual inspection from the ground and is not intended as a full arboricultural inspection.  
• Plan produced in accordance with recommendations set out in BS 5837:2012 - 'Trees in Relation to design, demolition and construction'.  
• Due to the legal protection afforded to breeding birds vegetation removal should not take place during the bird nesting period; generally, although not restricted to, March - August inclusive.  
• Survey carried out using sub metre GPS survey device and Topographical Survey information provided by Client.
