# DESK STUDY & GROUND INVESTIGATION REPORT

Newmarket Road  
Royston  
Hertfordshire

Client: Countryside Properties

J16202

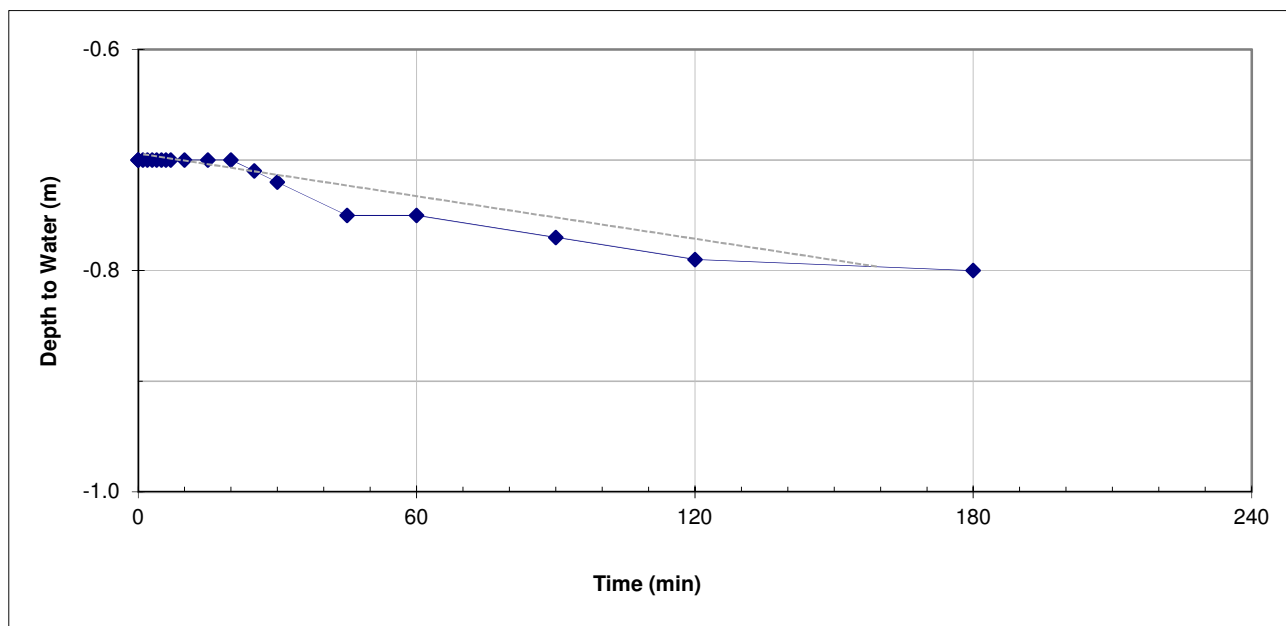
Trial Pit No. TP1 Soakage Test No. 1  
Pit Length (m) 2.2 Pit Width (m) 0.6 Pit Depth (m) 1

Design Soakage Rate 5.1E-06 m/s (based on linear portion of graph as shown)  
0.44 m/day

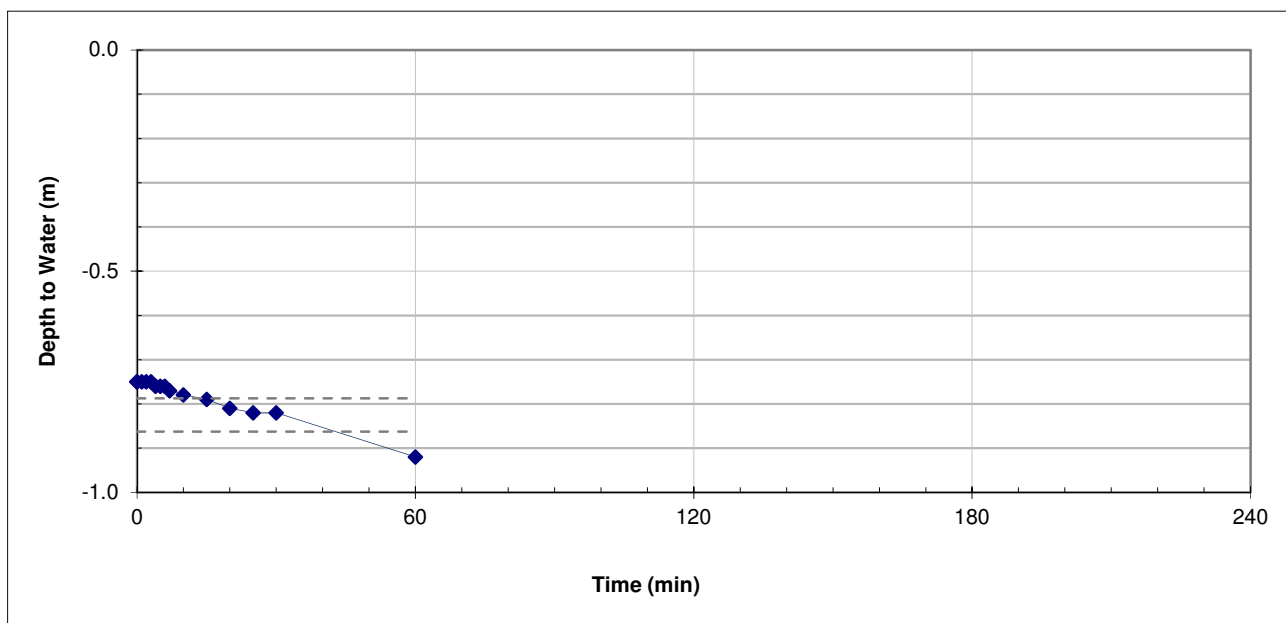
Trial Pit No. TP2 Soakage Test No. 1  
Pit Length (m) 2.2 Pit Width (m) 0.6 Pit Depth (m) 0.9

Design Soakage Rate 3.5E-05 m/s (based on BRE 365 method)  
3.04 m/day

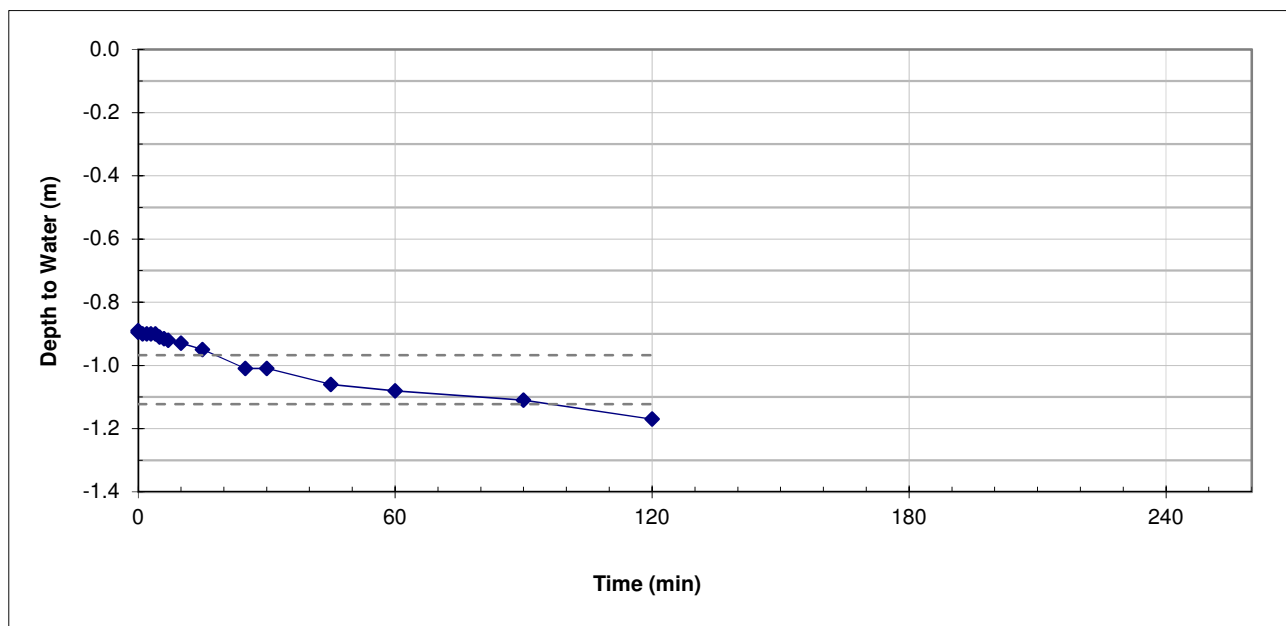
Trial Pit No. TP3 Soakage Test No. 1  
Pit Length (m) 2.6 Pit Width (m) 0.6 Pit Depth (m) 1.2

Design Soakage Rate 2.0E-05 m/s (based on BRE 365 method)  
1.73 m/day

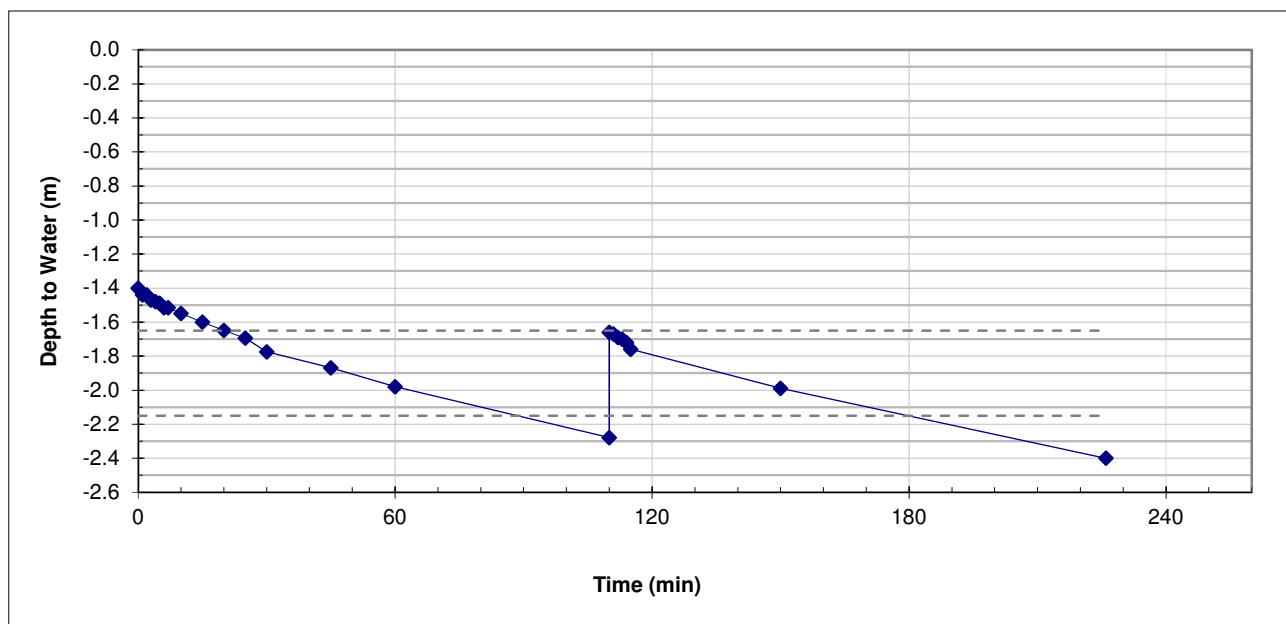
Trial Pit No. TP5 Soakage Test No. 1  
Pit Length (m) 2.6 Pit Width (m) 0.7 Pit Depth (m) 2.4

Design Soakage Rate 4.4E-05 m/s (based on BRE 365 method)  
3.82 m/day

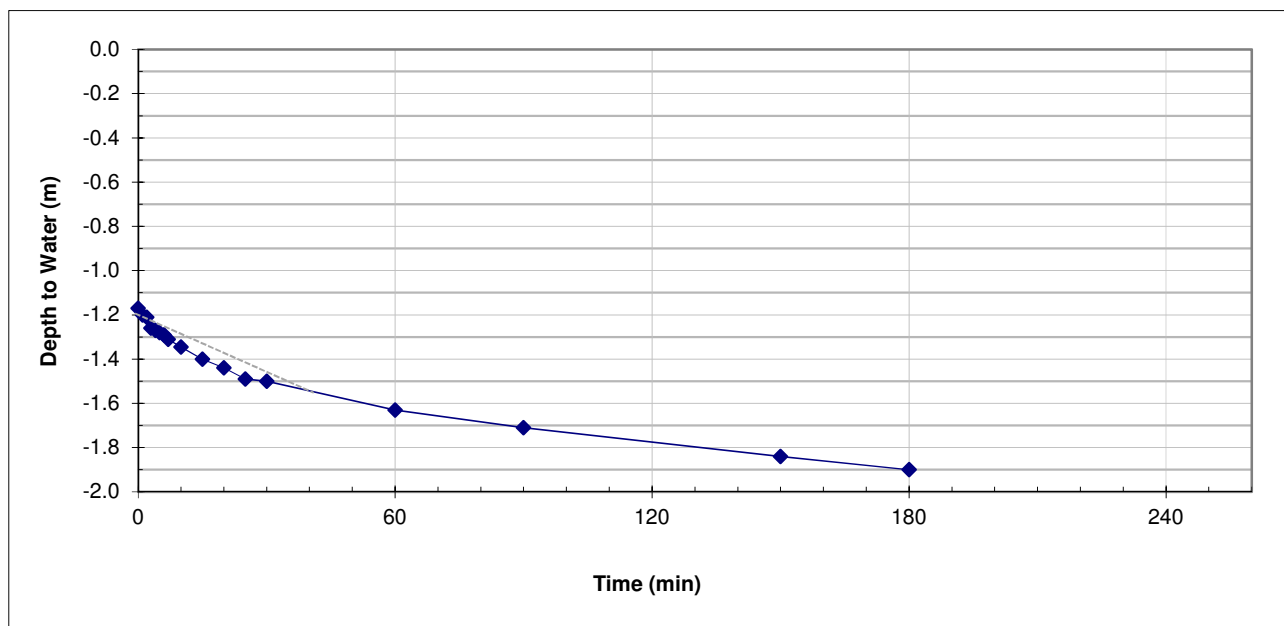
Trial Pit No. TP6 Soakage Test No. 1  
Pit Length (m) 2.1 Pit Width (m) 0.7 Pit Depth (m) 2.5

Design Soakage Rate 3.0E-05 m/s (based on linear portion of graph as shown)  
2.57 m/day

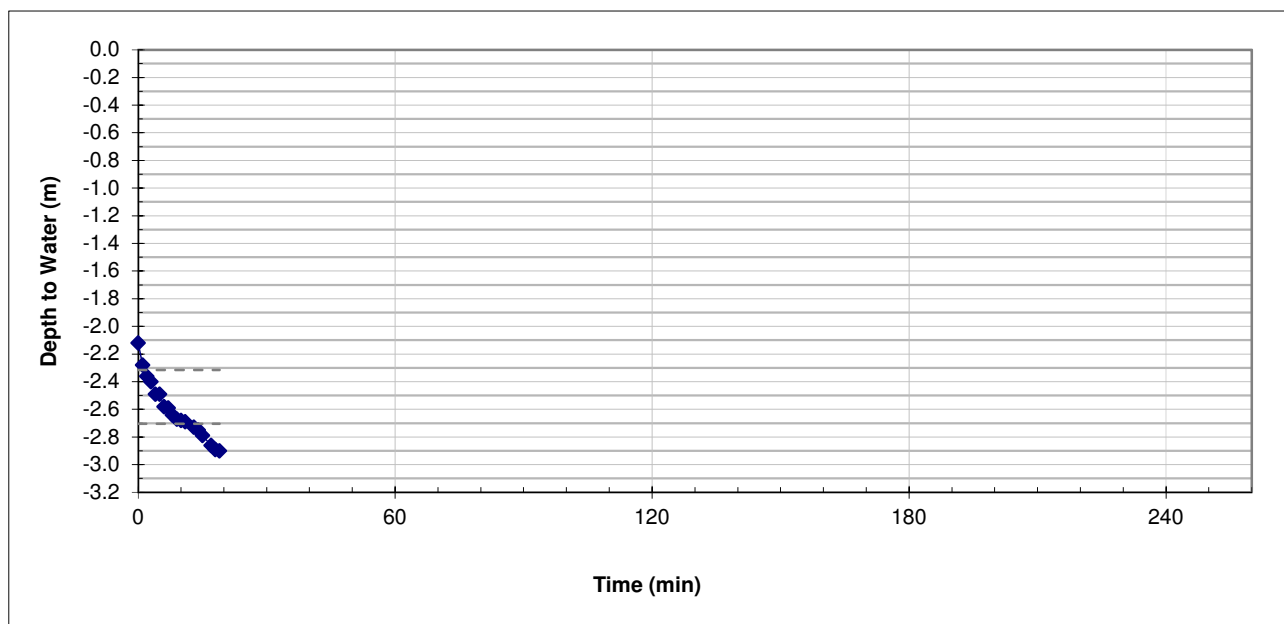
Trial Pit No. TP7 Soakage Test No. 1  
Pit Length (m) 2.1 Pit Width (m) 0.9 Pit Depth (m) 2.9

Design Soakage Rate 2.9E-04 m/s (based on BRE 365 method)  
25.09 m/day

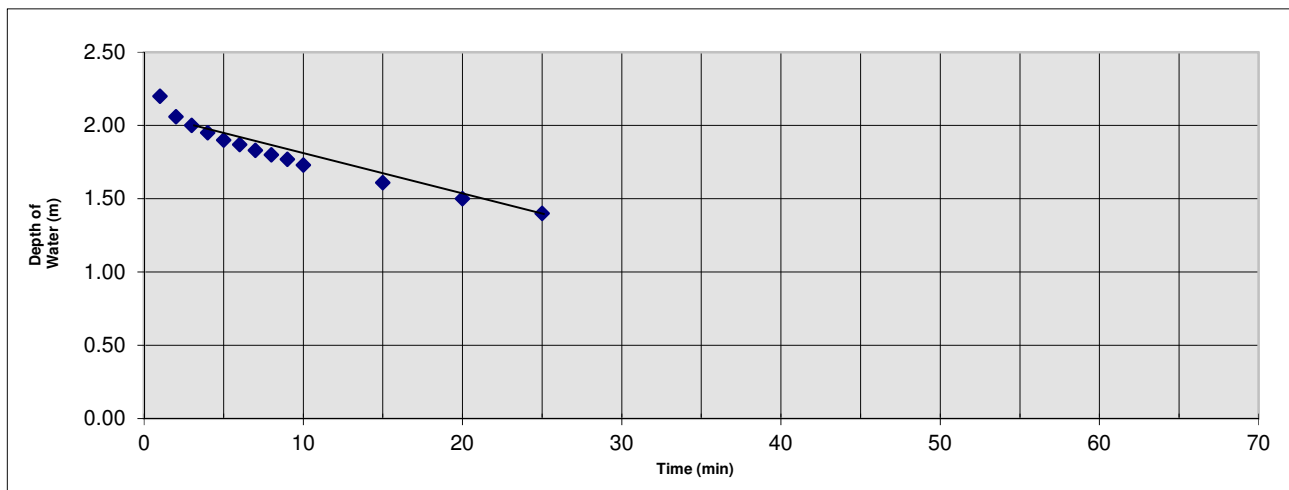
**Test No:** 1

Test carried out in Cable percussion borehole  
Borehole collapsed to 3.6 m after 25 minutes

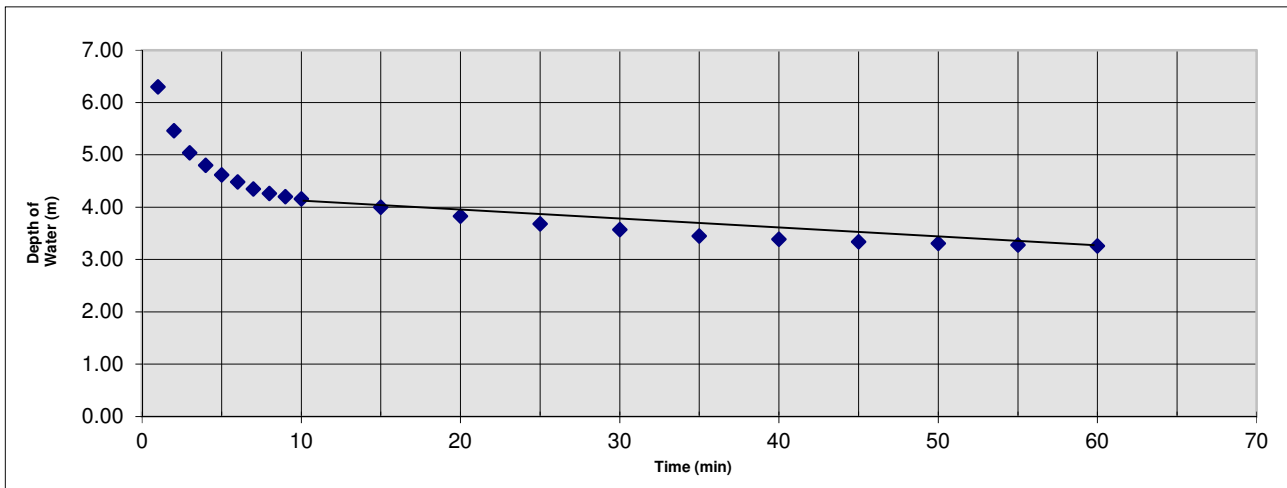
**Test No:** 3

Test carried out in Cable percussion borehole  
Sides of borehole remained stable during test

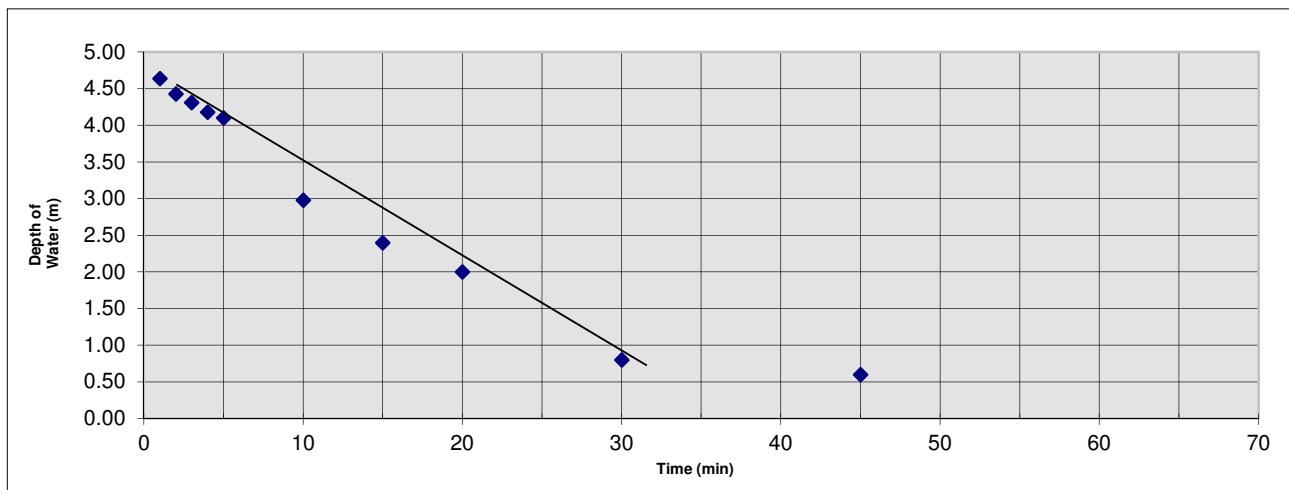
**Test No:** 1

Test carried out in Cable percussion borehole  
Sides of borehole remained stable during test

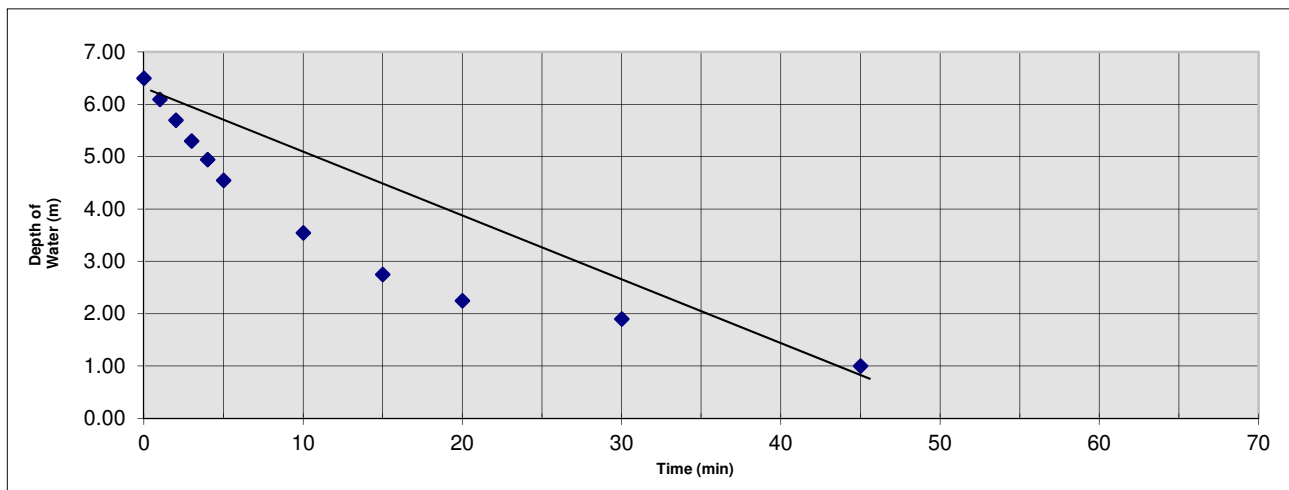
**Test No:** 1

Test carried out in Cable percussion borehole  
Sides of borehole remained stable during test

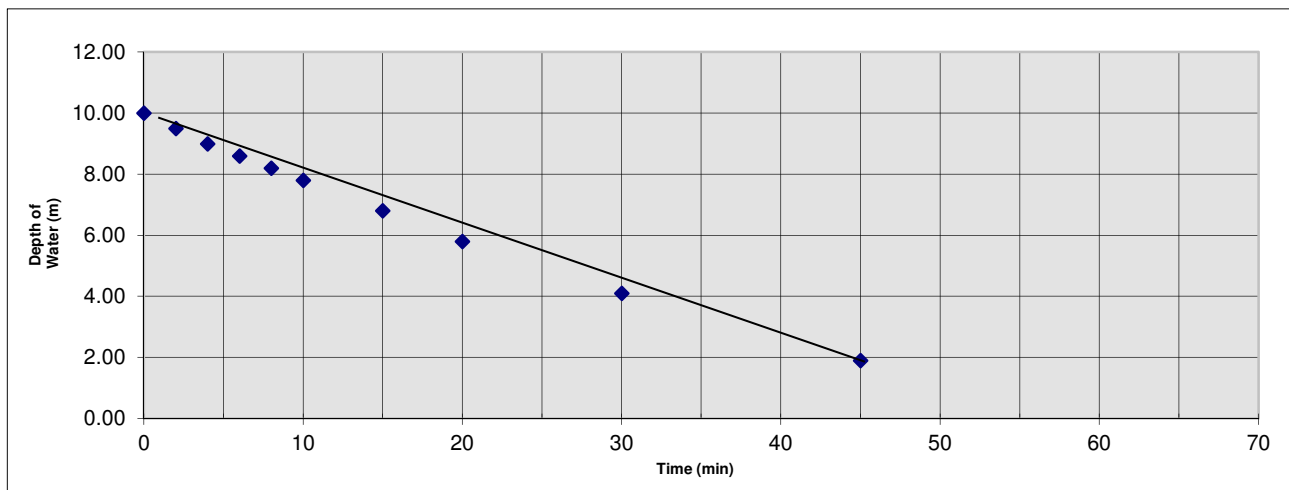
**Test No:** 3

Test carried out in Cable percussion borehole  
Sides of borehole remained stable during test

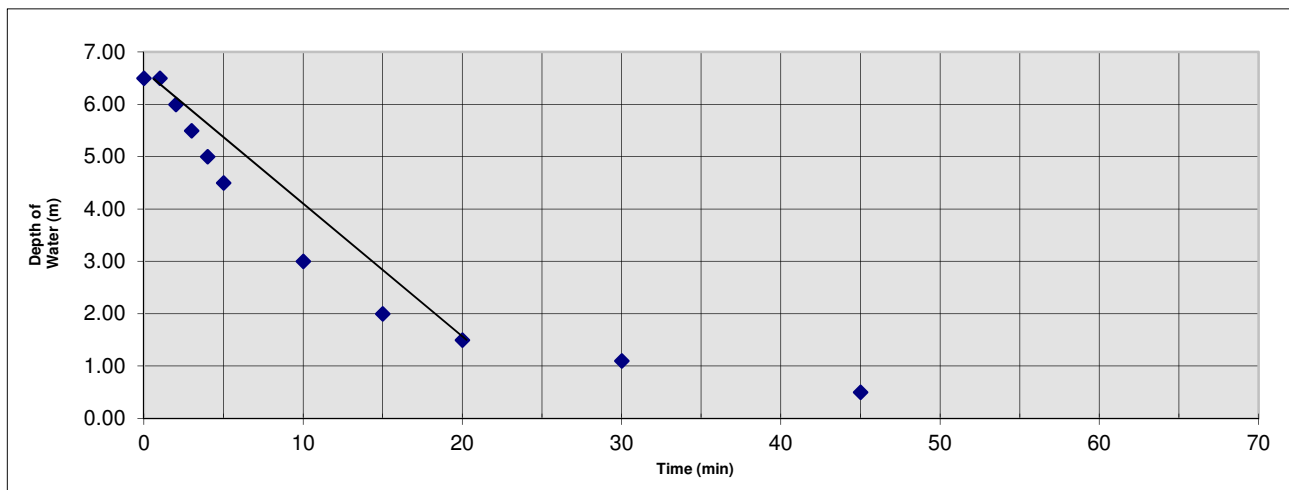
**Test No:** 4

Test carried out in Cable percussion borehole  
Sides of borehole remained stable during test
