23 Tilehouse Street

Job No.  
206

Proposed Roof Plan

025

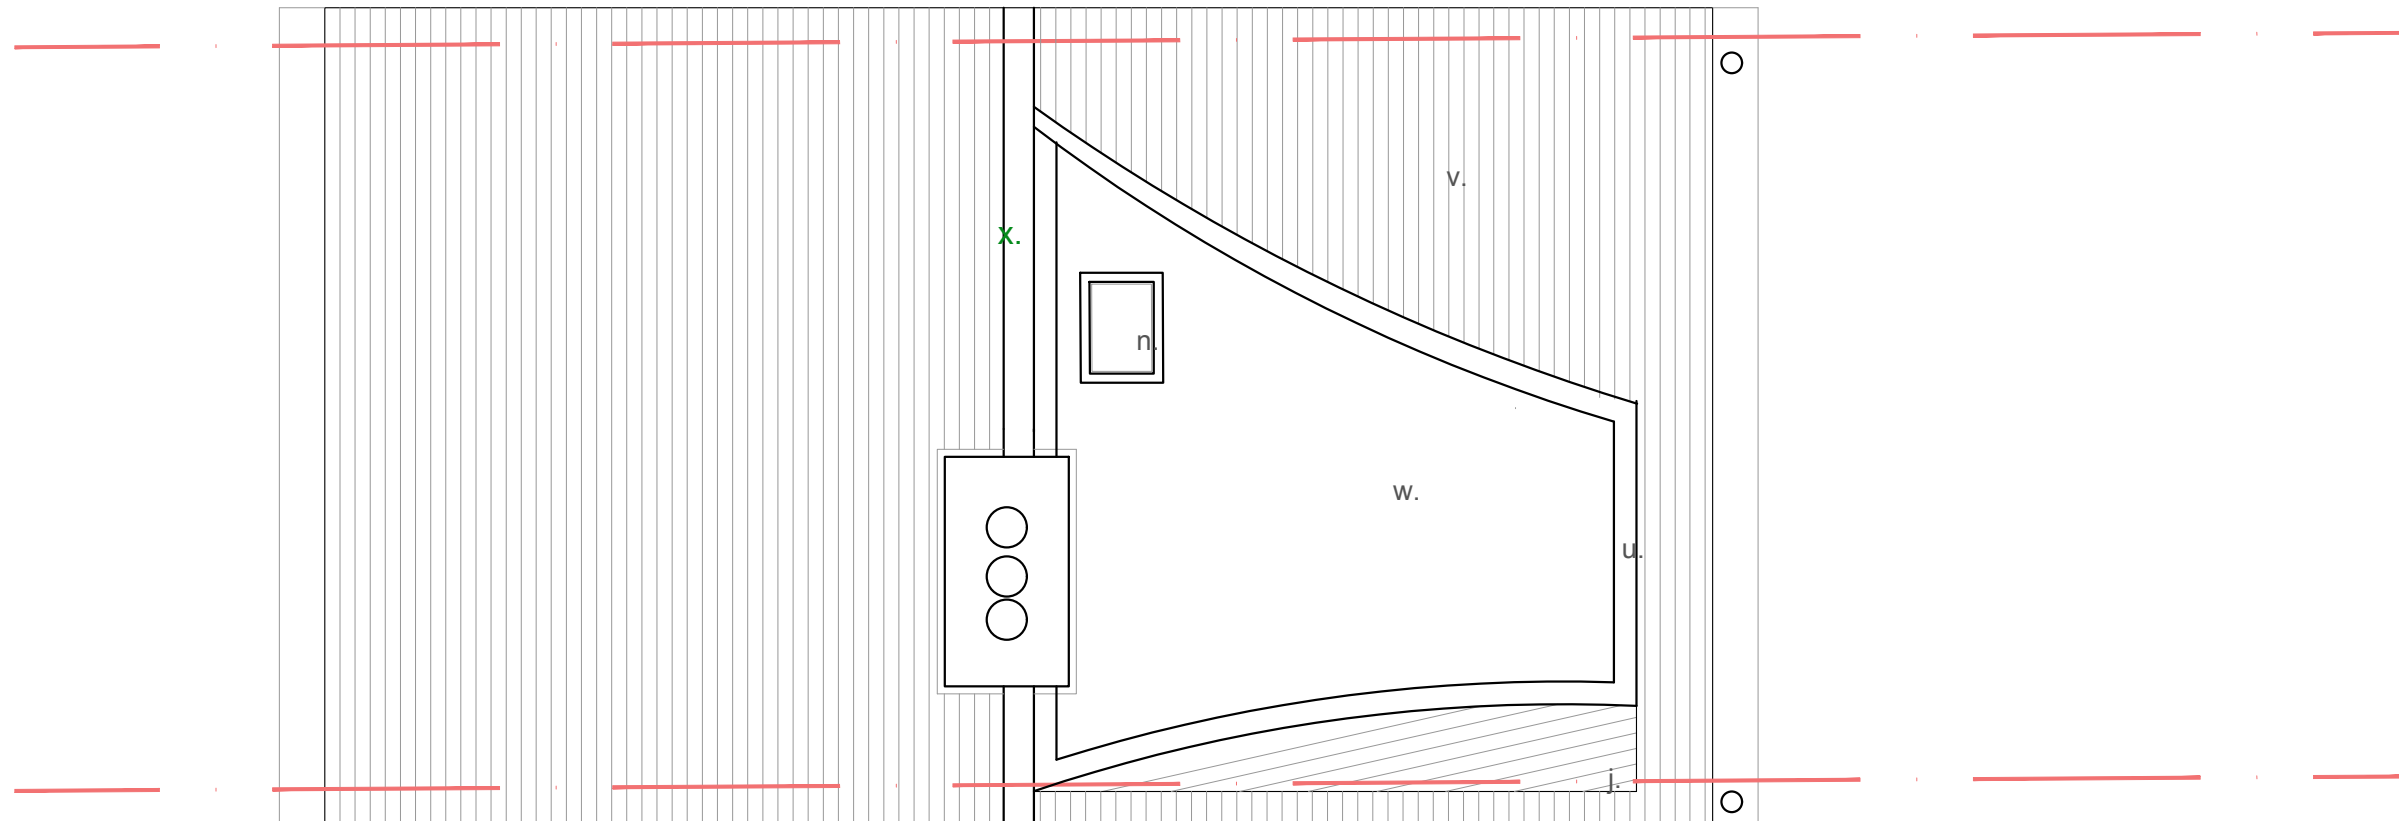
| i. New glazed light well | u. oxidised copper cladding to match new clay tiles |
| j. Zinc roof | v. replacement handmade clay tiles |
| l. new low level window below | x. New dry fixed ridge vent |
