Widbury Barn  
Widbury Hill  
Ware, Herts  
SG12 7QE

Newmarket Road, Royston SG8 7NJ

## Borehole Soakage Test

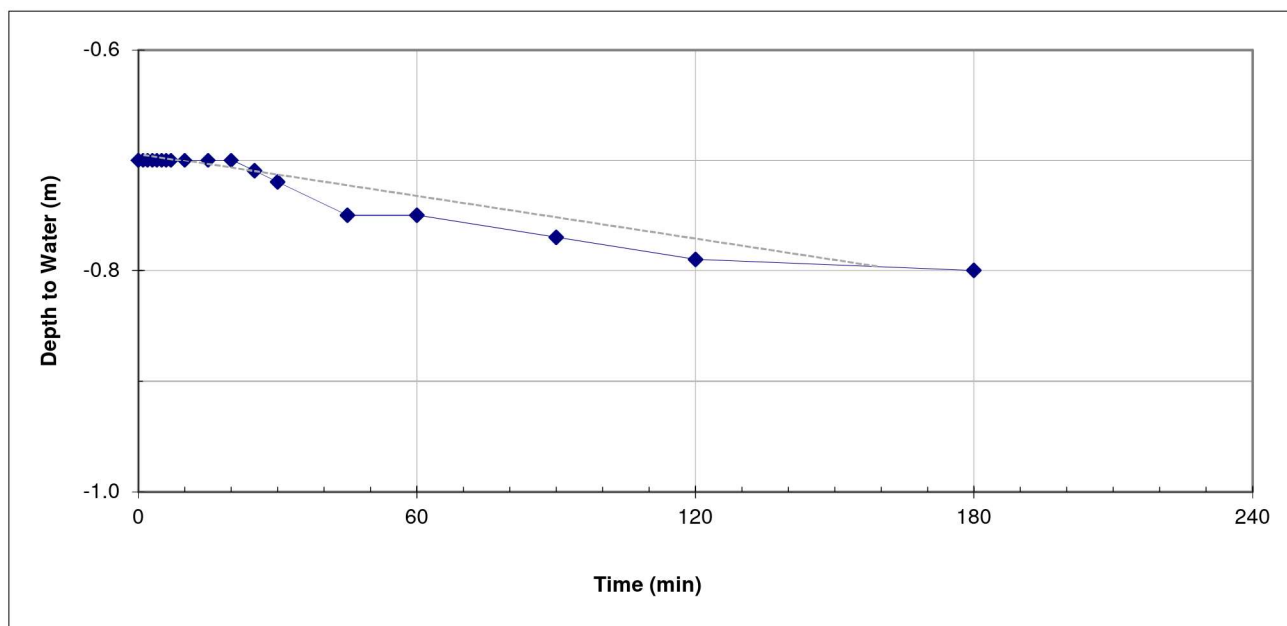
Trial Pit No. TP1 Soakage Test No. 1  
Pit Length (m) 2.2 Pit Width (m) 0.6 Pit Depth (m) 1

Design Soakage Rate 5.1E-06 m/s (based on linear portion of graph as shown)  
0.44 m/day

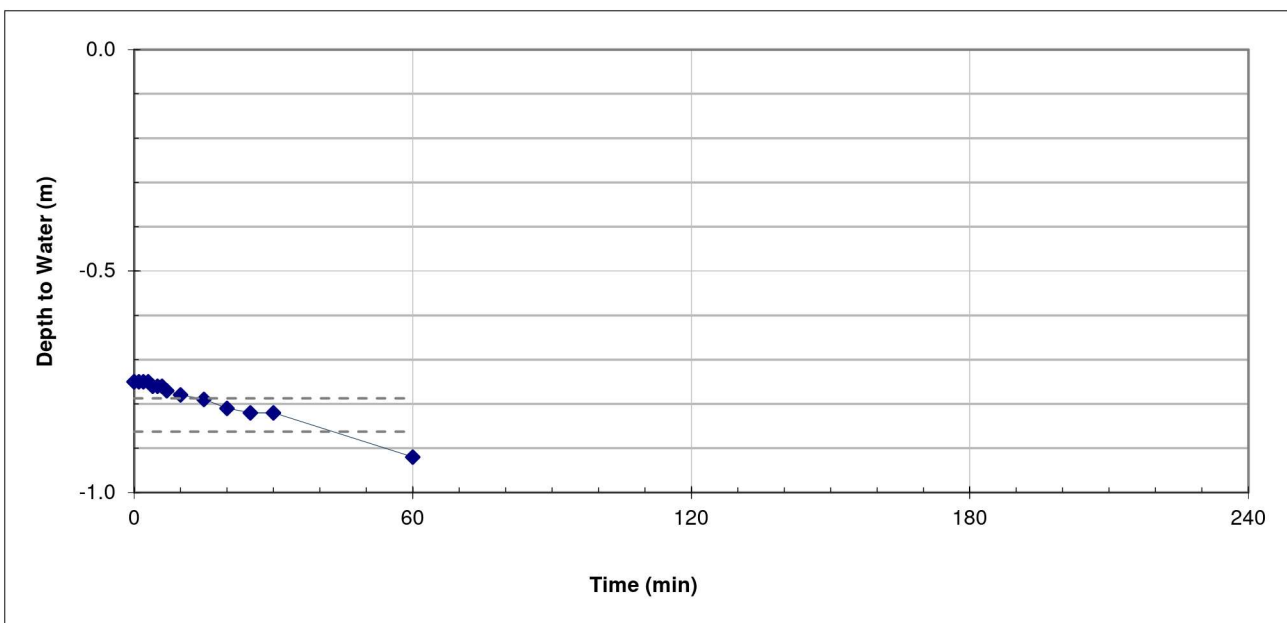
Trial Pit No. TP2 Soakage Test No. 1  
Pit Length (m) 2.2 Pit Width (m) 0.6 Pit Depth (m) 0.9

Design Soakage Rate 3.5E-05 m/s (based on BRE 365 method)  
3.04 m/day

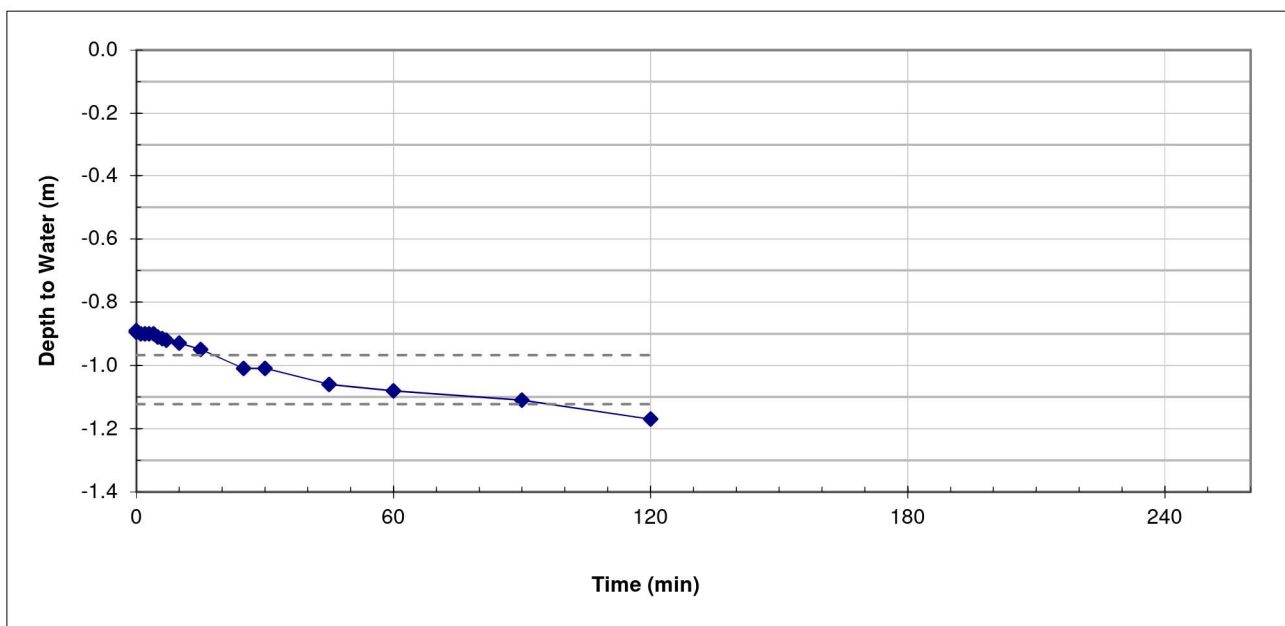
Trial Pit No. TP3 Soakage Test No. 1  
Pit Length (m) 2.6 Pit Width (m) 0.6 Pit Depth (m) 1.2

Design Soakage Rate 2.0E-05 m/s (based on BRE 365 method)  
1.73 m/day

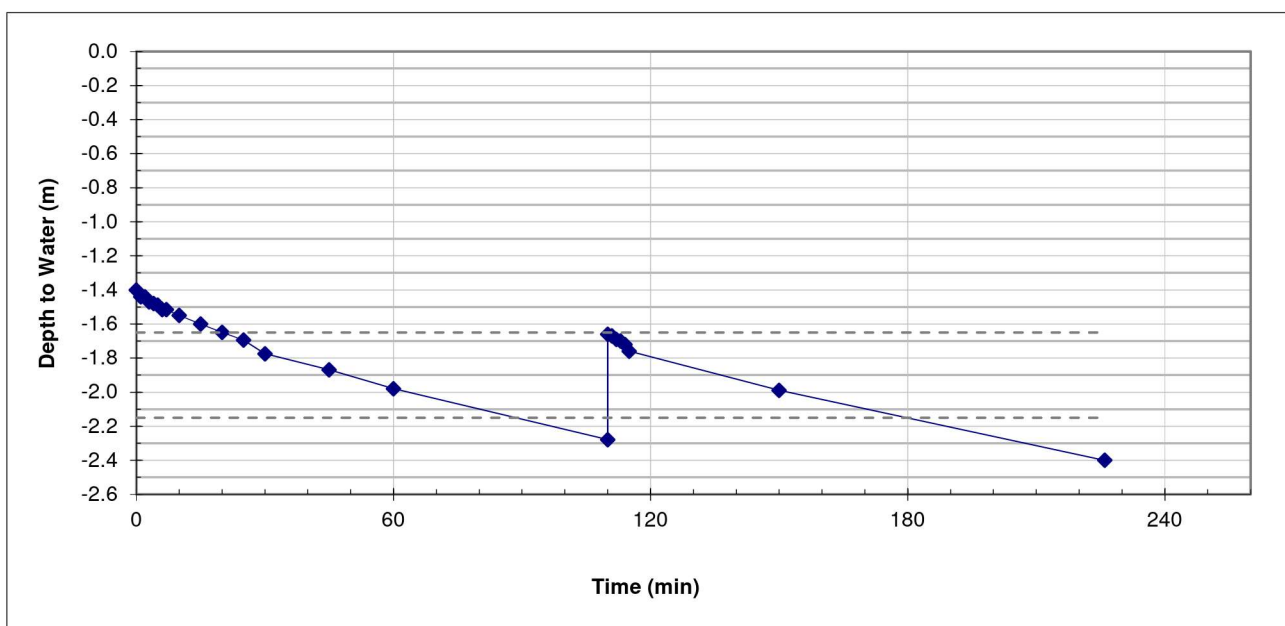
Trial Pit No. TP5 Soakage Test No. 1  
Pit Length (m) 2.6 Pit Width (m) 0.7 Pit Depth (m) 2.4

Design Soakage Rate 4.4E-05 m/s (based on BRE 365 method)  
3.82 m/day

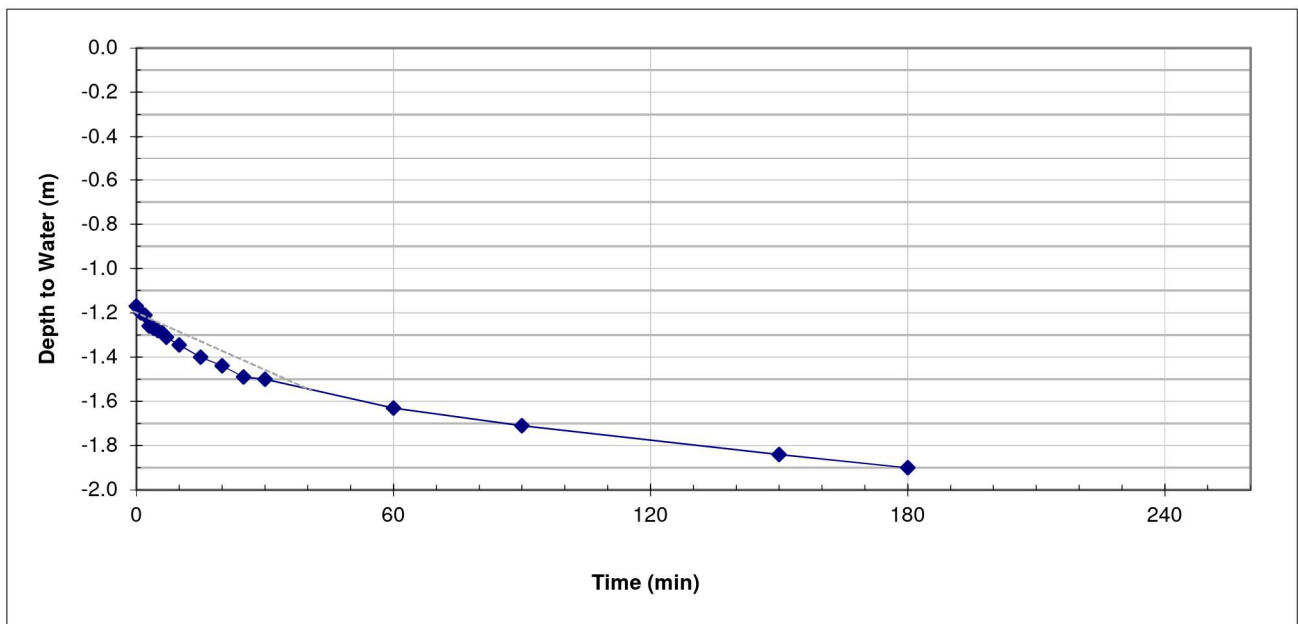
Trial Pit No. TP6 Soakage Test No. 1  
Pit Length (m) 2.1 Pit Width (m) 0.7 Pit Depth (m) 2.5

Design Soakage Rate 3.0E-05 m/s (based on linear portion of graph as shown)  
2.57 m/day

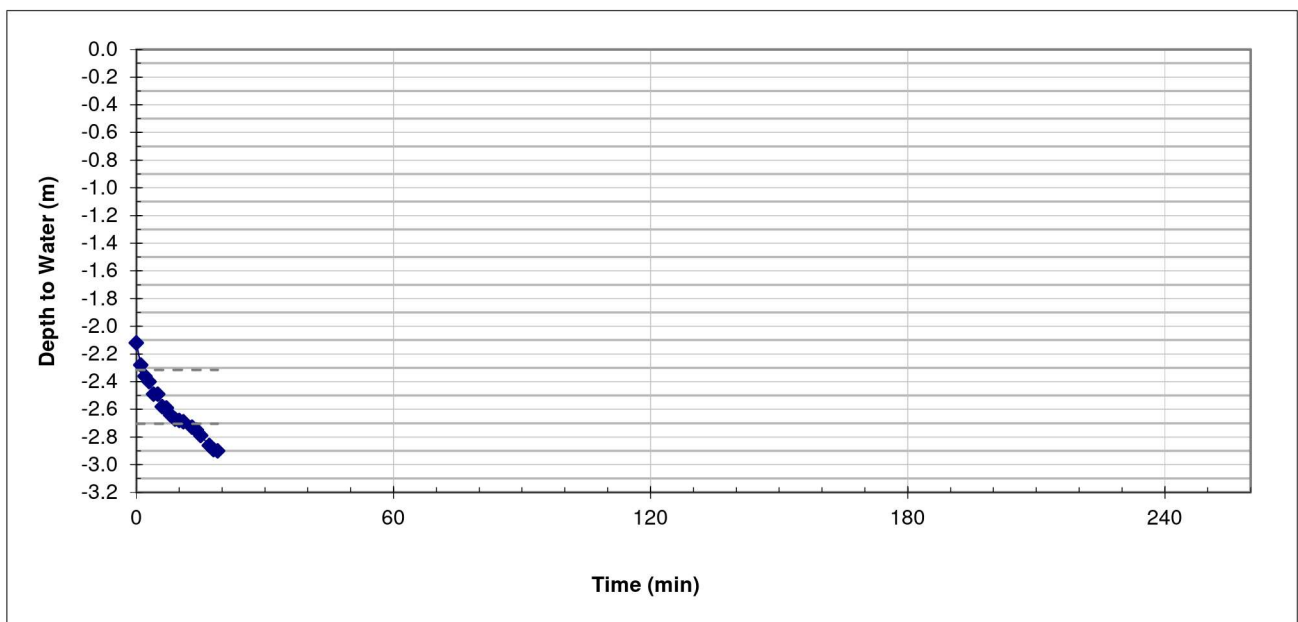
Trial Pit No. TP7 Soakage Test No. 1  
Pit Length (m) 2.1 Pit Width (m) 0.9 Pit Depth (m) 2.9

Design Soakage Rate 2.9E-04 m/s (based on BRE 365 method)  
25.09 m/day

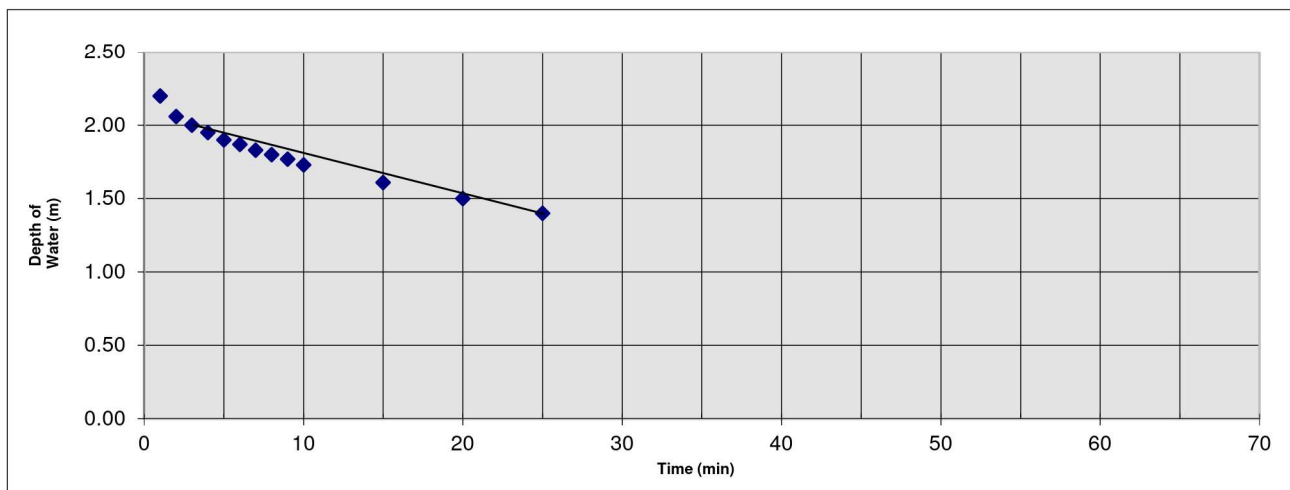
**Test No:** 1

Test carried out in Cable percussion borehole  
Borehole collapsed to 3.6 m after 25 minutes

**Soakage rate (m/sec)** 9.81033E-06

**Soakage rate (m/day)** 0.847612819

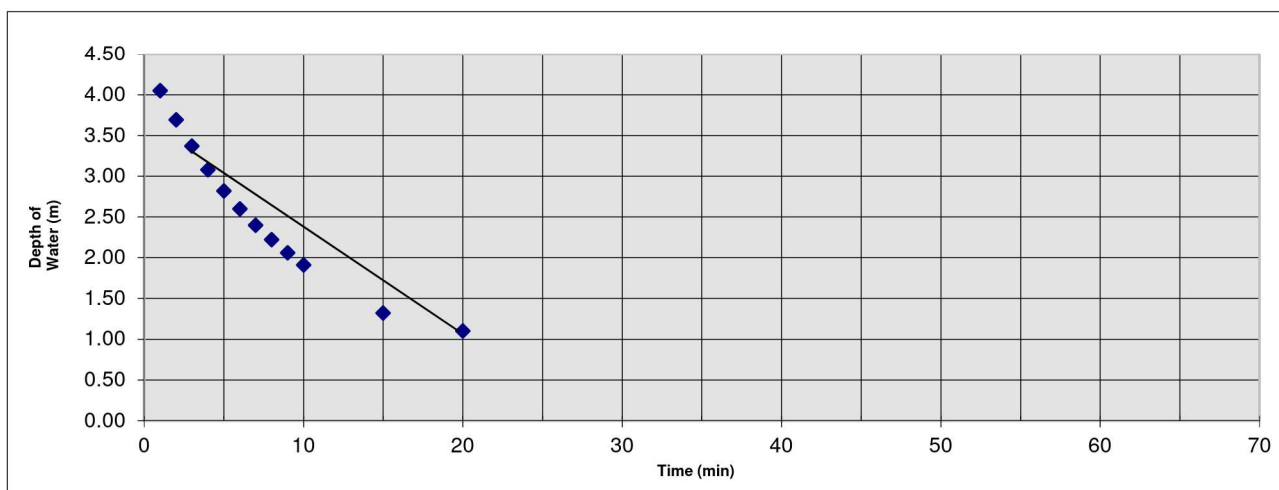
**Test No:** 2

Test carried out in Cable percussion borehole  
Borehole collapsed to 8.9 m after 20 minutes

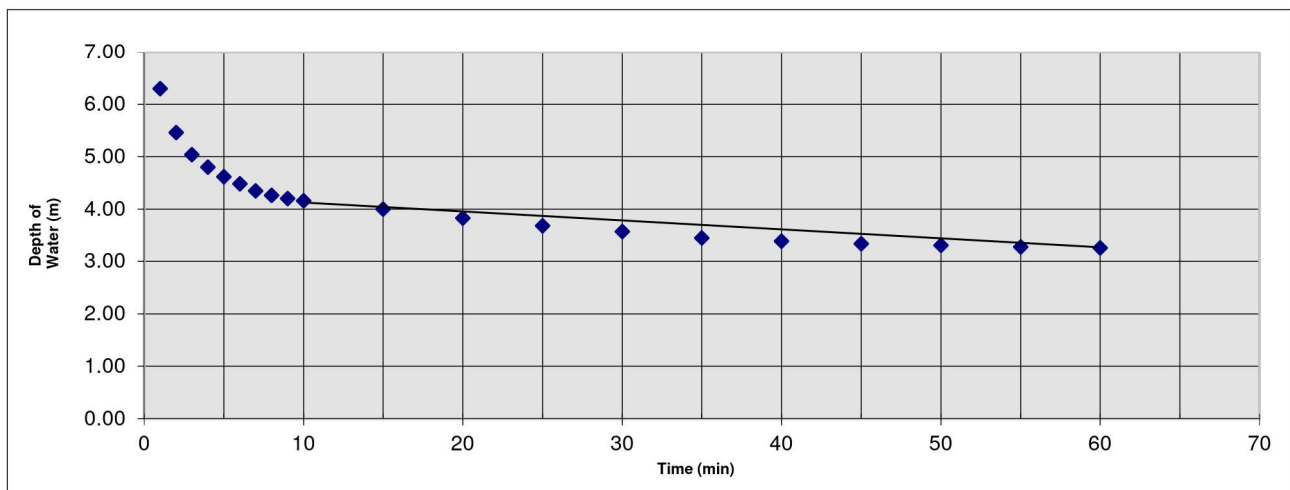
**Test No:** 3

Test carried out in Cable percussion borehole  
Sides of borehole remained stable during test

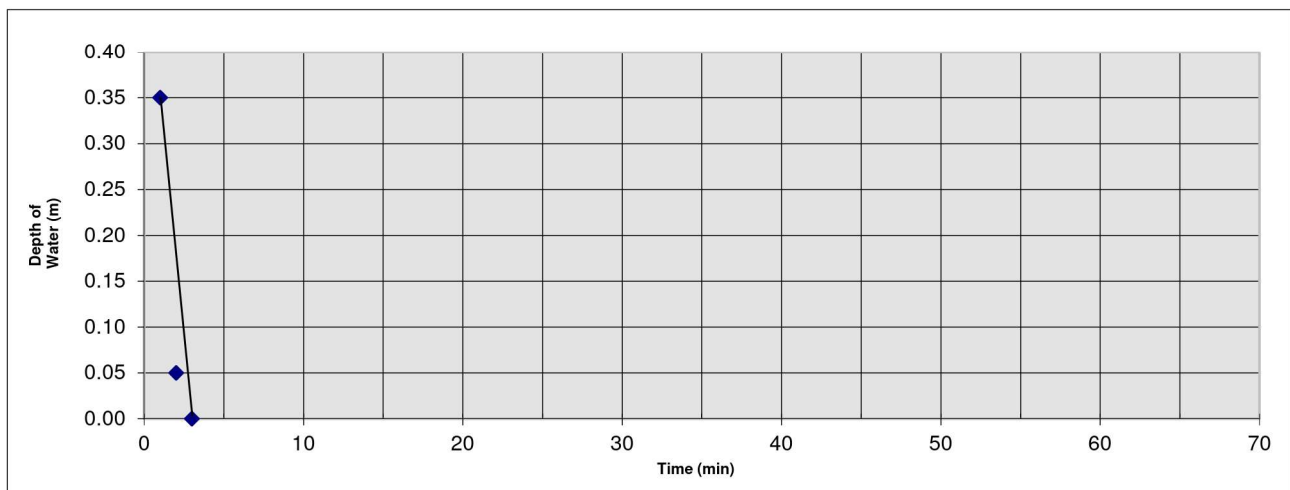
**Test No:** 4

Test carried out in Cable percussion borehole  
Sides of borehole remained stable during test
