# Heritage Statement

Radwell Grange, Great North Road, Baldock, SG7 5EU

Reroofing of a grade II listed house and the introduction of 1 no. dormer and 2 no. conservation roof lights.

January 2025

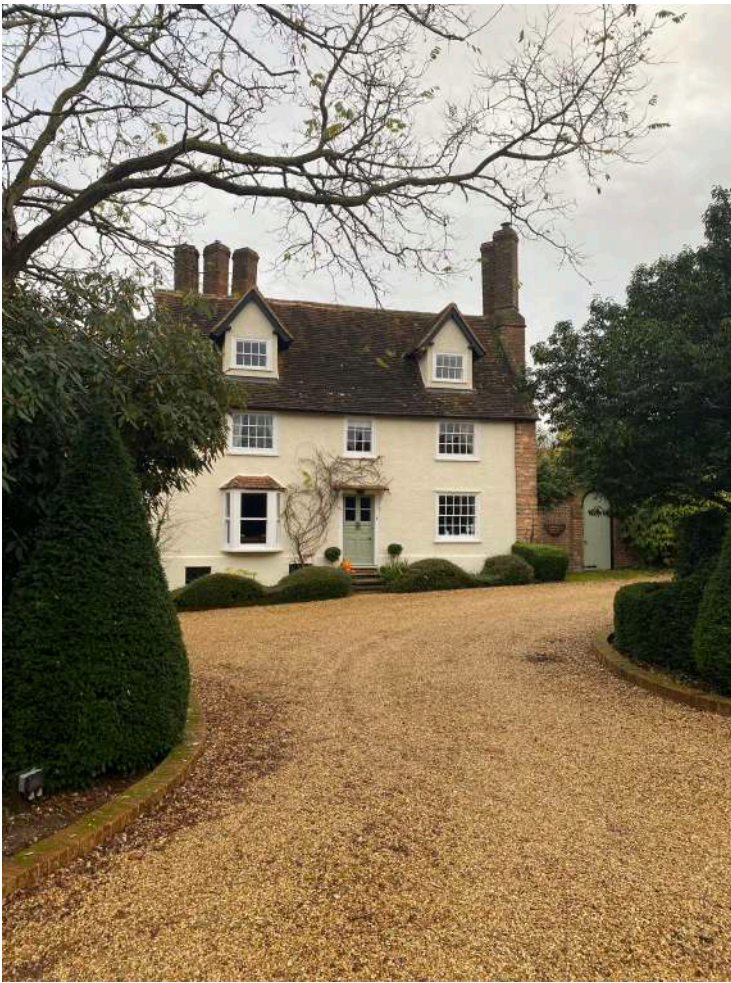
Photograph of the front elevation showing the existing dormers in place

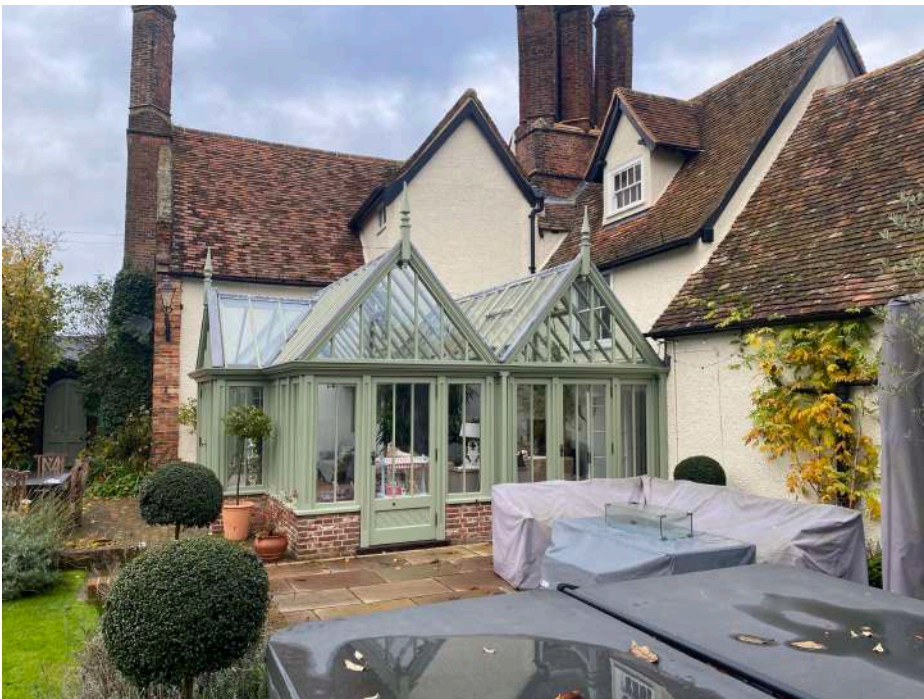
Photograph of the rear showing the existing haphazard arrangement of modern and old tiles

5.4 The whole sale restoration and reinstatement of the roof tiles is considered to be necessary given the existing roof condition. The existing roof is a mixture of modern concrete tiles and poorly degrading historic tiles, provided appropriate tiles are used and details are mimicked the impact upon the building is considered to be positive, securing the ongoing condition of the building.

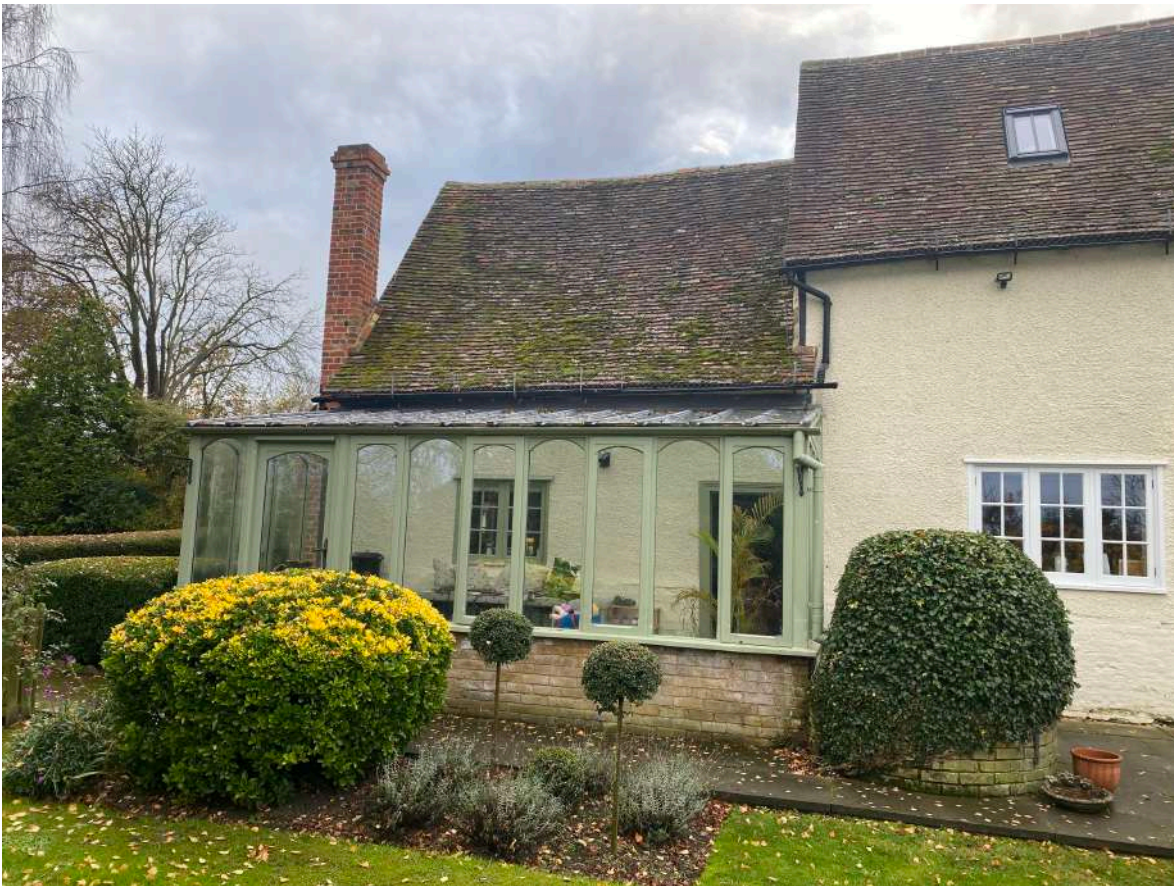
Photograph of the southern most wing where the proposed dormer is to be installed

4.3 The proposal seeks to introduce a new dormer window within the northern elevation of the southern most range.

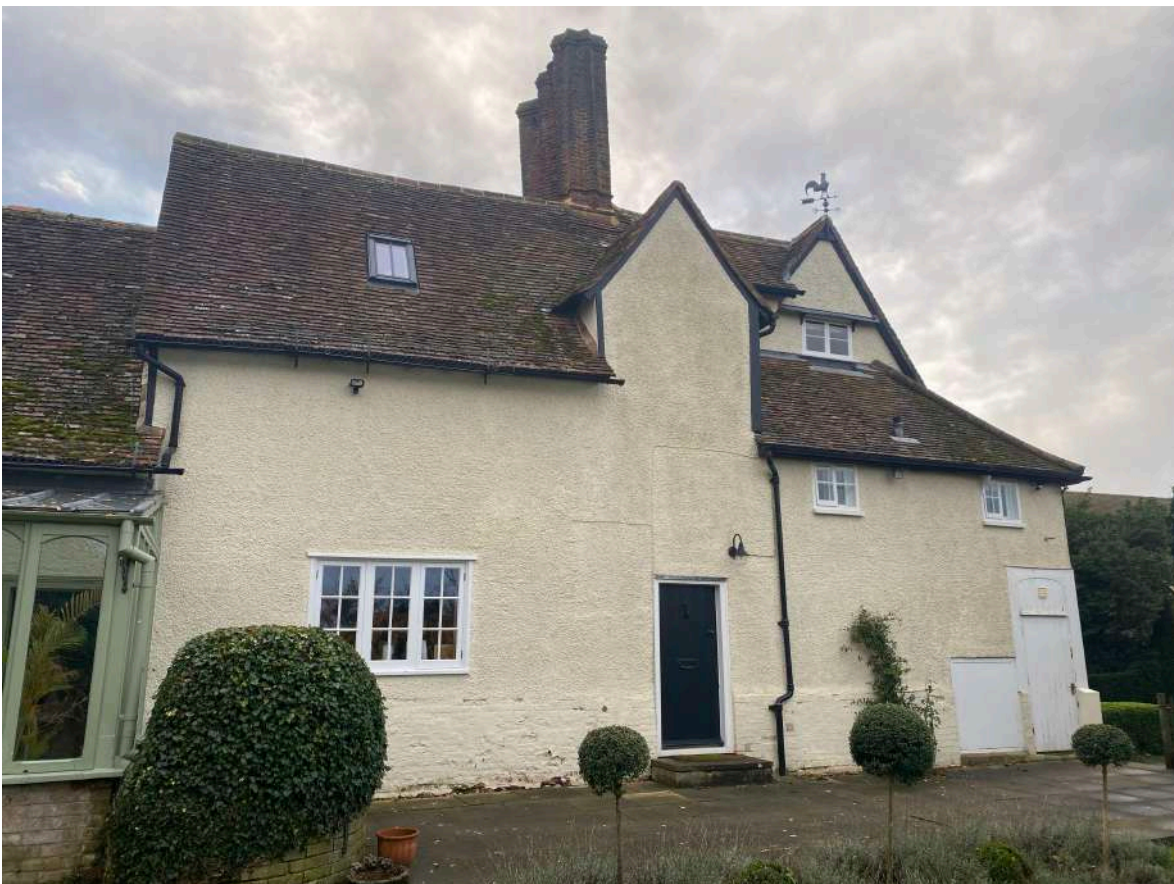
Photograph of the stair tower where the proposed roof light is to be installed

4.2 The proposals seek to introduce 2 no. conservation roof lights, both of the roof lights are set above staircases to introduce natural light and ventilation. Both fittings would be conservation roof lights to match those already installed within the house.
