| PROJECT | 19.14 Maydencroft Manor | | | |
| TITLE | North Elevation<br>Conservation Works Record | | | |
| DRAWING<br>NUMBER | 19.14.04.54 | | | |
| STATUS | RECORD | | | |

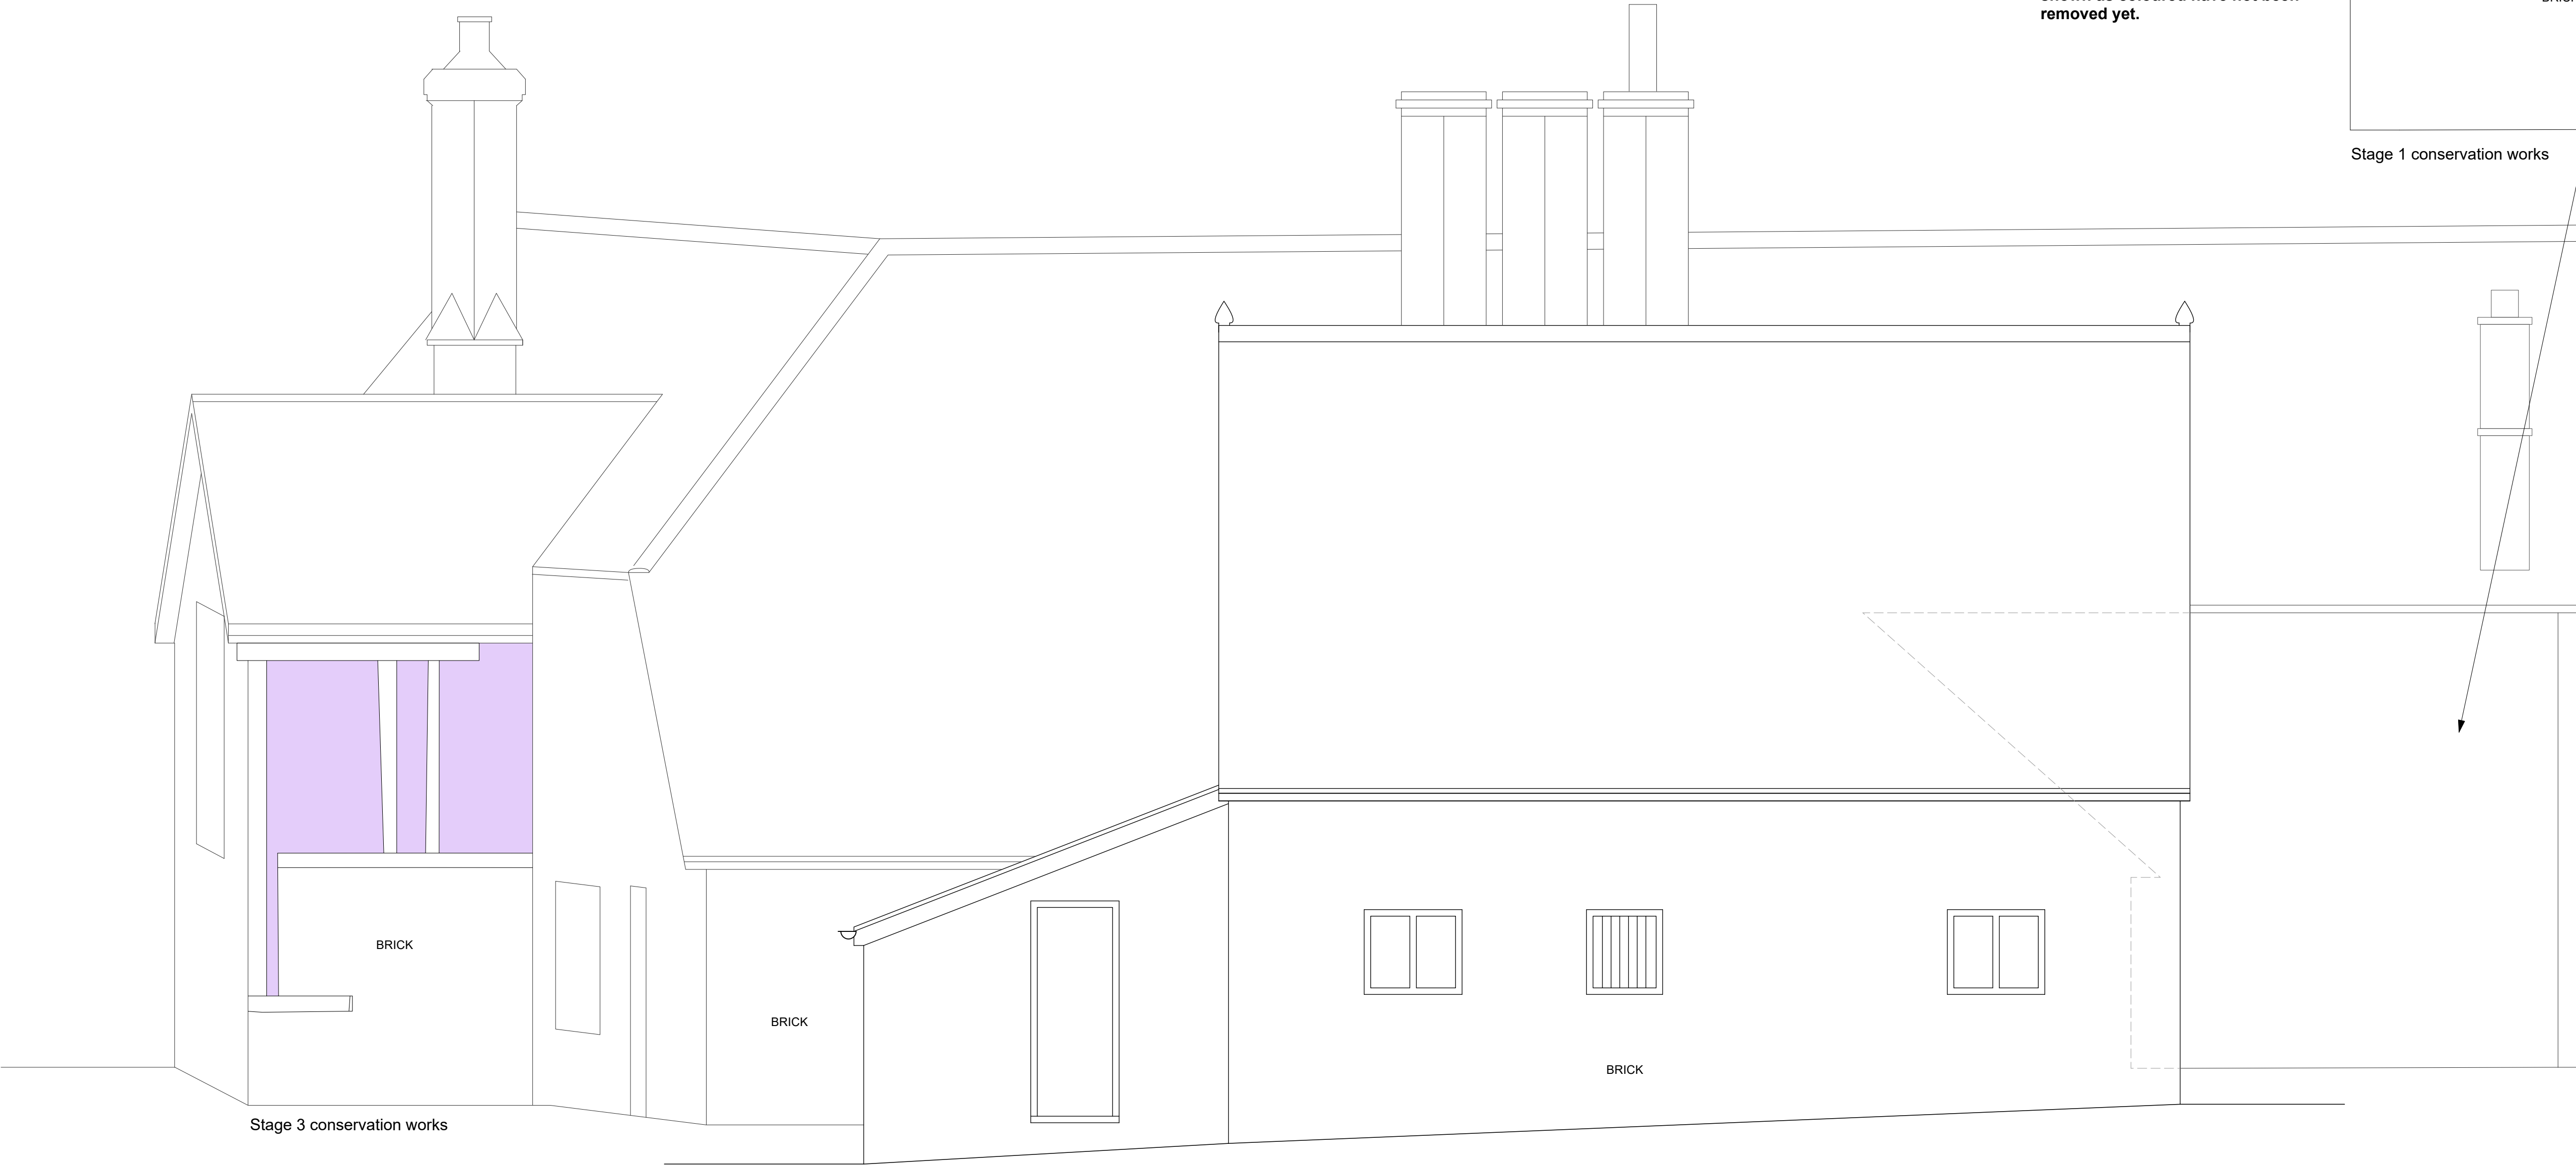
- Cement render removed, substrate found: outer wall modern boards & EML with thin mineral wool insulation, inner wall of laths behind.  
Works: Thin sheeps wool where depth permits, Woodwool carrier board, lime render finish with mineral paint finish in Ochre.

- Cement render removed, substrate found: outer wall modern lath broken and rotting in places. Inner wall of lath.  
Works: Woodwool carrier board, lime render finish with mineral paint finish in Ochre

- Cement render removed, substrate found: Brick outer wall (no timber frame)  
Works: Woodwool carrier board, lime render finish with mineral paint finish in Ochre

- Cement render removed, substrate found: outer wall modern board, inner wall modern board (plywood/plasterboard) mineral wool between  
Works: Thin sheeps wool where depth permits, Woodwool carrier board, lime render finish with mineral paint finish in Ochre.

- Cement render removed, substrate found: outer wall modern boards, inner wall brick  
Works: Thin sheeps wool, Woodwool carrier board, Lime render finish with mineral paint finish in Ochre

- Timber replacement/ scarf repairs
- Timber frame previously buried/partially buried in cement now exposed.
- Timber frame previously partially visible now covered by lime render.

- Timber frame reinstated in historic location denoted by evidence in surrounding timber
- Timber frame removed
