# Optima<sup>TM</sup>

SCULPTURED SYSTEM

# PROFILES

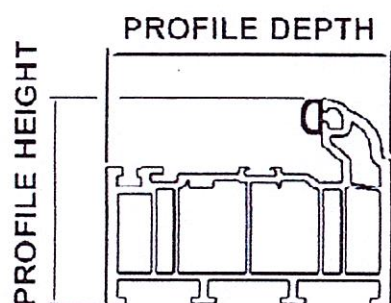
## GENERAL TERMINOLOGY

**DRAINAGE PLATFORM**

**REBATE  
UPSTAND**

**KNOCK IN  
BEAD  
LOCATION**

**REINFORCEMENT  
CHAMBER**

**EUROGROOVE**

**DRAINAGE  
CHAMBER**
