| PROJECT | Maydencroft Loft | | | |
| TITLE | Proposed Glazed Hatch Details | | | |
| DRAWING<br>NUMBER | 25.11.03.42 | | | |
| STATUS | PLANNING | | | |

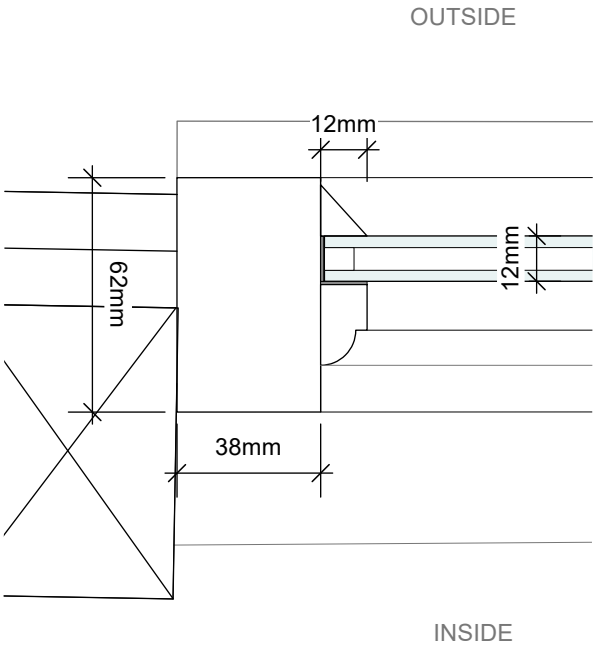
Plan detail of glazed hatch Jamb @ 1:2

- 1 Existing timber wall studs
- 2 Existing timber framing of historic hatch
- 3 Existing external lime render
- 4 Existing external carrier board
- 5 Existing internal carrier board
- 6 30mm Insulating lime plaster (between studs)
- 7 Internal timber cill
- 8 External timber cill (painted white)
- 9 Timber framed glazed fixed light (painted white)
- 10 12mm slimlite heritage glazing
