# Post-Planning Drainage Strategy

**Project Ref:** 213692  
**Document Ref:** 213692-CCL-XX-00-01010  
**Site:** Guysfield Care Home, Willian Road, Willian, NR Letchworth,  
Herts, SG6 2AB  
**Client:** Caring Homes Ltd  
**Prepared By:** Matthew Herring MEng CEng MICE  
**Date of Report:** 18 March 2026  
**Revision:** P01  
**Status Code:** S3

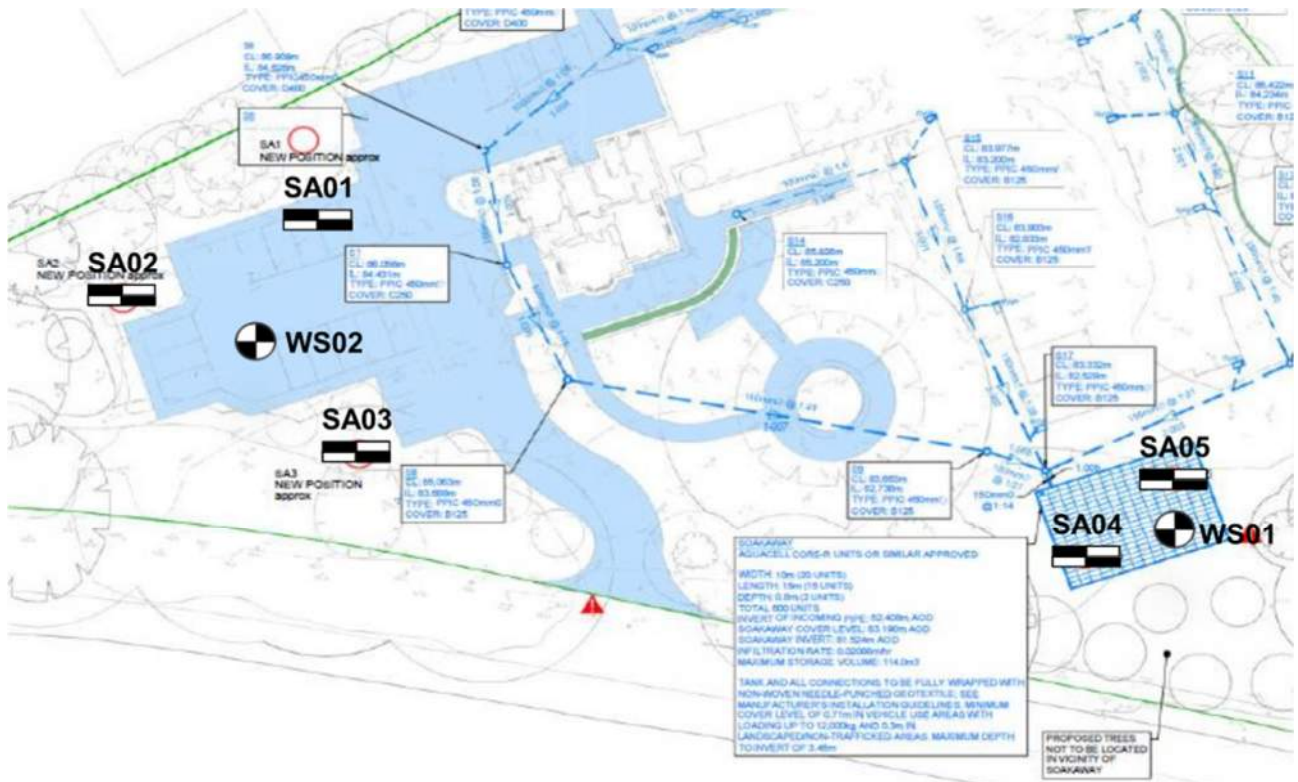
Figure 2: Infiltration Test Locations

We undertook infiltration testing in the locations noted on Figure 2 below over 7-9<sup>th</sup> January 2026 and took groundwater levels across the winter period with no groundwater encountered up to a depth of 5m. The test locations were intended to be as close as feasible and to the relevant depths in line with the Drainage Strategy provided at planning stage.

Infiltration testing shows that infiltration rates onsite vary across the various areas tested. There is a strong correlation between those tests undertaken in sand compared to those undertaken in clay with the more productive rates established in sand. As noted in Table 1, the lowest recorded rates in each area have been used for the surface water drainage design and on that basis, we do anticipate that the rates we will actually achieve in each of the areas will be favourable compared to the assumption used.

On the basis of the better infiltration rates being in the sand material which is deeper, we will ensure that the surface water discharges in this sand material in both infiltration areas. Within the soakaway, this is straightforward as the tank will be positioned at an appropriate depth within the sand and within the permeable paved area, our detail will include provision of recessed permeable pipes as part of the build up. For the permeable paved area, by utilising the lower sandy areas, our actual discharge rate will be much higher than the assumed rate used in our calculations.

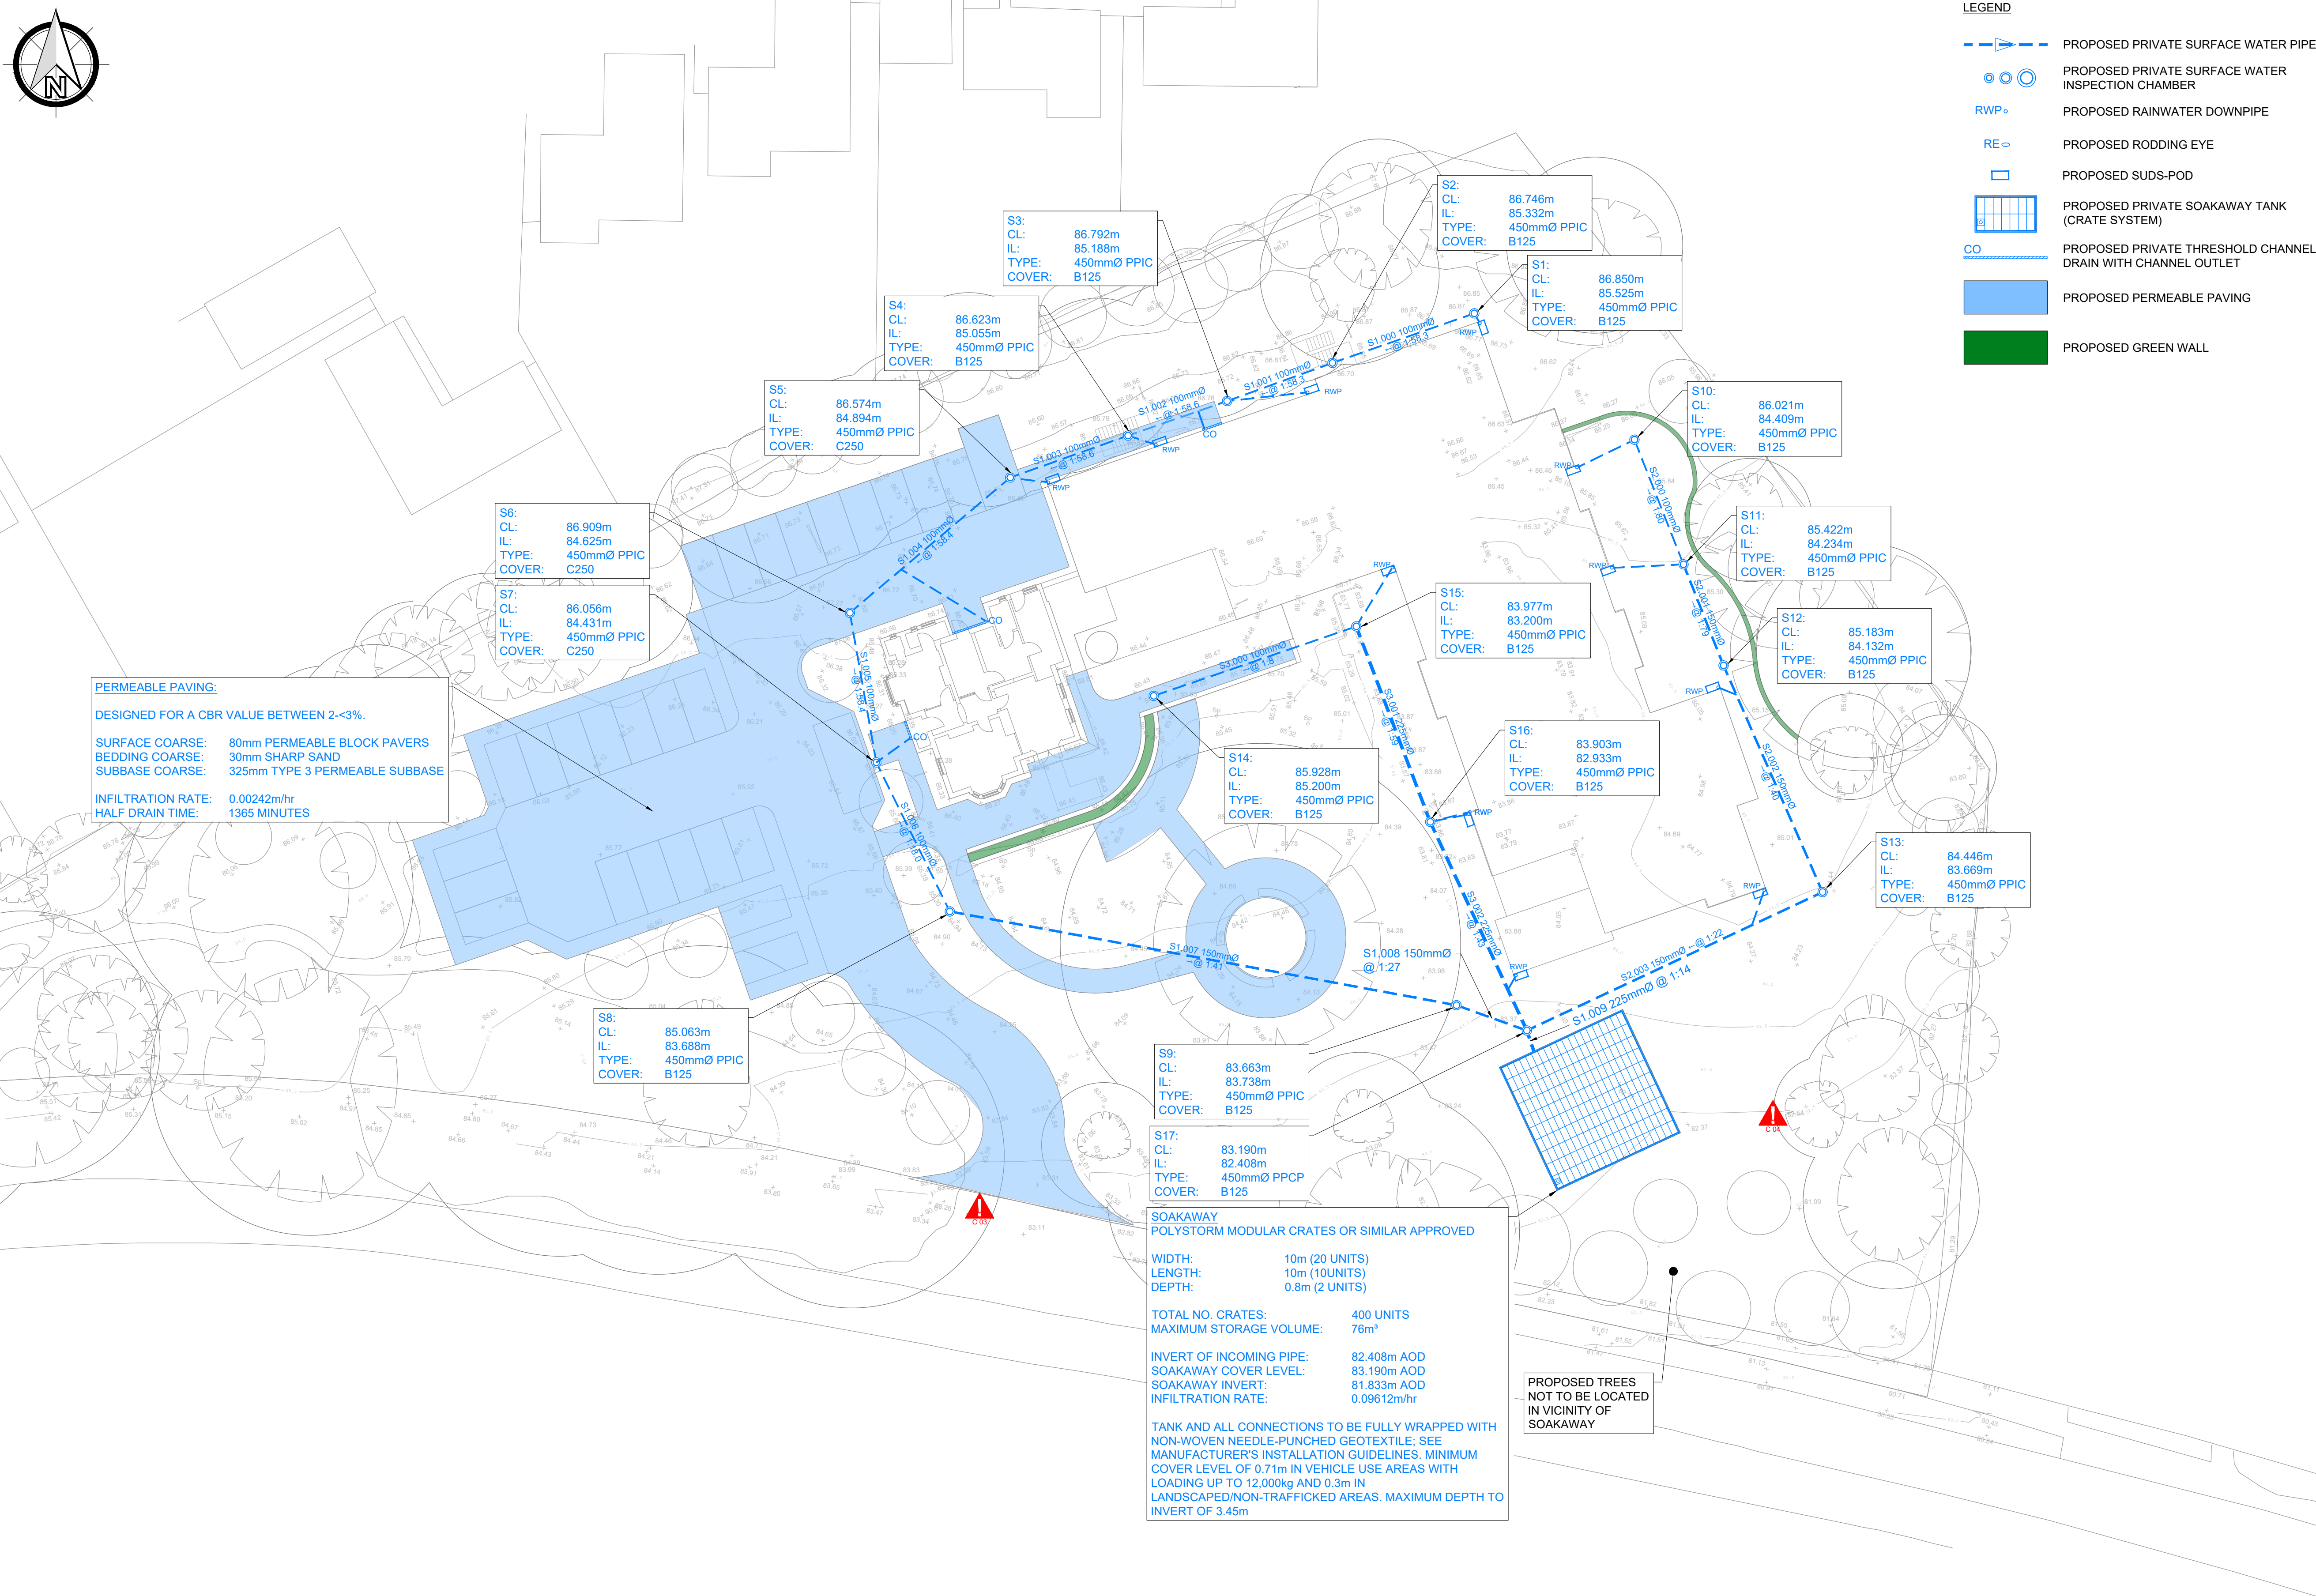
A Causeway Flow network model has been created to evidence the viability of infiltrating surface water drainage network for the proposed development. The surface water drains to a cellular storage soakaway in the south of the site, located near to an existing ring soakaway. The design demonstrated that a cellular storage soakaway sized 10.0m x 10.0m x 0.8m would be required for the 1-in-100-year event plus 45% climate change. The soakaway was sized using the infiltration rate from SA04 of 0.09612m/hr and delivers a half-drain time less than 24 hours and demonstrates no flooding in any event up to and including 1 in 100 plus climate change.

The Causeway Flow modelling is included in Appendix F and the proposed drainage design is outlined across drawing ref 213692-CCL-XX-00-DR-C-3000 included in Appendix G. The construction details can be seen in Appendix G outlining the specification of the drainage designs. As noted above, the method for discharge of the surface water is going to be discharge via infiltration. On that basis, to enable a design solution, we have established the following design assumptions which were appropriate at the time of the design:

Calculations for the Causeway Flow model are available in Appendix F and a drawing of the proposed surface water drainage layout is available in Appendix G. An impermeable areas plan showing the areas considered within the calculations is included within Appendix D.

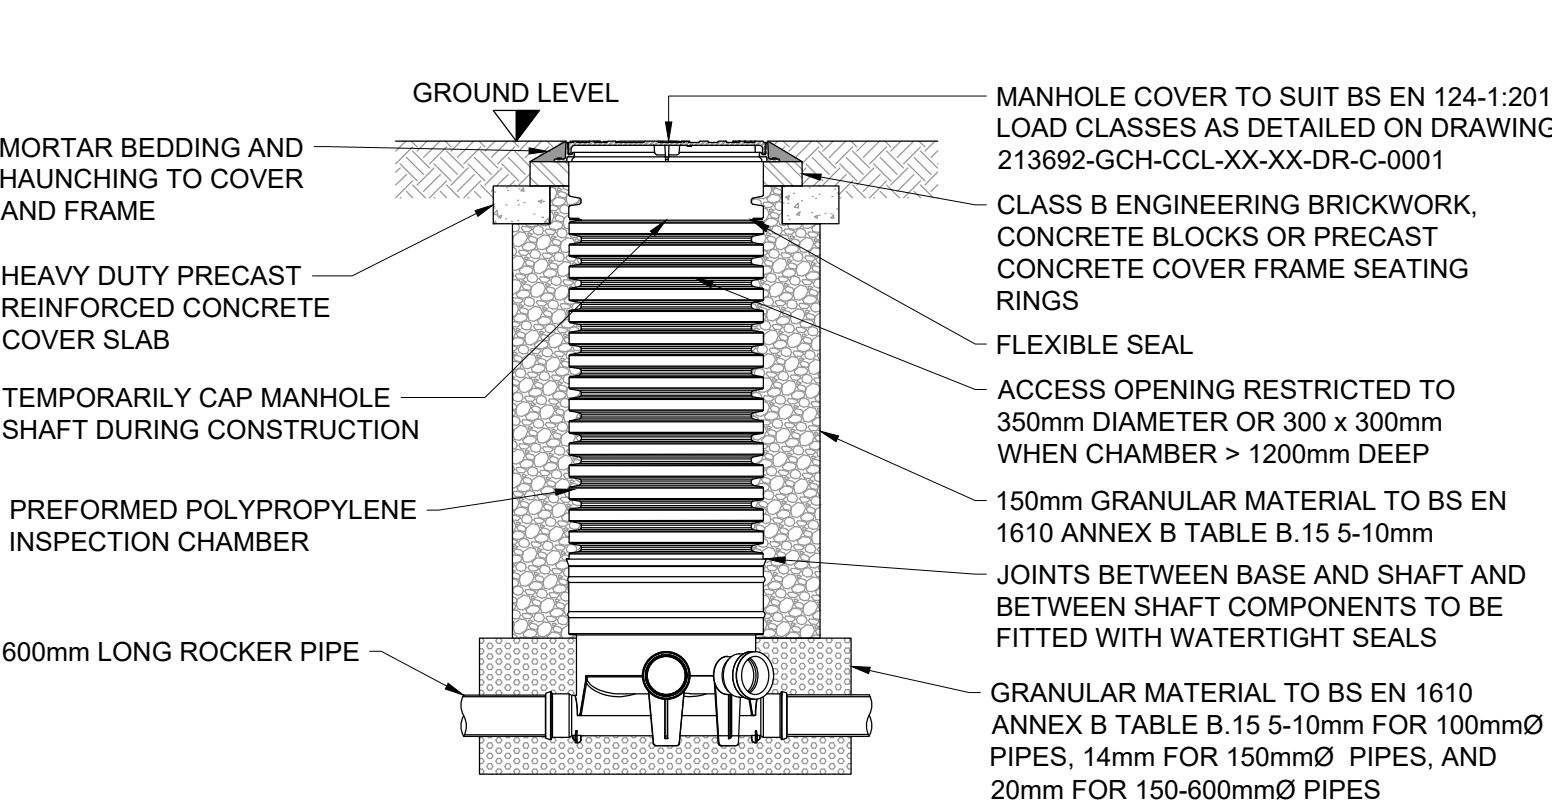
### TYPICAL TURTLE ENVIRO INSPECTION CHAMBER DETAIL

INSPECTION CHAMBER IN TRAFFICKED AREAS  
SCALE 1:20

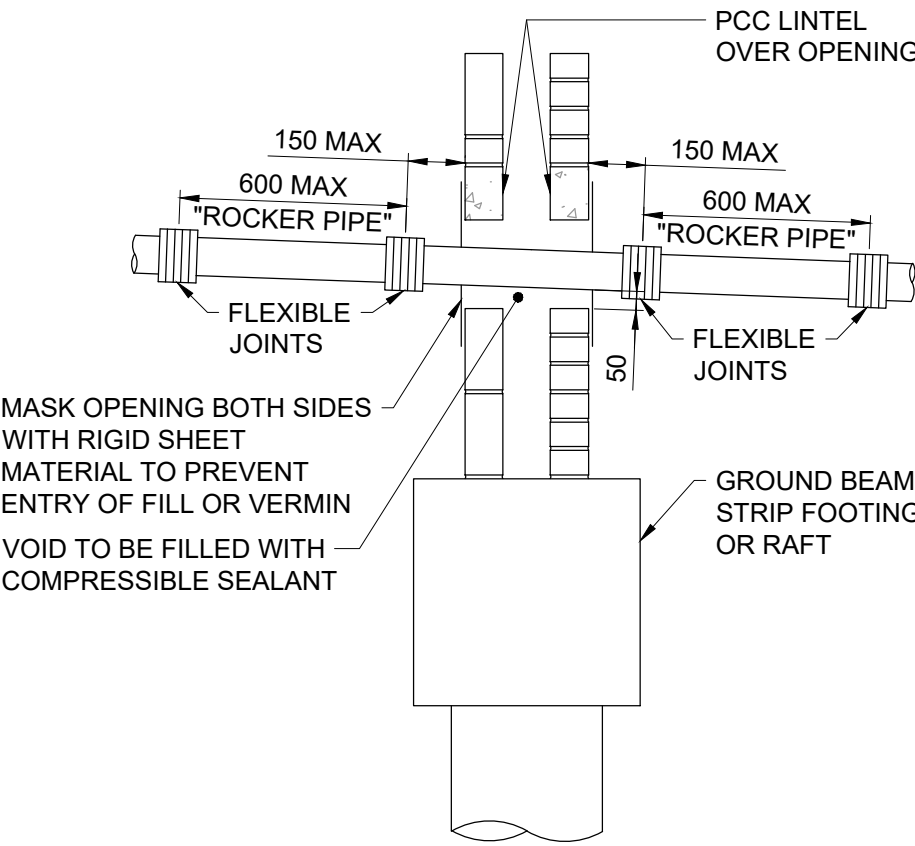
### PIPE PENETRATING WALLS ARCH OR LINTELLED OPENING TO GIVE 50mm SPACE ALL ROUND PIPE

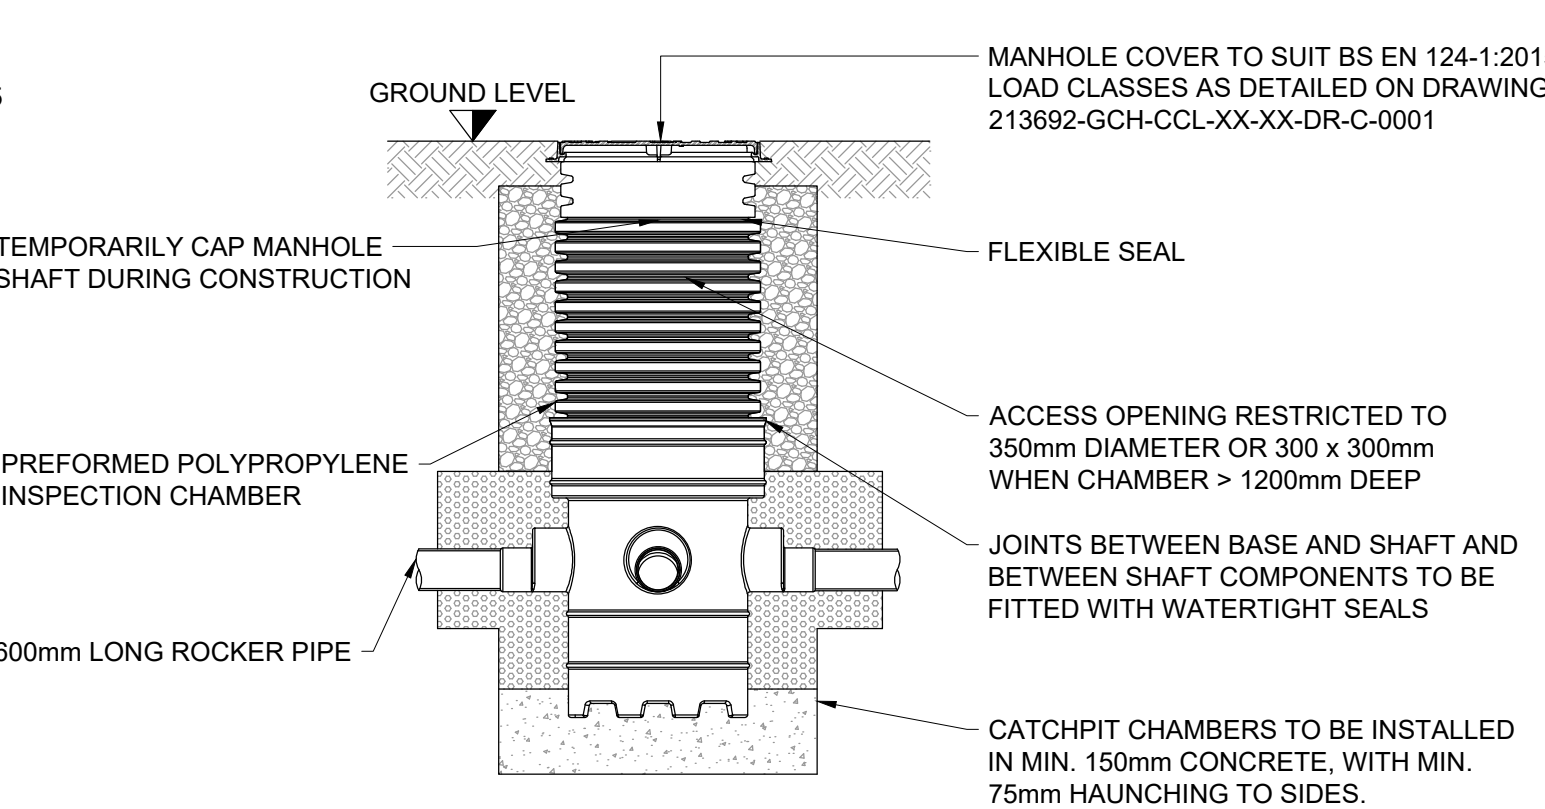
### TYPICAL TURTLE ENVIRO CATCHPIT DETAIL

CATCHPIT CHAMBER IN SOFT LANDSCAPED AREAS  
SCALE 1:20

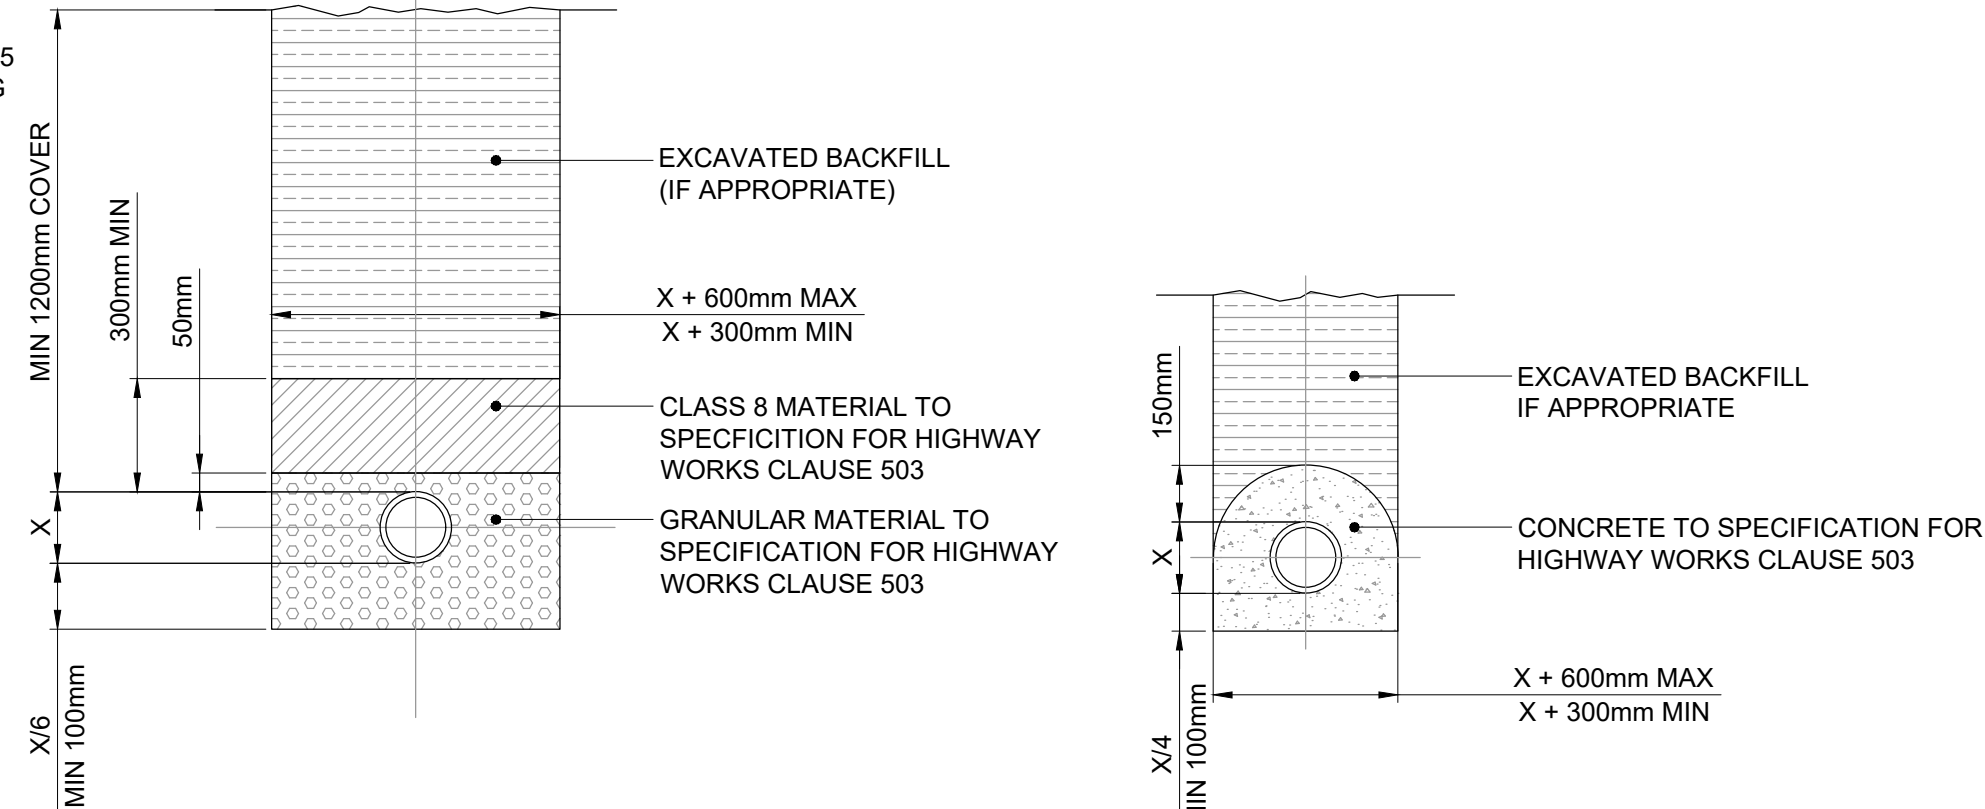
### CLASS S BEDDING (PIPES UP TO 600mm)

PIPES WITH VEHICLE LOADING  
NOT TO SCALE

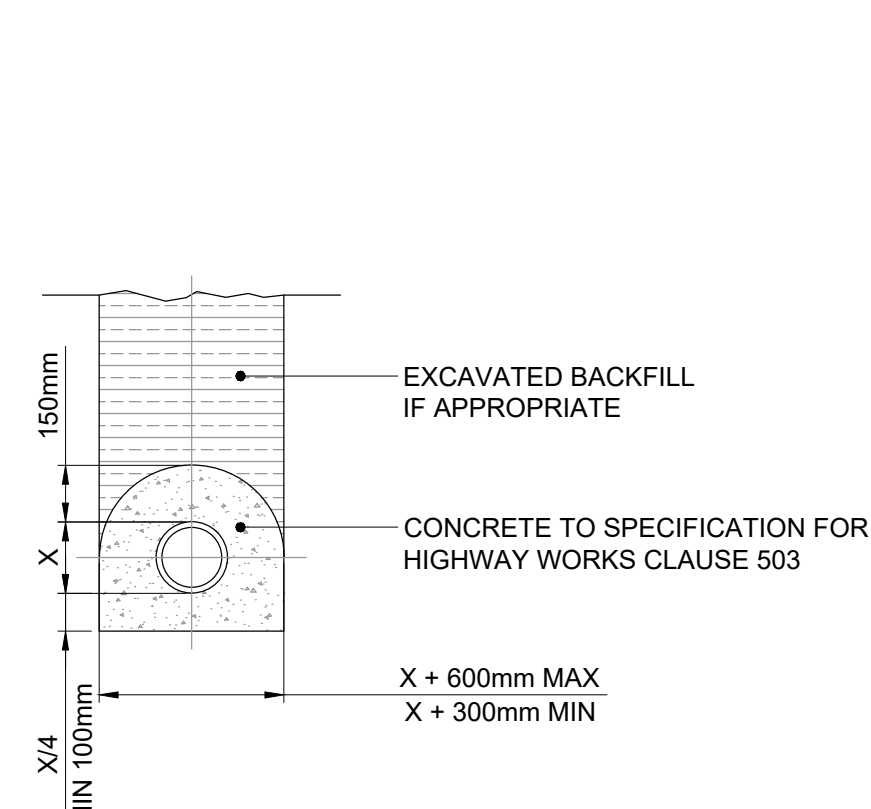
### CLASS Z BEDDING (PIPES UP TO 600mm)

PIPES WITH VEHICLE LOADING  
NOT TO SCALE

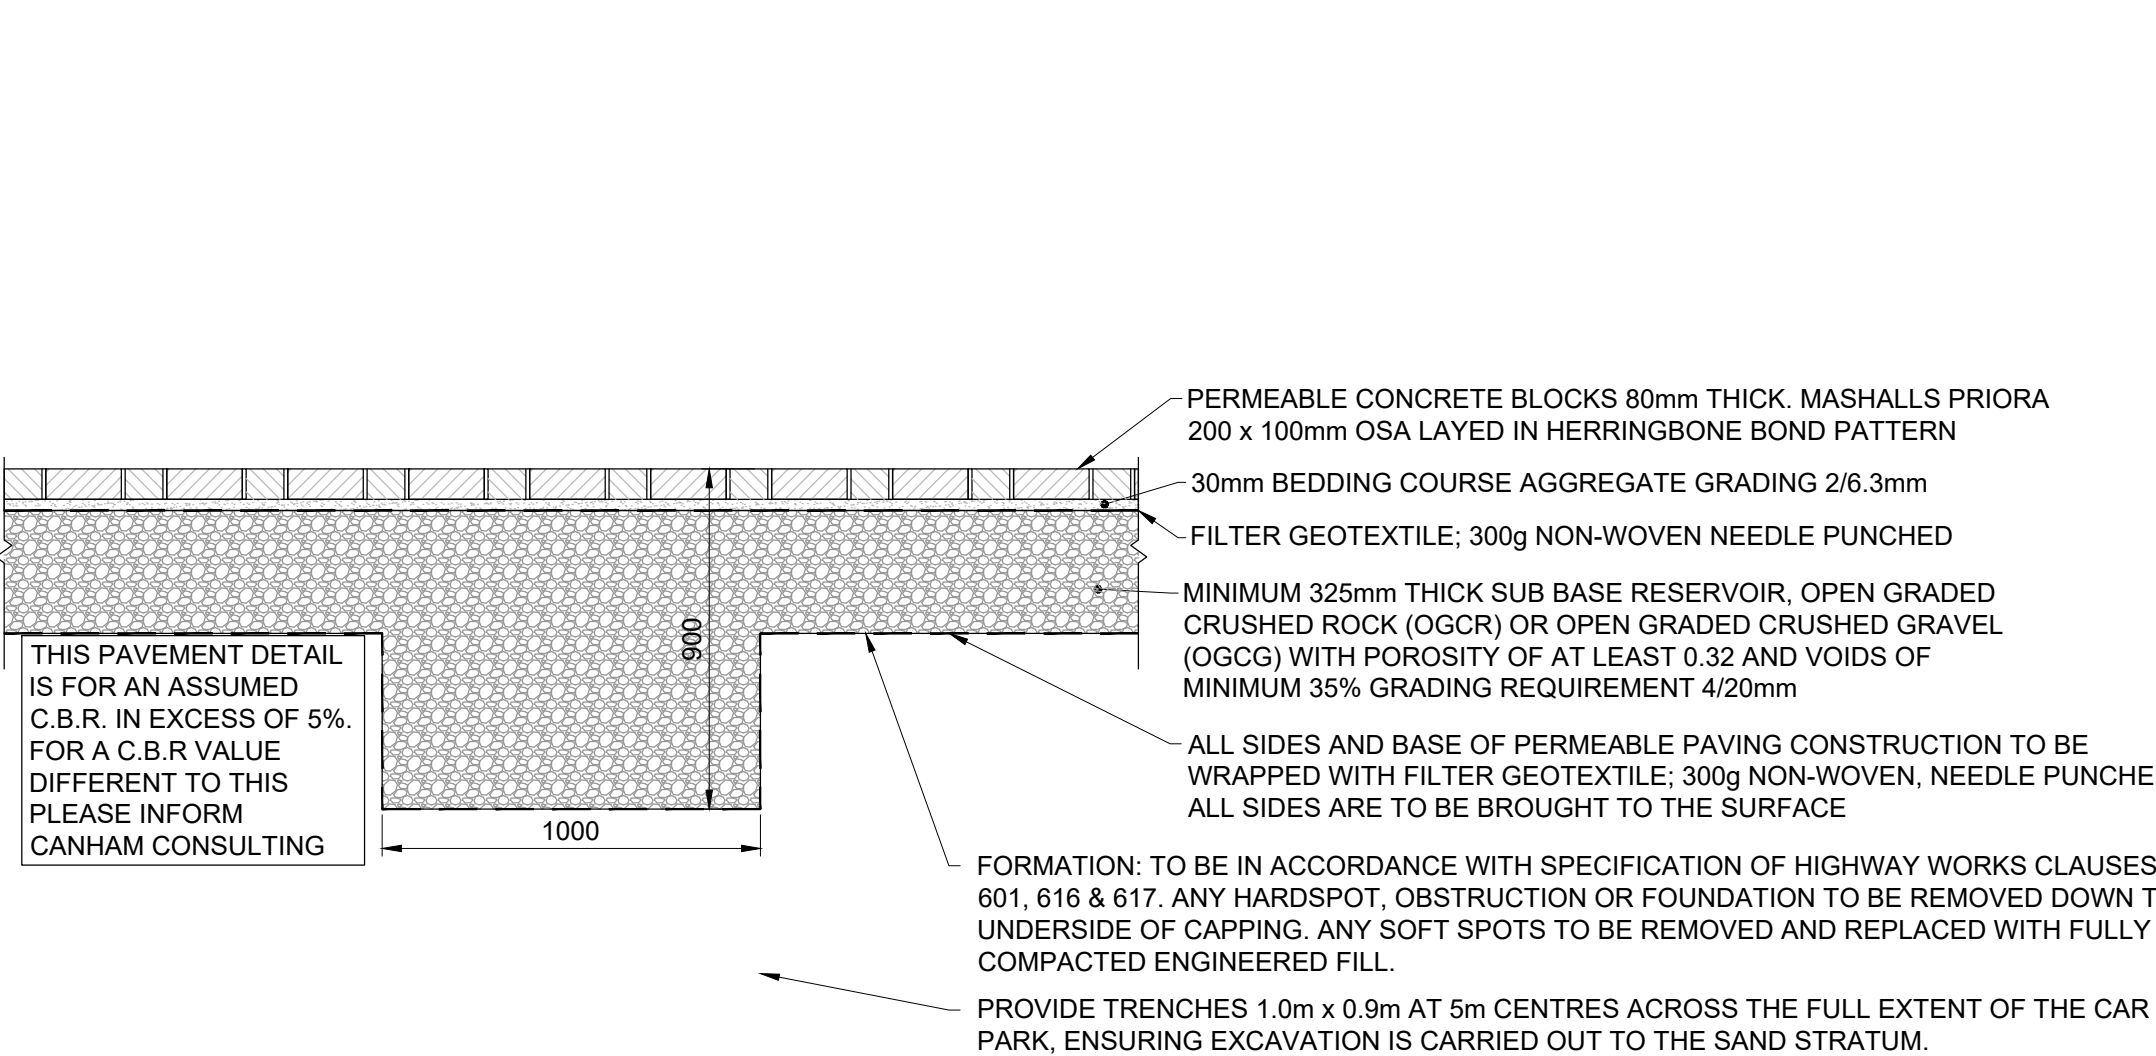
### PERMEABLE PAVING DETAIL

**PERMEABLE PAVING:**  
DESIGNED FOR A CBR VALUE BETWEEN 2-<3%.

SURFACE COARSE: 80mm PERMEABLE BLOCK PAVERS  
BEDDING COARSE: 30mm SHARP SAND  
SUBBASE COARSE: 325mm TYPE 3 PERMEABLE SUBBASE

INFILTRATION RATE: 0.00242m/hr  
HALF DRAIN TIME: 1365 MINUTES
