Michael Collins Architect Ltd

The Biggin

Job No.  
**299** Internal Elevations  
as Proposed

**033**

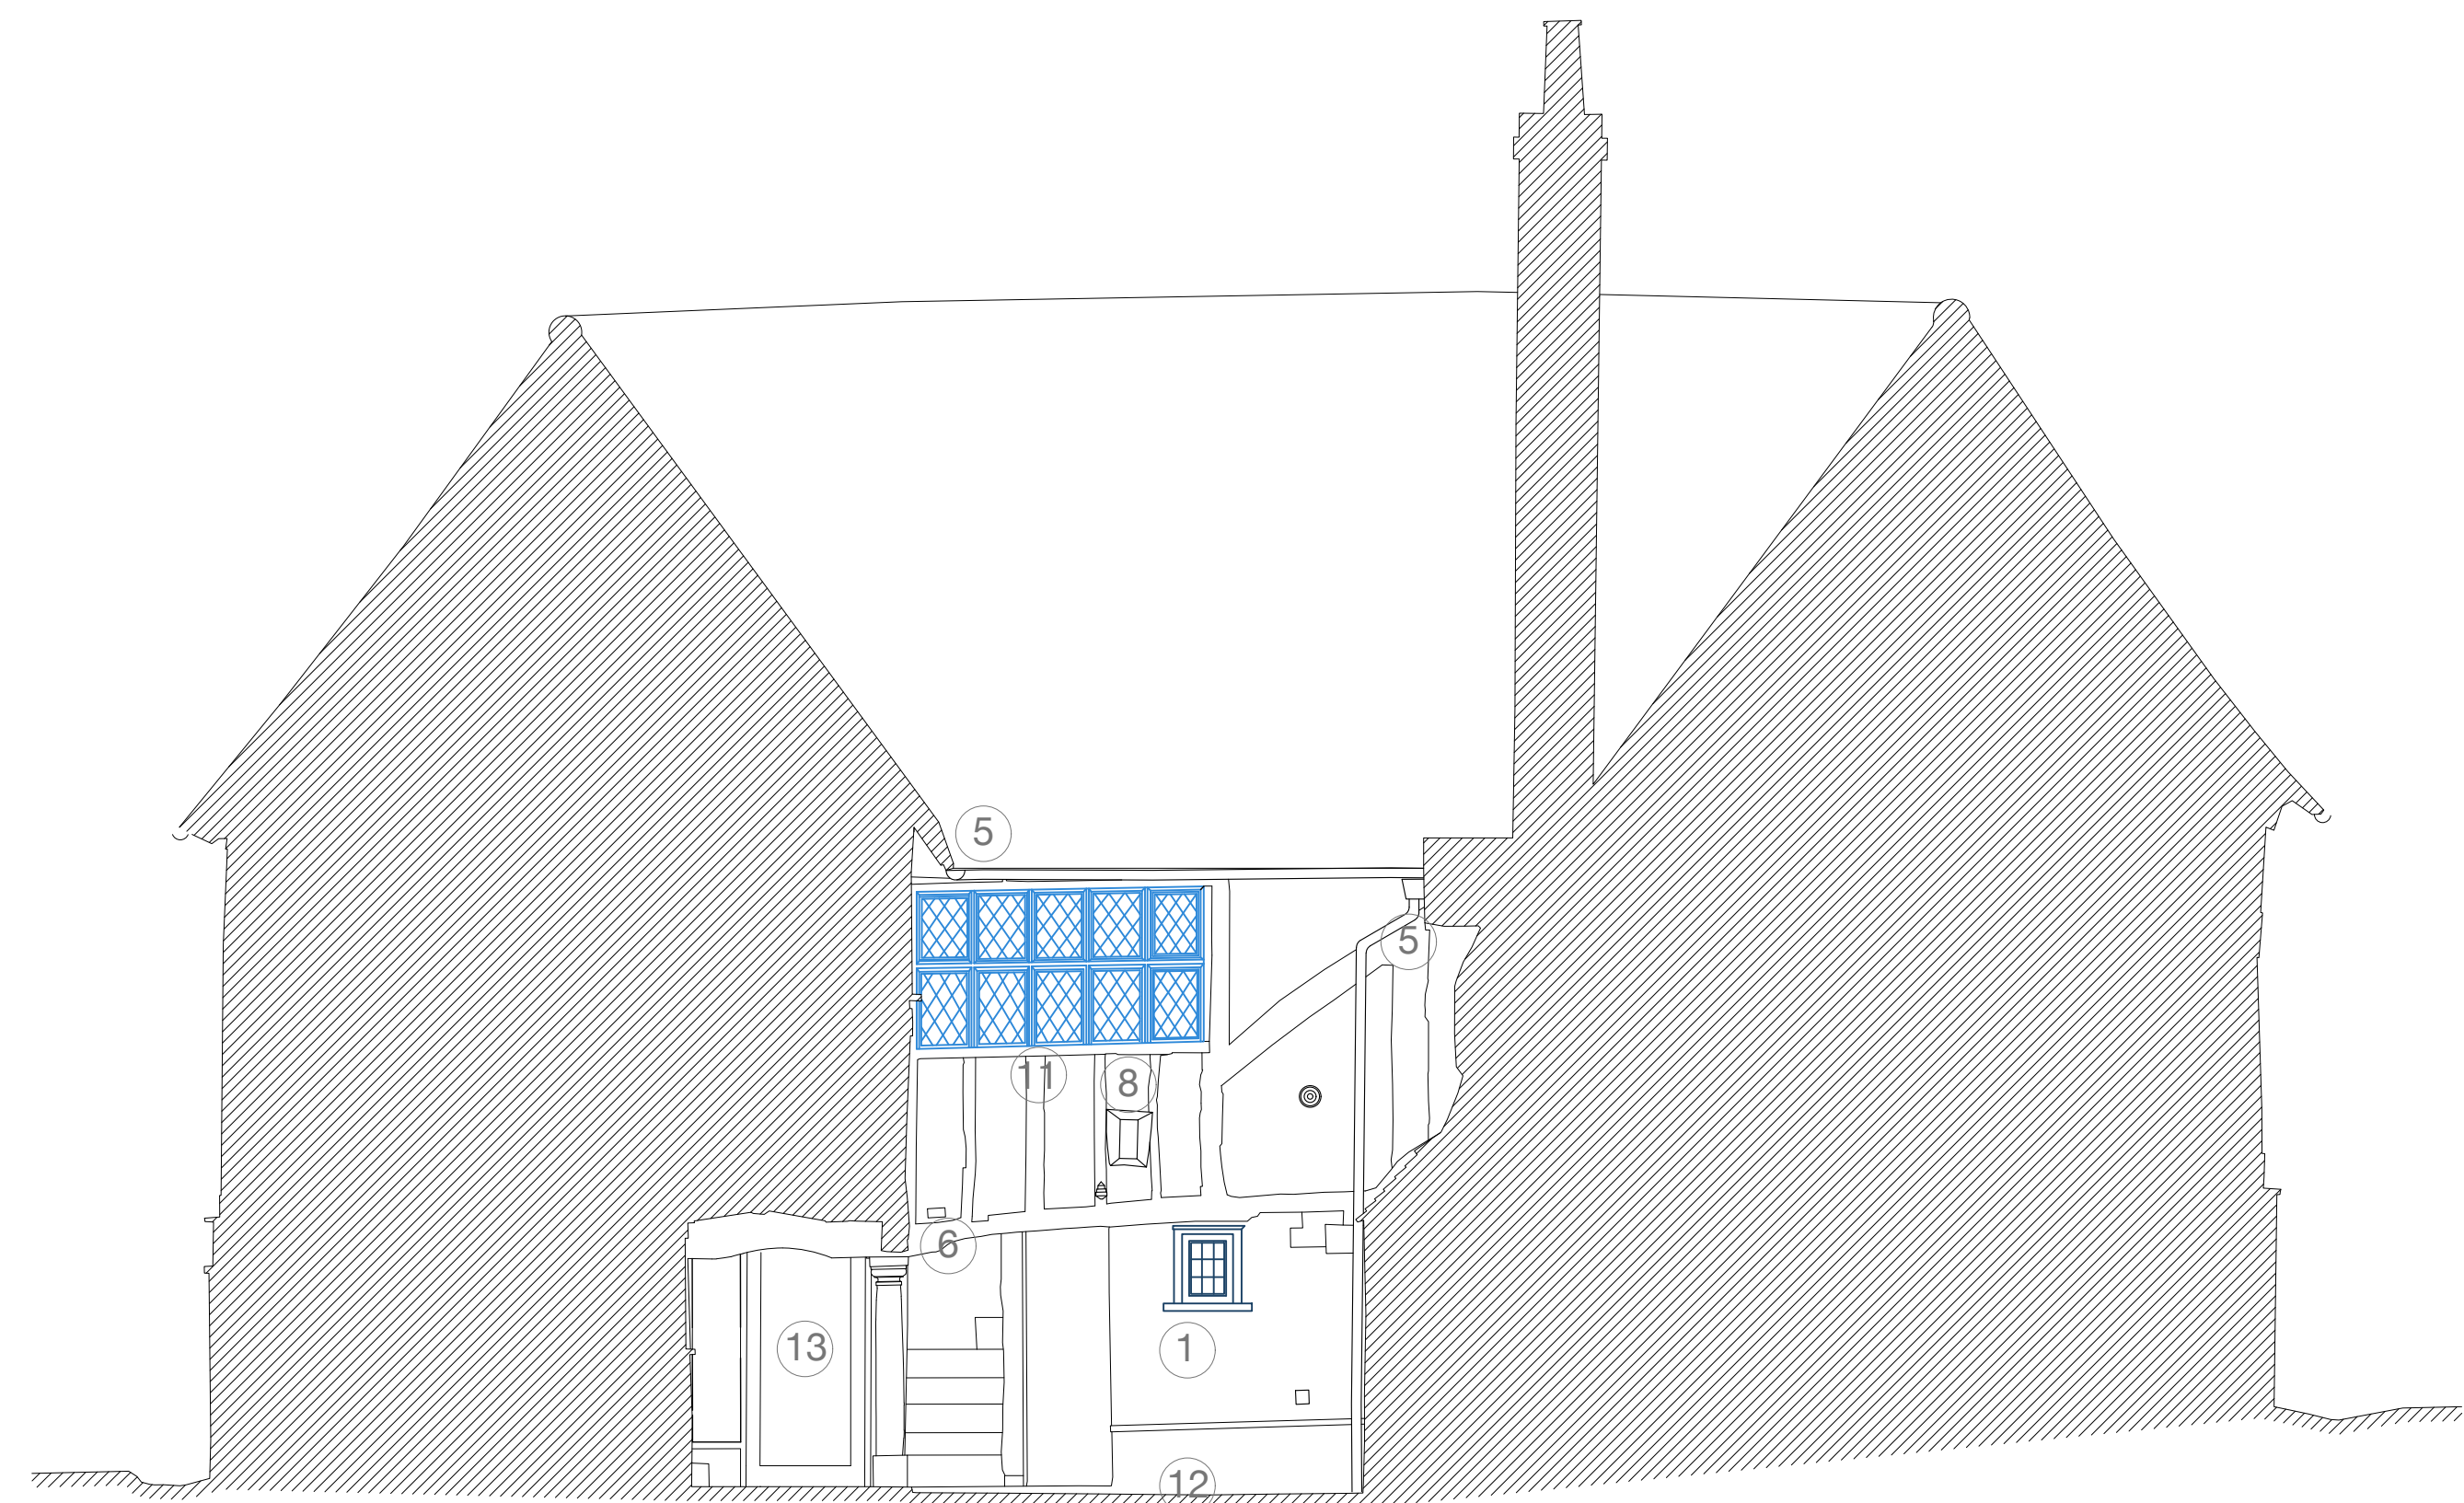
Courtyard South Facing Elevation, Proposed

1. Removal of cement pointing. New lime mortar pointing as per structural survey.
2. Timber repair
3. Removal of cement edging. New french drain.
4. Code 5 lead work to window heads
5. Repairs to existing rainwater goods: cast iron new joint spigots and end-stops
6. New bronze light fitting
7. Remove hedging
8. Removal of fixtures and fittings
9. Lintel works as per structural survey
10. Rectification of existing felt drip detail
11. Remove partition wall from WF-23
12. New permeable paving
13. Replacement door as per window and door schedule and drawing 070

- Retain, Repair, Introduce Slimline Glazing: treat damage and dry out moisture. Introduce slimline secondary glazing. Strip white paint subject to timber condition.
- Retain and Repair: Clean, repair any damage. Courtyard only.
- Replace: replace with double glazed dark hardwood frames rectangular leaded lights

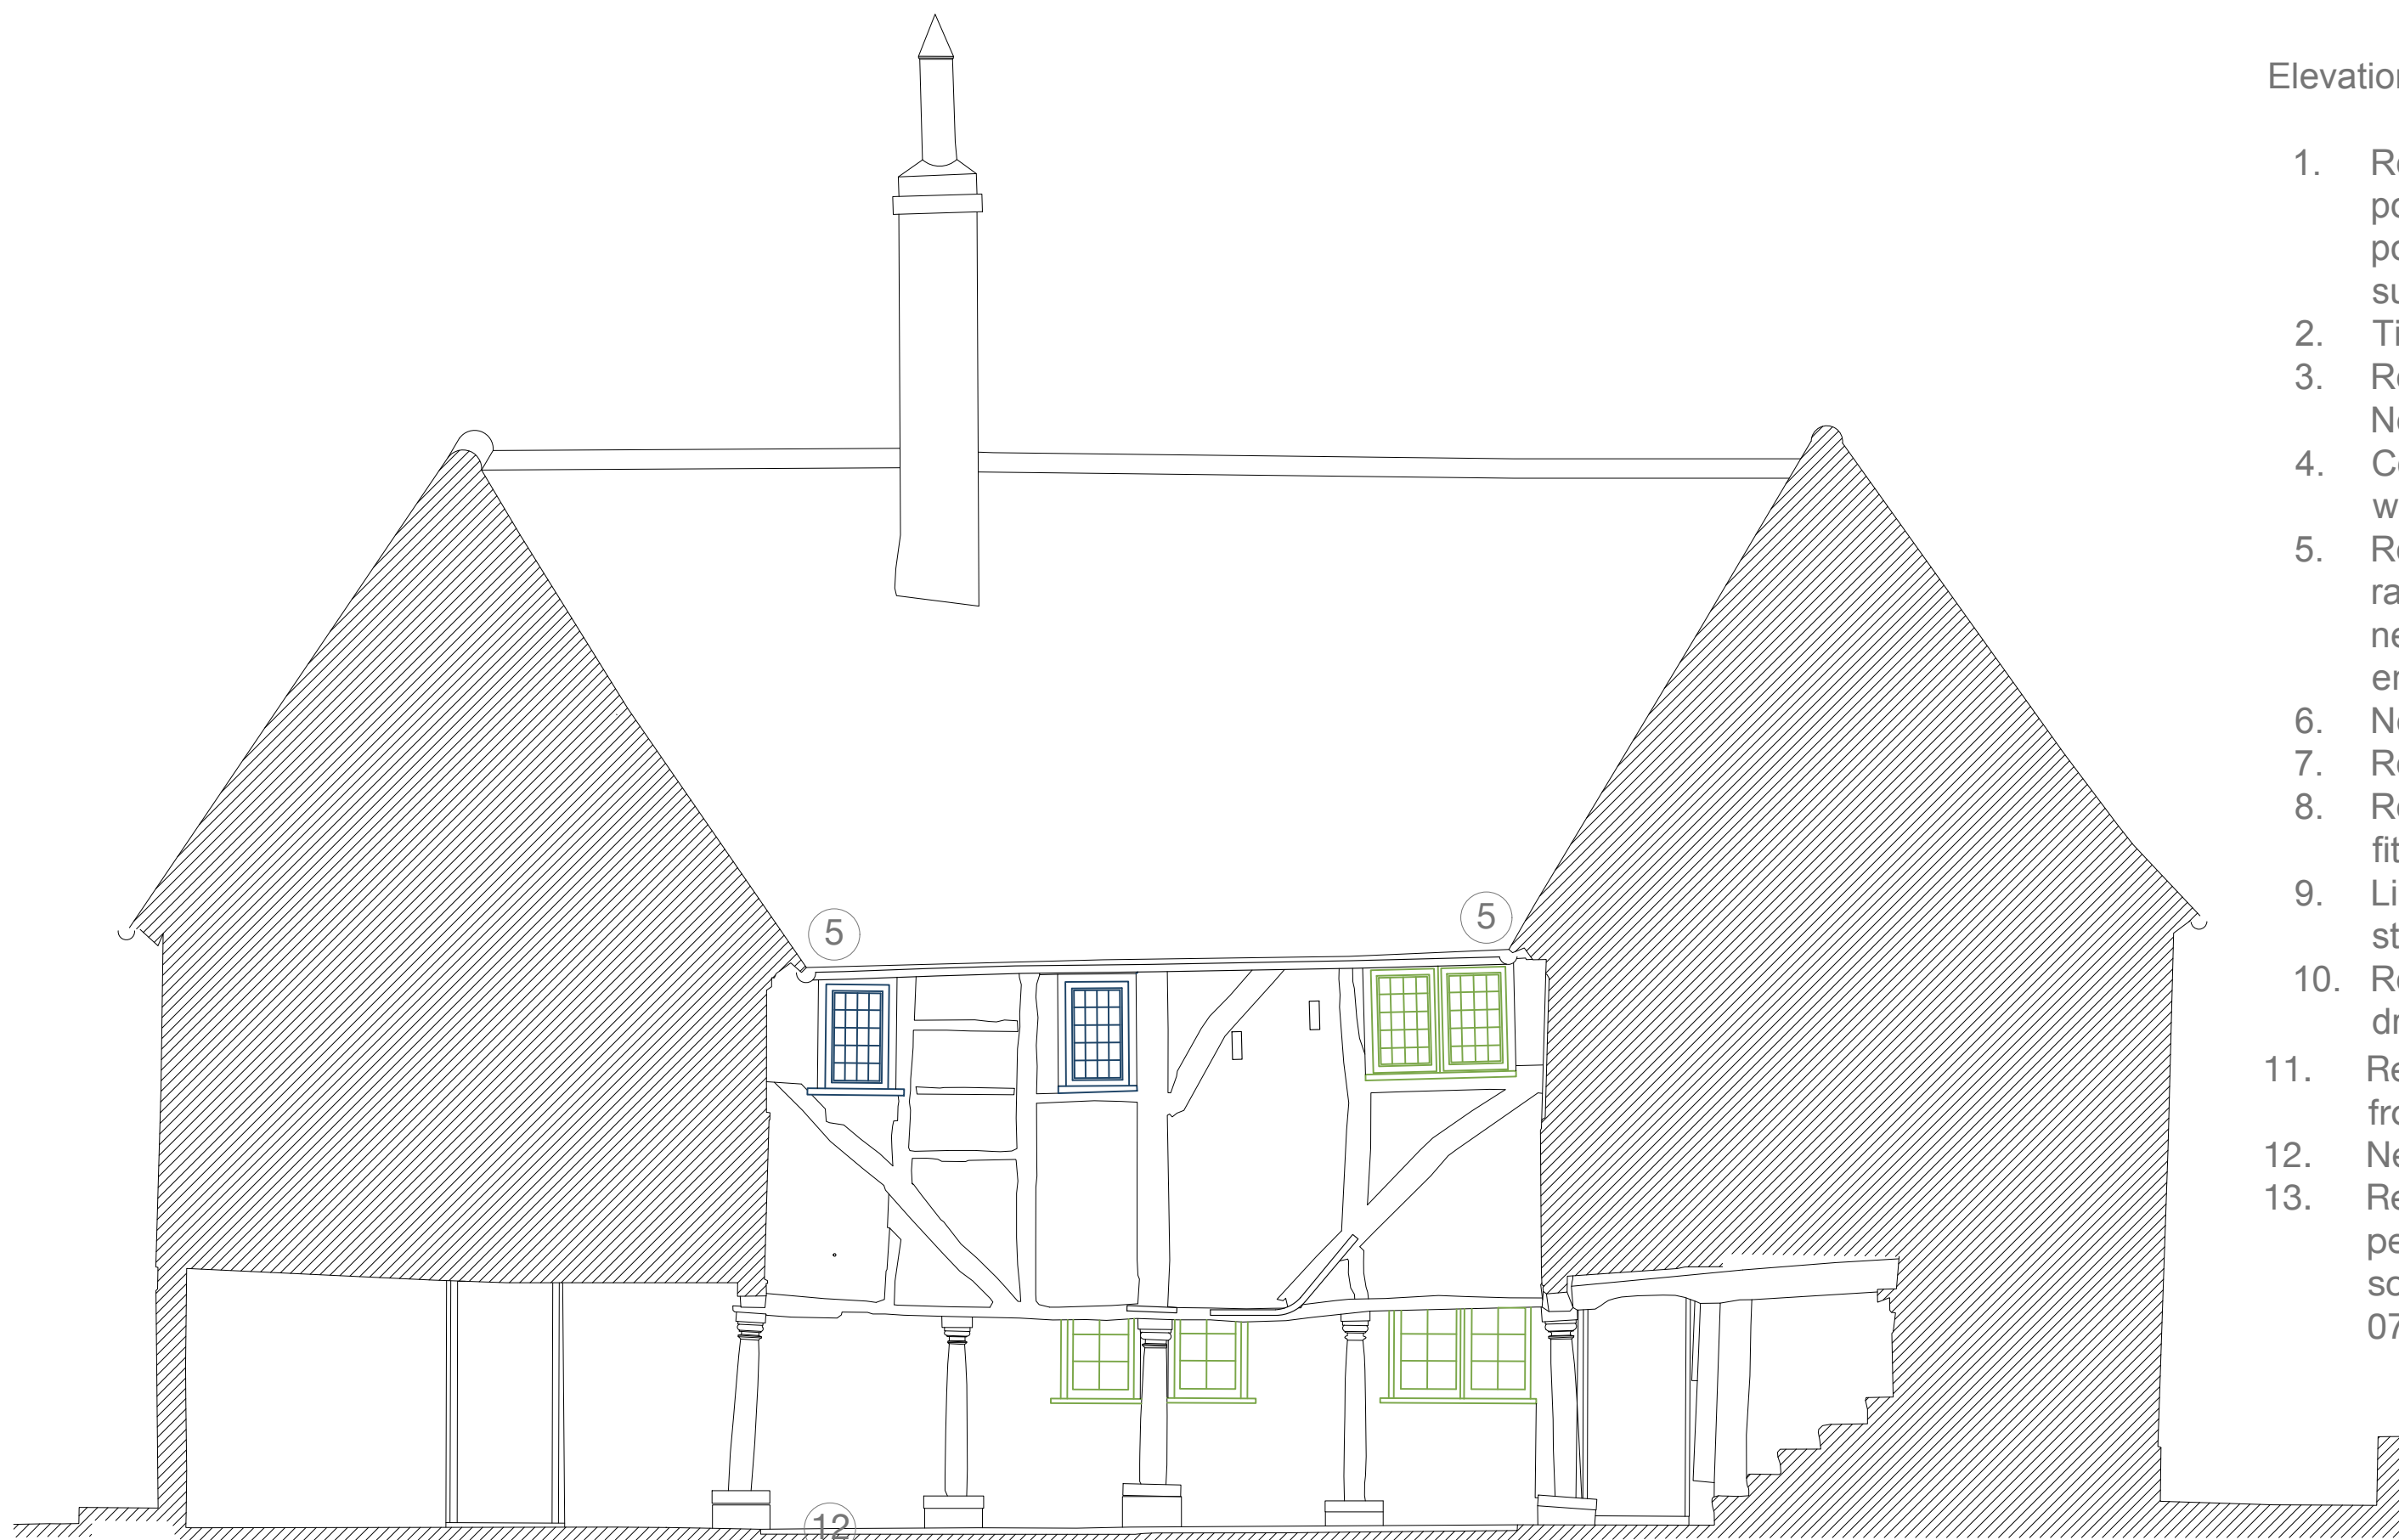
Courtyard East Facing Elevation, Proposed

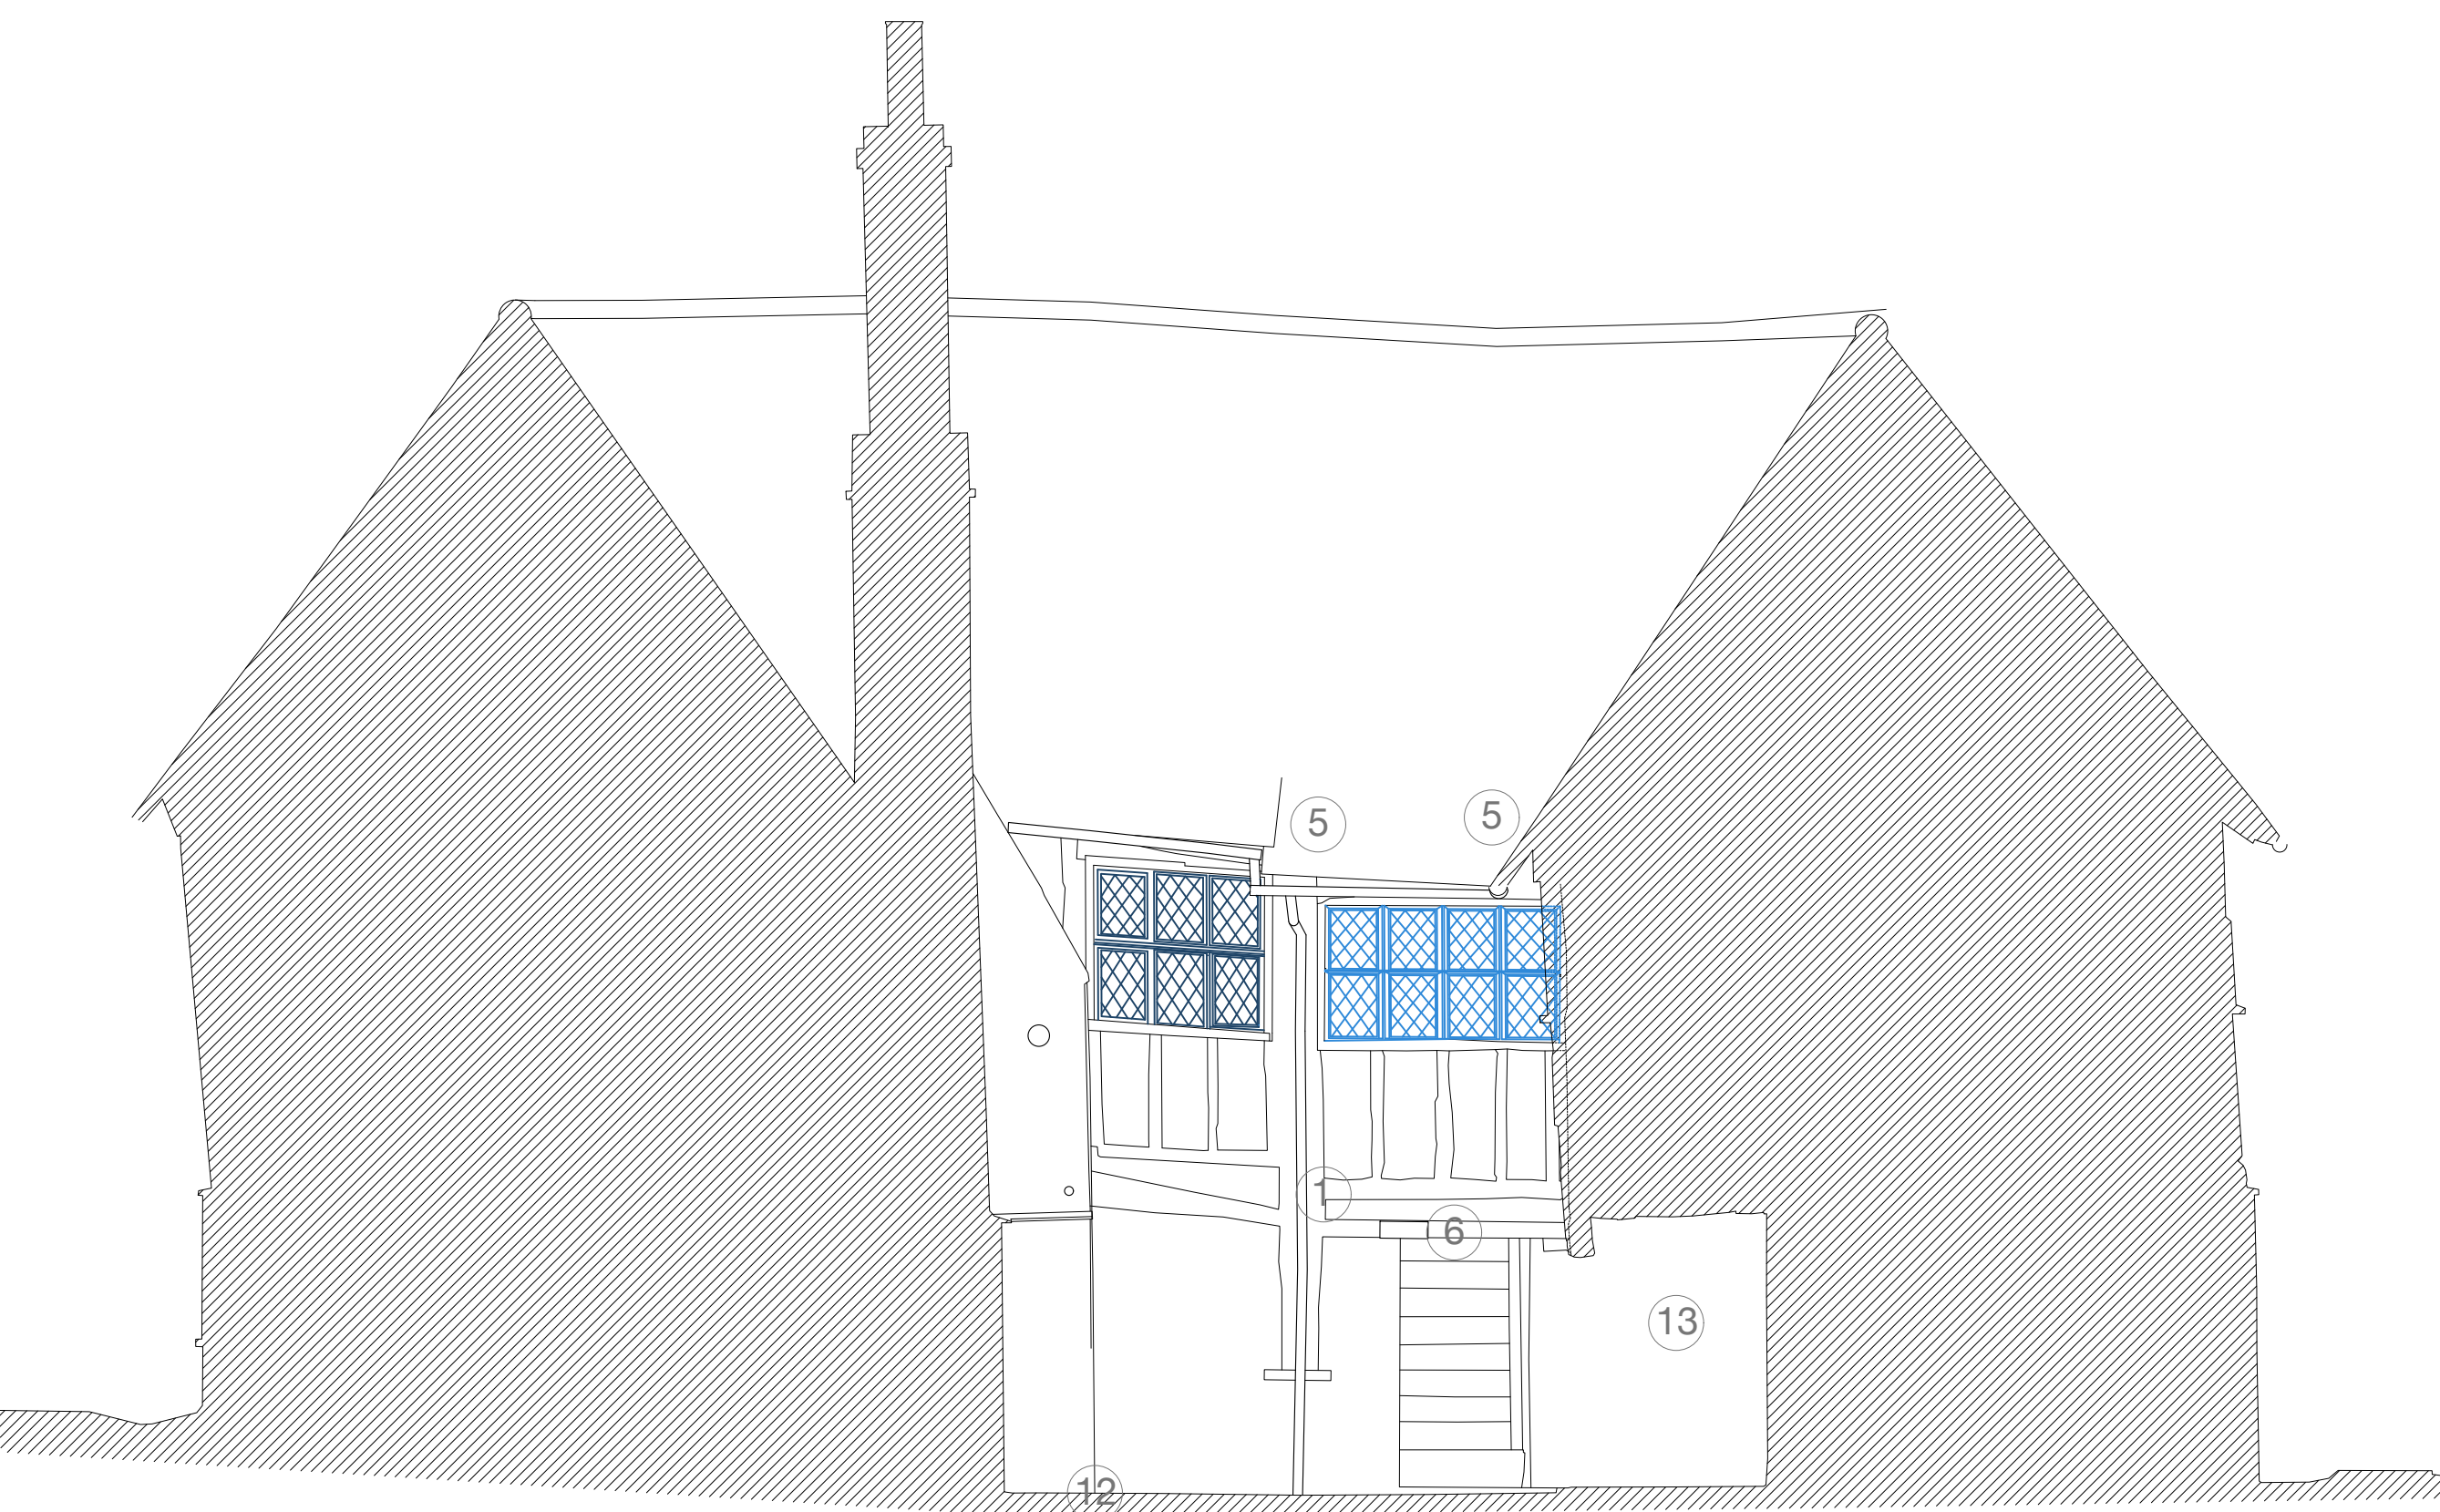
Courtyard North Facing Elevation, Proposed

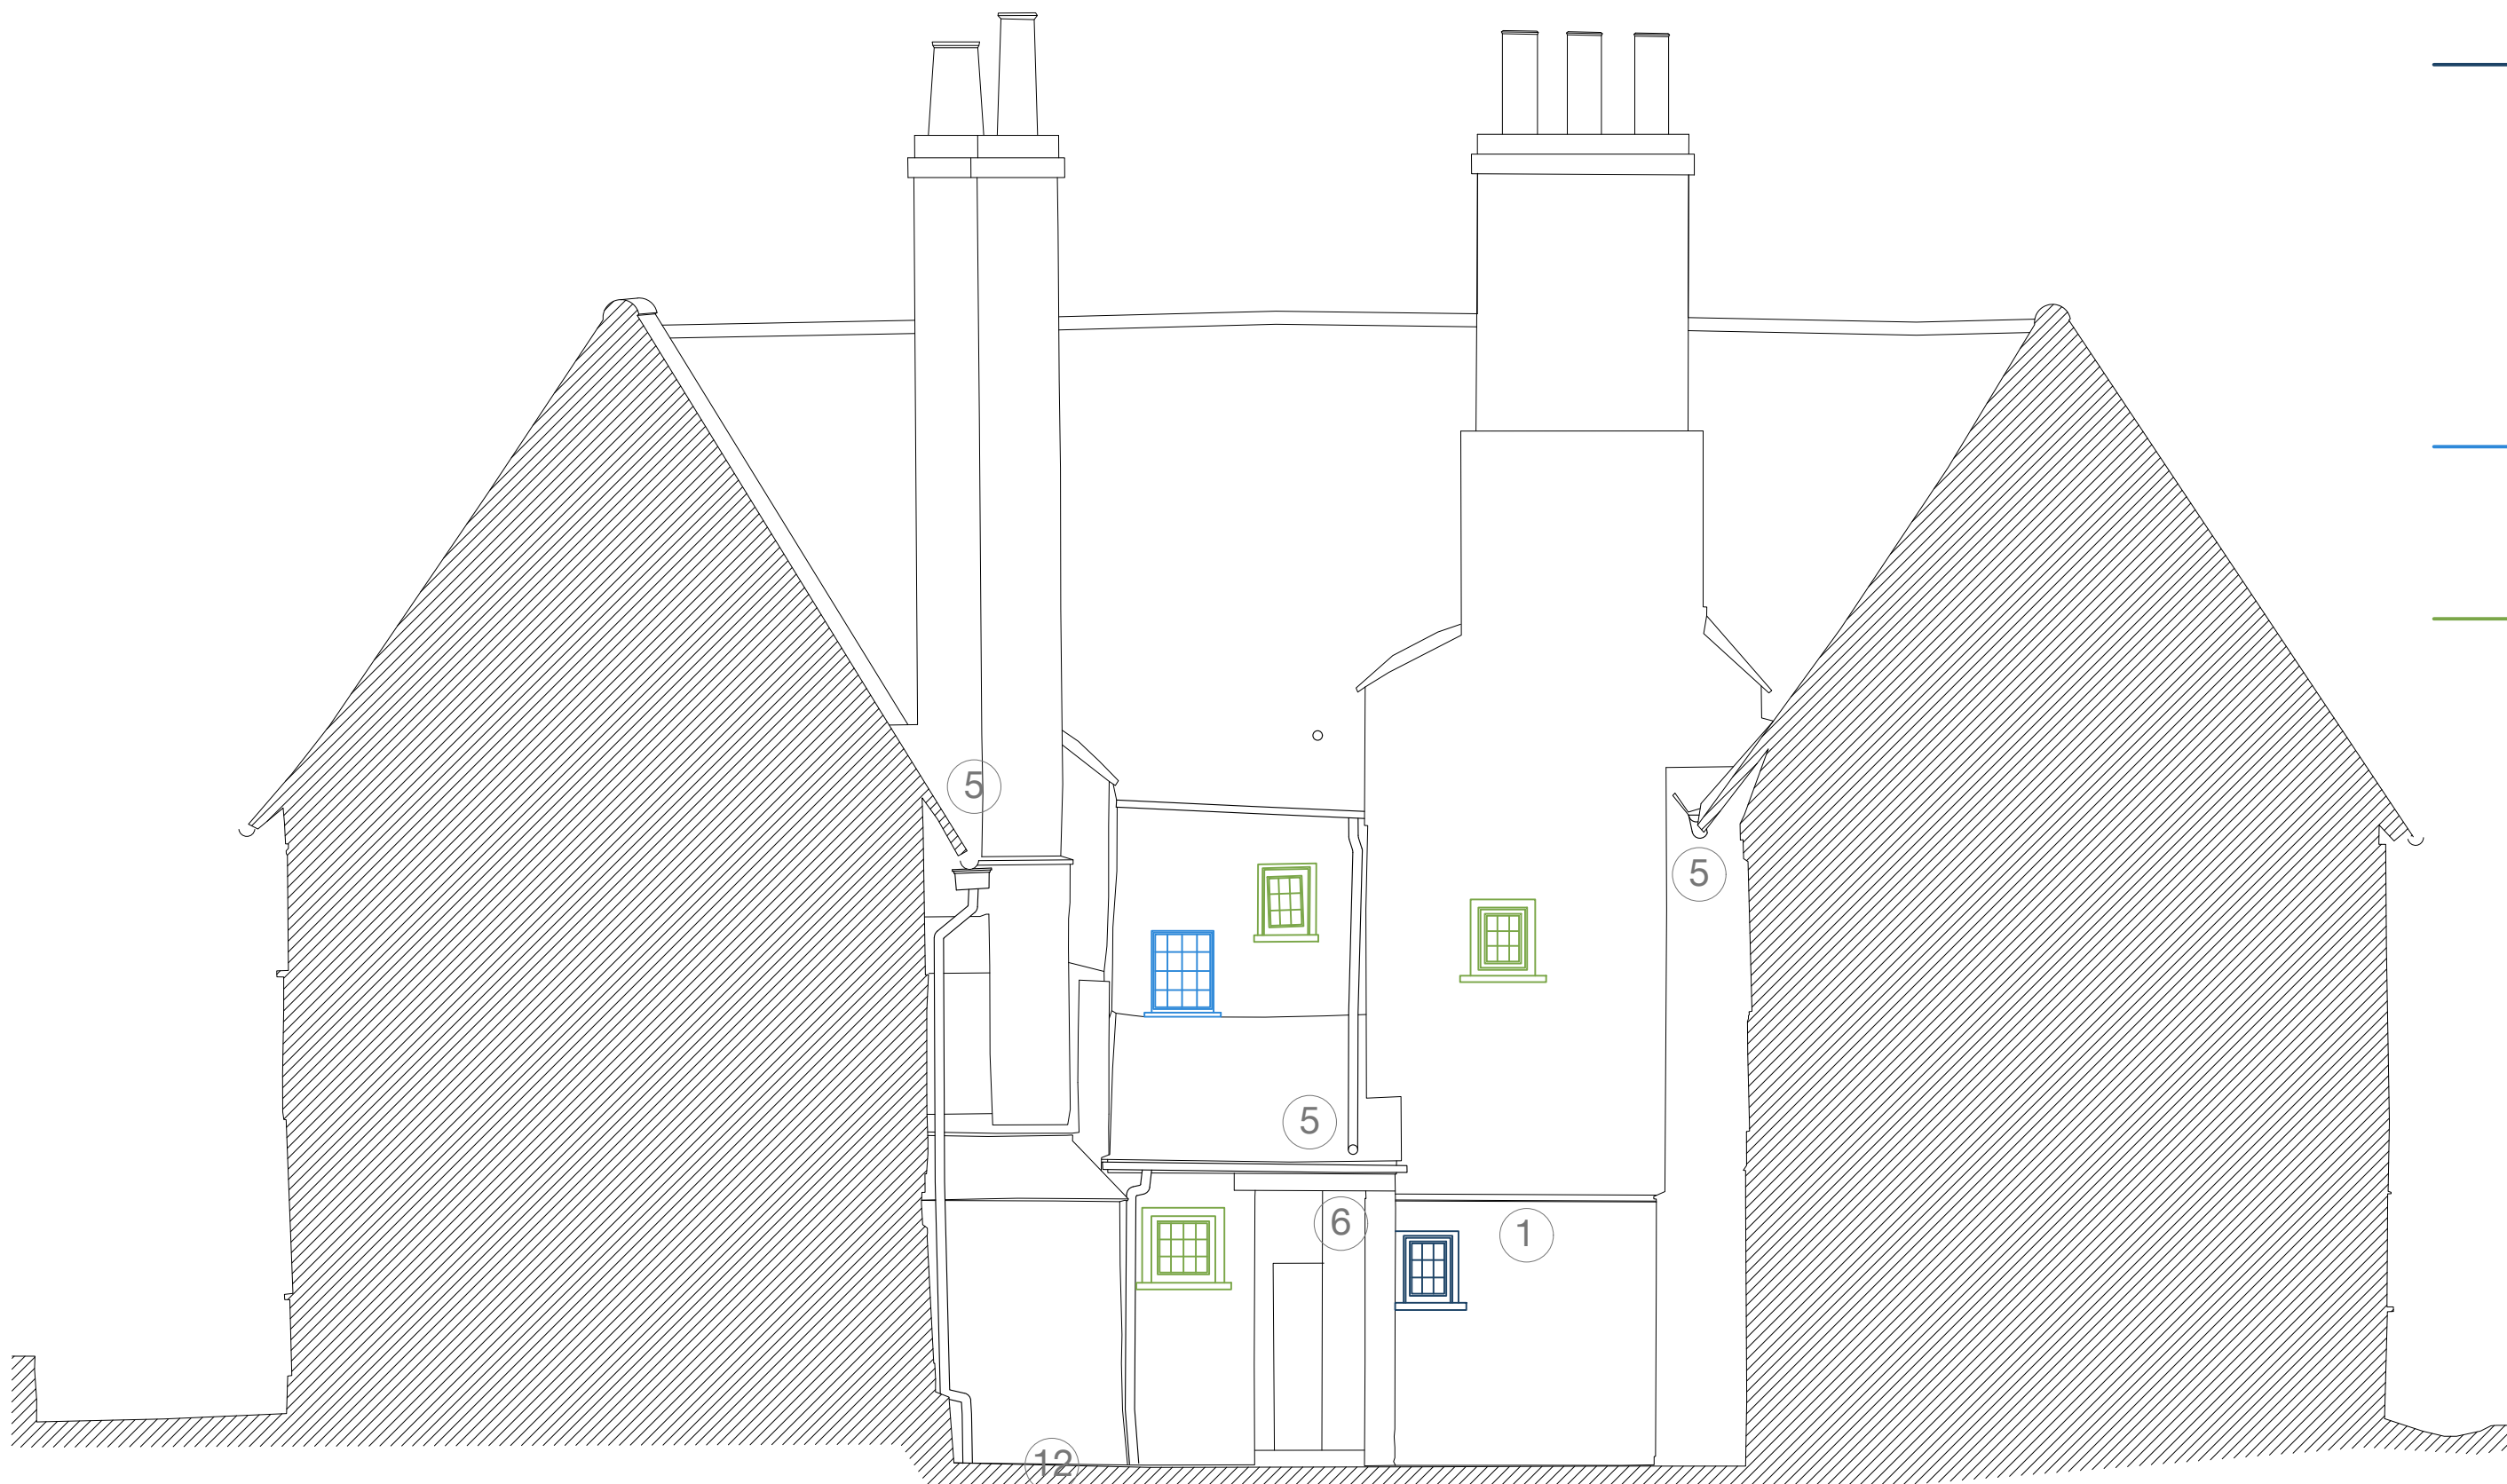
Courtyard West Facing Elevation, Proposed
