## Design and Heritage Statement

### Proposed Replacement of Timber Cladding to Dormer Cheeks with Code 6 Lead

30 Bancroft, Hitchin, SG5 1LA

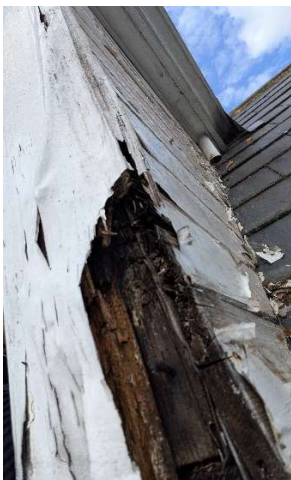
The existing timber cladding to the sides of the dormers is rotting and has reached the end of its useful life. Its continued retention would risk ongoing deterioration, reduced weather protection and potential future damage to adjacent fabric.

The proposed works comprise the removal of rotting timber cladding from the sides of the existing dormers and its replacement with Code 6 lead sheeting fixed over plywood, with a ventilated space provided behind. The works are required because the existing timber cladding has deteriorated and is no longer performing adequately as a weathering material.
