Michael Collins Architect LLP

23 Tilehouse Street

Job No. 206 Proposed Section

Stage: Stage 2  
 Status: Preliminary

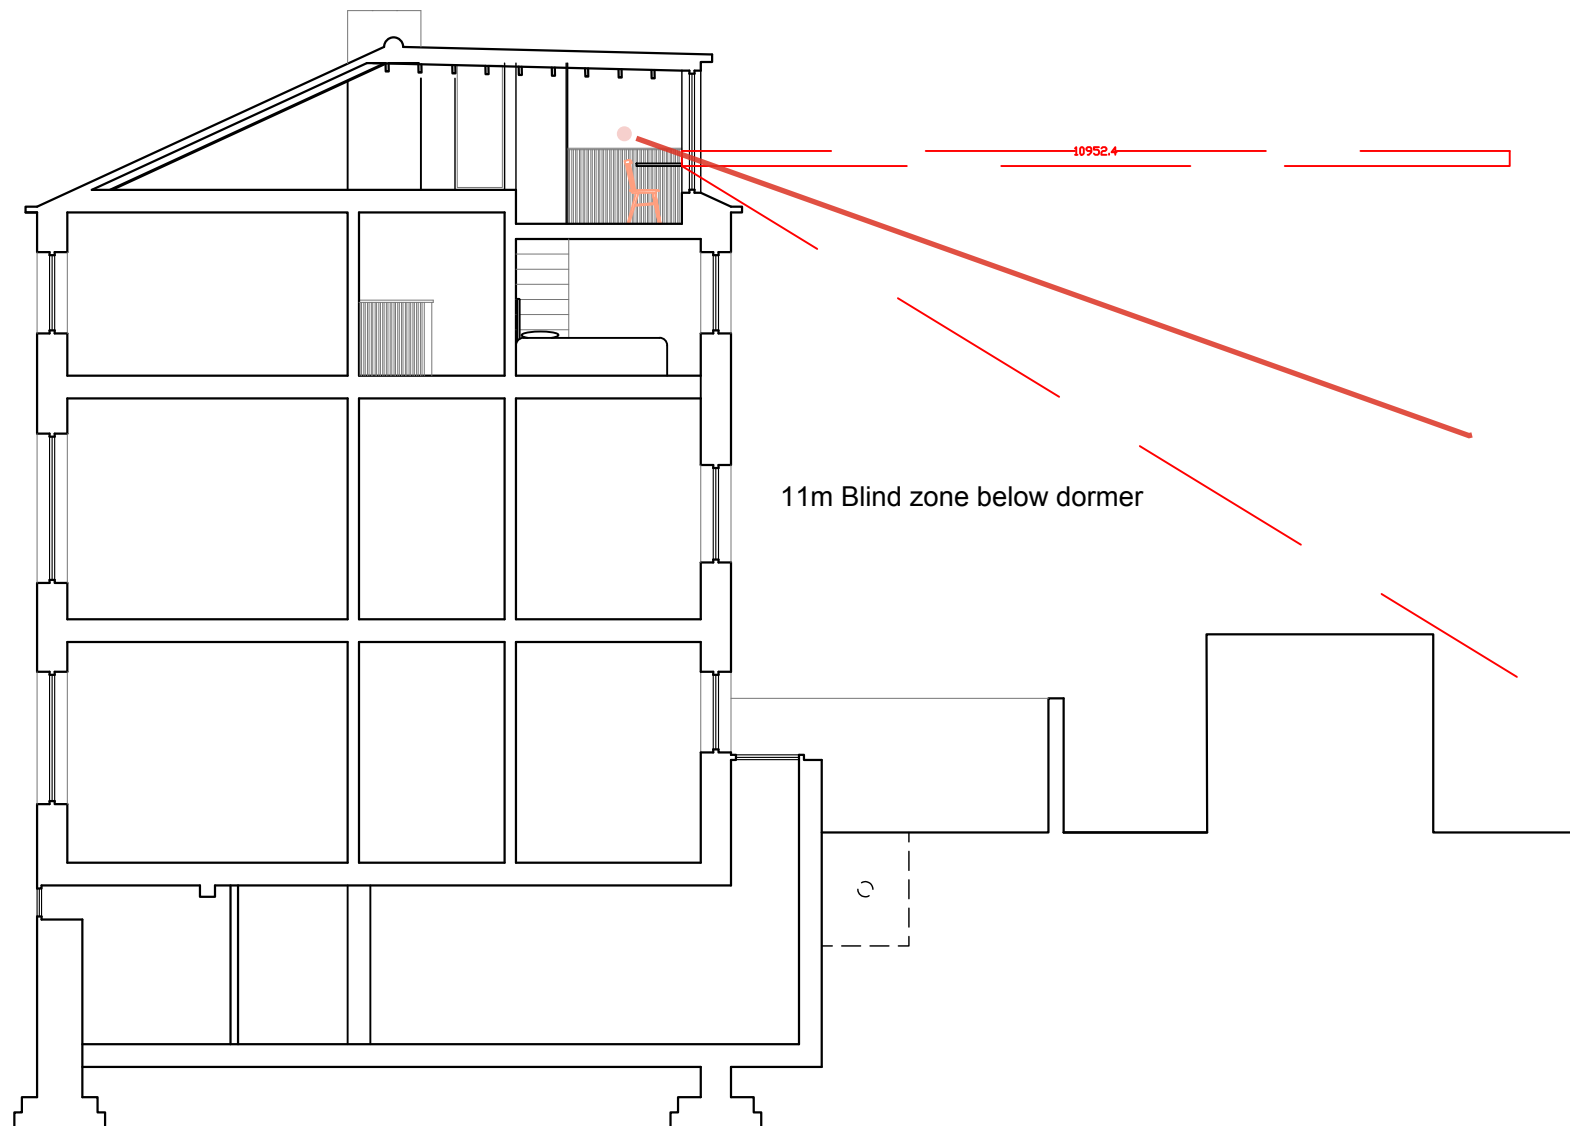
027

- a. Existing coal chute opened and glazed
- b. New basement office
- c. New stud partitions
- d. Existing tanking membrane retained
- e. Newtanking system and underpinning
- f. Rooflight over
- g. Existing stone steps retained
- h. existing timber beam/ceiling over retained
- i. New glazed light well
- j. Zinc roof
- k. existing gate retained
- l. new low level window below
- m. Ceiling opened over existing stair
- n. Rooflight over
- o. New sash and case window
- p. New office and gallery
- q. New lightweight stair
- r. Existing chimney retained
- s. new aluminum framed window with oak surround
- t. Existing plaster and lath ceiling retained
- u. oxidised copper cladding to match new clay tiles
- v. replacement handmade clay tiles
- w. zinc cladding
- z. New dry bedded ventilated ridge
- aa. Frosted glazing to 1m above FFL
