project Codicote House

title Proposed Roof Plan

purpose of issue  
**PLANNING**  
scale As indicated @ A1 drawn GT BAM job no. drg status  
date 30/05/19 checked MWB 4498  
project code originator volume level type role number rev  
drg / doc ref **CDH- BMD- Z1- 02- DR-A- 11136 P3**

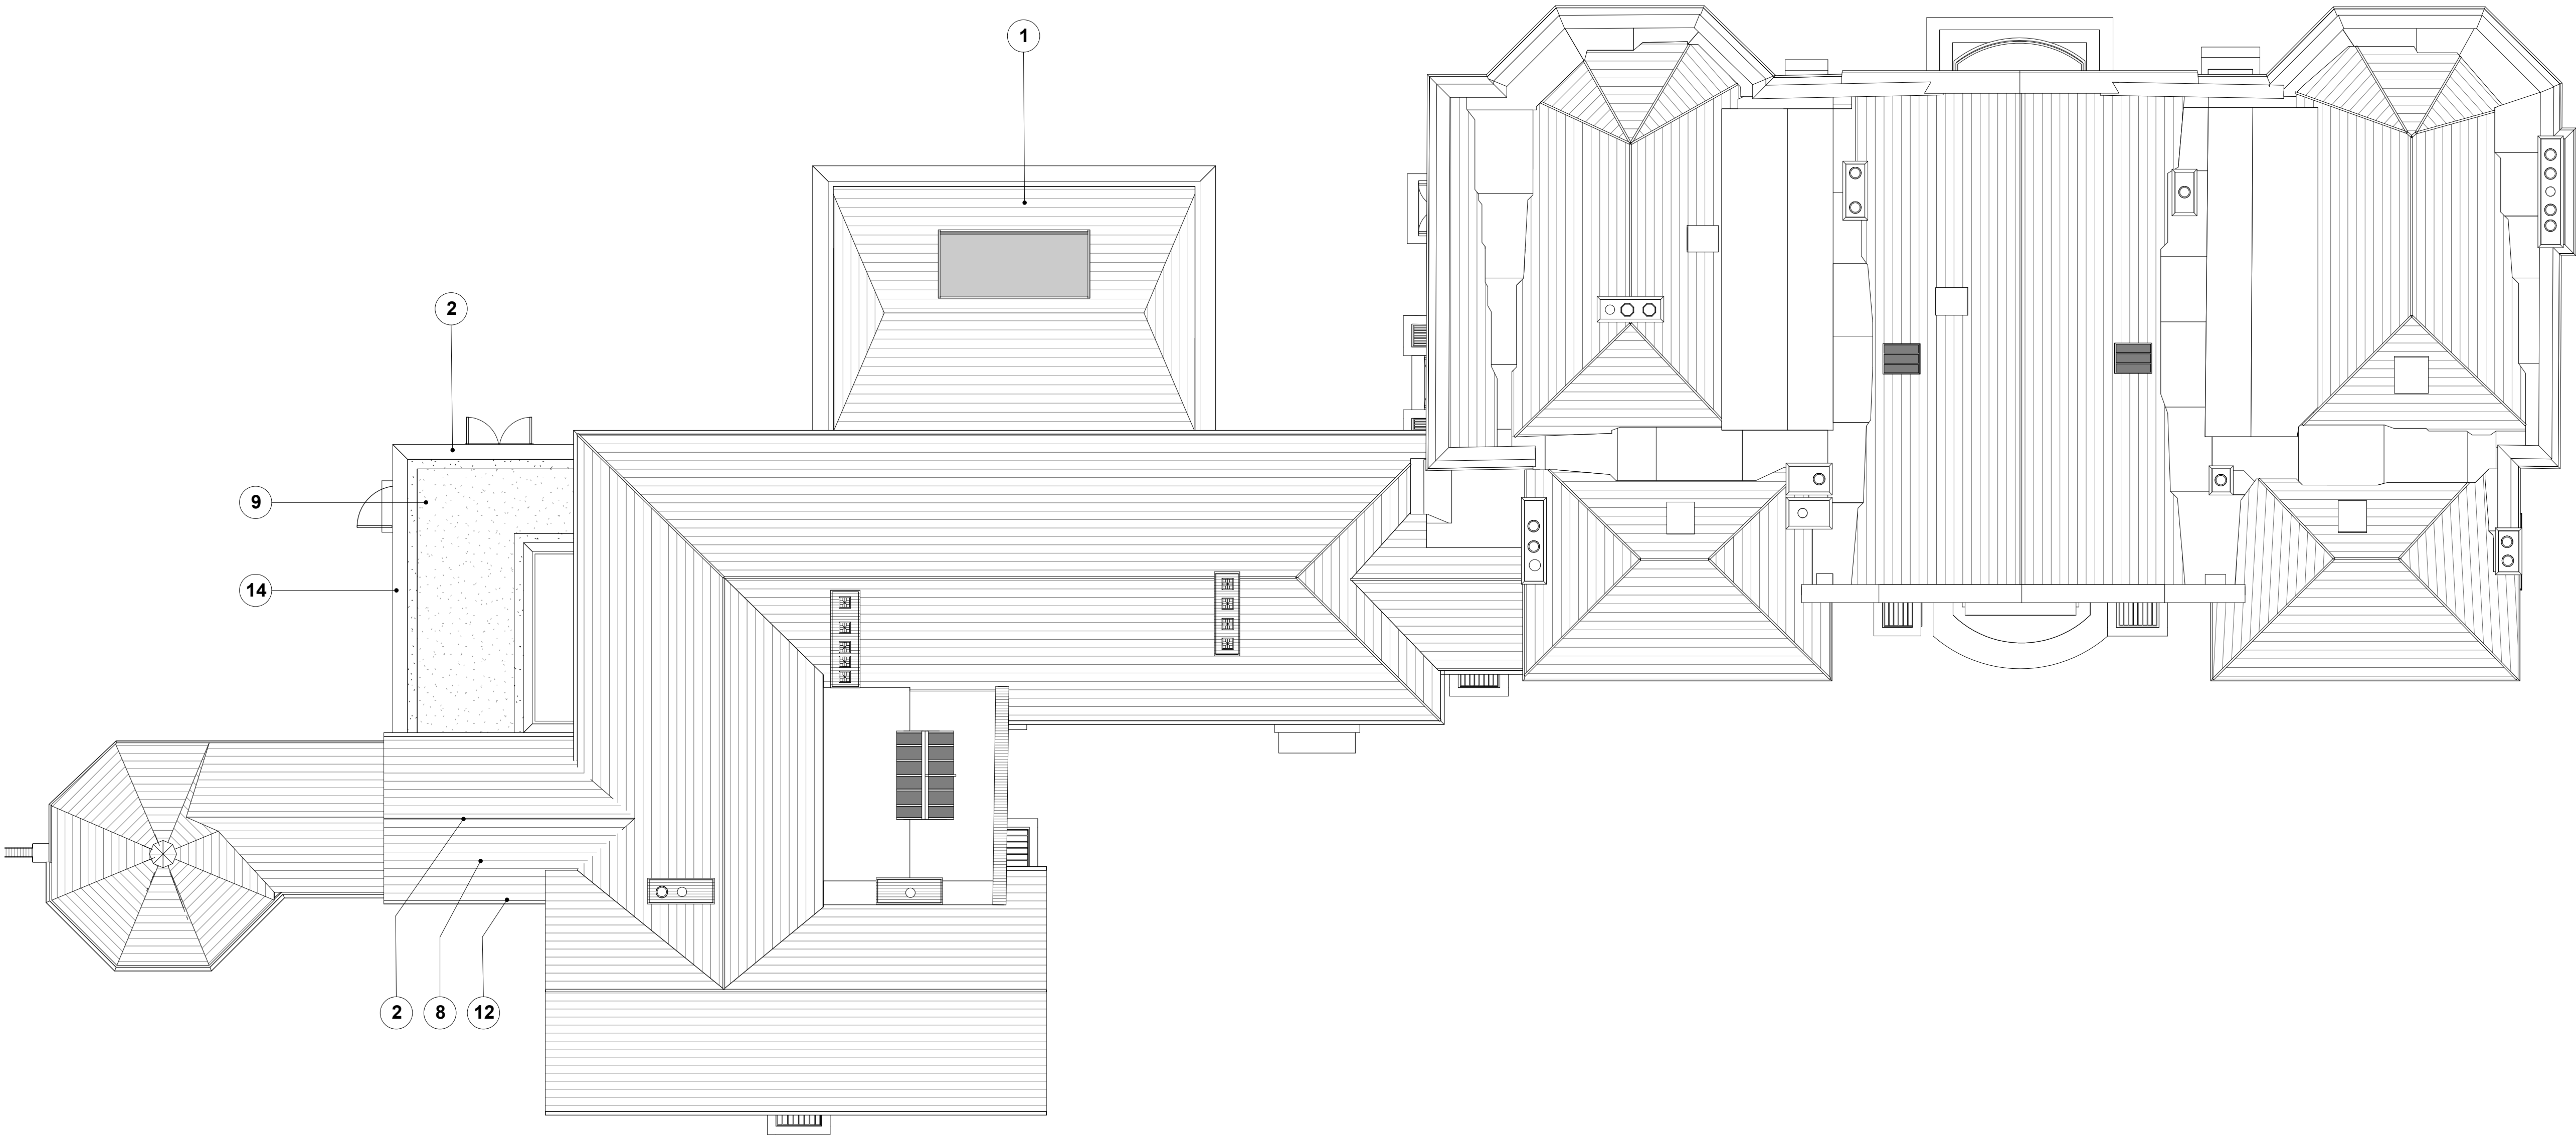
- Recently consented Garden Room addition and landscape adjustments
- Existing modern spiral stair removed and existing courtyard garden walls raised / rebuilt in matching gault brickwork to form new single storey enclosure to courtyard and two storey gabled addition of traditional construction housing new stair and lift

- New minimally metal framed fixed glazing with concealed service door access (for maintenance) around new light well
- New Gault brick finish to addition to carefully match existing brickwork, mortar and pointing. Existing string course to service wing extended into new brickwork.

- New gabled roof finished in traditional slate to match existing adjacent
- New single ply roof and gutters laid to minimal pitches on heavily insulated substrate with sedum planted top. (concealed from view)

- Cast iron rainwater goods adjusted to suit new roofs and underground drainage
- New cast iron hopper and downpipe to new flat roof
- New cast iron gutters and downpipes to addition to match existing

- New fixed timber framed window to existing opening in brickwork
- Cast stone copings to top of wall
- Painted timber barge boards to gable to match existing adjacent
