# REMODELLING AND REFURBISHMENT OF BALDOCK METHODIST CHURCH

## DESIGN AND ACCESS STATEMENT

JUNE 2026

This Design and Access Statement is submitted in support of Planning and Listed Building Consent applications for the sensitive internal remodelling and refurbishment of the former Baldock Methodist Church.

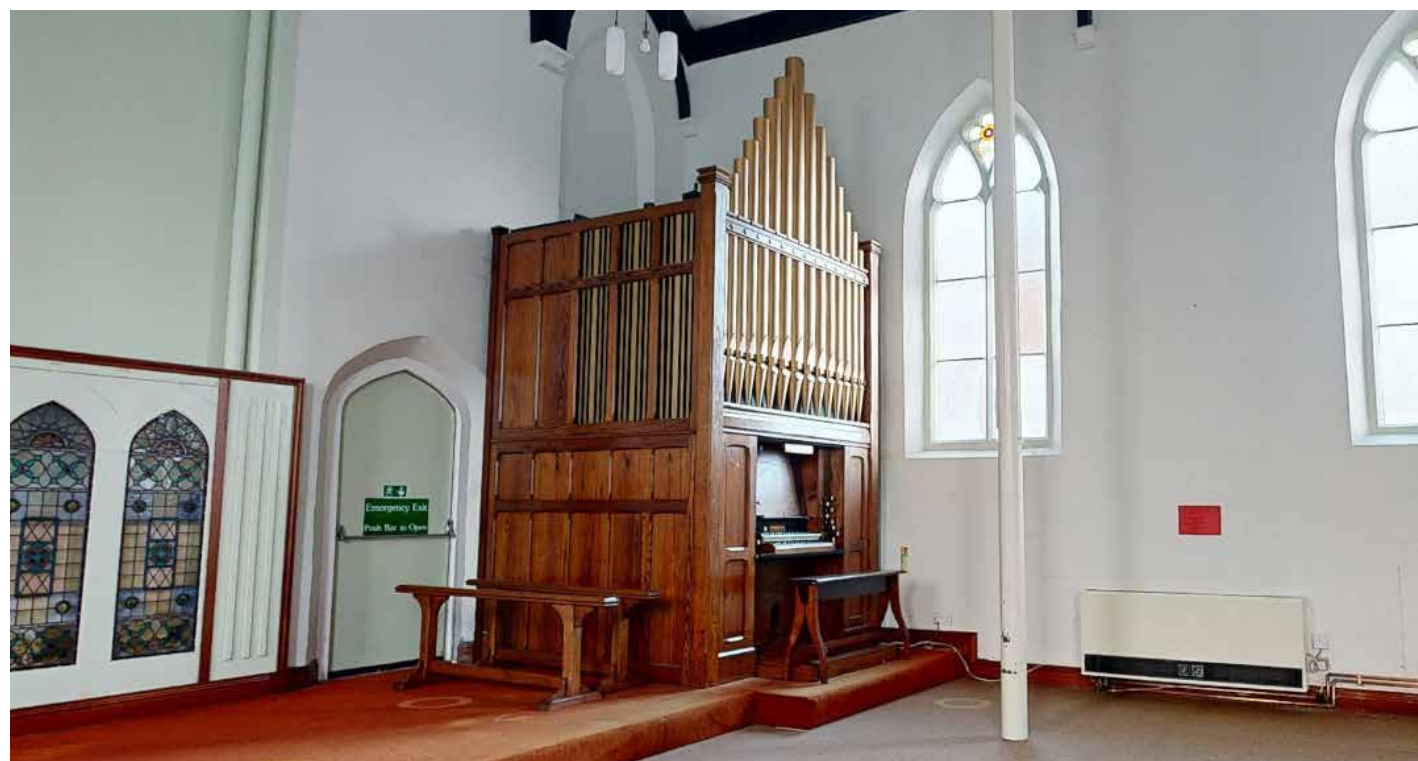
*Fig. 01 : The Henry Speechly pipe organ*

The Henry Speechly pipe organ was installed in the church at the same time as the 1982/83 alterations to the building (replacing a larger, older instrument) and is to be removed and offered for re-homing through “Pipe up for Pipe Organs”  
- A British charity established in 2022 seeking to sustainably re-home unwanted British pipe organs. *(Fig. 01)*

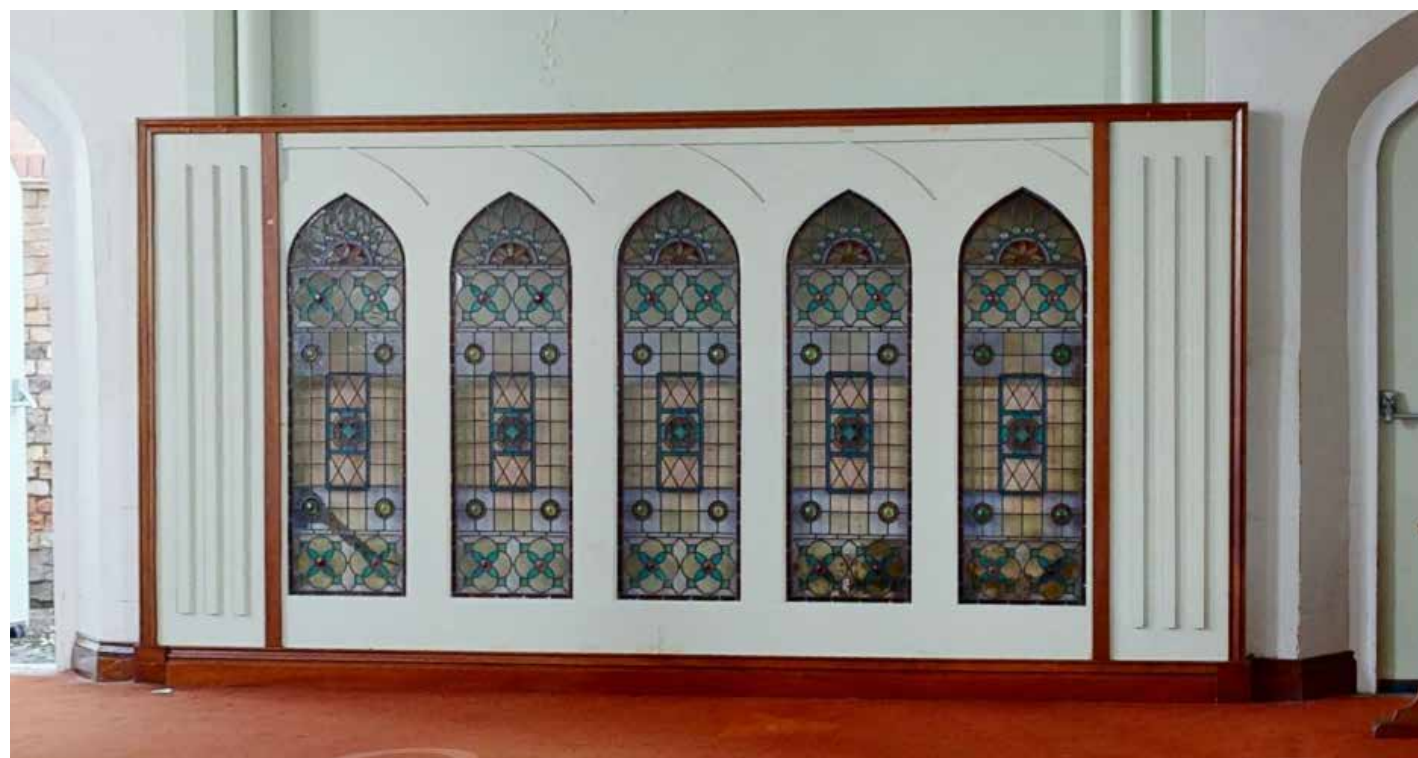
*Fig. 02 : Decorative leaded glass panes*

The decorative leaded glass panes, currently located behind the raised platform at the front of the church are thought to have originated from a glazed screen separating the entrance vestibule from the body of the church (removed during the 1982/83 works). These are to be retained and incorporated into the new first floor vestibule. *(Fig. 02)*

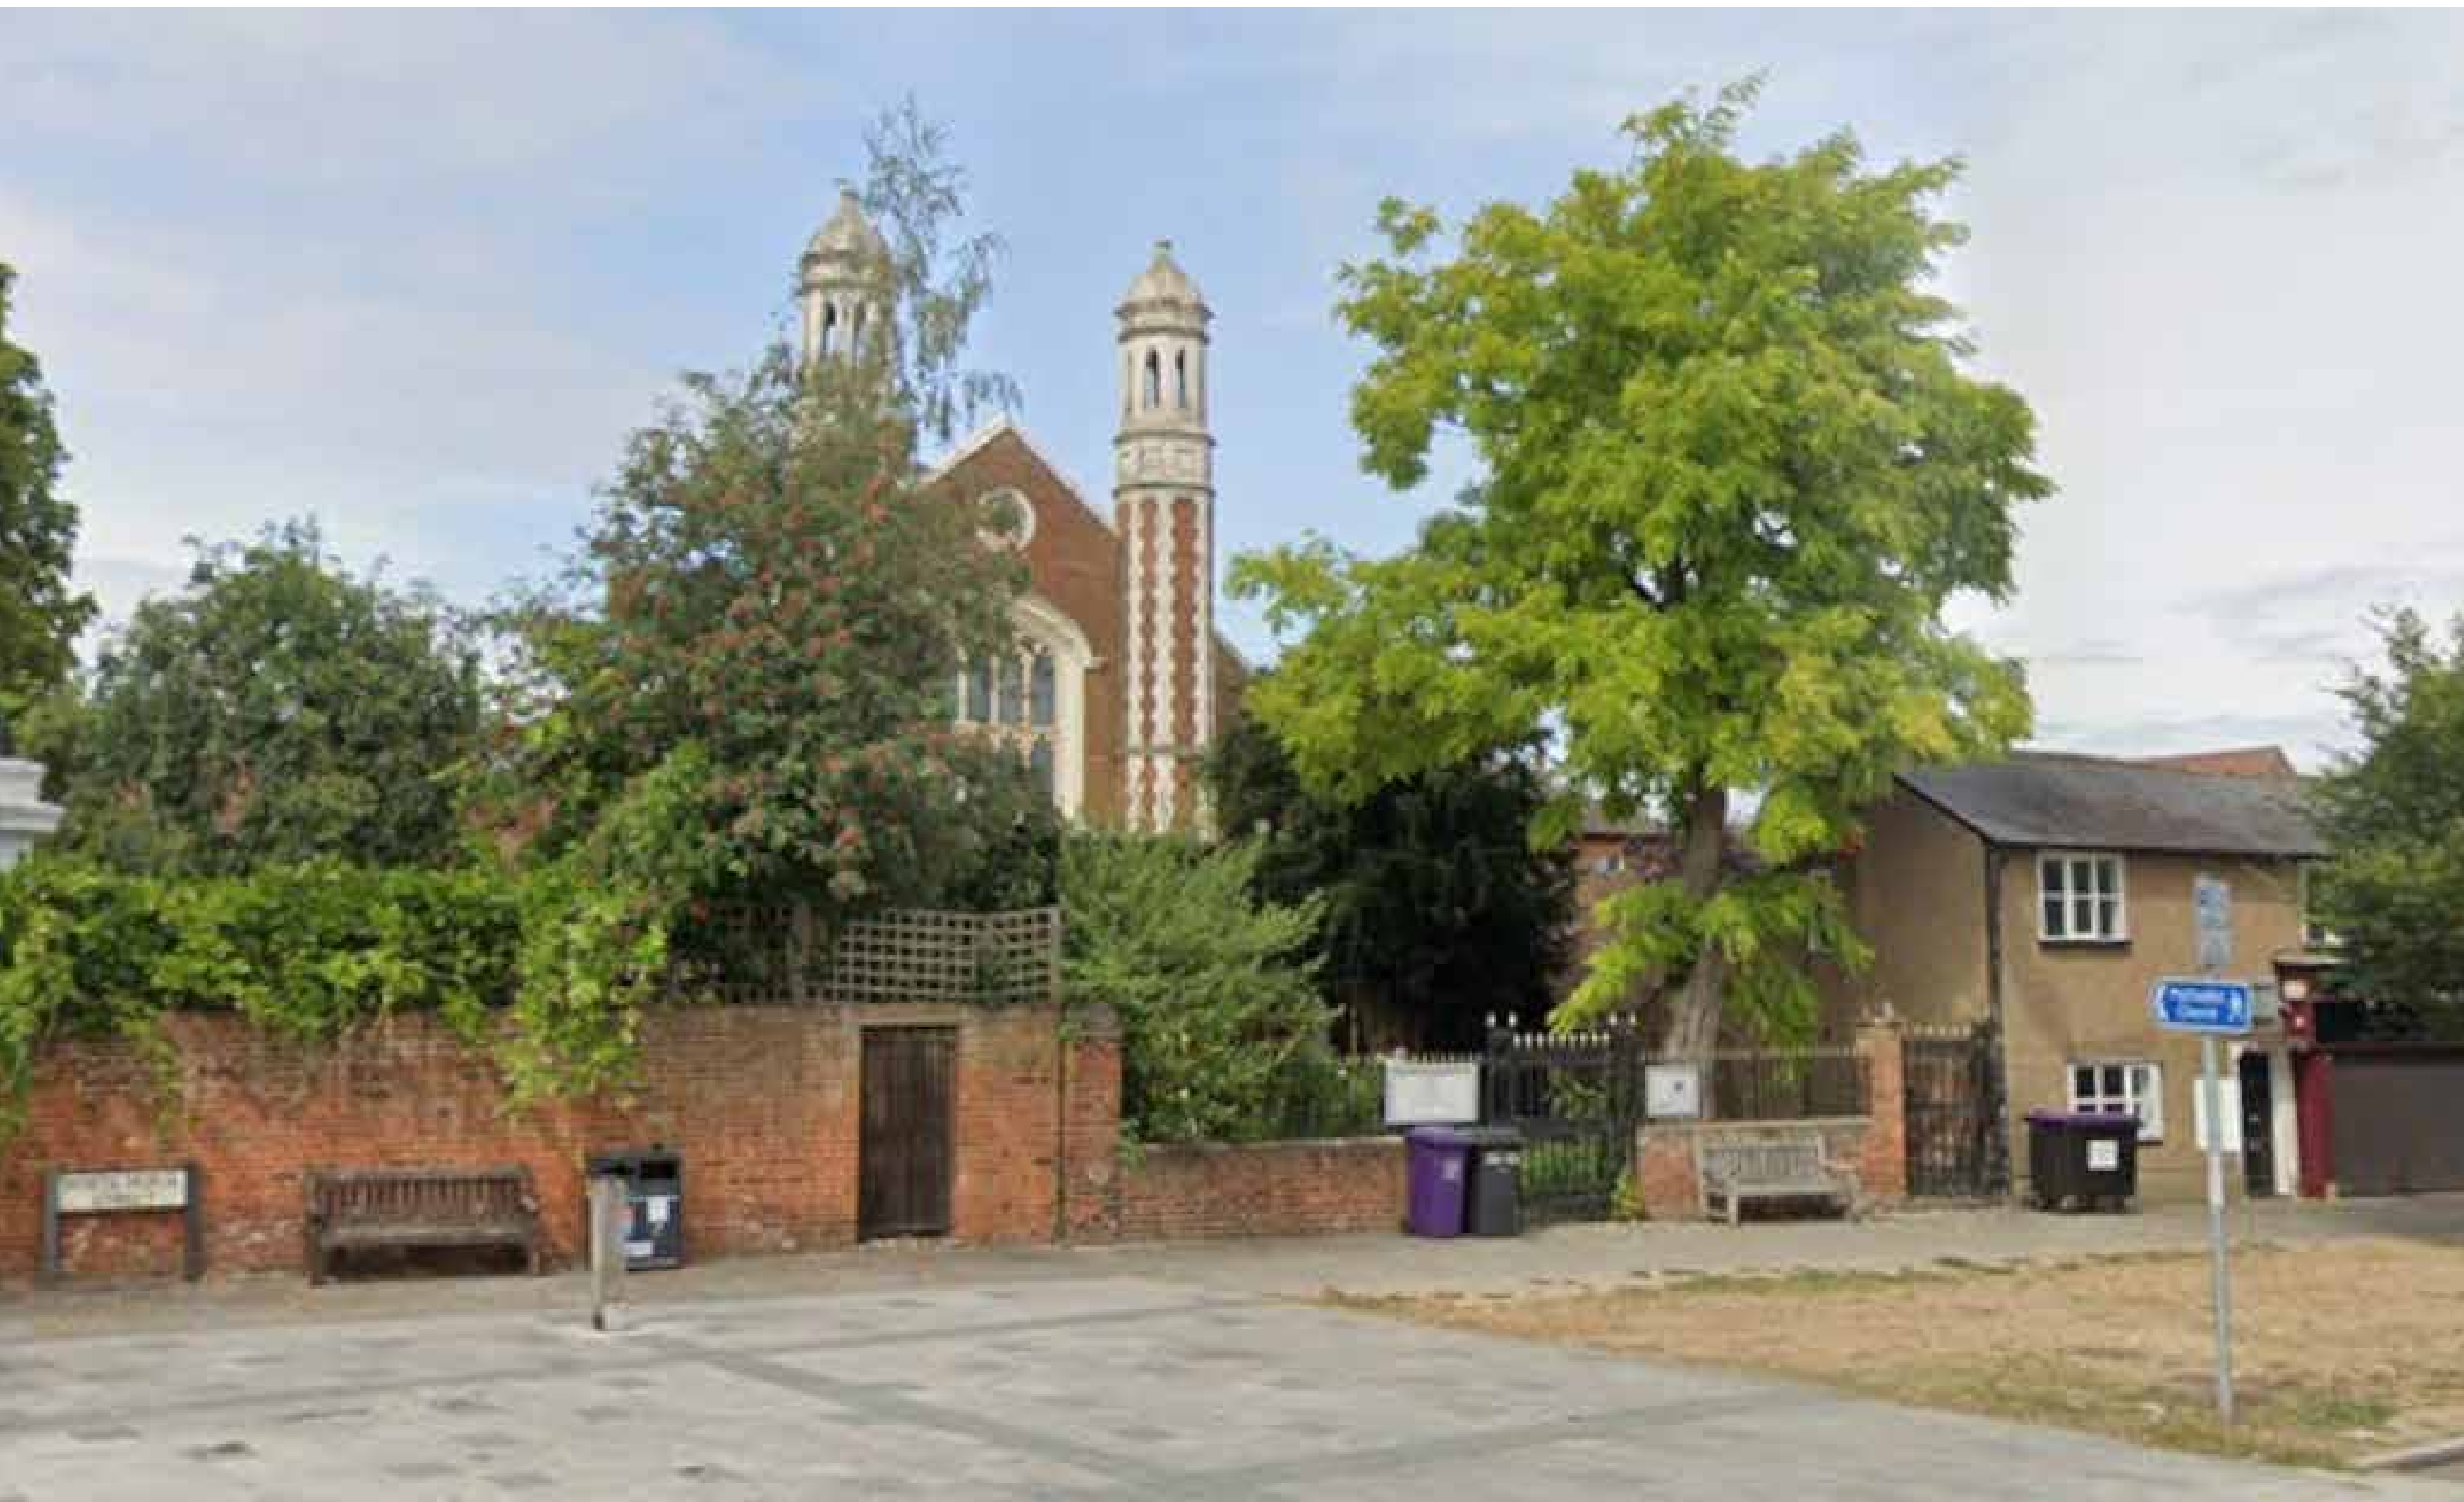
*Fig. 06 : Front elevation on Whitehorse Street*

The building has architectural, historic, and communal significance which derives from its external form and composition as a nineteenth-century Methodist chapel. It retains its original function and architectural character as a local landmark. **(Fig. 05)** The pair of prominent turrets and main large window on the front elevation are a recognised feature on Baldock High Street. **(Fig. 06)**

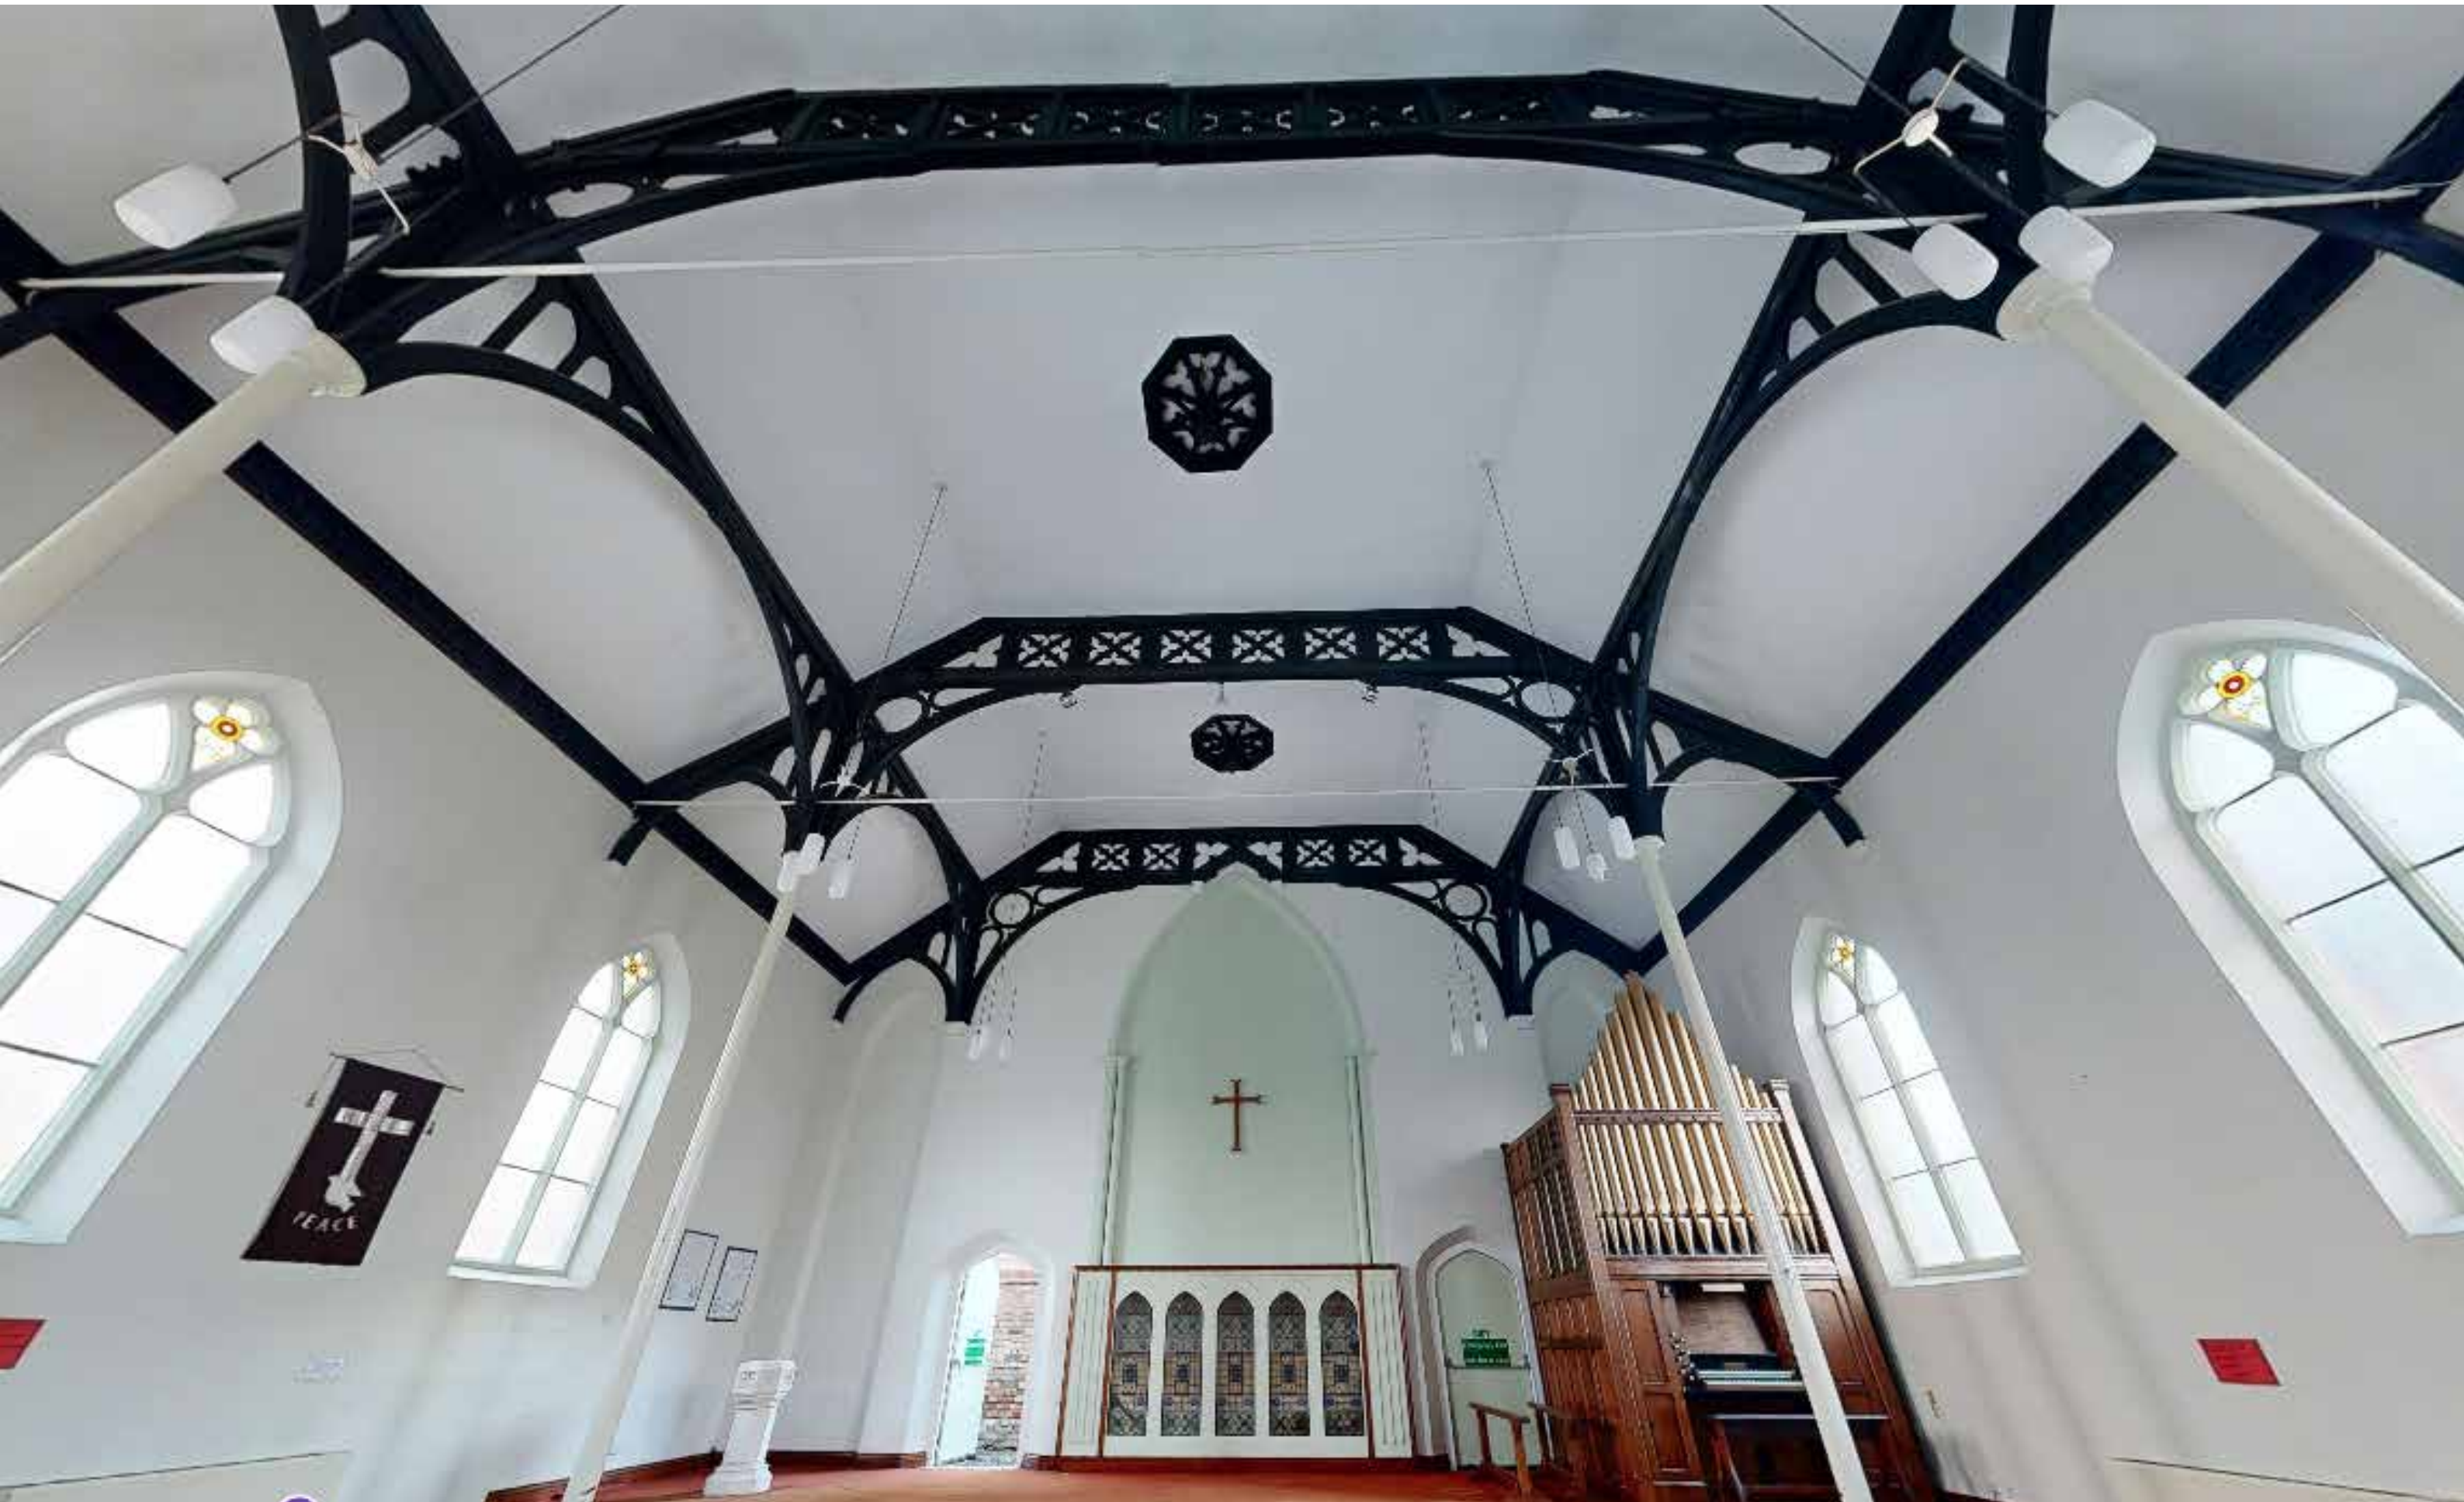
Internal prominent characteristics of the church can be seen in **(Fig. 07)**, the vaulted ceiling, ornate decorative ceiling roses, and ornate roof structure supported by slim cylindrical steel columns in a regular grid formation create the open worship space with a sense of grandeur. It also has pointed arched windows and door openings which are a key feature of its Victorian Gothic architectural style.

*Fig. 07 : Internal view of the vaulted ceiling and original decorative features*

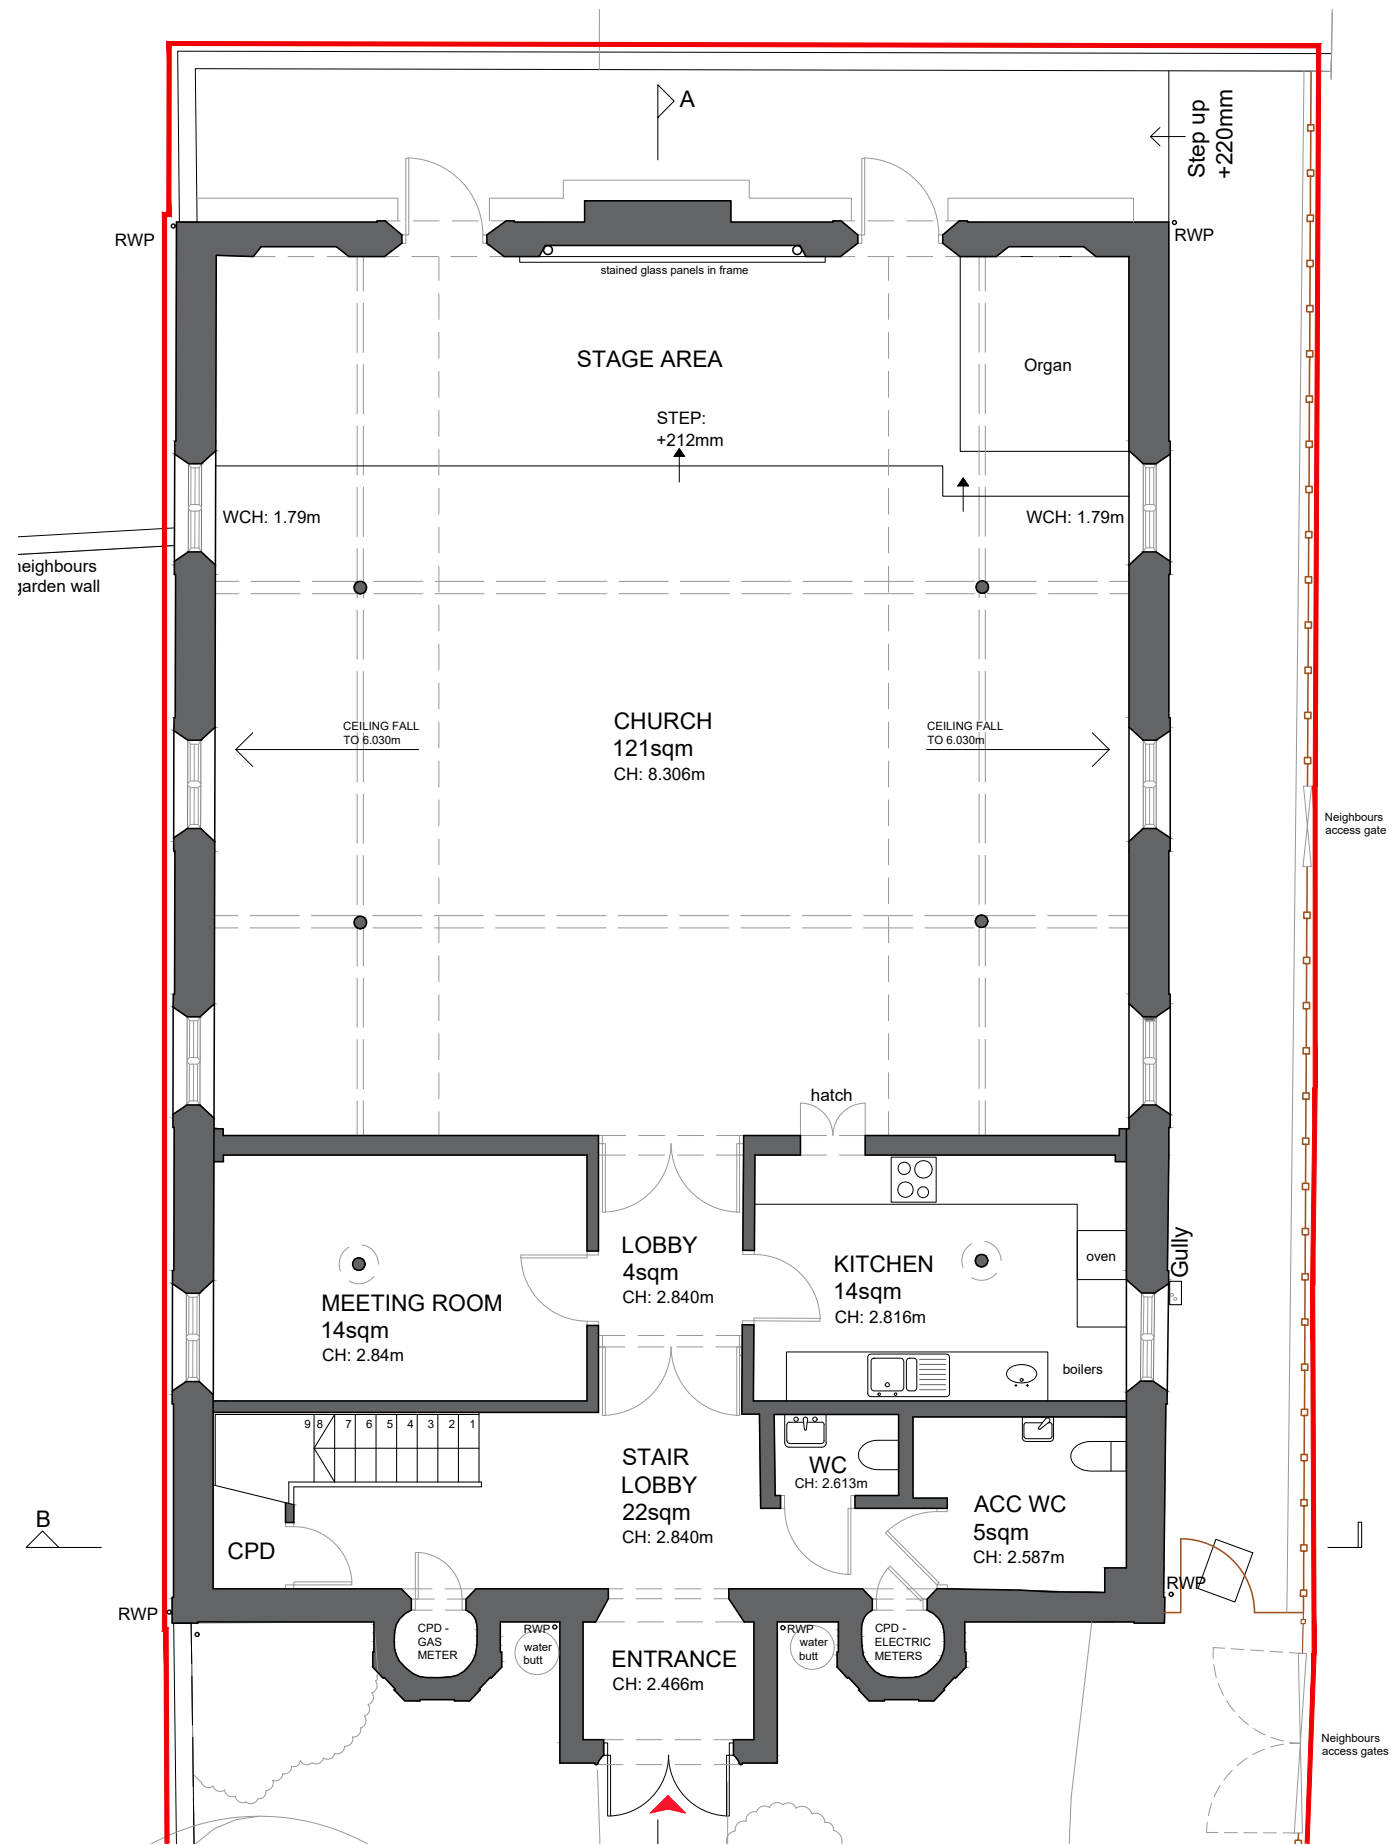
Fig. 08 : Existing Ground Floor Layout

The current only means of access to the first floor is a single staircase, which prevents all disabled access to these first floor rooms. The escape route to the rear of the building is compromised with a step up to the raised platform area, so the main entrance door is the only step free exit. There is a disabled WC facility, but this requires modernisation and there is a lack of baby change facilities. The front entrance double doors are currently wide enough to accommodate wheelchairs and buggies; therefore, these doors will remain but require refurbishing. *(Fig's. 08 & 09 show the existing internal layouts)*

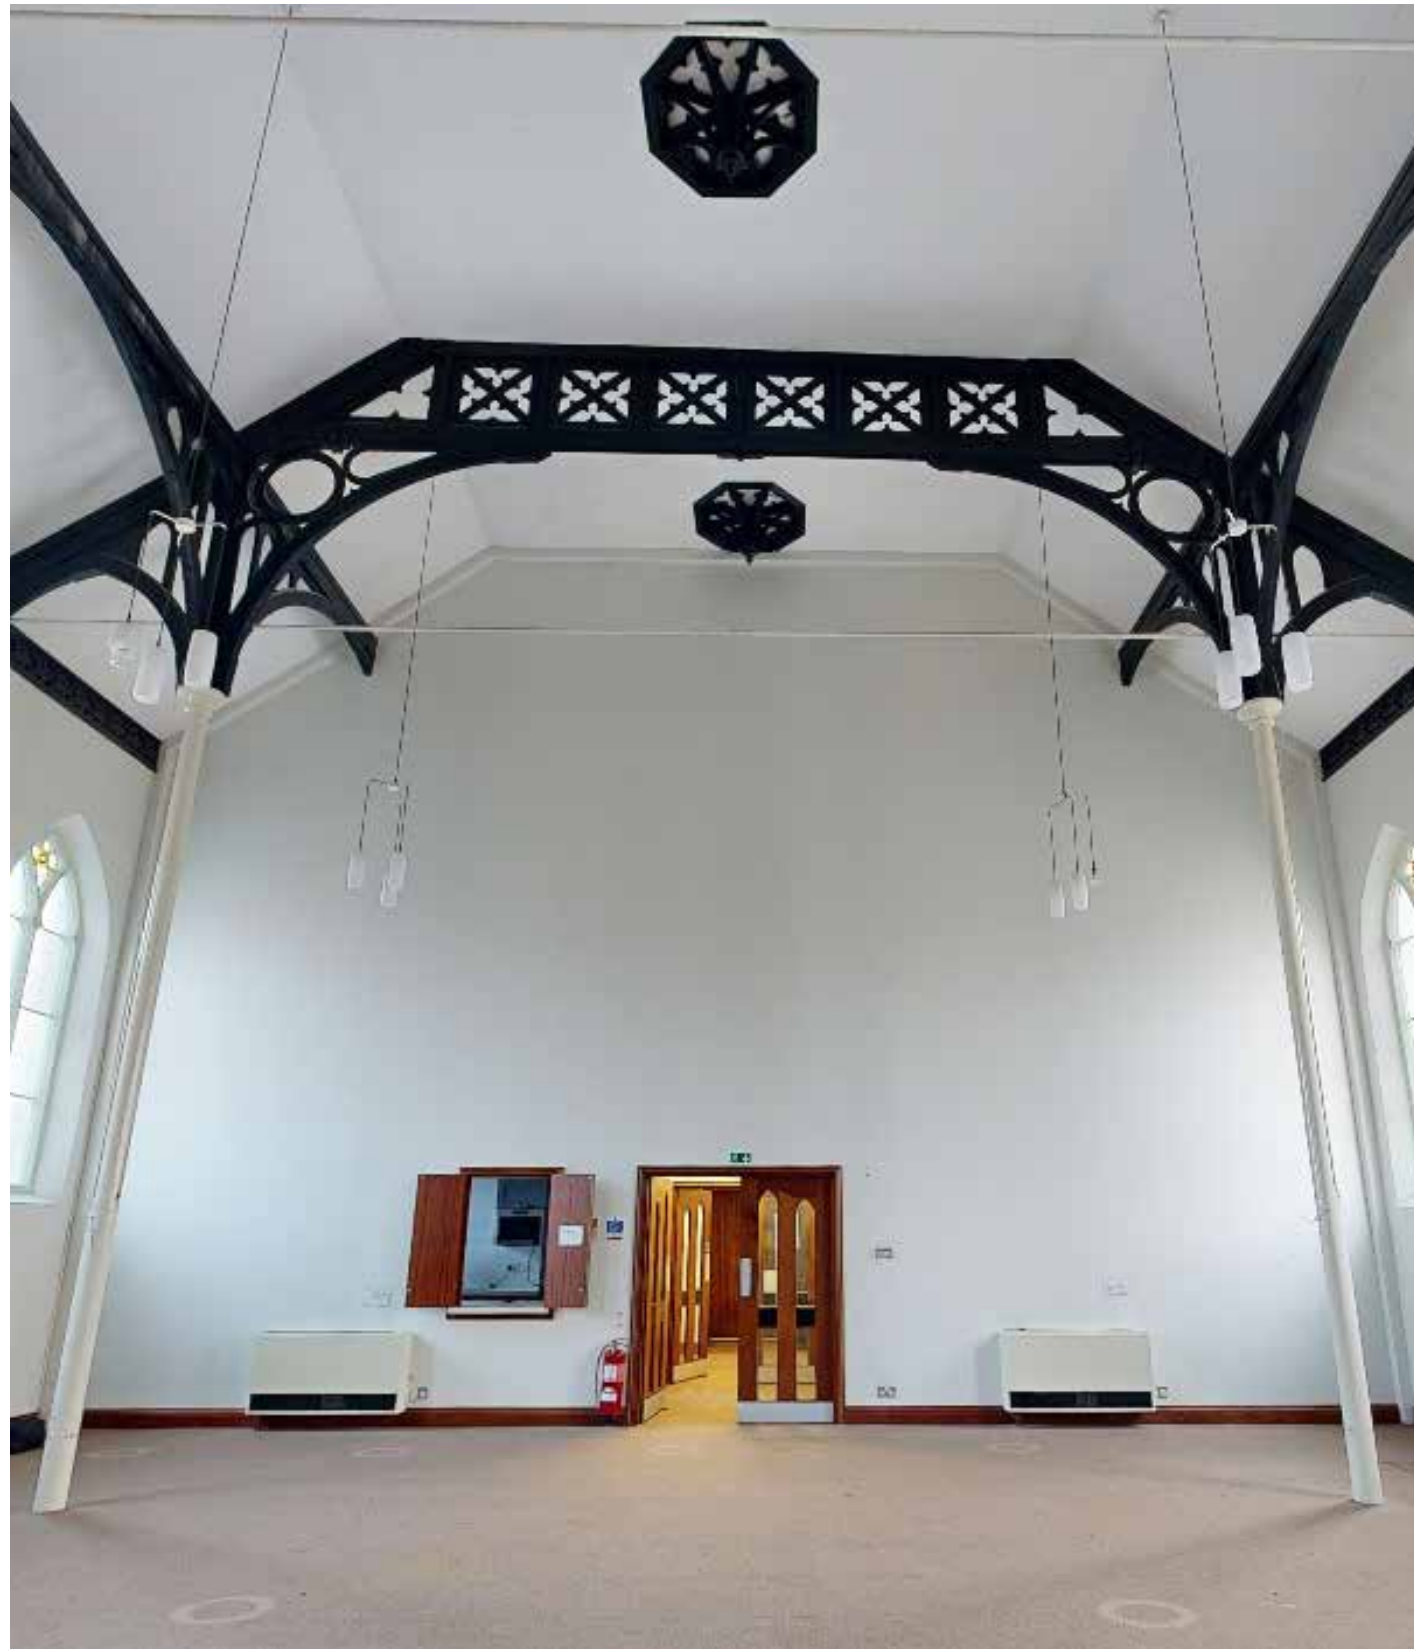
*Fig. 10 : Internal view of the 1982-3 addition of the full height wall*

While the original structure, windows and ornate Victorian style trusses internally remain of architectural importance, these late twentieth-century alterations have reduced the clarity of the interior.

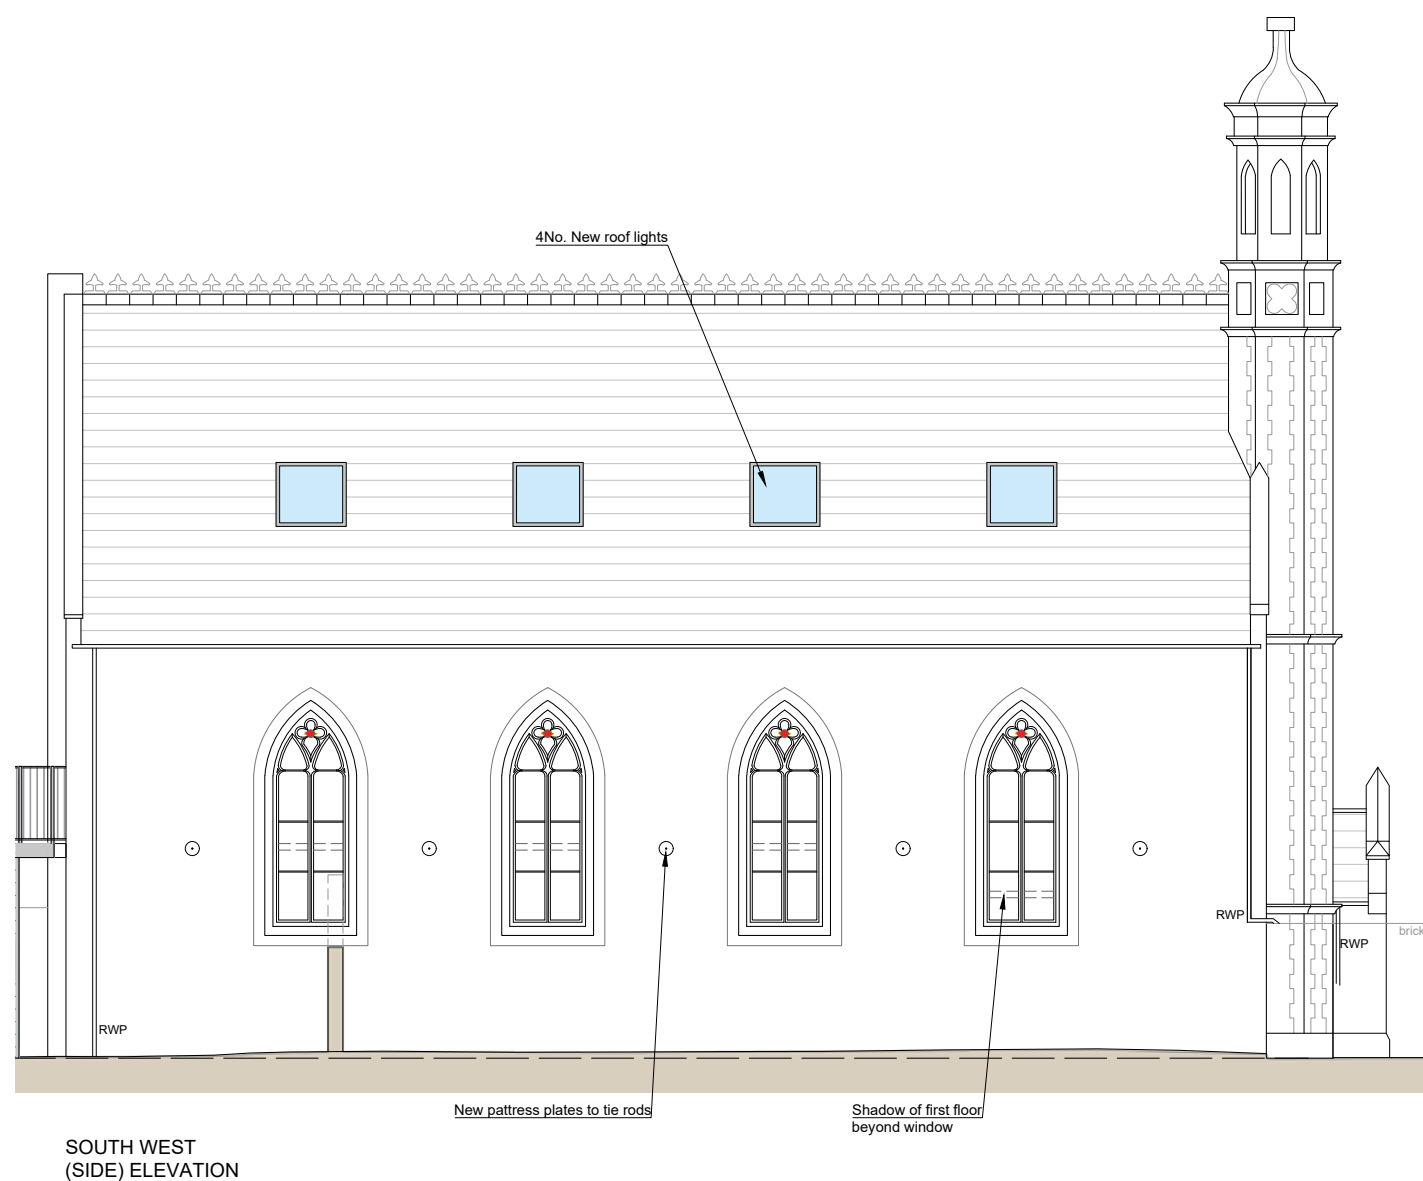
**Fig. 11 : Proposed roof lights on the side elevations**

High level roof light windows will be inserted within the roof above the first floor level. These will be strategically aligned with the existing side windows to create a bright and attractive environment for the church's main worship sanctuary.

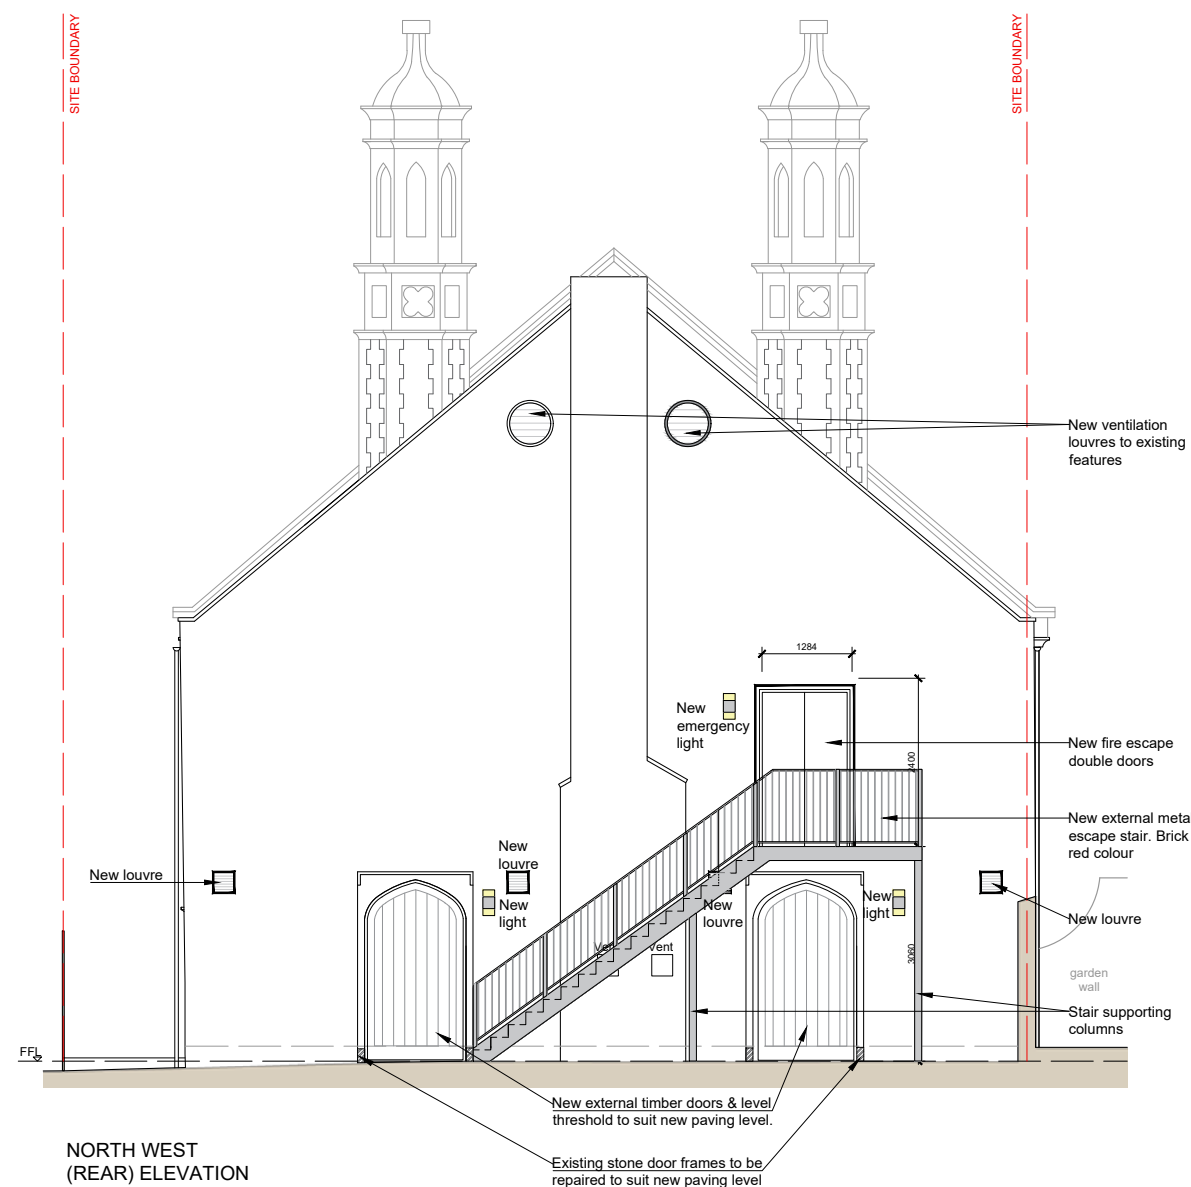
Careful consideration has been given to its siting, scale, and design, with the intention of ensuring it is as lightweight and recessive as possible. The intervention has been located to the rear to minimise impact on principal elevations and key architectural features, and is designed to read as a clearly subordinate addition. (Fig. 12)

Its design minimises its visual and physical impact on the host building. Interference with

**Fig. 12 : Proposed external escape stair at rear of building**

principal and significant architectural features elevations is avoided and is conceived as a lightweight, recessive intervention. While it inevitably introduces a degree of change to the building's external appearance, this is considered to result in less than substantial harm which is necessary to facilitate safe continued use.

The proposed external fire escape staircase and associated external fire exit are required to provide safe and compliant emergency egress from the first floor accommodation. The external solution represents the only viable option for achieving a safe evacuation route in a way which wouldn't render the configurations of the first floor and ground floor inadequate and unable to provide for the main essential needs of Baldock Baptist Church, as set out in the Statement of Need. The alternative option – to provide an internal enclosed fire escape staircase – would result in the loss of a Sunday School classroom on the ground floor as well as causing significant harm to the front view of the worship sanctuary by virtue of the presence of a substantial “box” feature. The church's Sunday School currently consists of five separate classes. In addition, a group for adults runs concurrently. The presently proposed configuration of the ground floor would provide two classrooms plus teaching spaces for a further three classes in the hall (shown on the ground floor indicative furniture layout). It is acknowledged even this configuration is tight for the church's needs and the loss of one of the classrooms would mean the building would be inadequate for the church's needs.

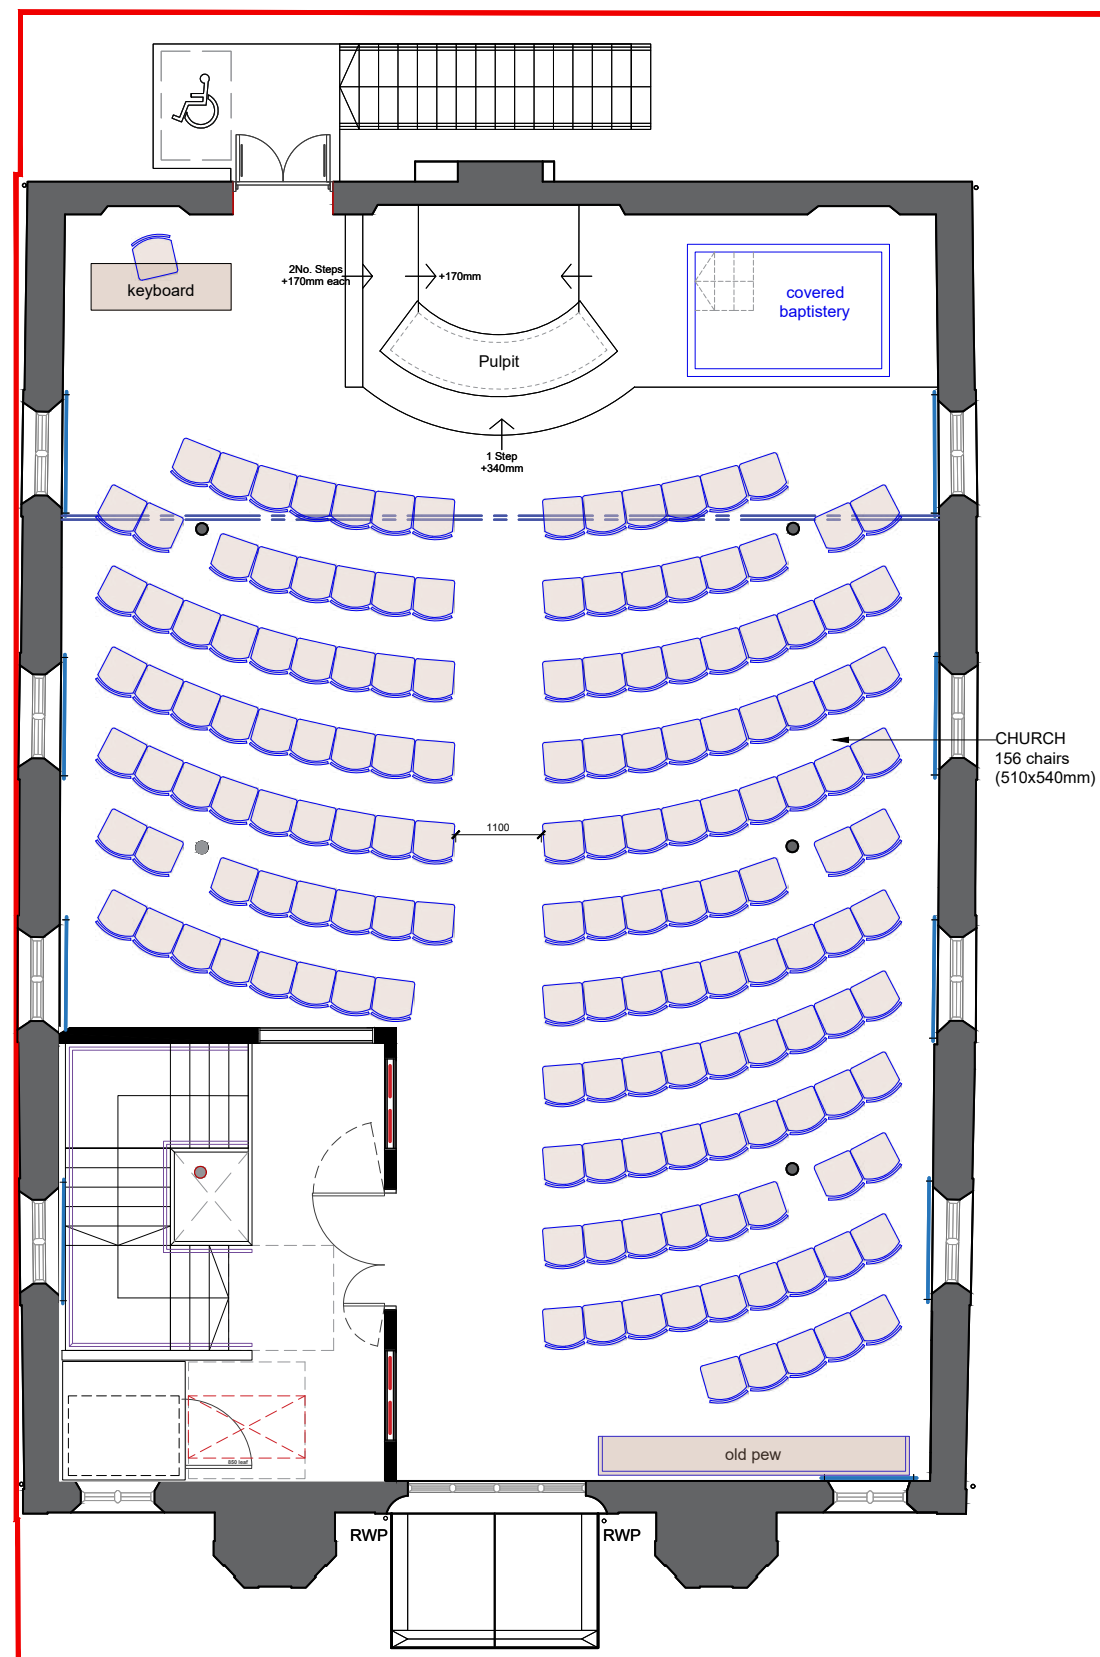
**Fig. 13 : Proposed seating for the worship sanctuary of up to 170 people**

In terms of **point A**; the requirement for the worship sanctuary to be capable of seating 170 persons has been derived in part by the church's present congregation of around 110 persons but with strong anticipated growth in numbers due to the presence of many young families and newcomers; and in part by the church's occasional hosting of special meetings (principally weddings, baptisms and funerals) which all attract significant numbers of visitors in addition to the regular congregation. **(Fig. 13)**

The indicative seating layout for a wall to wall first floor sanctuary shows this arrangement would be capable of satisfactorily accommodating 156 chairs (chairs are of a modest proportion at around 500mm width) with a historic pew at the rear capable

of accommodating an additional 10 persons; thereby providing seating for a total of 166 persons.
