# REMODELLING AND REFURBISHMENT OF BALDOCK METHODIST CHURCH

## DESIGN AND ACCESS STATEMENT

JUNE 2026

This Design and Access Statement is submitted in support of Planning and Listed Building Consent applications for the sensitive internal remodelling and refurbishment of the former Baldock Methodist Church.

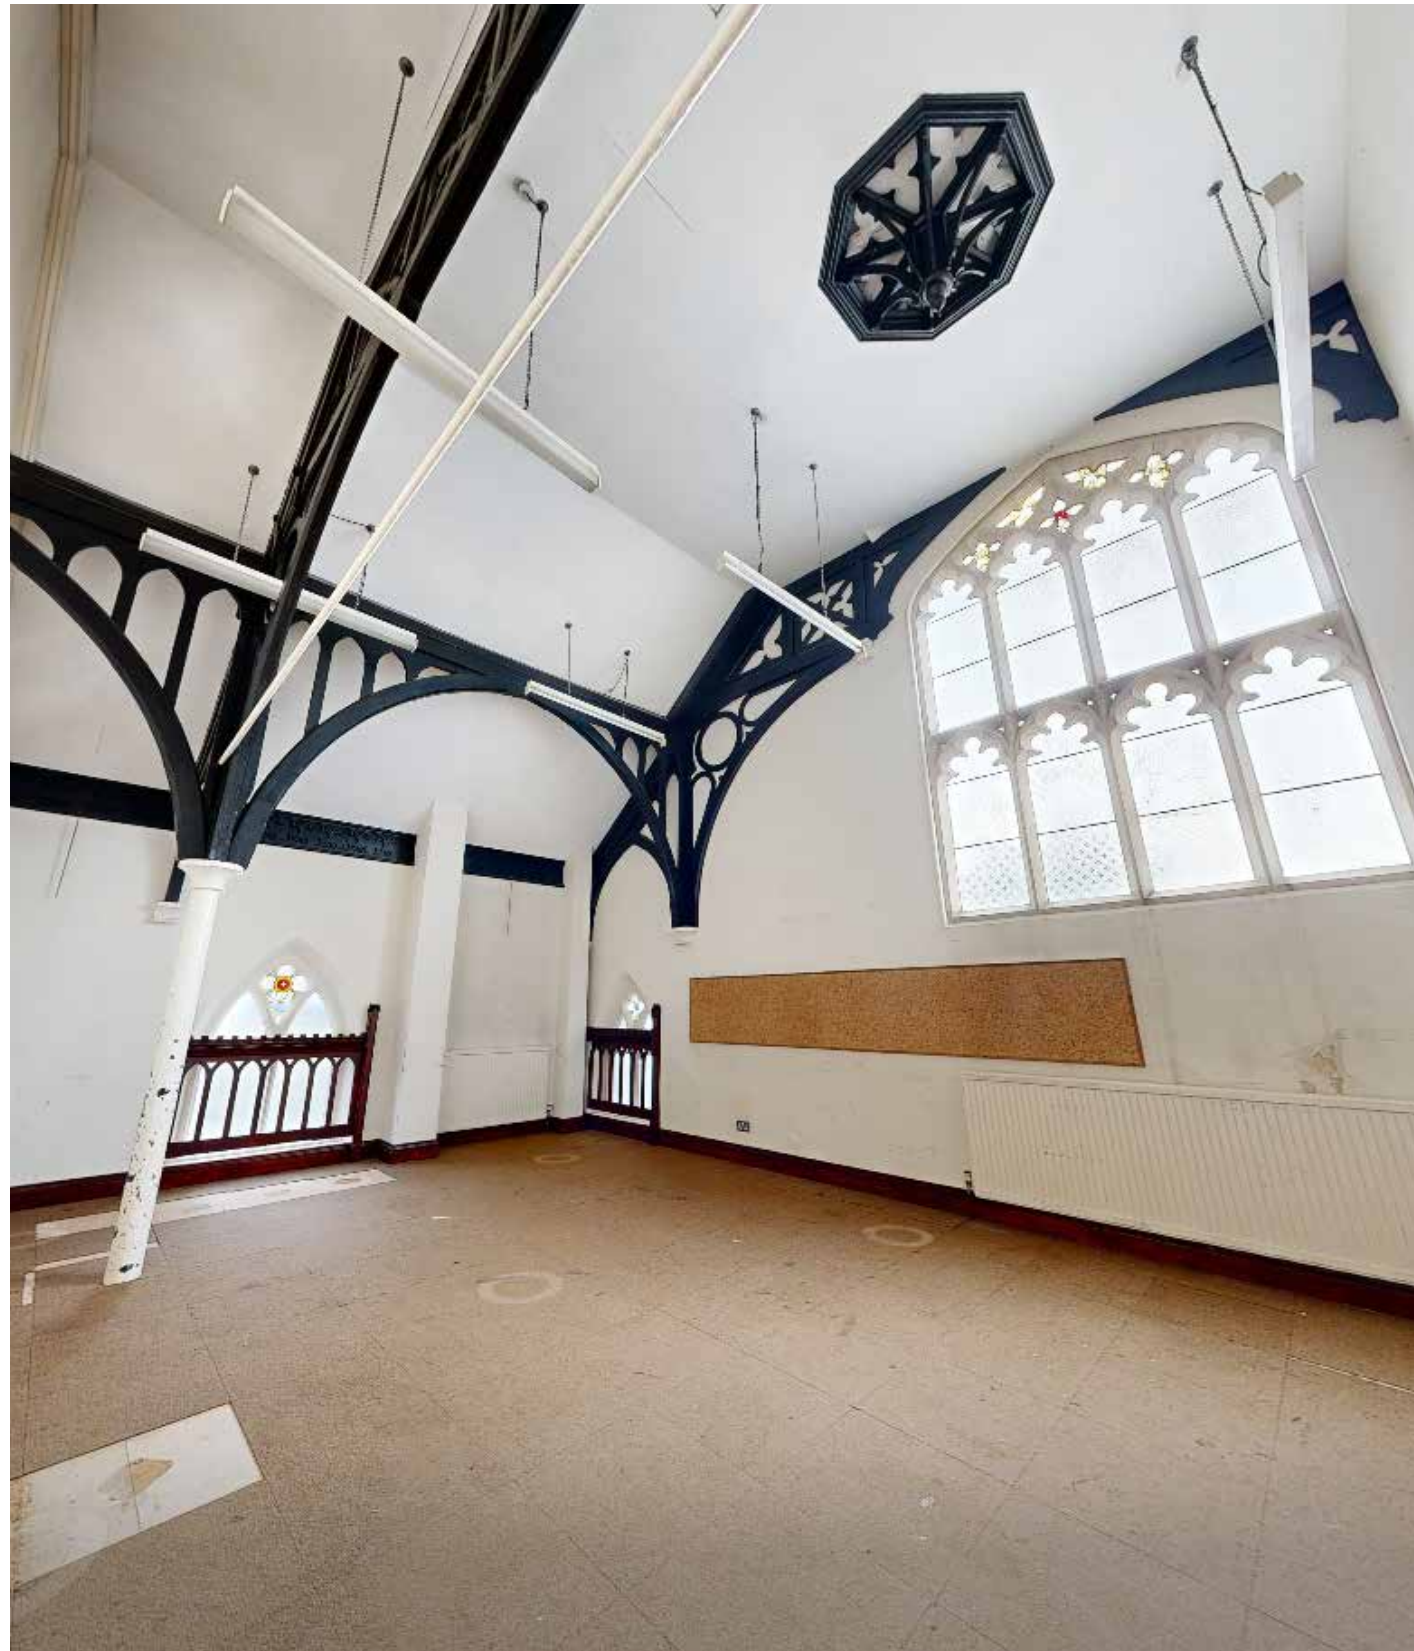
*Fig. 15 : Existing photograph. Main feature window on the first floor*

The main feature window on the front elevation will once again become the focal point of the worship space. *(Fig. 15)* The layout ensures that this main window feature remains unaltered and retains its full legibility both internally and externally.

be discreetly located in the corner with a capped ceiling so the existing historic structure and roof trusses are on full display and can be read as an architectural feature in a relatively undisturbed view within the worship space on the first floor. This will be a vast improvement over the current layout where the roof trusses are half covered by the first floor level and a full height wall.

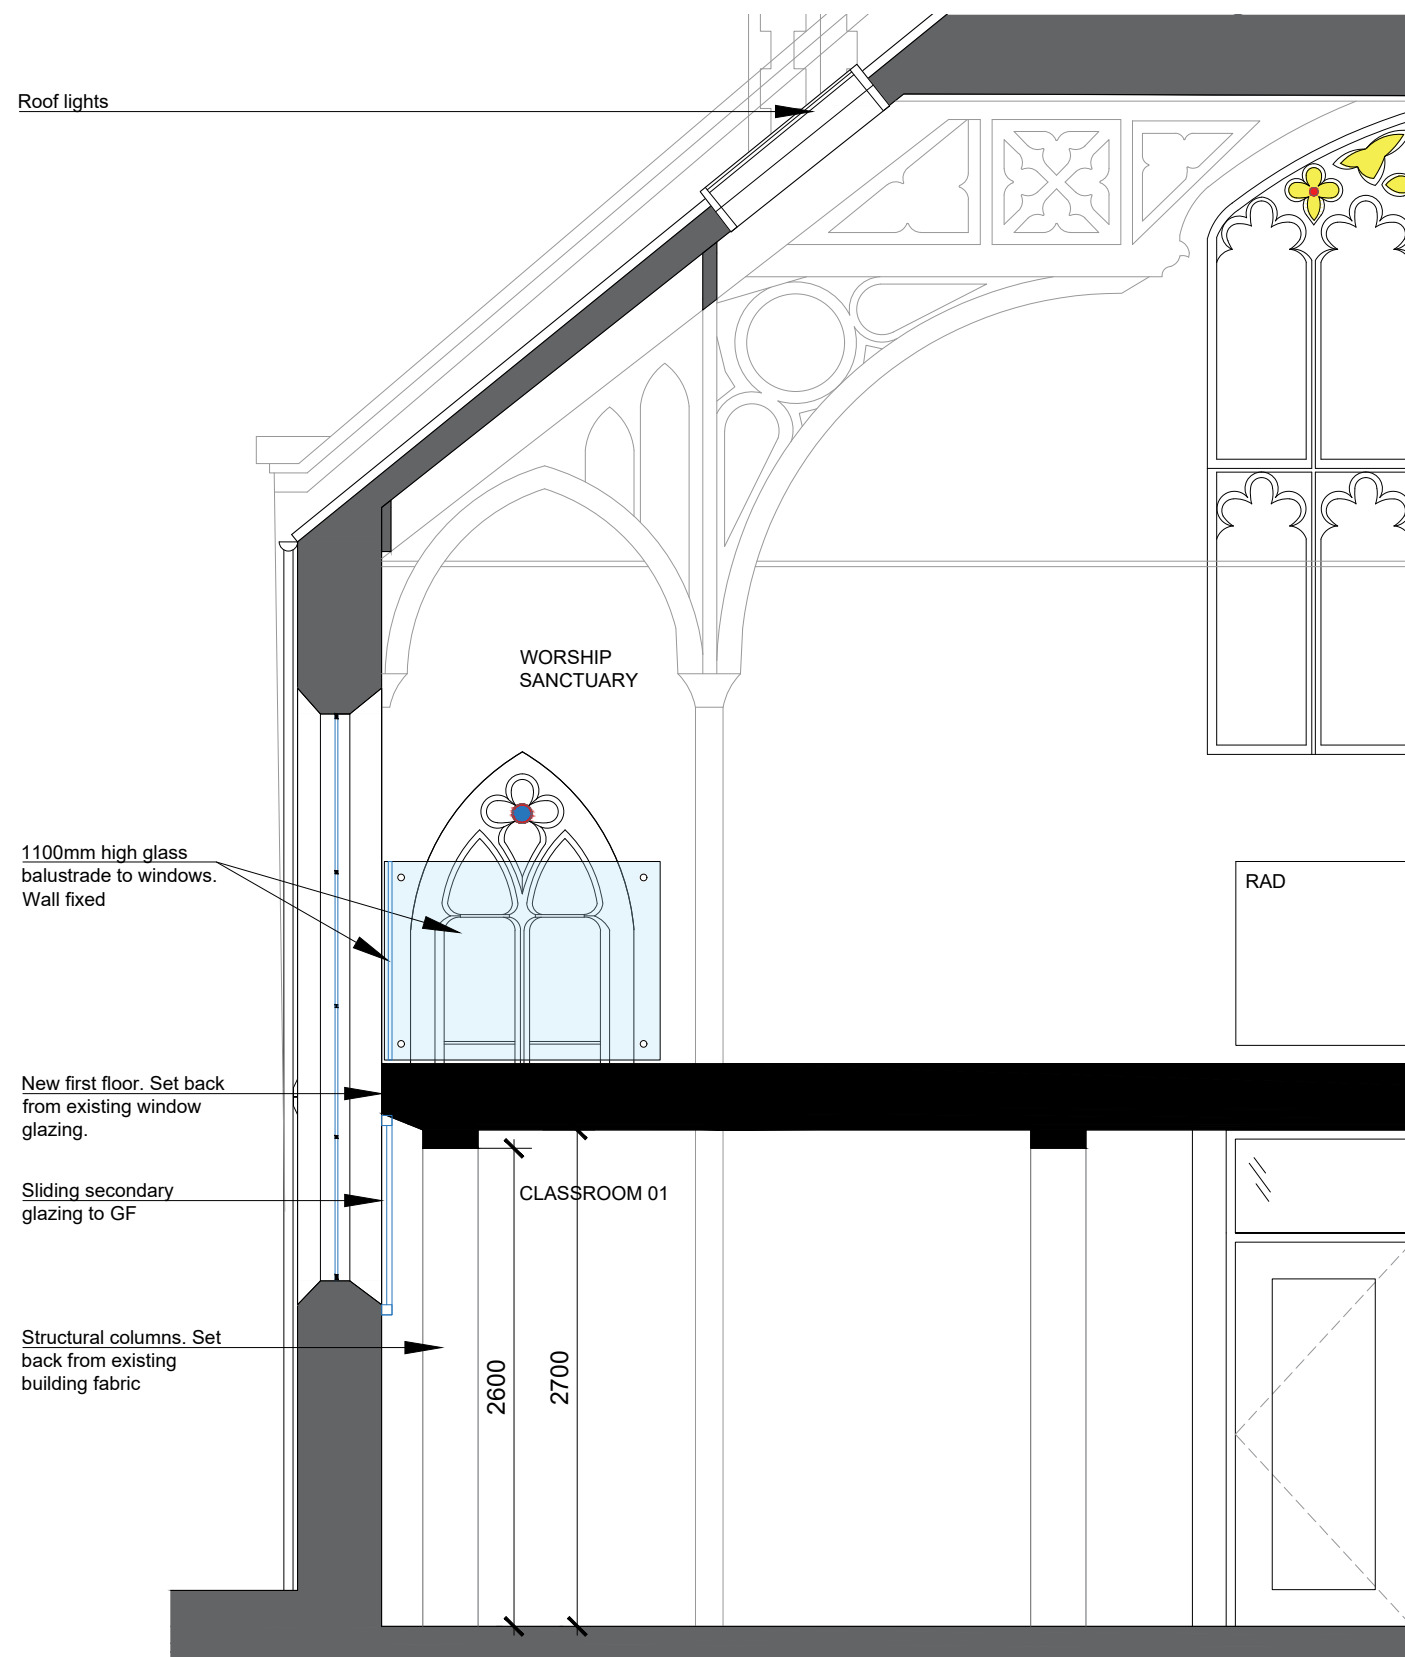
The structural beams of the new first floor are to be set back from the perimeter walls by 400mm. This has been designed to create a chamfered underside edge to the floor level, to reduce its impact where it intersects the window openings.

The new floor will terminate at the wall line rather than extending into the window openings, leaving the windows clear of interference by the works. All the windows, mullions and their stone surrounds will be untouched by the works apart from any necessary repairs and redecoration. Currently, the existing first floor level intersects 3 windows and the windows are obscured by heavy dark timber balustrades at first floor level. On the first floor, the proposal is for 1100mm high glass safety balustrades to each of the windows which will be fixed to the walls on either side. Proposed secondary glazing at ground floor level will have discreet timber frames fixed to the walls and will be custom designed to slide open for maintenance and the central mullion will align with existing mullions, so they appear minimal from the outside. This secondary glazing also acts as an acoustic barrier which is essential for the proposed simultaneous use of the ground and first floors. *(Fig. 16)*

**Fig. 16 : Snippet from Section C, Architects drawing 030**

This design solution leaves the existing windows untouched and a clear gap between the windows and the new first floor. Hence there will be some appreciation of the double height windows from both above and below.

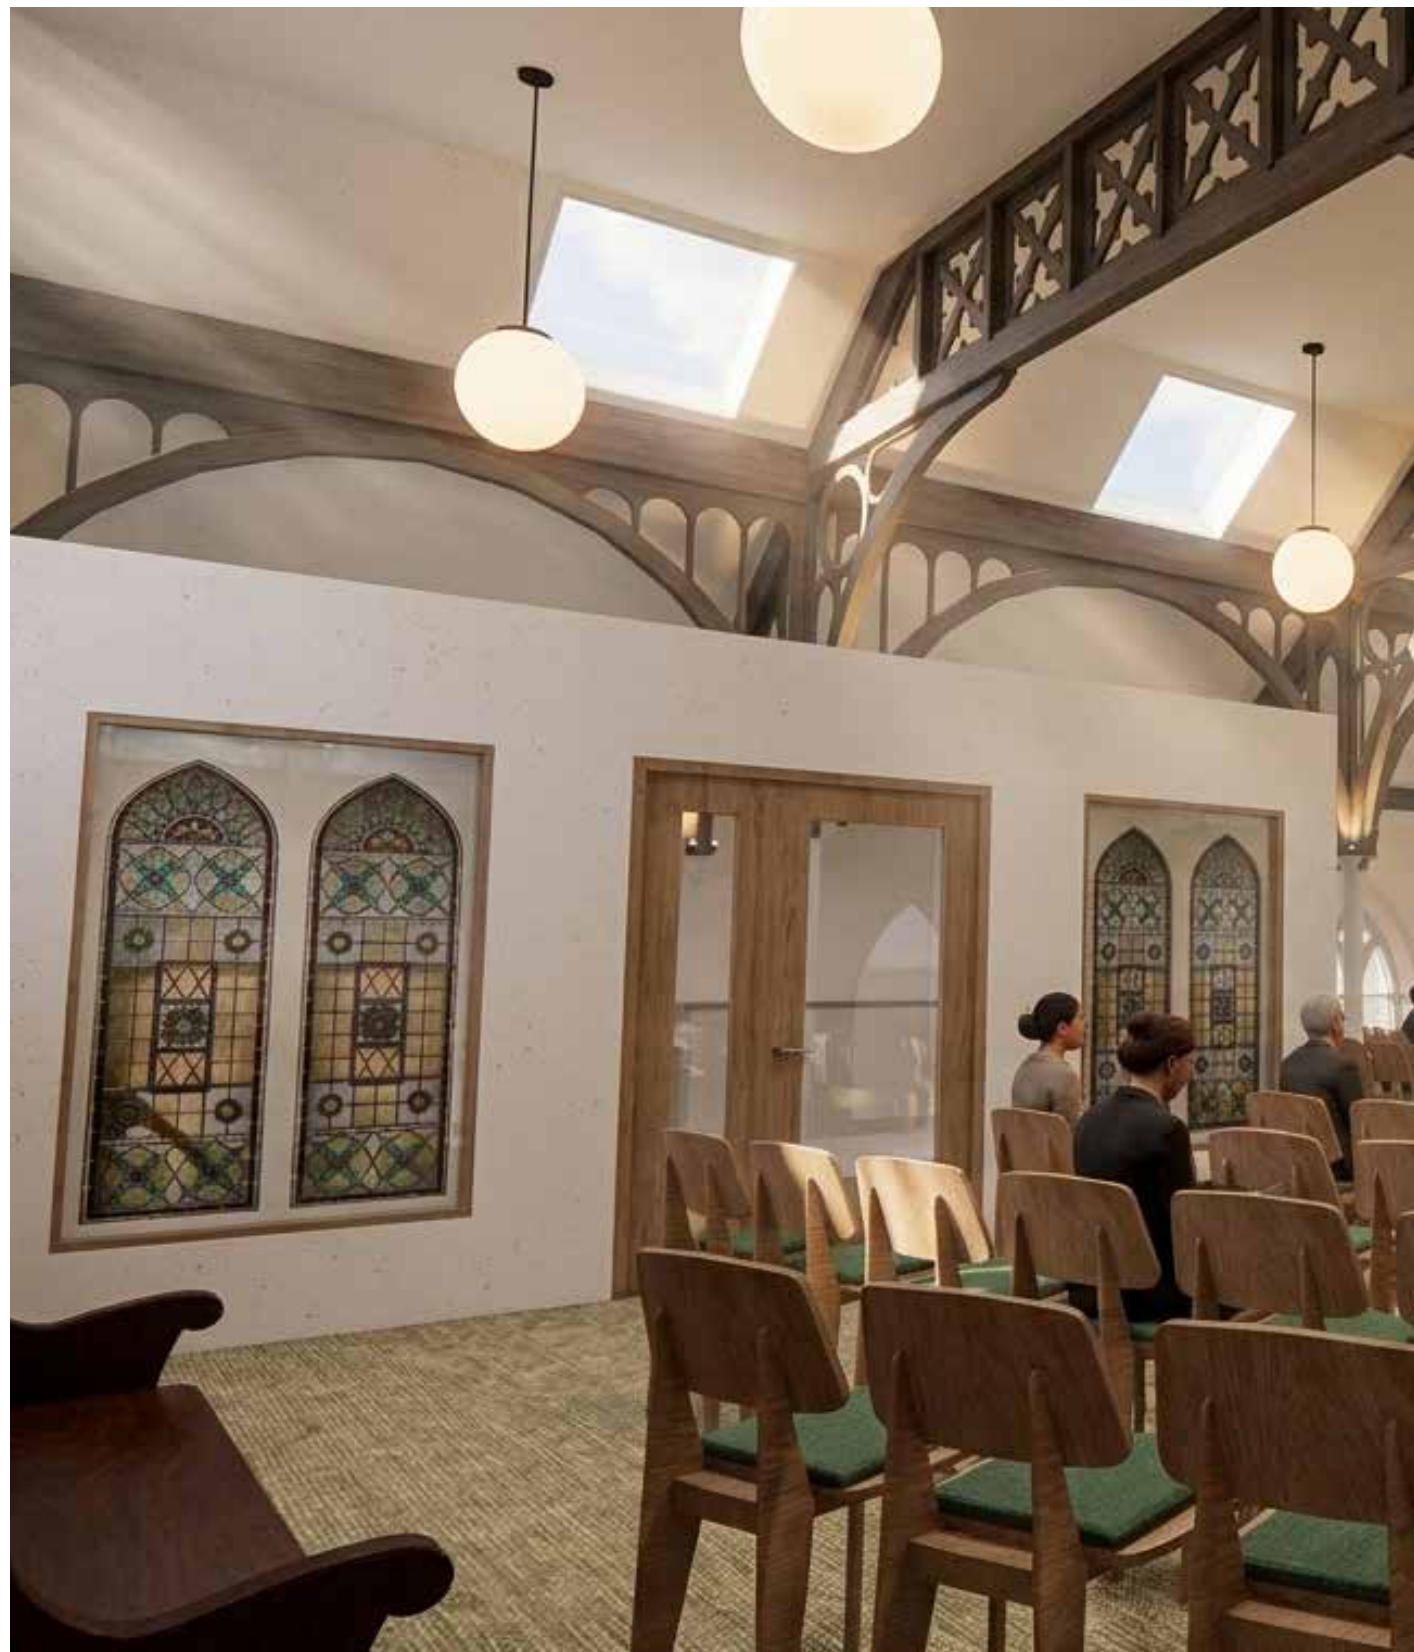
Where historic fabric survives; such as timber joinery, the roof structure and decorative leaded glass, this will be retained, protected and, where appropriate, enhanced. New insertions, including the proposed first floor and reconfigured internal partitions, will be detailed to minimise physical and visual impact on these features. Lightweight construction methods and recessive detailing will be used to preserve an appreciation of the building's original volume and form. The original decorative leaded glass panes will be refurbished and installed within the first floor new circulation core walls. *(Fig. 21)*

*Fig. 21 : 3D visual showing the location of the leaded glass panes. Relocated to the first floor, displayed in within the circulation core walls*

The decorative leaded glass panes, currently located behind the raised platform at the front of the church are thought to have originated from a glazed screen separating the entrance vestibule from the body of the church (removed during the 1982/83 works). These are to be retained and incorporated into the new first floor vestibule. *(Fig. 02)*

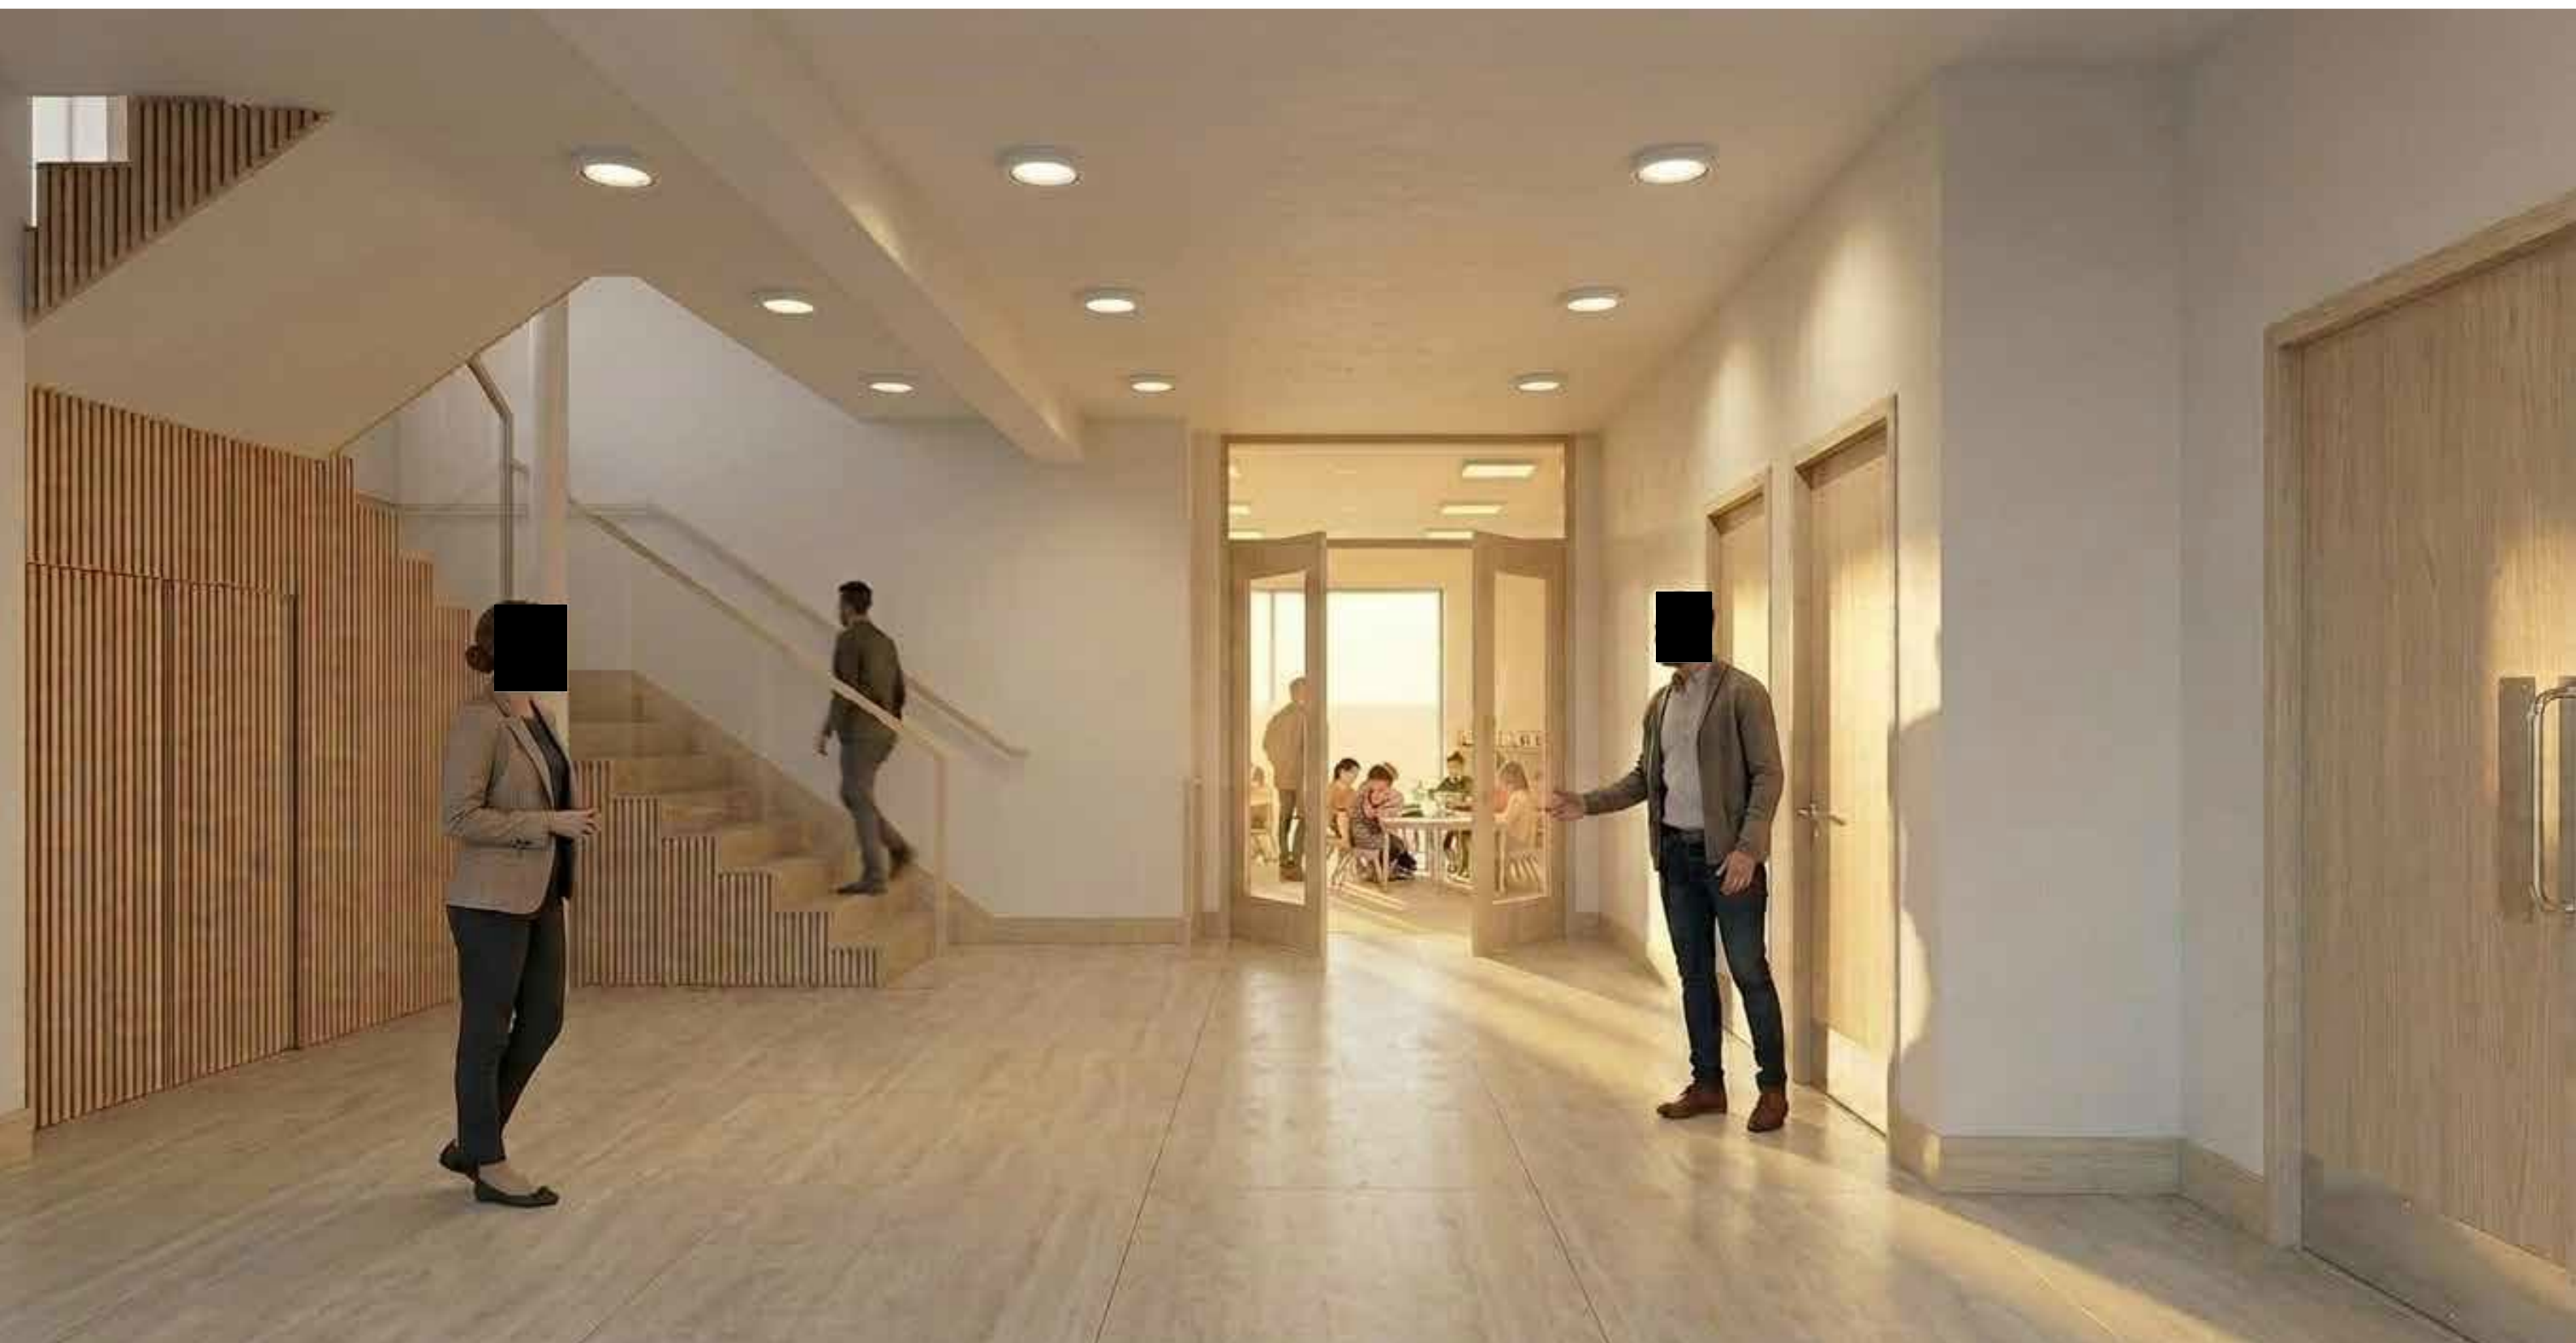
*Fig. 22 : Front entrance lobby and stair. Contemporary internal materials proposed as a contrast to the historic building*

Overall, the proposals adopt a balanced approach that respects the building's historic character while delivering a coherent and contemporary internal environment fit for long-term use. *(Fig. 22)*

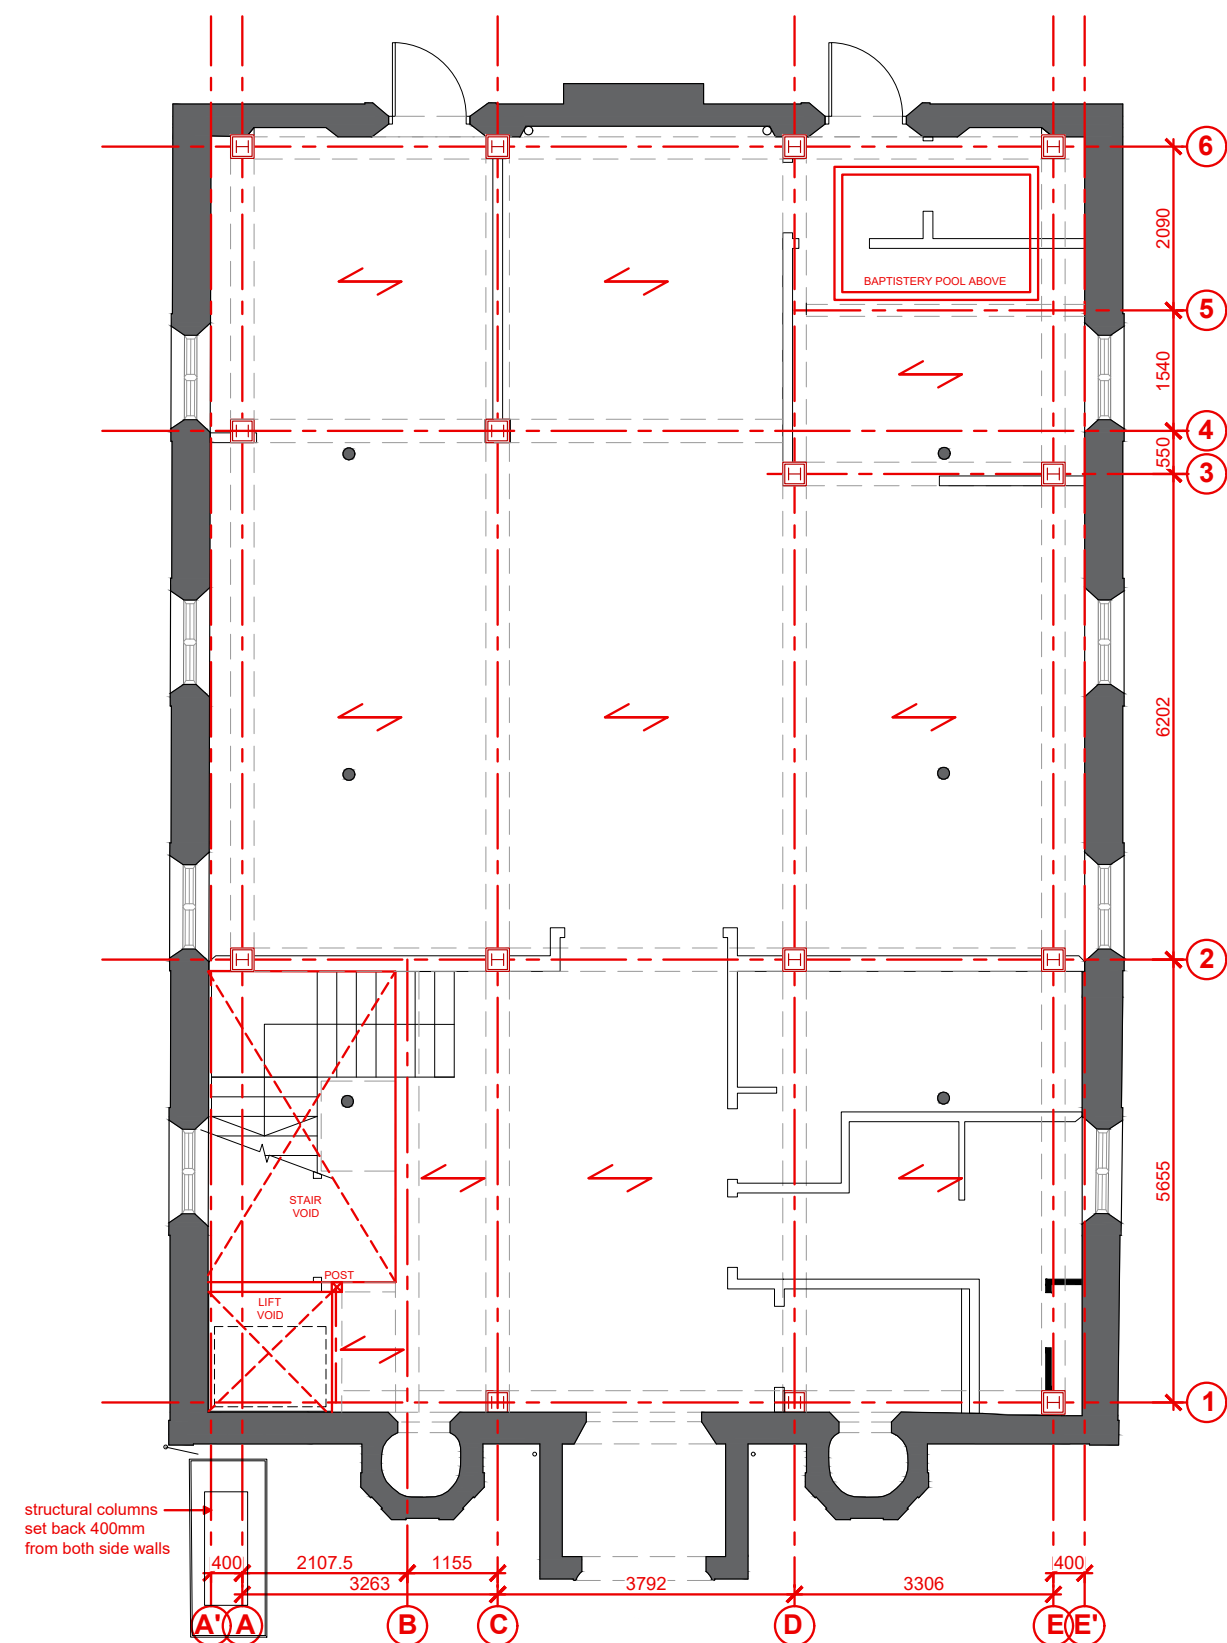
**Fig. 23 : Proposed structural layout of the first floor, showing column and beam locations**

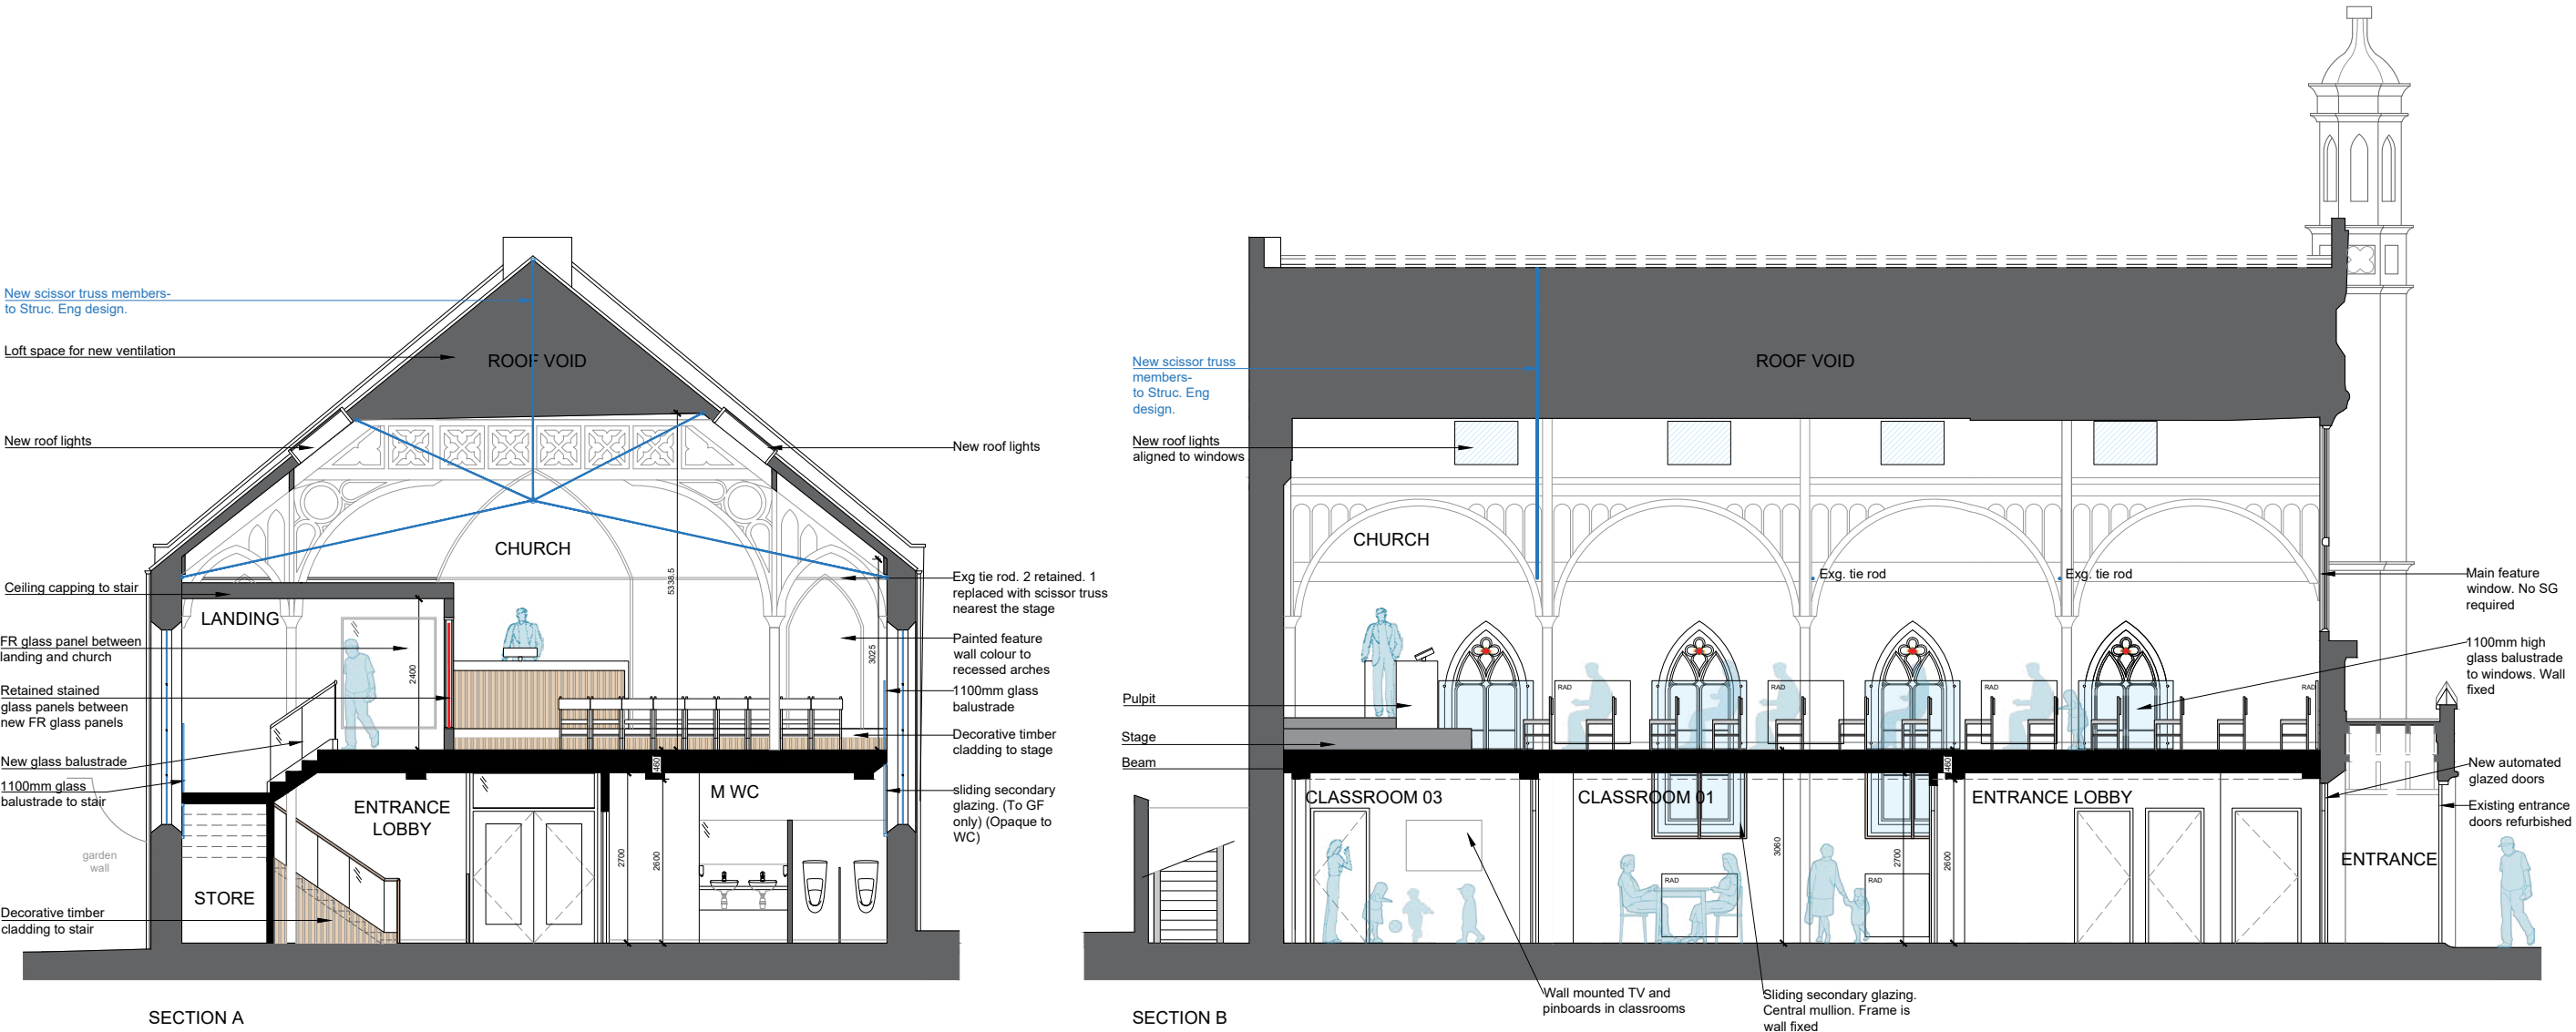
The side elevations perimeter walls of the building have suffered with significant wall spreading, such that the internal dimensions are significantly greater at high level in the centre of the building than at low level at the ends. The extent of this issue is clearly visible to the untrained eye. The primary cause of the wall spreading is a flawed roof design insofar as the roof structure is not triangulated. This means that the rafters do not bear down vertically on the walls but diagonally, pushing them outwards.

It appears that wall spreading ceased at an unknown date some decades ago when internal horizontal wall tie rods were added at eaves level to the three primary roof structure locations. Re-pointing to the side elevations as part of the 1982/83 scheme shows no signs of cracking, suggesting no further wall spreading has occurred over the past 44 years.

Given the extent of the wall spreading of the side elevations perimeter walls, the Structural Engineer has recommended that steps are taken to tie these walls to the new first floor structure. Hence tie rods cast into the floor are proposed to pass through the walls to the external face where exposed pattress plates will be fixed. These are located midway between the windows. They are required to further secure the walls from future movement. *(Fig. 24)*

Fig. 24 : Proposed sections displaying the location of the new scissor-truss members

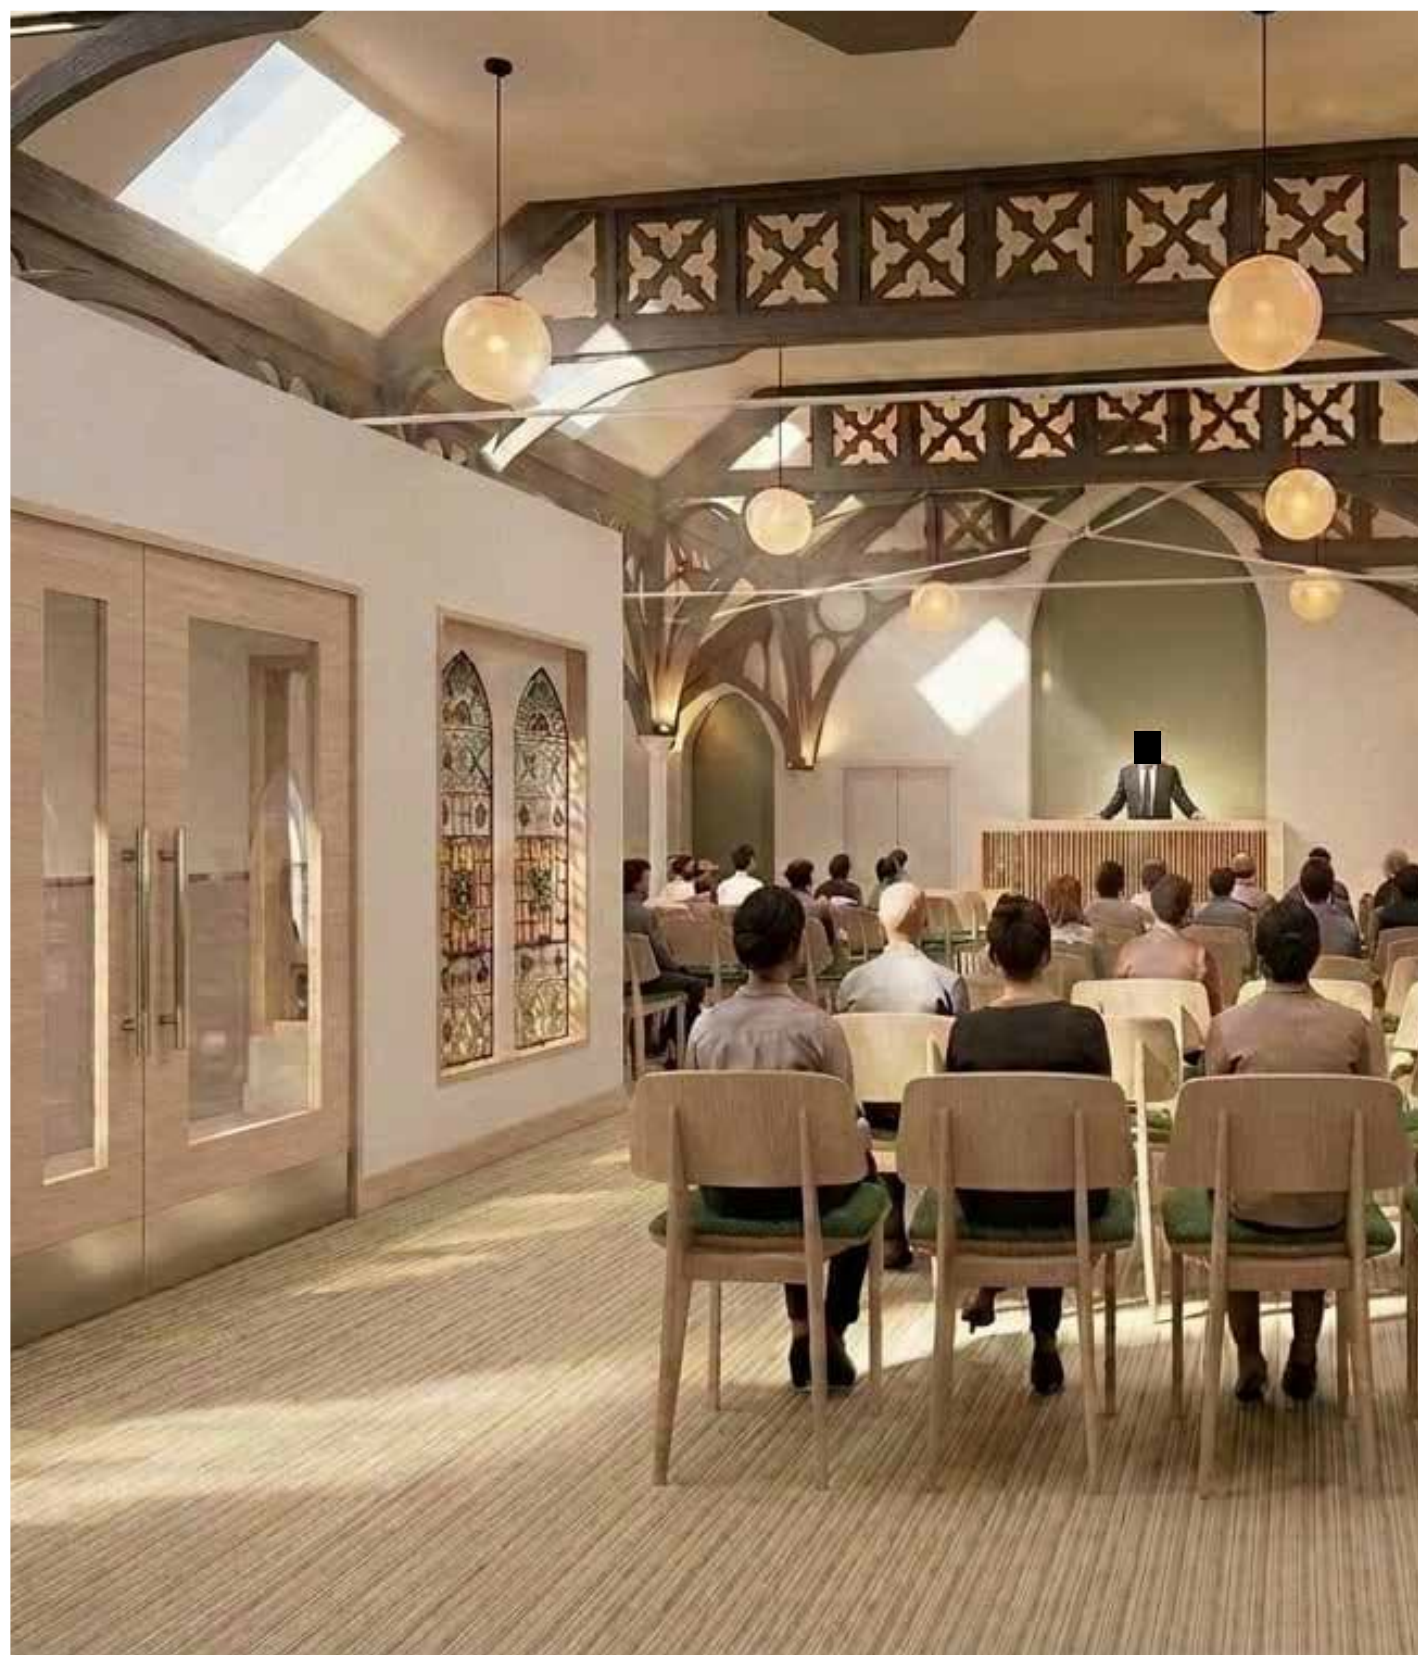
*Fig. 25 : 3D visual showing flexible seating, roof lights and wide door opening to the stair core on first floor*

Vertical circulation has been carefully considered to ensure that both the ground and first floor are accessible. Stair provision will be designed in accordance with Building

Regulations, with clear handrails, consistent riser/tread dimensions and appropriate visual contrast. Platform lift access will be provided to the first floor, ensuring step-free access between floors and enabling full use of all facilities by all users.

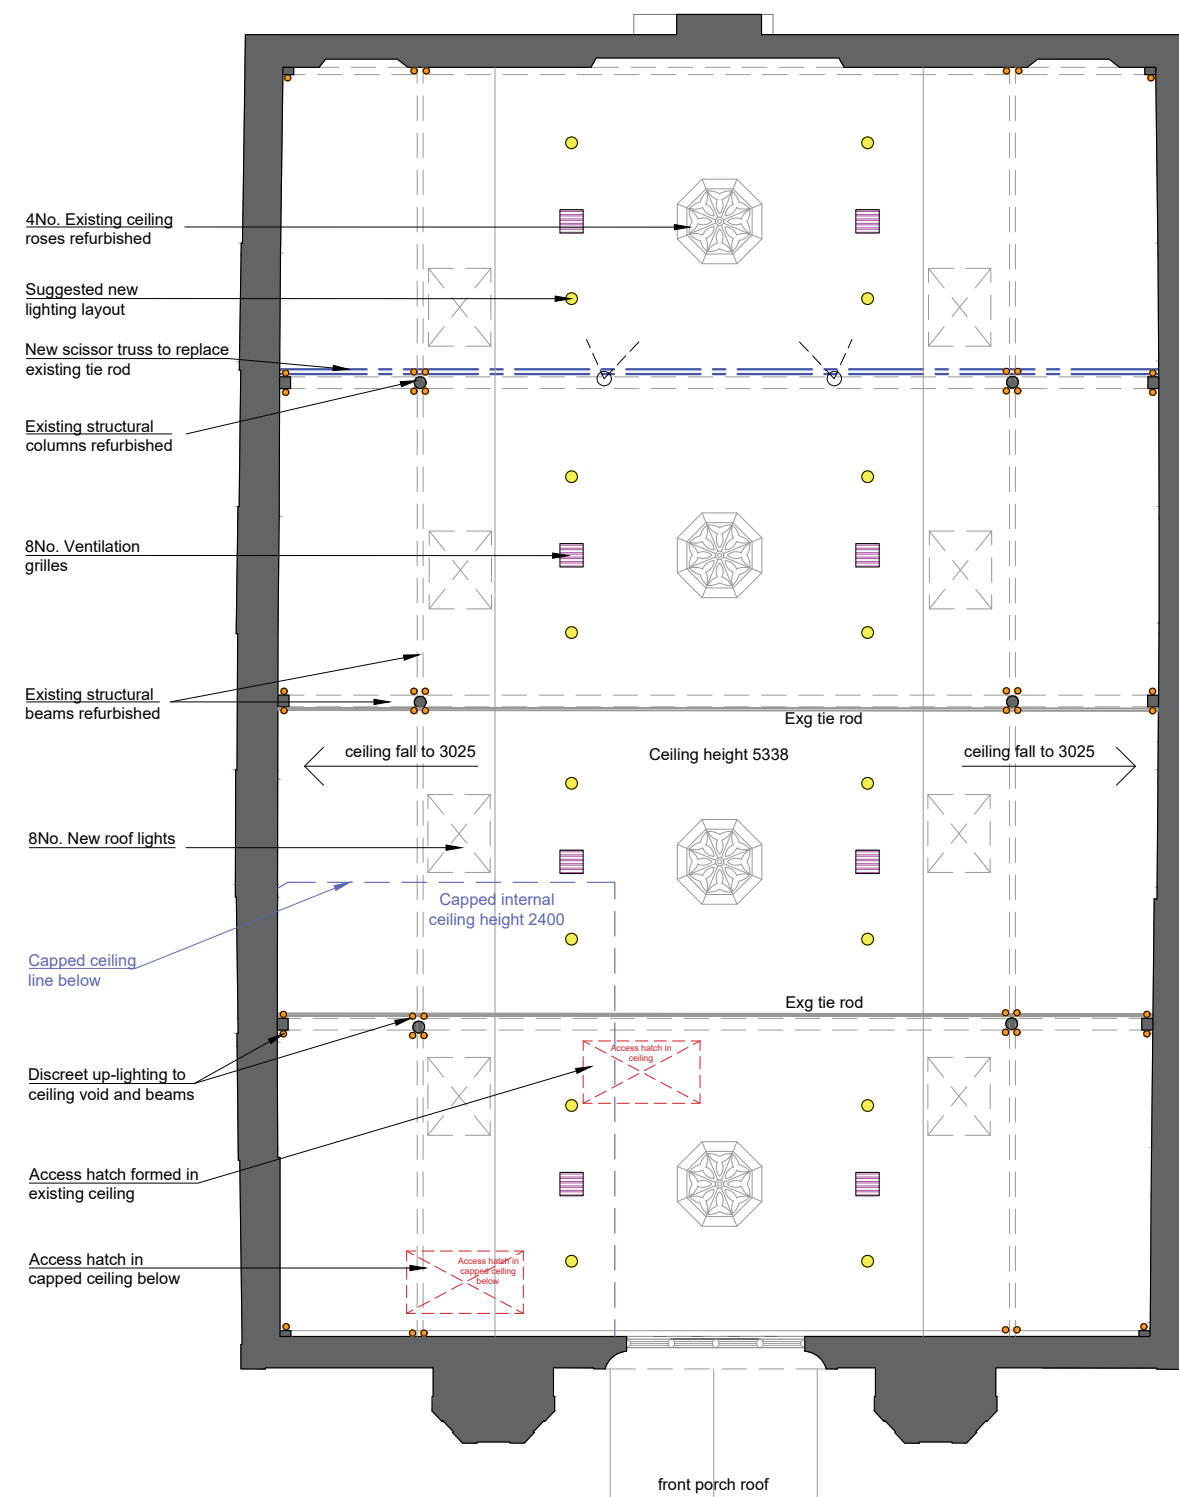
**Fig. 26 : Proposed new lighting layout and roof light positions on the first floor**

All new electrical services to be provided will meet current standards. Electrical distribution to the first floor will be provided by cables from below passing through the floor to the local power points, to avoid crossing window positions and the harm this would cause. New energy efficient lighting is to be provided throughout the building.
