# REMODELLING AND REFURBISHMENT OF BALDOCK METHODIST CHURCH

## DESIGN AND ACCESS STATEMENT

JUNE 2026

This Design and Access Statement is submitted in support of Planning and Listed Building Consent applications for the sensitive internal remodelling and refurbishment of the former Baldock Methodist Church.

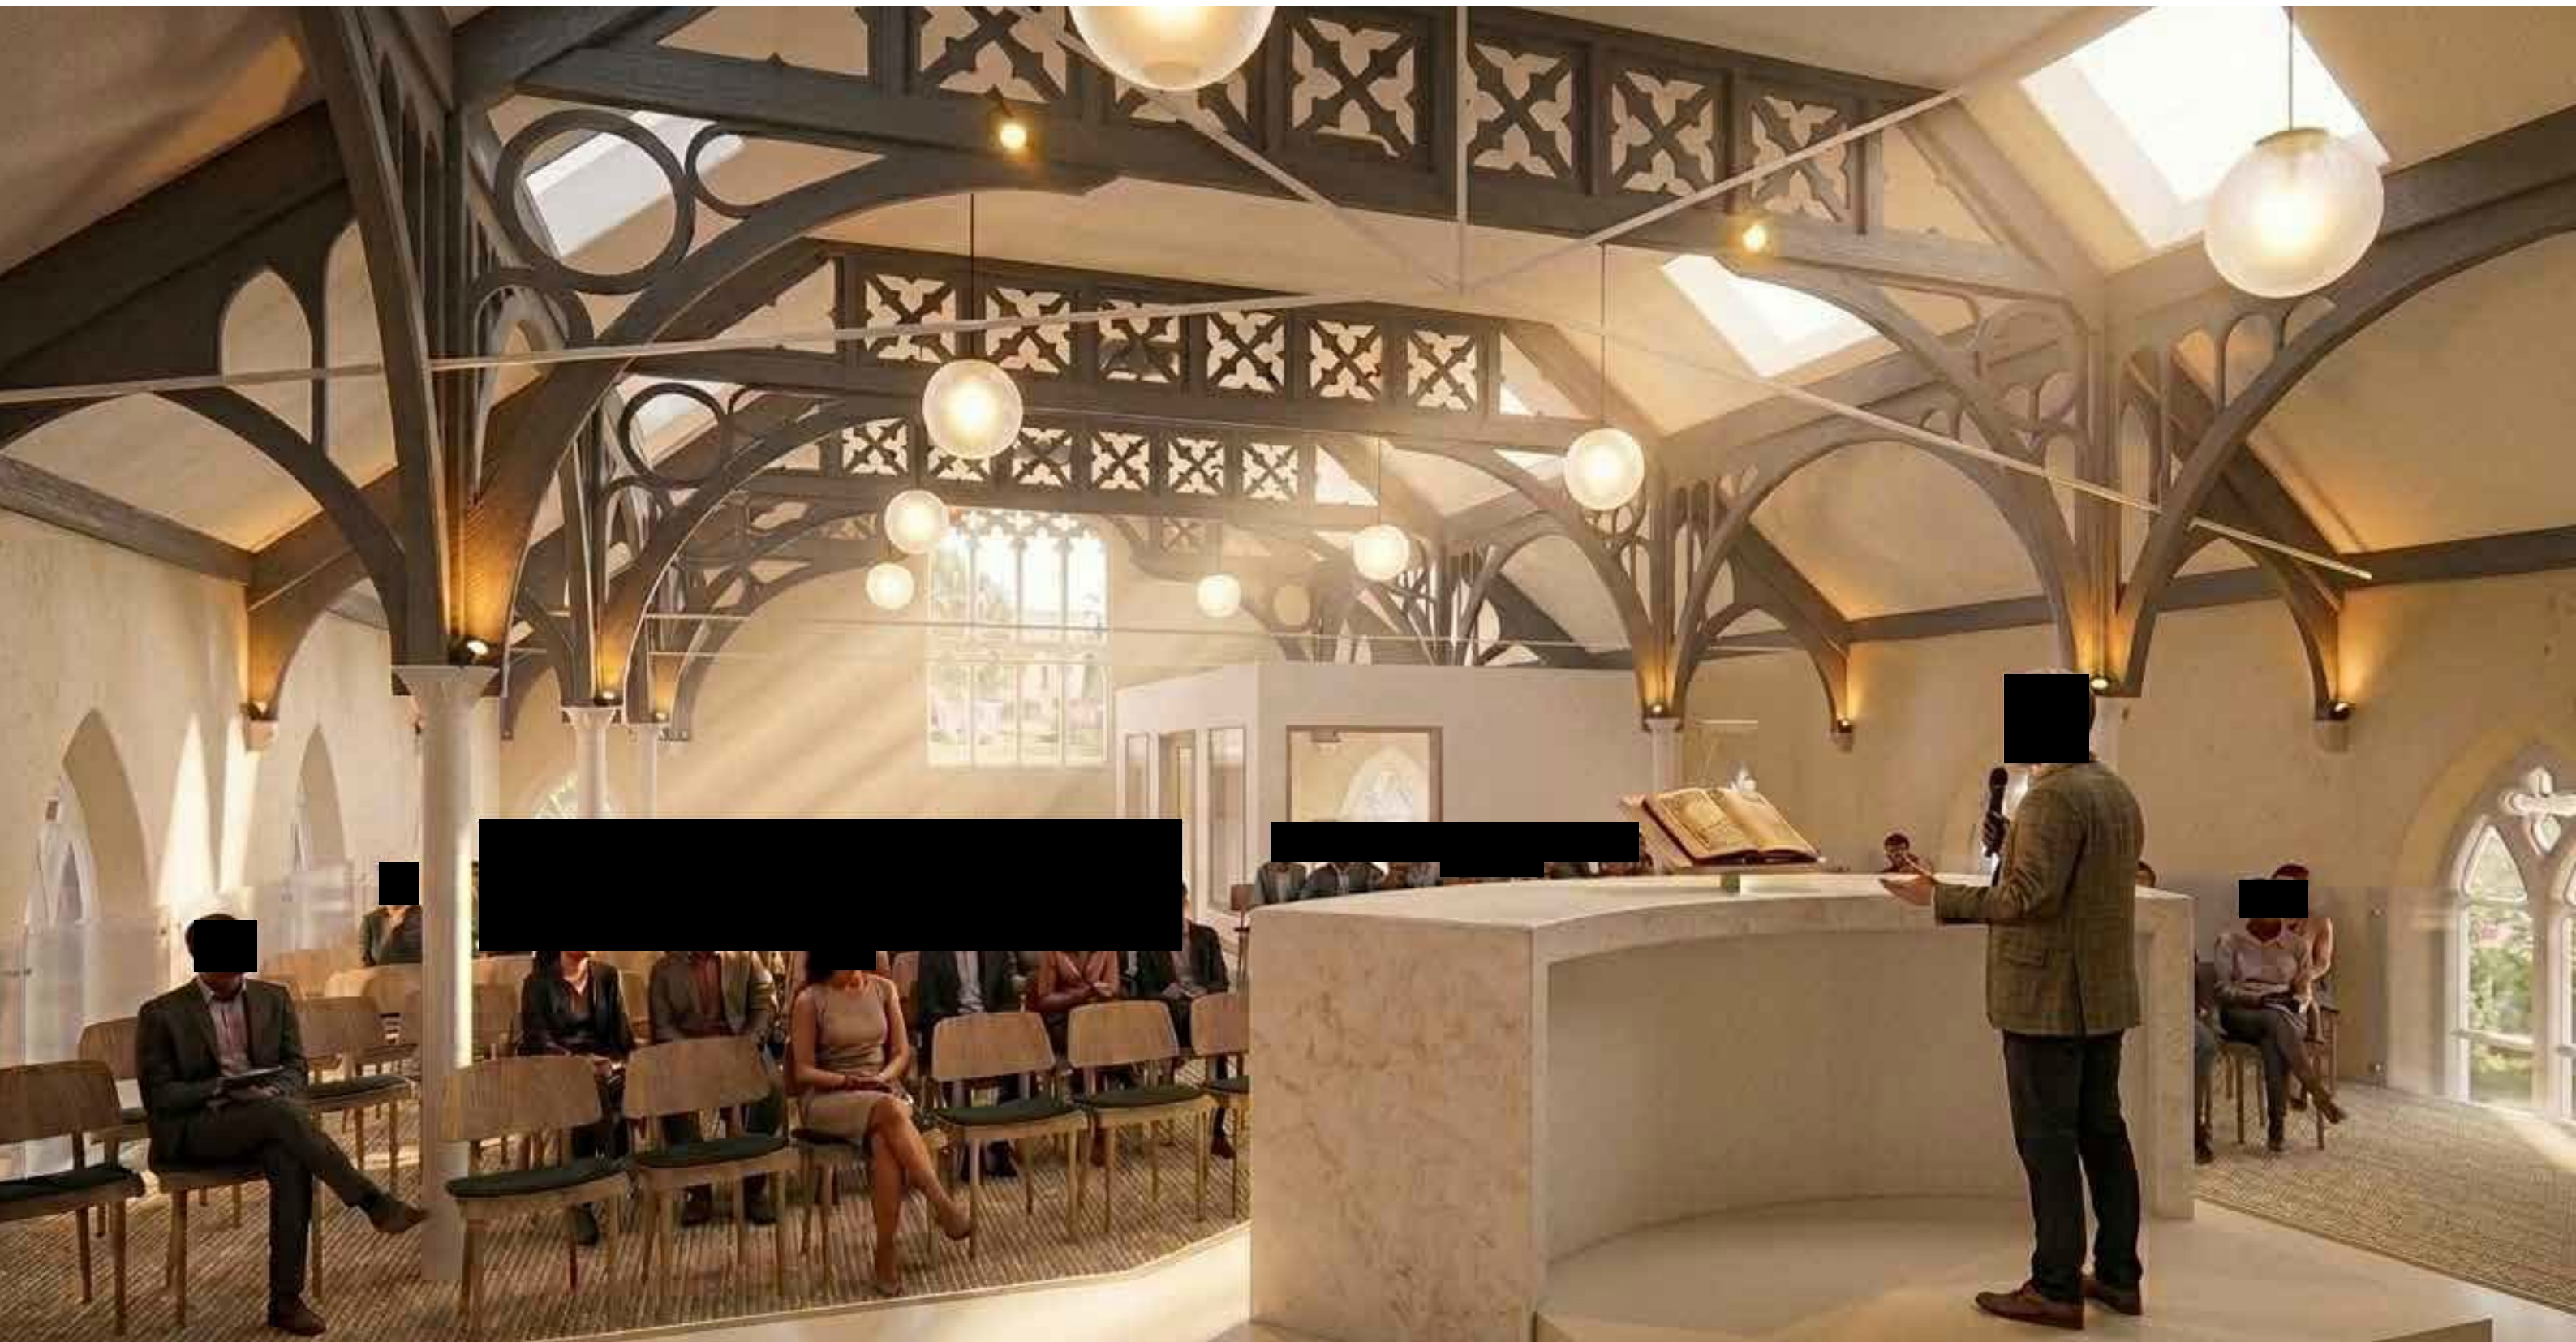
*Fig. 27 : Proposed first floor worship space, the new open layout displays uninterrupted views of the main feature window, ornate ceiling and structure*

However, the building's key external character and contribution to the streetscape would be retained and improved, and its overall ecclesiastical identity would remain intact. The existing level of internal alteration also reduces sensitivity in some areas, and the scheme will allow better appreciation of surviving historic features. *(Fig. 27)*
