| Report: | GROUND APPRAISAL REPORT |
| Site: | PIXMORE AVENUE, LETCHWORTH, HERTFORDSHIRE, SG6 1LJ |
| Reference: | GE18750-GAR-JUN20 |

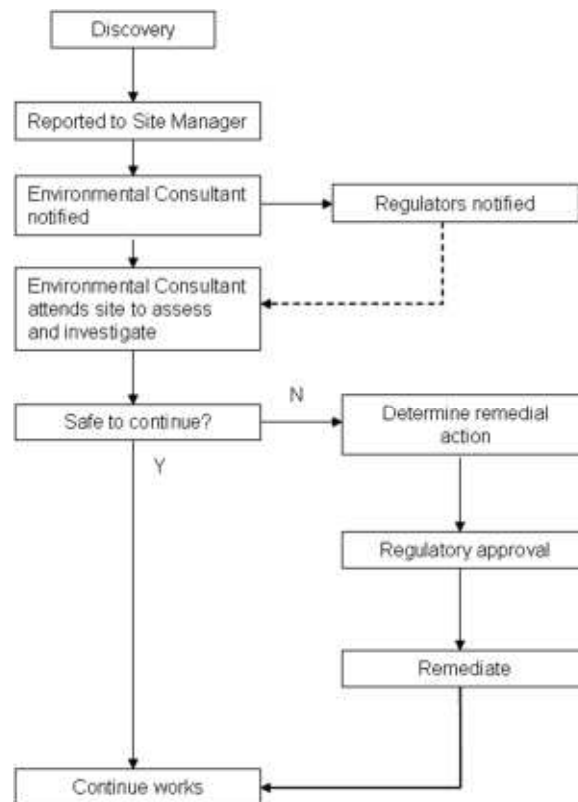
**Discovery Strategy Process**

The process is shown below.

A copy of the discovery strategy should be lodged on site and provisions made to ensure that all workers are made aware of their responsibility to observe, report and act on any potentially suspicious or contaminated materials they may encounter.

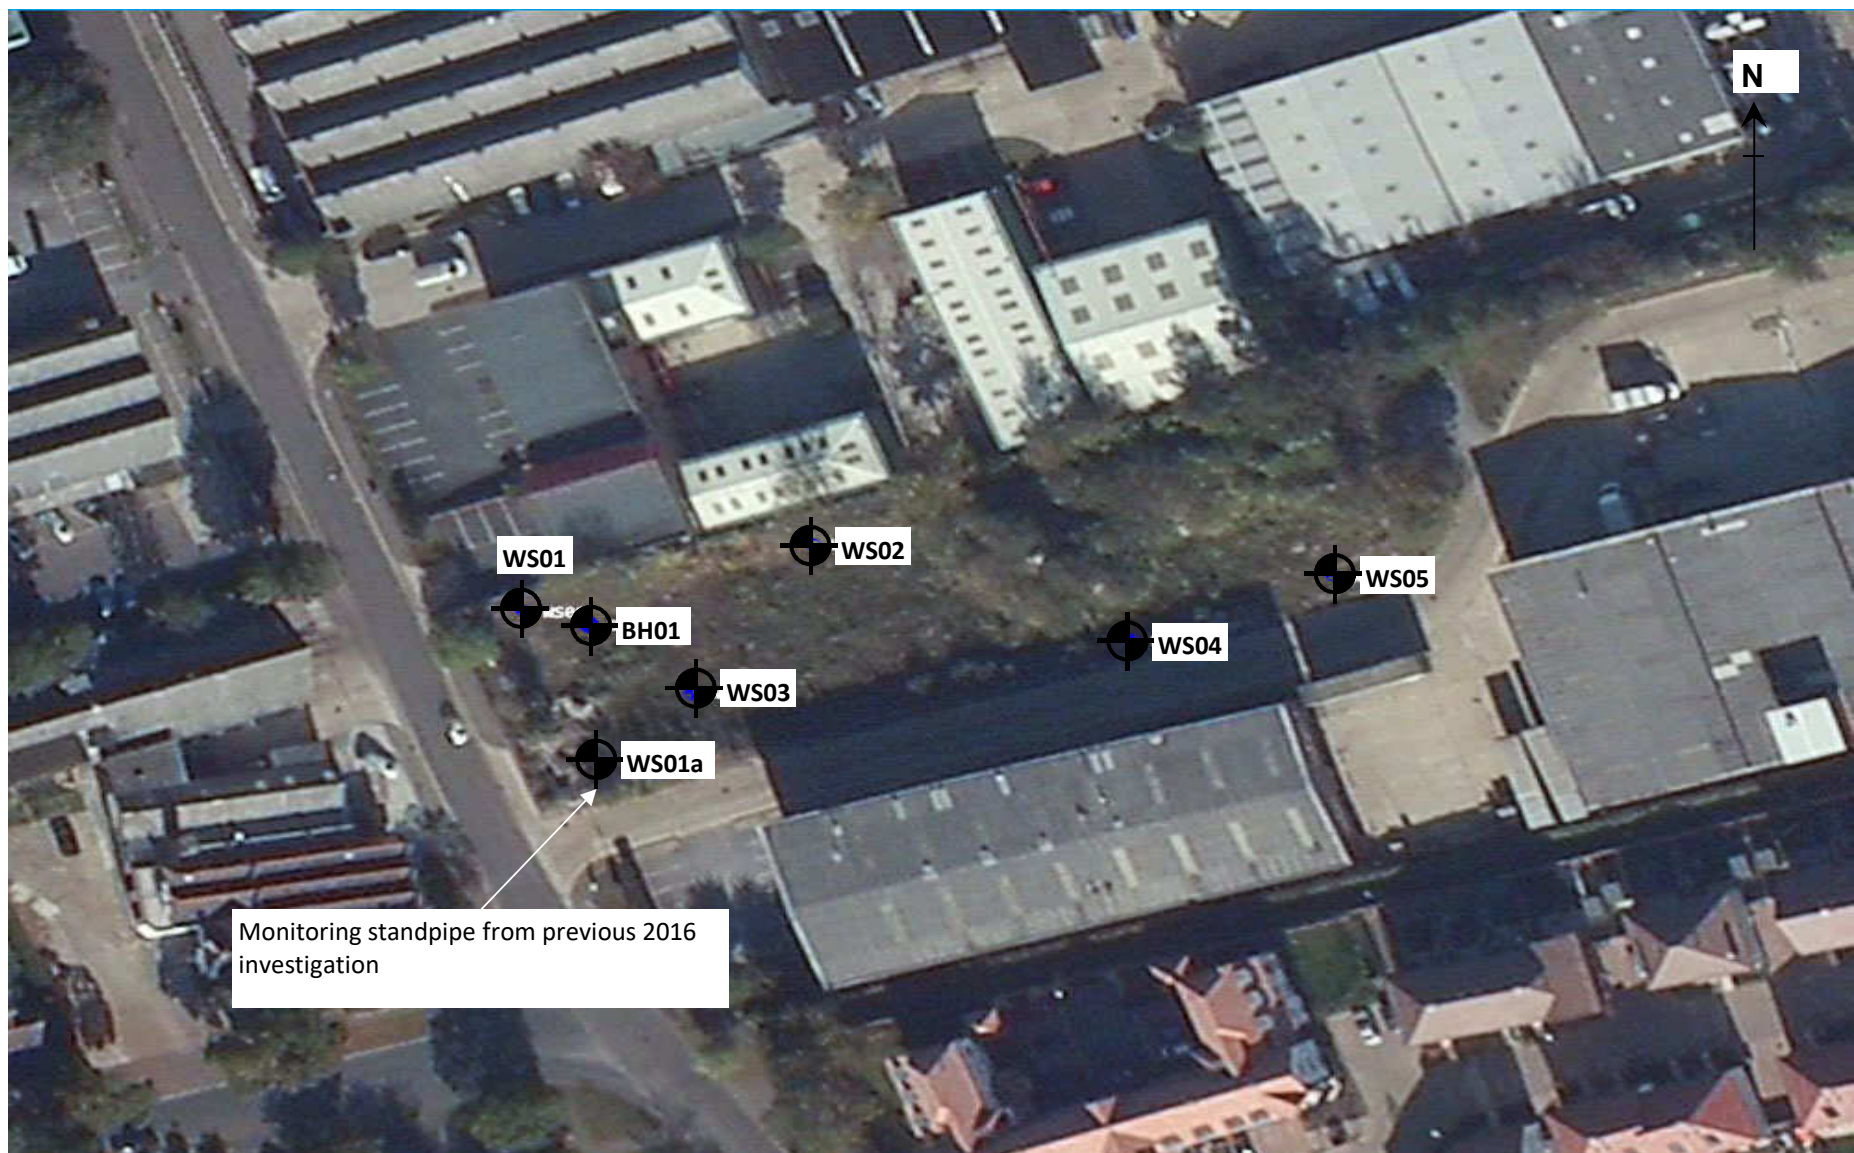
| <b>Project:</b> | Pixmore Avenue, Letchworth | | | <b>Title</b> | Exploratory Hole Location Plan | | |

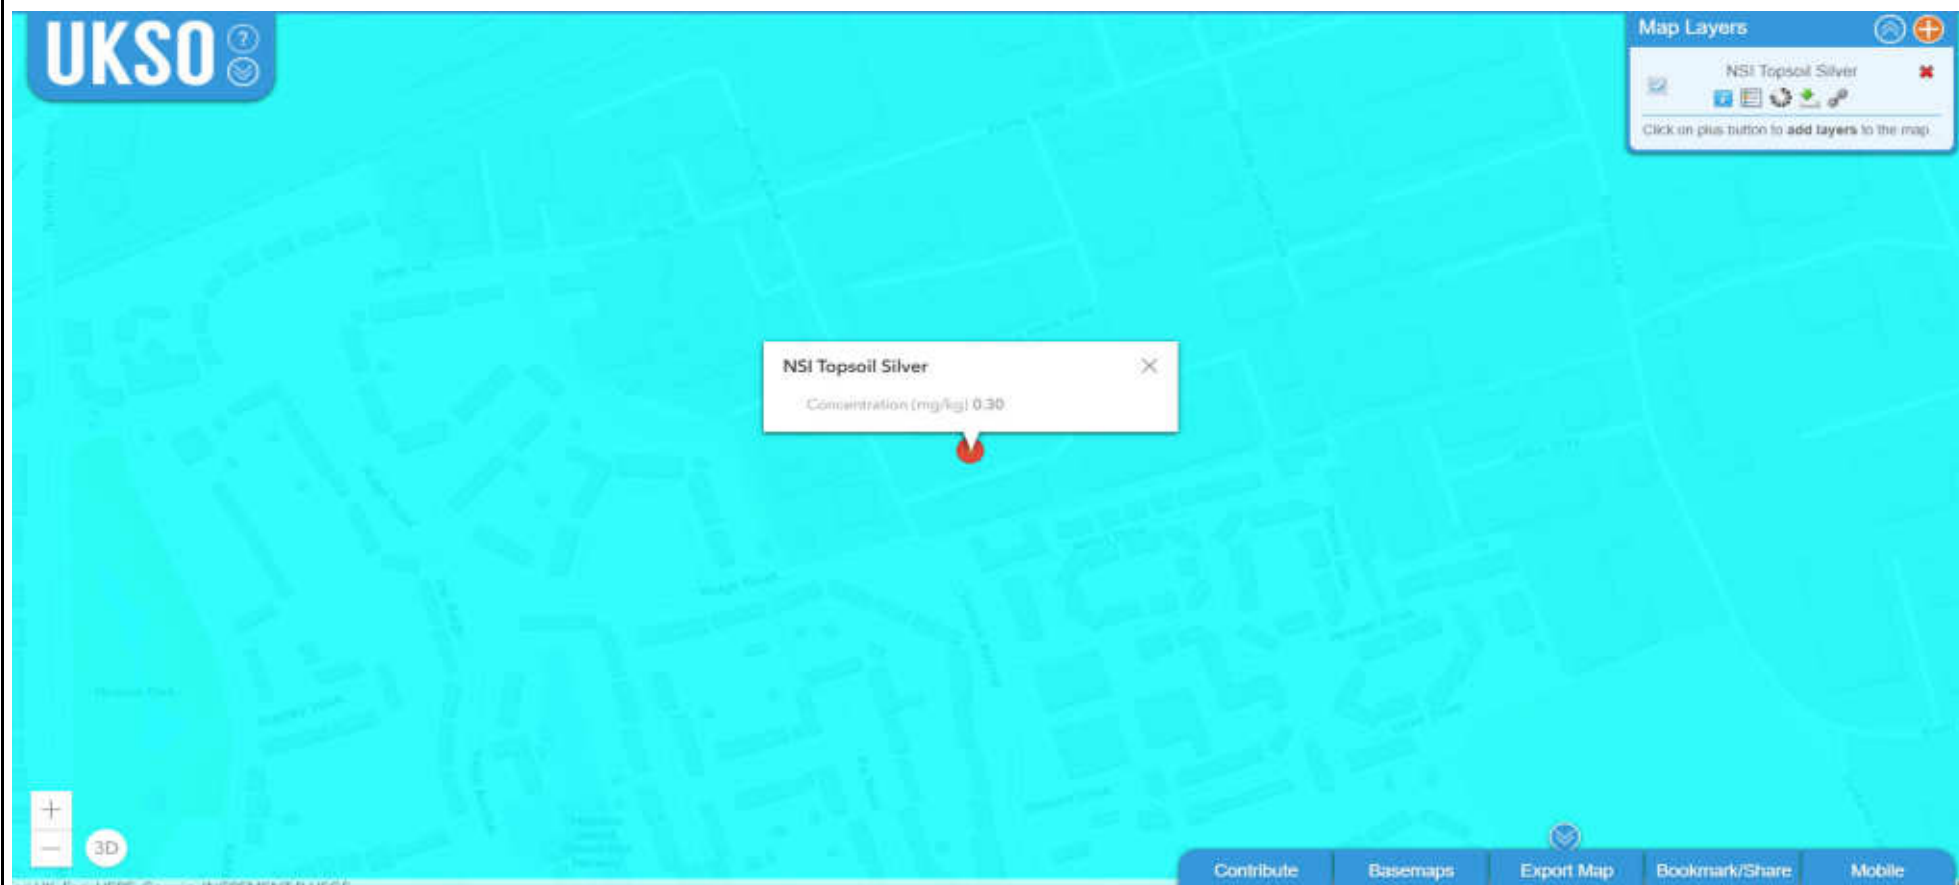
| <b>Project:</b> | Pixmore Avenue, Letchworth | | | <b>Title</b> | UK Soil Observatory Natural Background Chemistry Map (Silver) | |

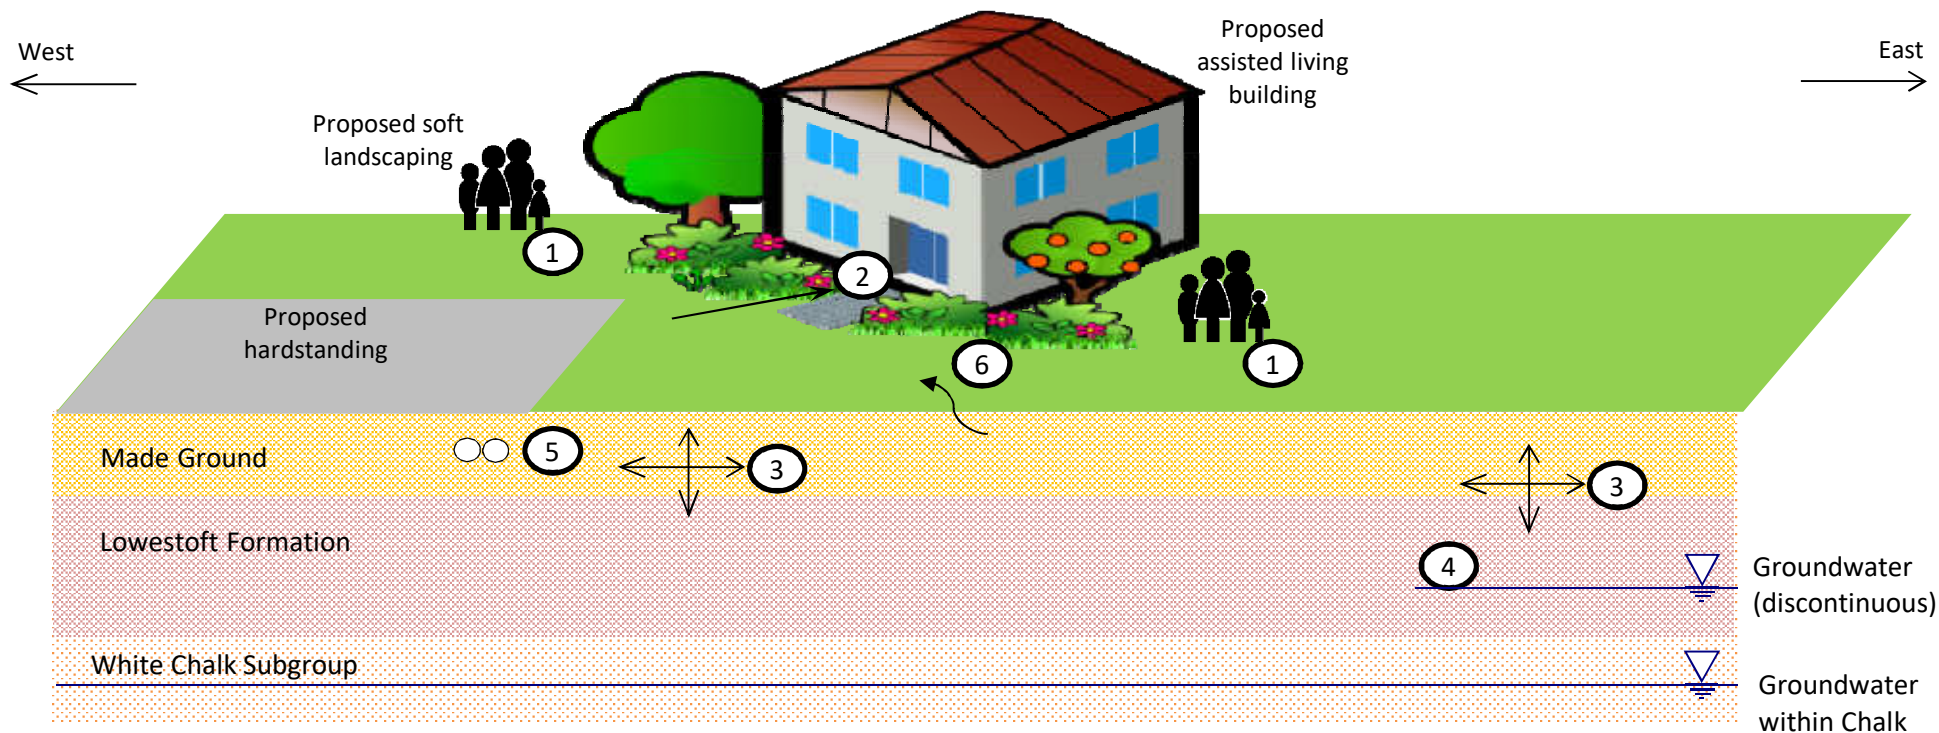
#### Possible Pollutant Linkages:

1. Direct contact with contaminated soils, ingestion of contaminated soils
2. Inhalation of soil dusts indoor and outdoor, and inhalation of gases/vapours within buildings
3. Vertical and lateral migration through permeable strata and with groundwater
4. Shallow groundwater vertical and lateral migration
5. Chemical attack of buried plastics and concrete
6. Ground gas migration from on site and/or off site sources

| <b>Project:</b> | Pixmore Avenue, Letchworth | | | <b>Title</b> | Conceptual Site Model (Proposed Development) | |
