**Great Ashby  
Stevenage  
Hertfordshire  
SG4 7EA**

Desk Study &  
Ground Investigation  
Report

Picture Estates Ltd

J22372  
Rev 2

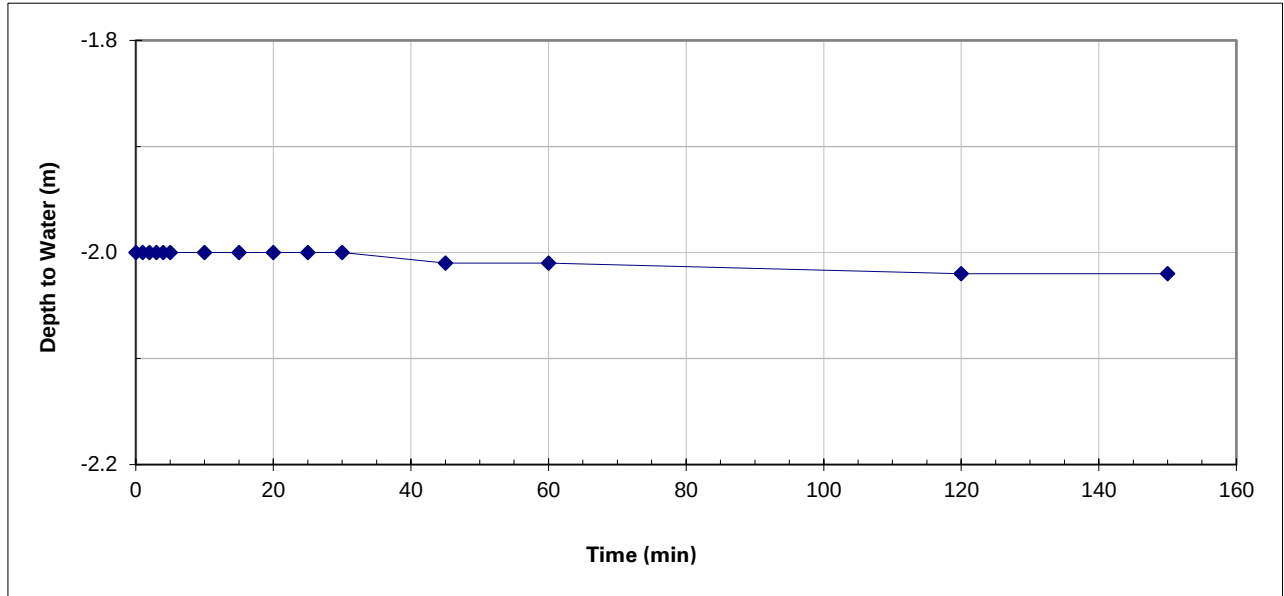
Trial Pit No. TP1 Soakage Test No. 1  
Pit Length (m) 2.8 Pit Width (m) 0.9 Pit Depth (m) 2.5

Design Soakage Rate 1.1E-06 m/s (based on linear portion of graph as shown)  
0.10 m/day

Soakage testing was carried out within each of the trial pits in general accordance with BRE 365 to provide information to inform the design of new soakaway drainage. It should be noted that where it was not possible to include a test during a single day, the soakage rate was considered to be low such that the use of shallow soakaways would not be feasible in that part of the site. No further testing was carried out in this case.

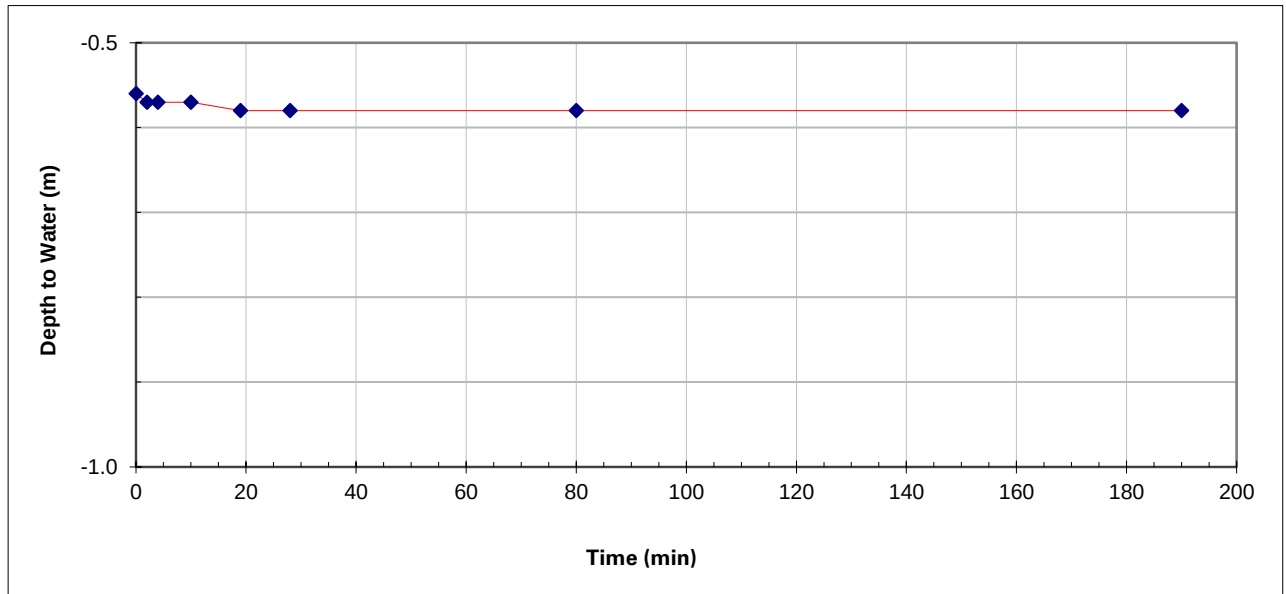
Trial Pit No. TP2 Soakage Test No. 1  
Pit Length (m) 3 Pit Width (m) 0.9 Pit Depth (m) 1.8

Design Soakage Rate 3.9E-07 m/s (based on linear portion of graph as shown)  
0.03 m/day

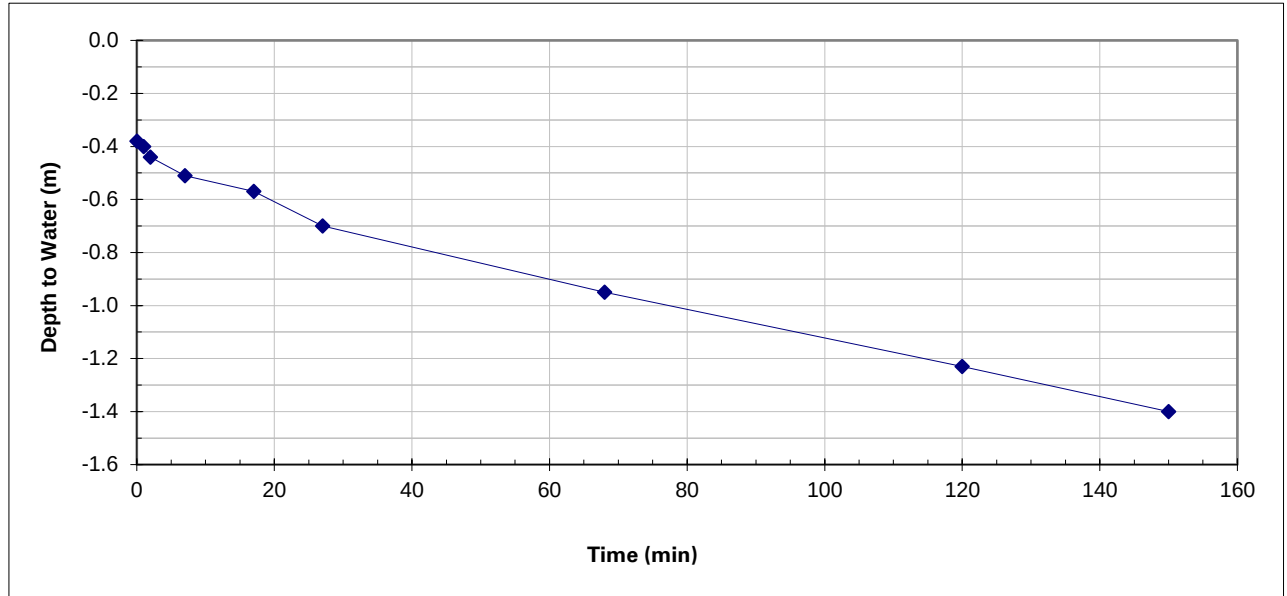
Trial Pit No. TP4 Soakage Test No. 2

Pit Length (m) 1.7 Pit Width (m) 0.7 Pit Depth (m) 1.82

Design Soakage Rate 2.3E-05 m/s (based on linear portion of graph as shown)

2.00 m/day

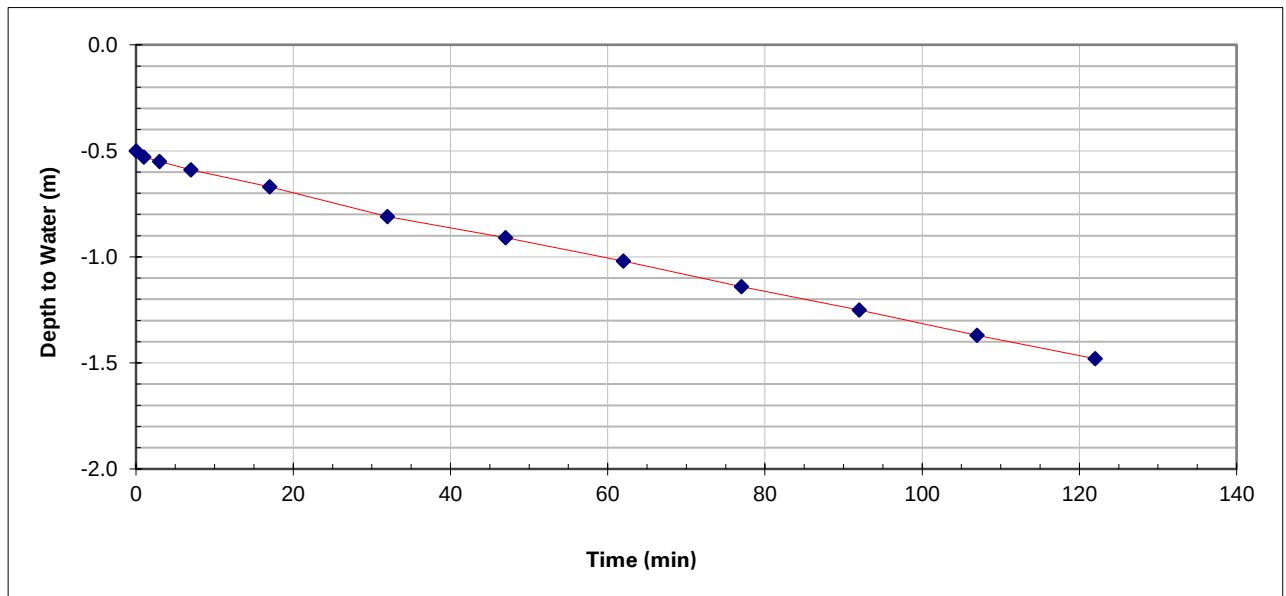
Trial Pit No. TP4 Soakage Test No. 3

Pit Length (m) 1.7 Pit Width (m) 0.7 Pit Depth (m) 1.82

Design Soakage Rate 3.1E-05 m/s (based on linear portion of graph as shown)

2.67 m/day

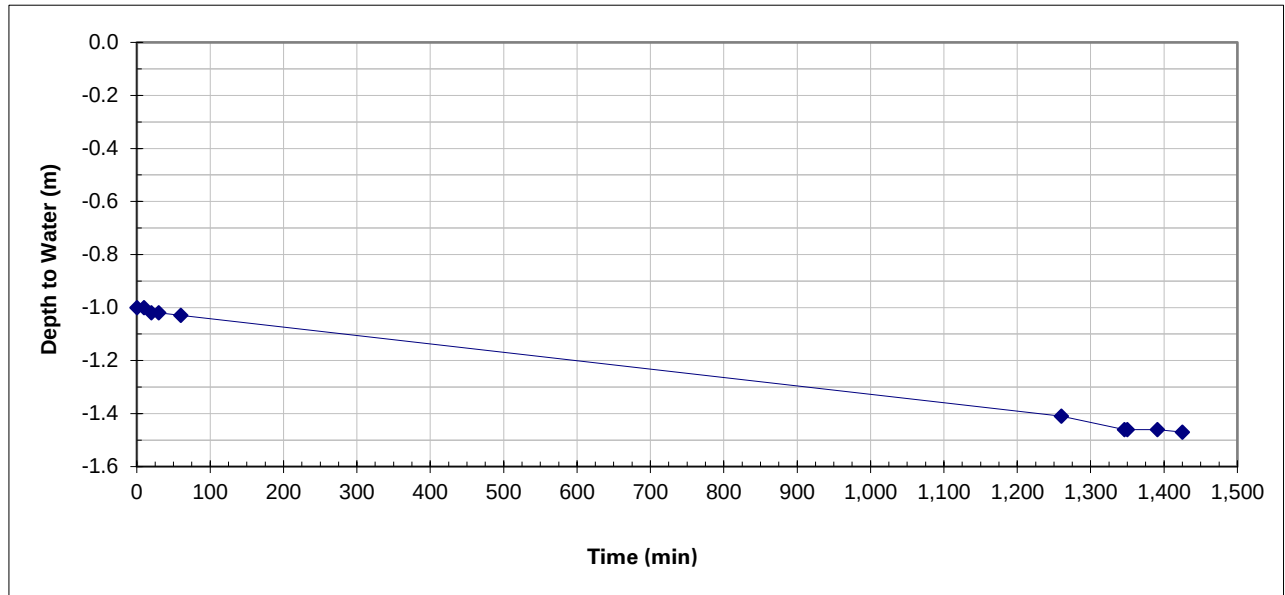
Trial Pit No. TP5 Soakage Test No. 1  
Pit Length (m) 2.1 Pit Width (m) 0.6 Pit Depth (m) 1.9

Design Soakage Rate  $1.5\text{E-}06$  m/s (based on linear portion of graph as shown)  
0.13 m/day

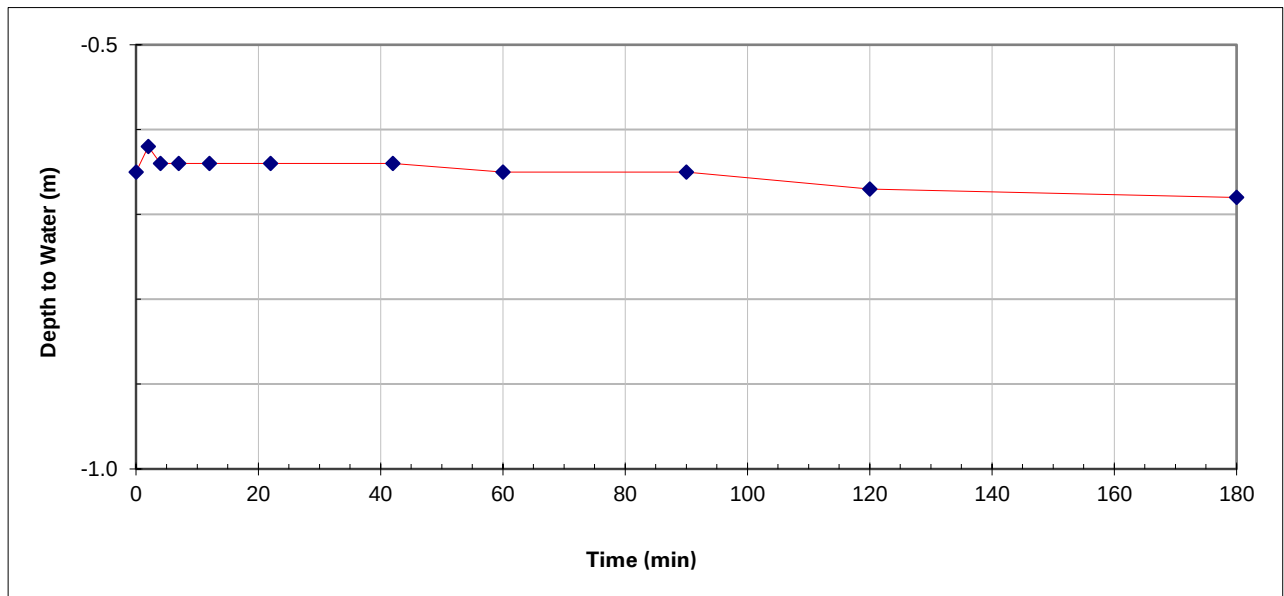
Trial Pit No. TP6 Soakage Test No. 1  
Pit Length (m) 2.1 Pit Width (m) 0.8 Pit Depth (m) 1.9

Design Soakage Rate  $1.1\text{E-}06$  m/s (based on linear portion of graph as shown)  
0.09 m/day

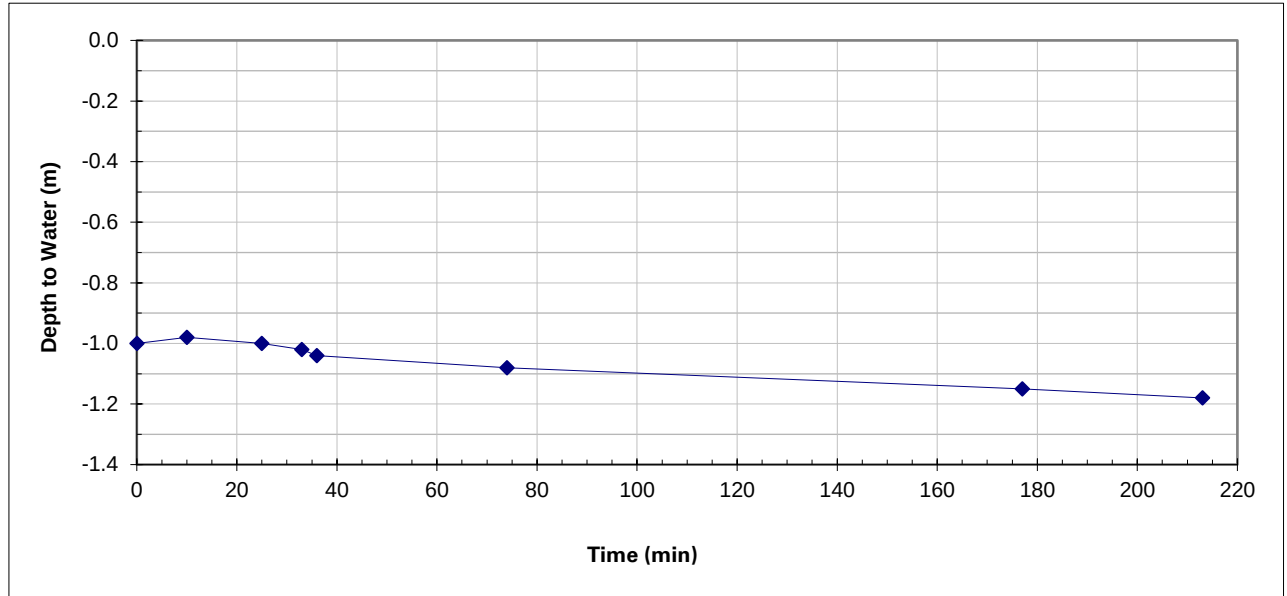
Trial Pit No. TP7 Soakage Test No. 1  
Pit Length (m) 2 Pit Width (m) 0.8 Pit Depth (m) 1.8

Design Soakage Rate 5.1E-06 m/s (based on linear portion of graph as shown)  
0.44 m/day

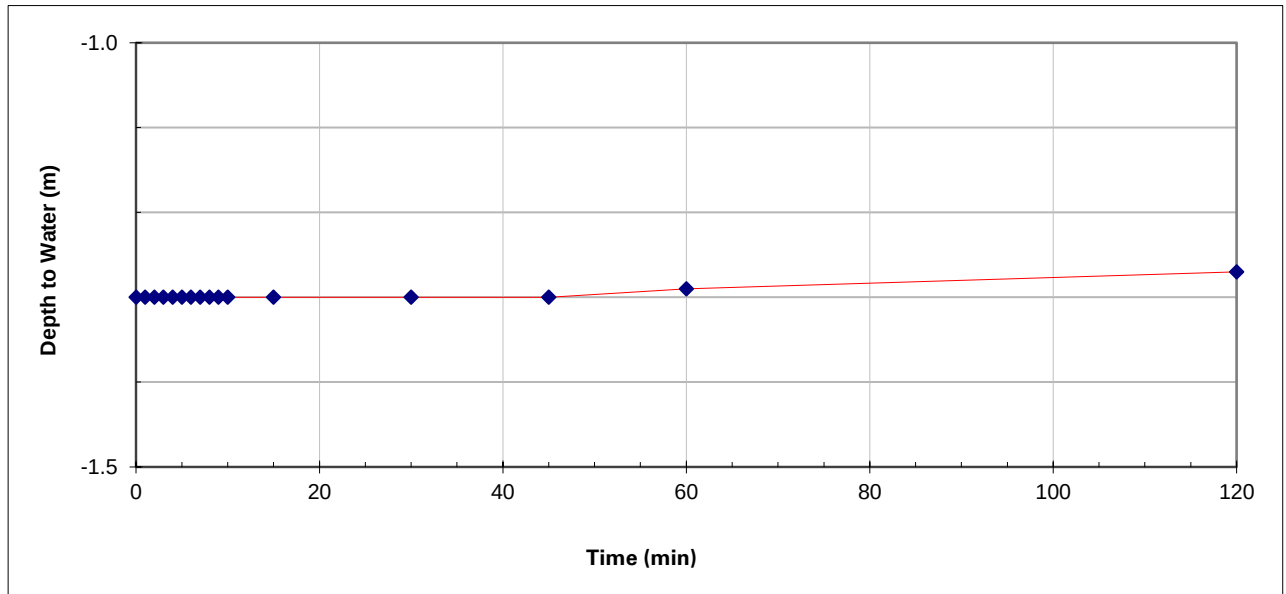
Trial Pit No. TP8 Soakage Test No. 1  
Pit Length (m) 3 Pit Width (m) 0.9 Pit Depth (m) 1.8

Design Soakage Rate -2.2E-06 m/s (based on linear portion of graph as shown)  
-0.19 m/day

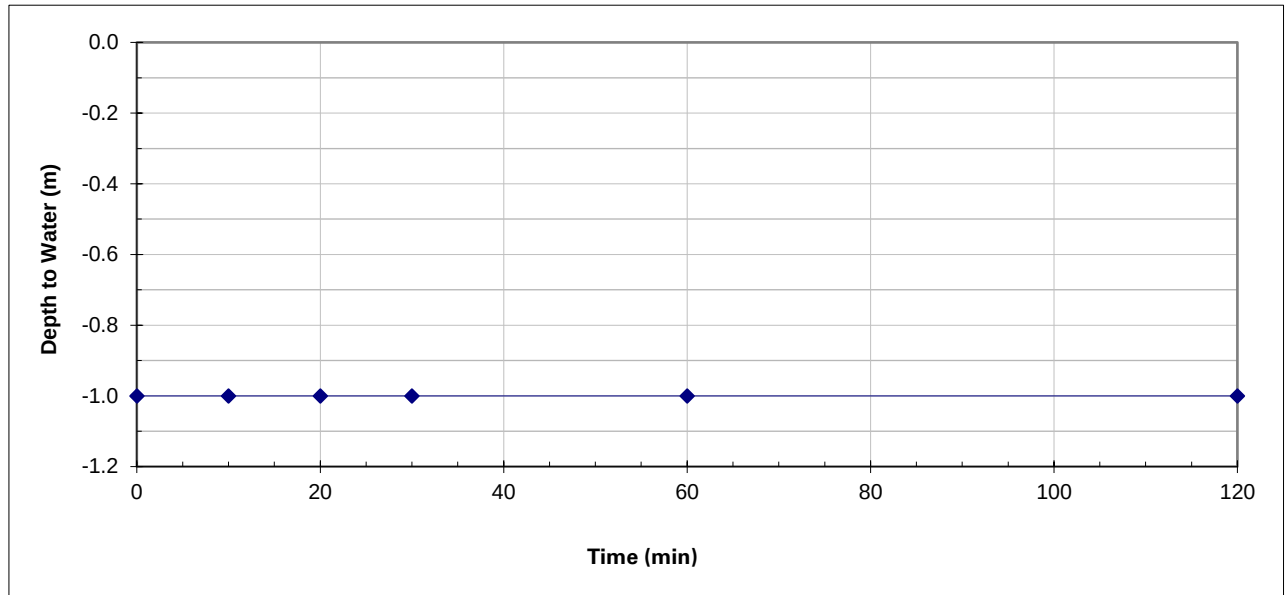
Trial Pit No. TP9 Soakage Test No. 1

Pit Length (m) 2 Pit Width (m) 0.6 Pit Depth (m) 1.9

Design Soakage Rate 0.0E+00 m/s (based on linear portion of graph as shown)  
0.00 m/day

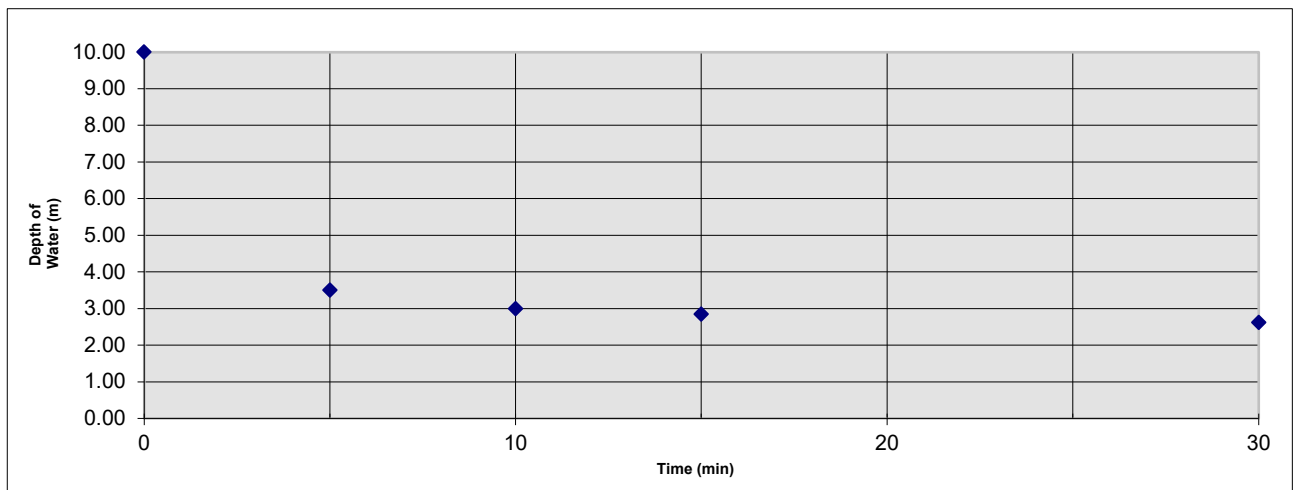
### Soakage Graph

Test carried out in the standpipe installed in the opendrive sampler borehole

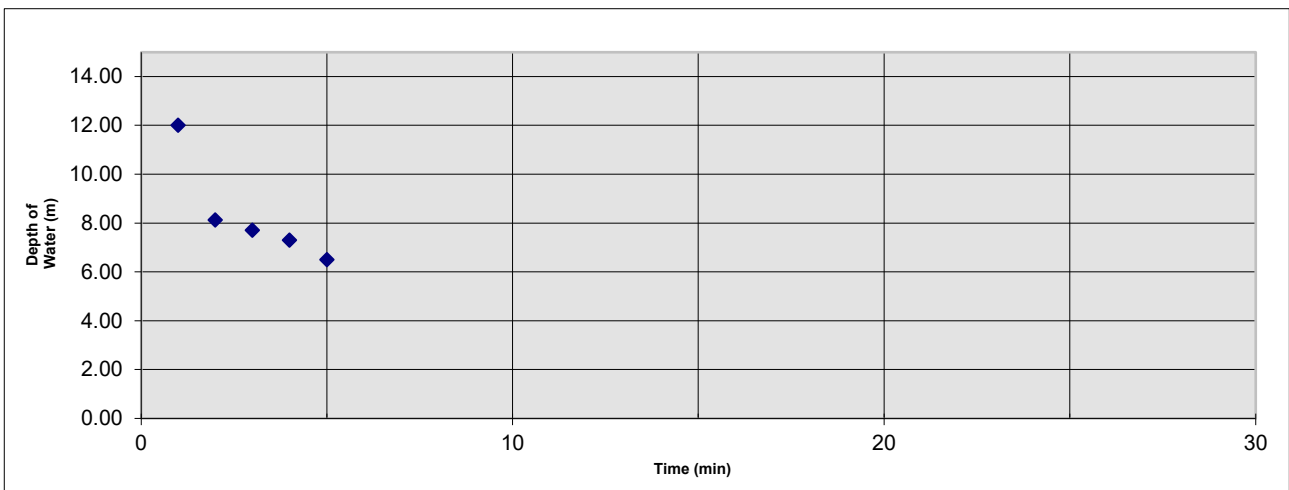
## Soakage Graph

Test carried out in the standpipe installed in the opendrive sampler borehole
