## Link Engineering

Project No. **251205**

MSCC5 Drain and Sewer Codes (SRM5 Scoring)

After surveying the drainage at Redwing's Lodge, Hinxworth, we recommend a re-visit with HPWJ van pack or a Jet/Vac to clean the lines that were not accessible during the time of survey, remarks at the end of each pipe section will specify the necessary remedial action to take. The main hotel building has two surface runs either side that lead to a rodding eye, however one of these was not able to be located, we assume it is buried. The inspection chambers that would give access to these SW6 and SW5 were UTL. If these covers are raised then that would allow us to confirm the surface run and its features. The restaurant on site uses a grease trap to clean the waste from the kitchen, we recommend that the grease trap and all surrounding drainage is cleared out and thoroughly cleaned then re-surveyed for the pipe condition. Following this, we located a buried manhole to the South East of the restaurant, this should be uncovered, lifted and surveyed.

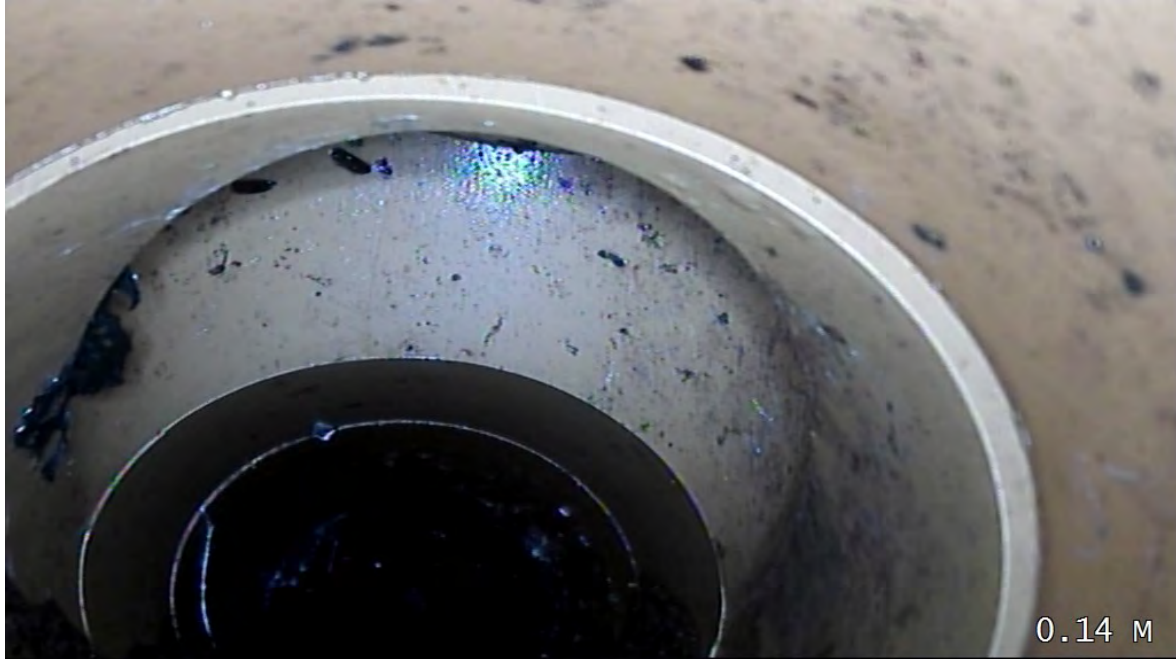
S1C3

00:00:06 - 0.14 m  
Junction at 12 o'clock, diameter 100mm

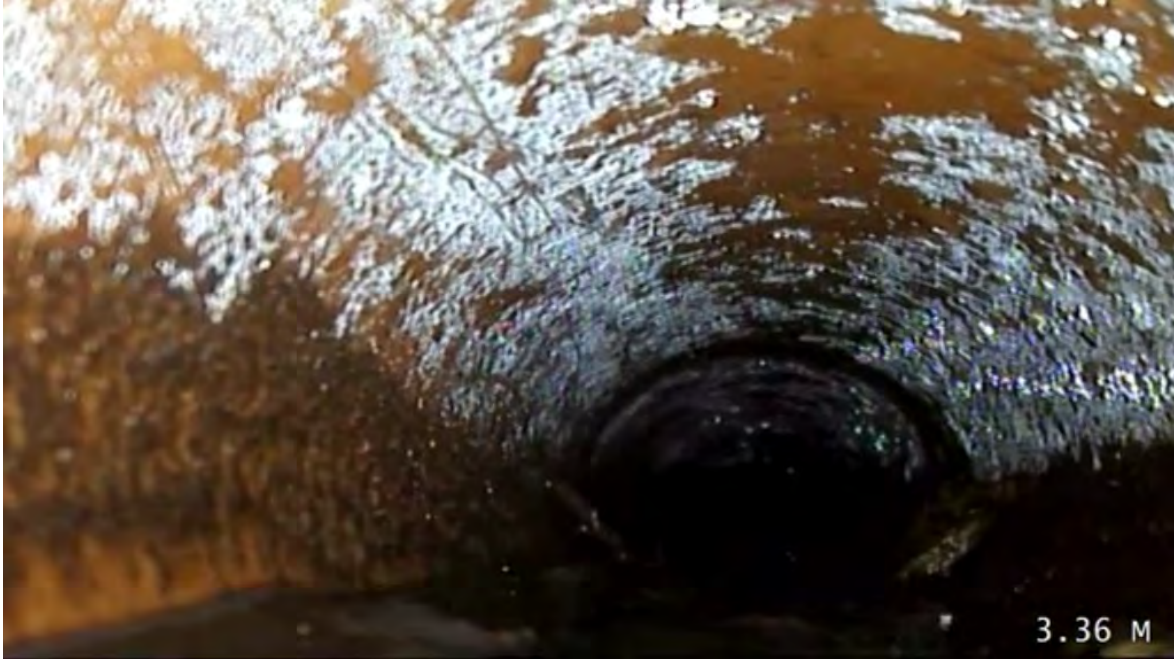
S1C5

00:00:35 - 3.36 m

Settled deposits coarse 10% cross-sectional area loss

Deposits observed which resulted in a loss of vision part way down the line. HPWJ required to remove all deposits. Re-survey to determine asset condition.

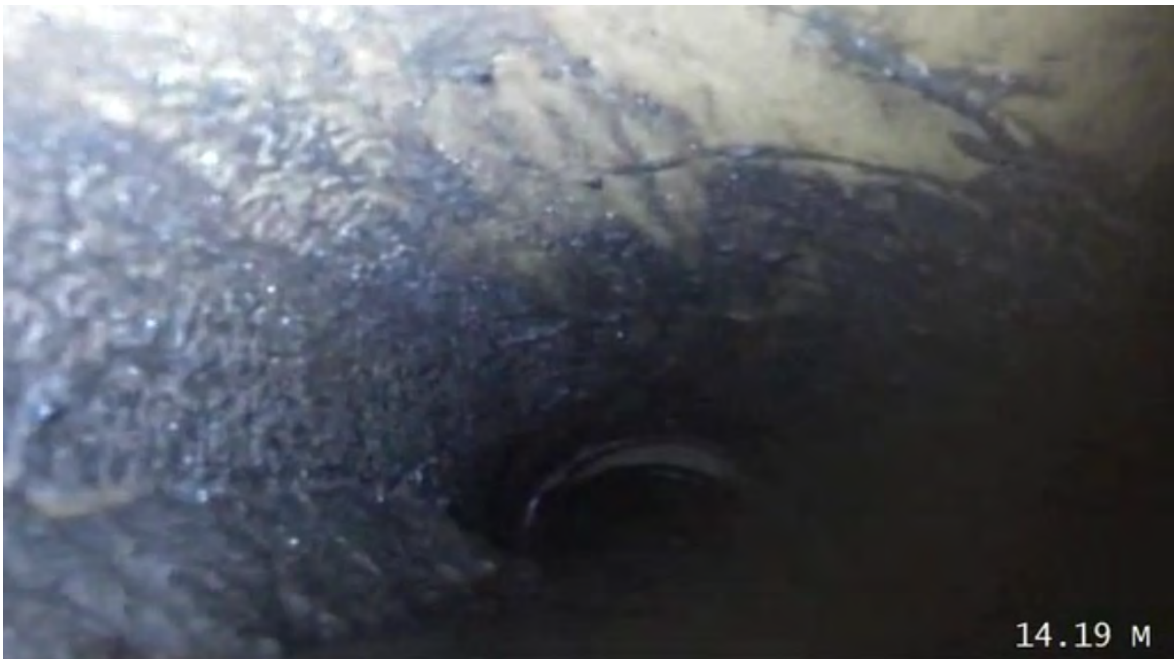
S1C6

00:01:38 - 14.19 m

Settled deposits fine 25% cross-sectional area loss

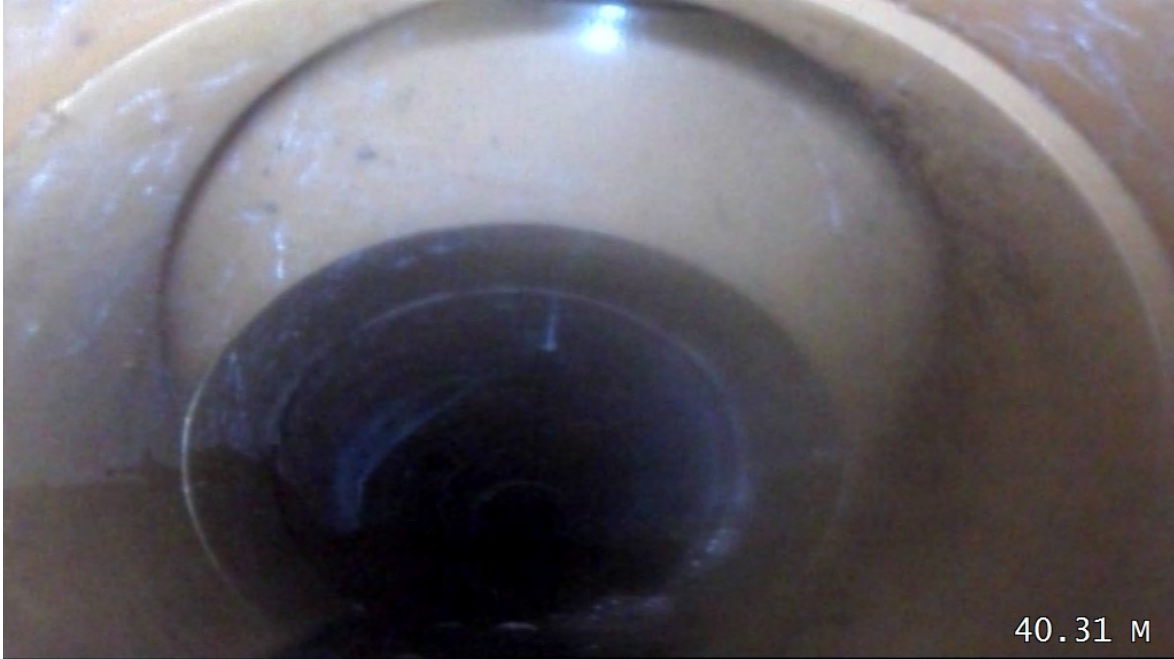
S1C9

00:03:50 - 40.31 m  
Junction at 12 o'clock, diameter 100mm

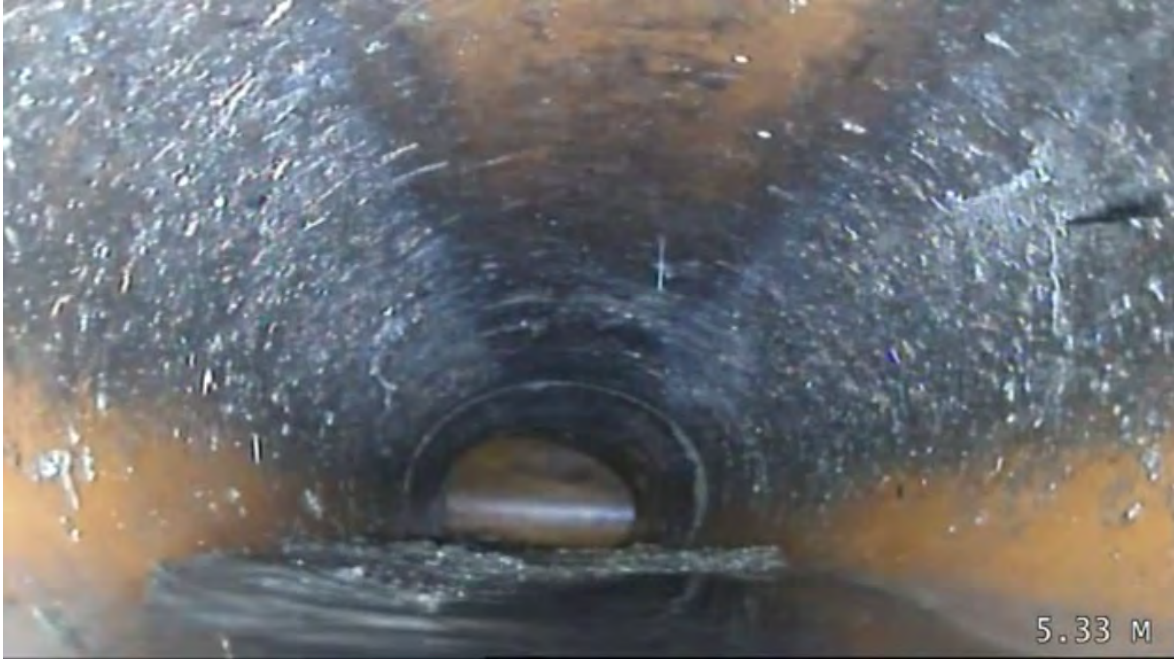
S3C3

00:00:22 - 5.33 m

Settled deposits fine 10% cross-sectional area loss

HPWJ recommended to clear pipe of debris.

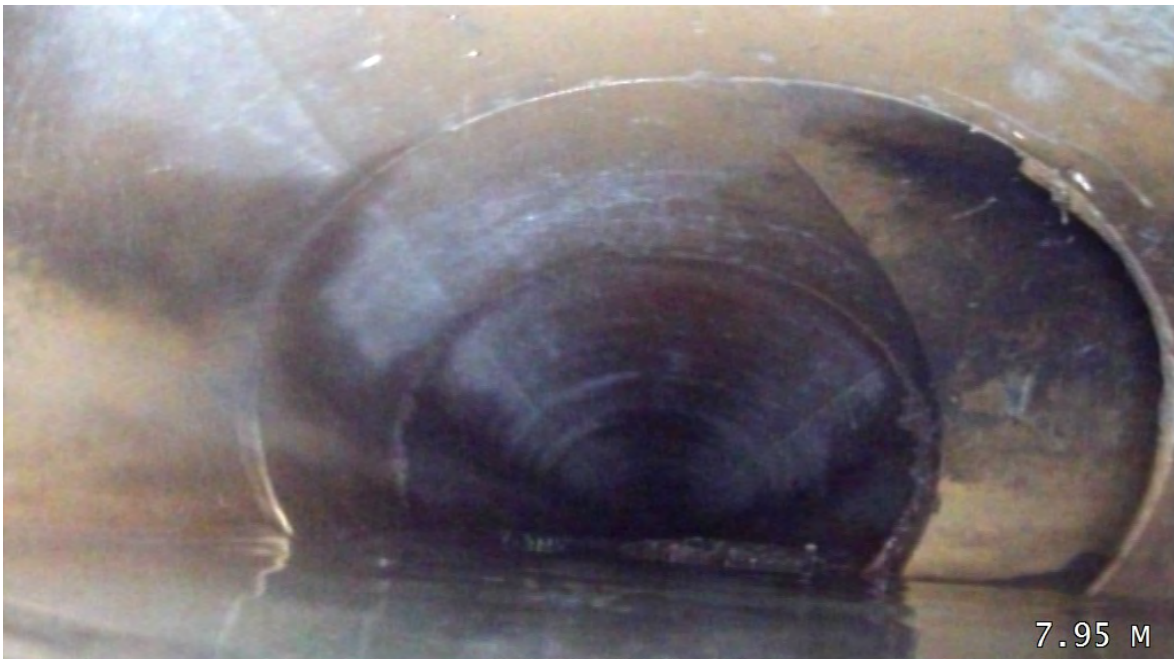
S4C8

00:00:50 - 7.95 m  
Junction at 3 o'clock, diameter 150mm

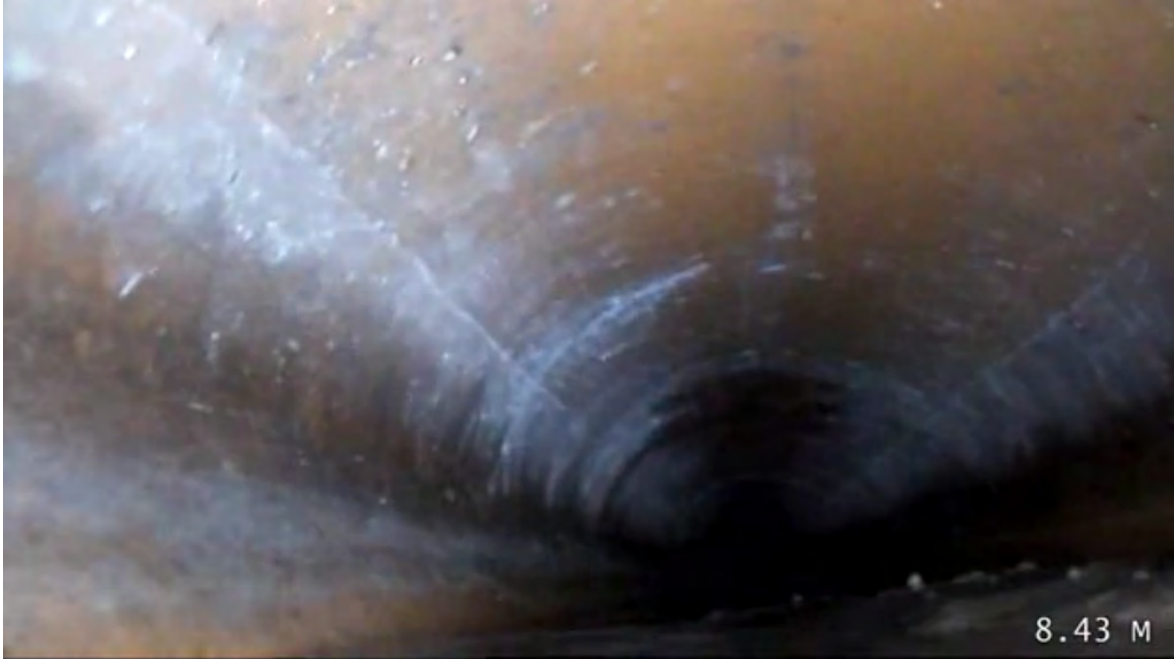
S4C9

00:00:55 - 8.43 m

Settled deposits fine 20% cross-sectional area loss

Debris observed, HPWJ required to remove all deposits.

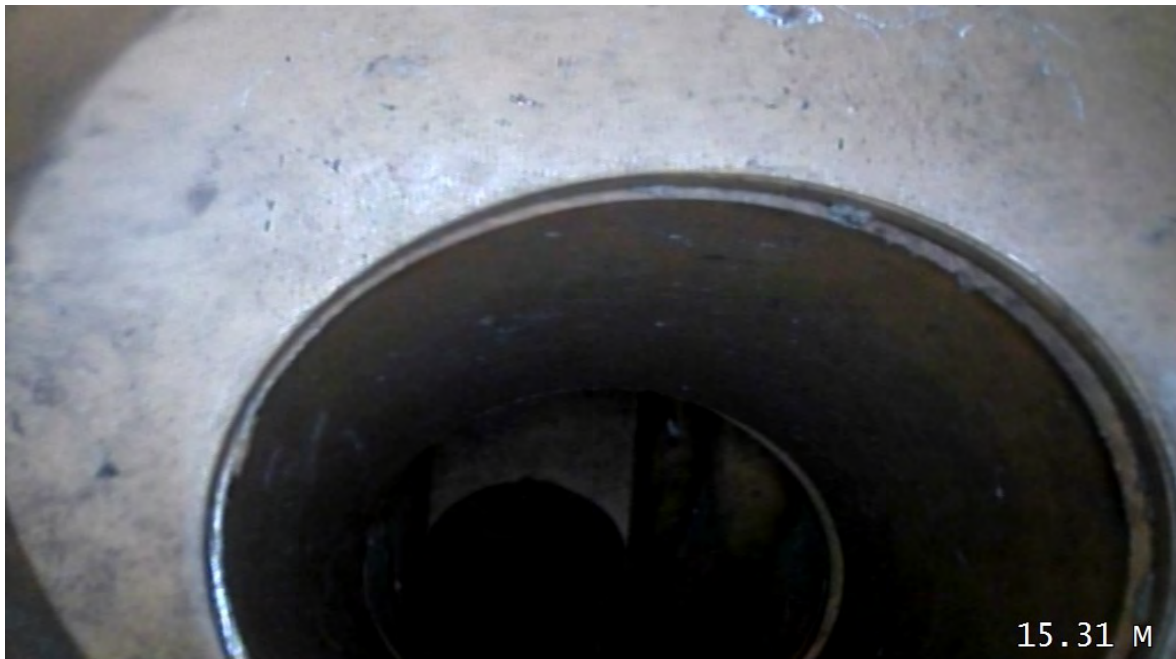
S4C12

00:01:31 - 15.31 m  
Dimensions of drain/sewer changes to 100mm

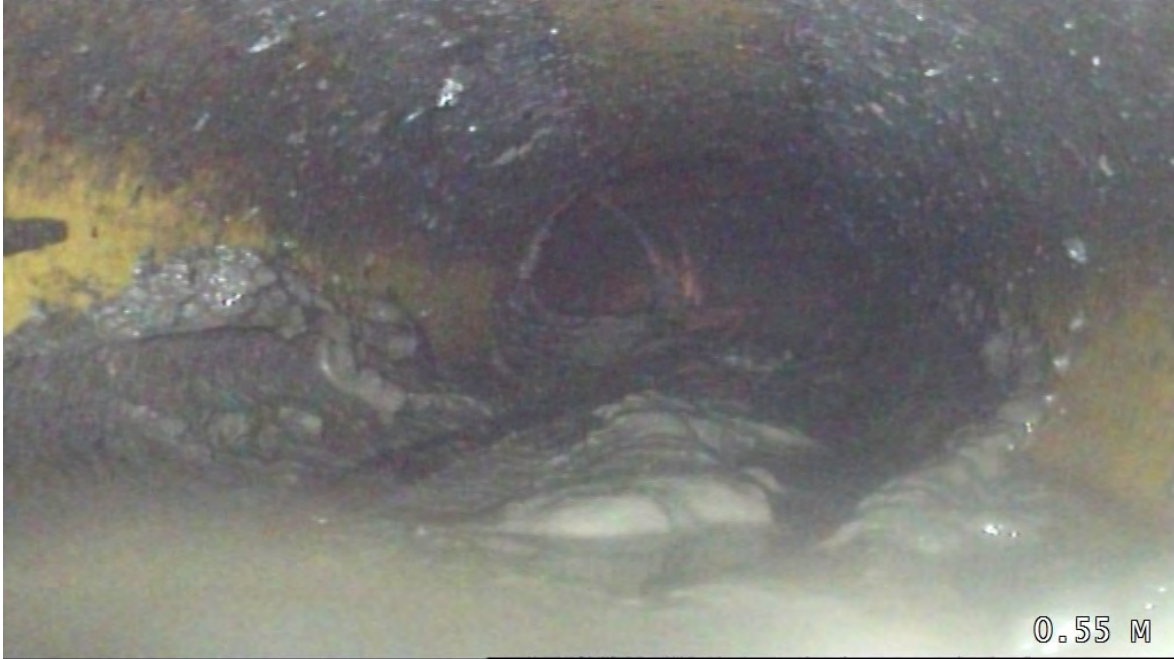
S5C3

00:00:11 - 0.55 m

Settled deposits fine 25% cross-sectional area loss

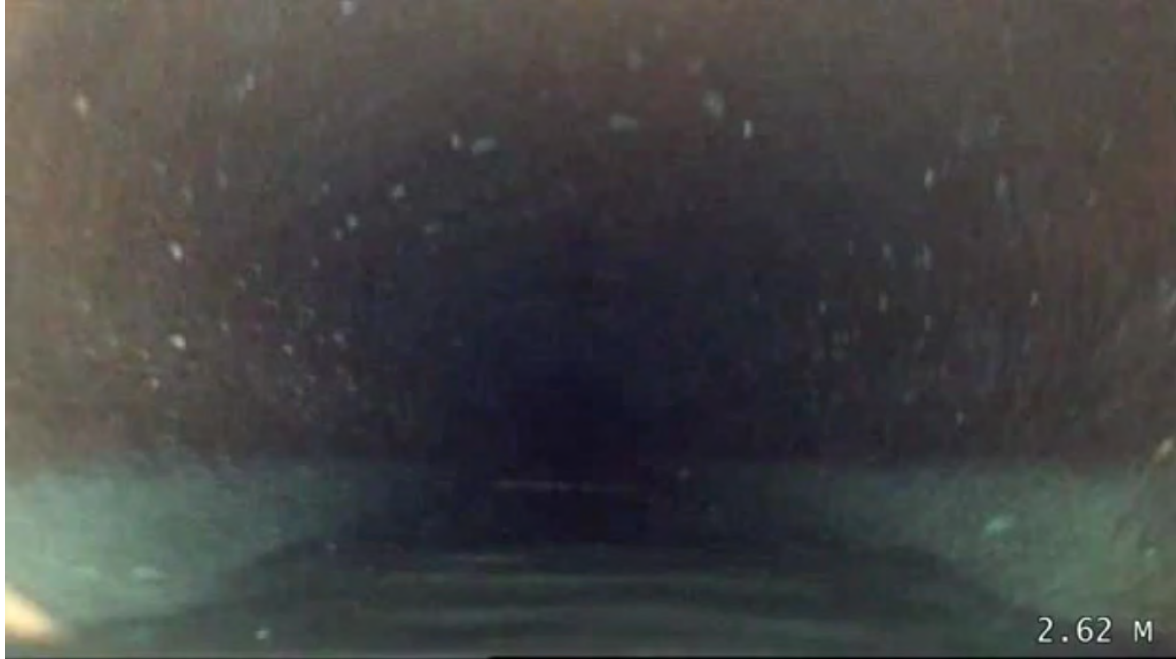
S6C3

00:00:12 - 2.62 m  
Water level 5% height/diameter

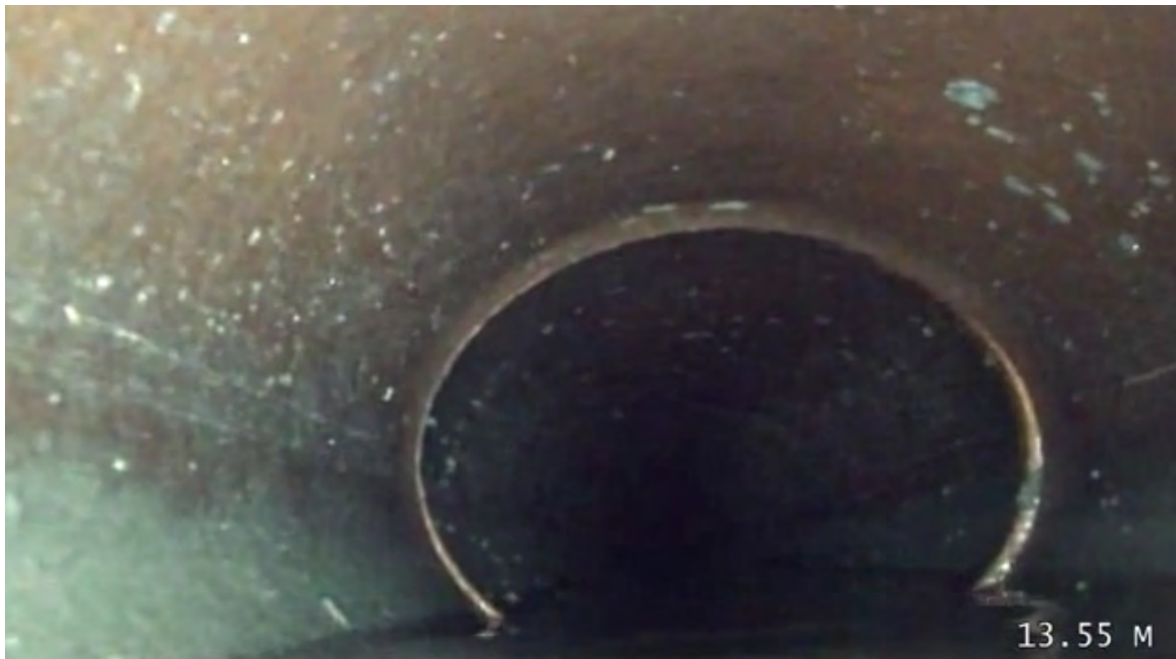
S6C4

00:01:13 - 13.55 m  
Water level 10% height/diameter

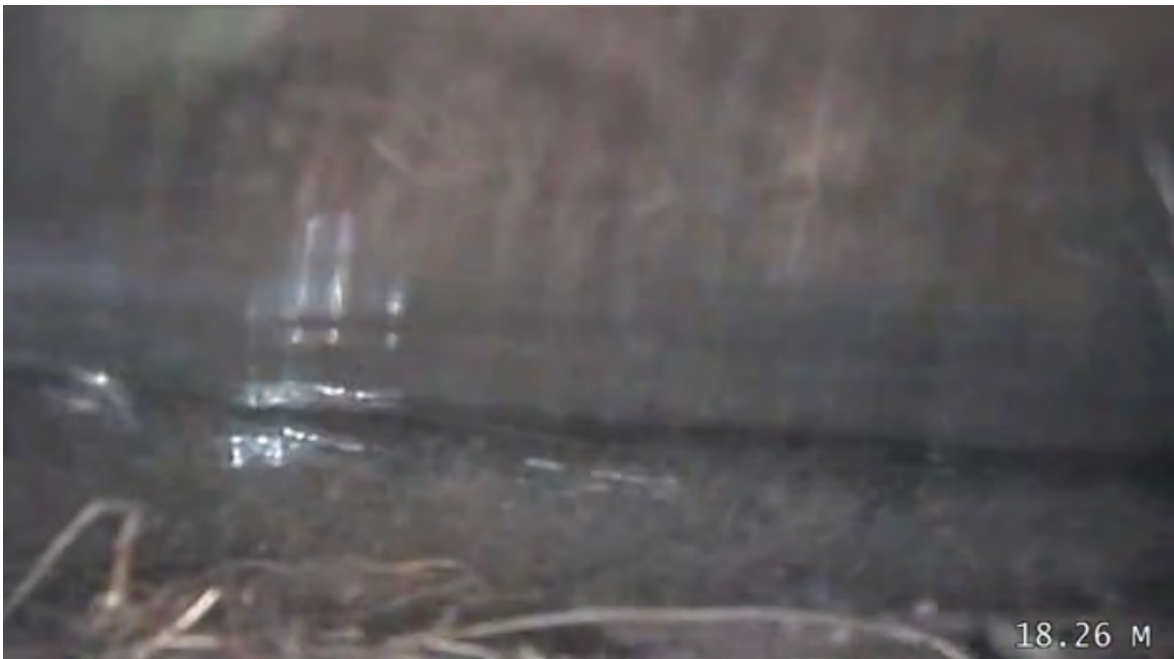
S6C6

00:01:44 - 18.26 m  
Roots fine

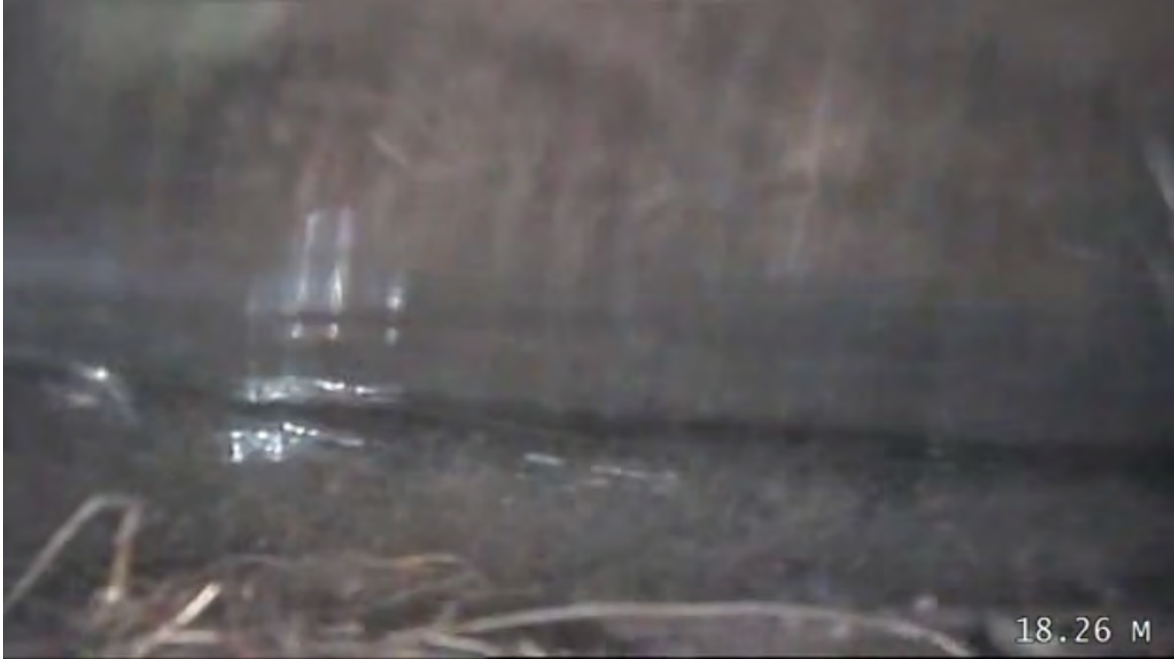
S6C7

00:01:44 - 18.26 m

Settled deposits fine 10% cross-sectional area loss

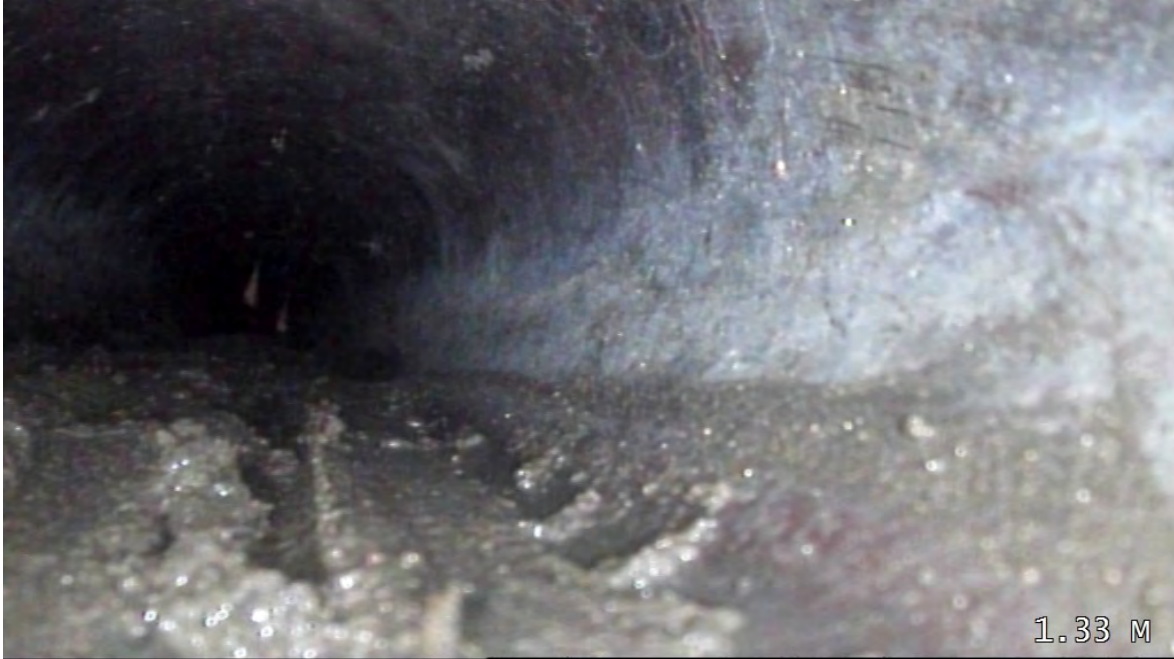
S7C3

00:00:07 - 1.33 m

Settled deposits coarse 10% cross-sectional area loss

HPWJ recommended to remove all deposits.

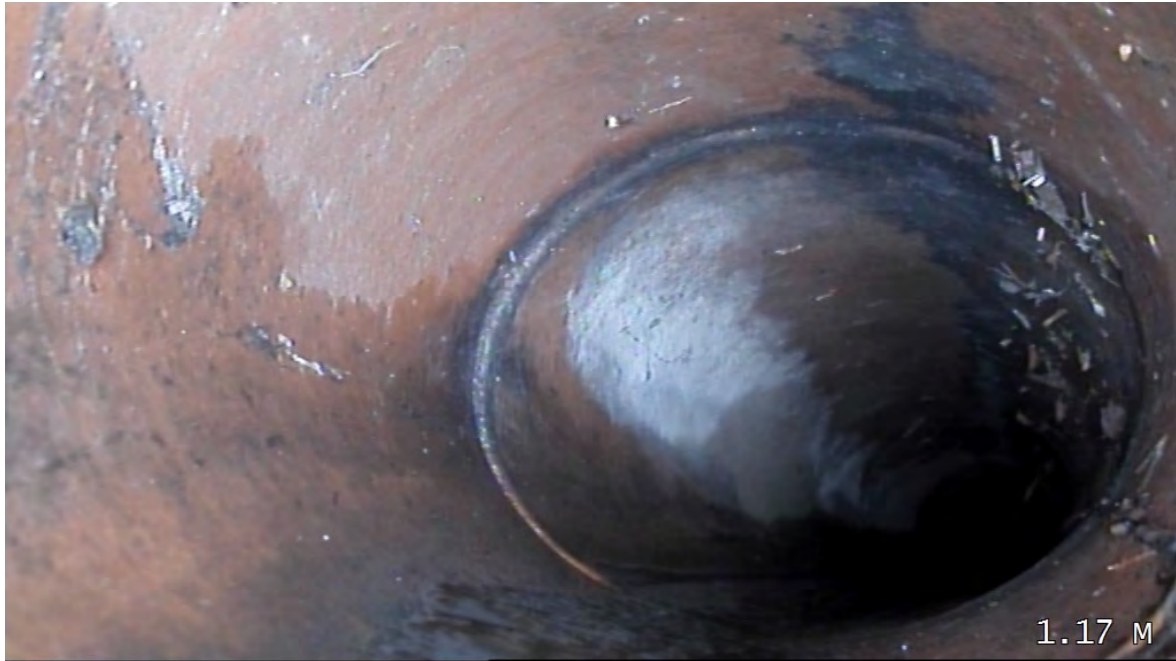
S8C3

00:00:09 - 1.17 m  
Line of drain/sewer deviates right

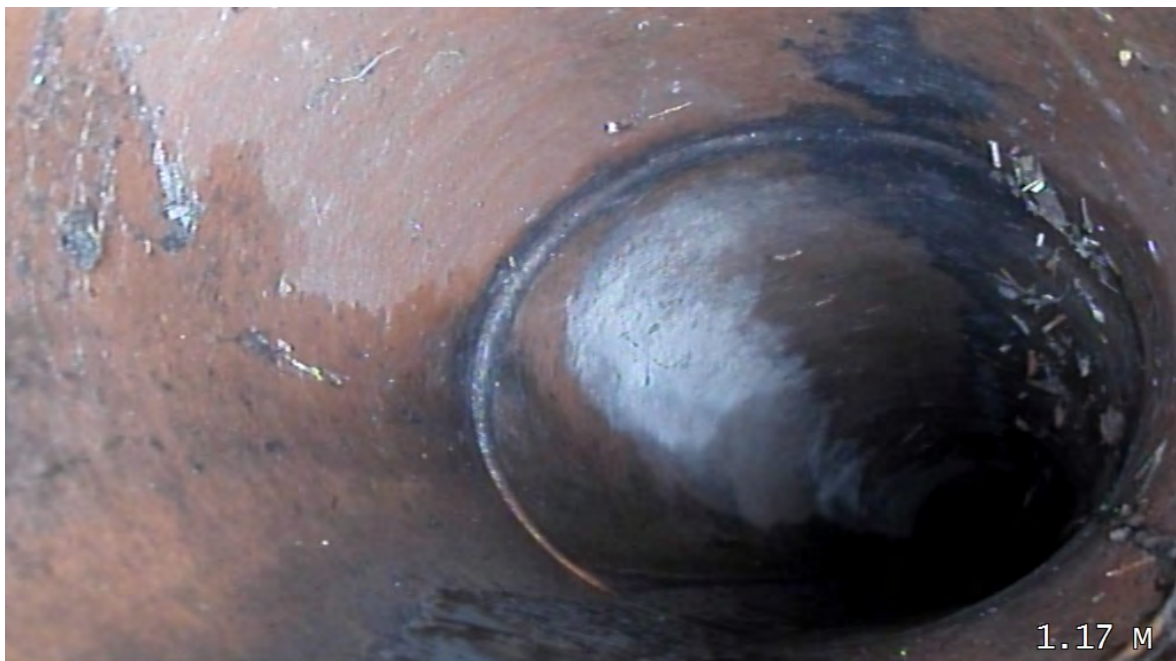
S8C4

00:00:09 - 1.17 m  
Line of drain/sewer deviates down

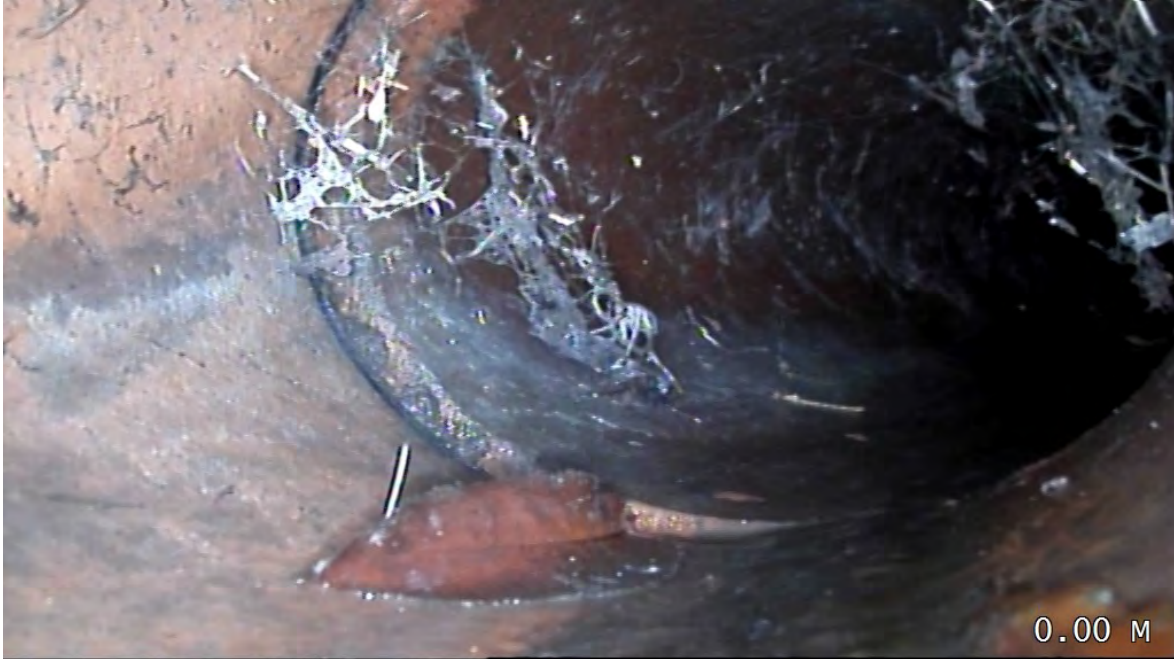
S9C3

00:00:02 - 0.00 m  
Line of drain/sewer deviates right

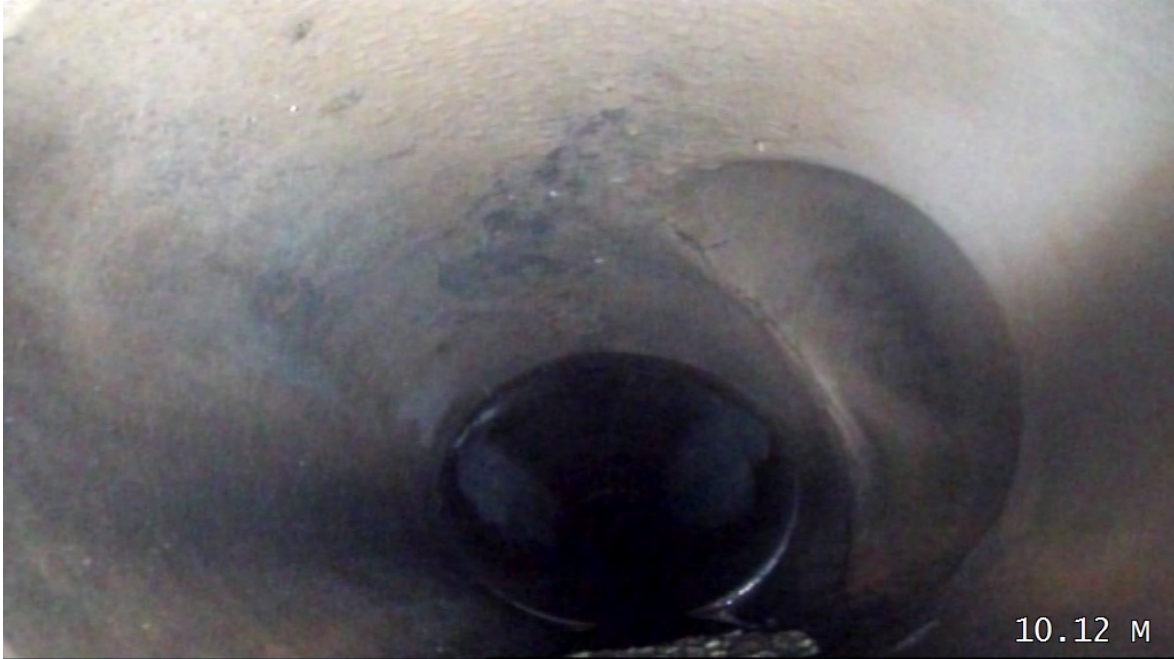
**S11C3**

00:00:56 - 10.12 m  
Junction at 3 o'clock, diameter 150mm

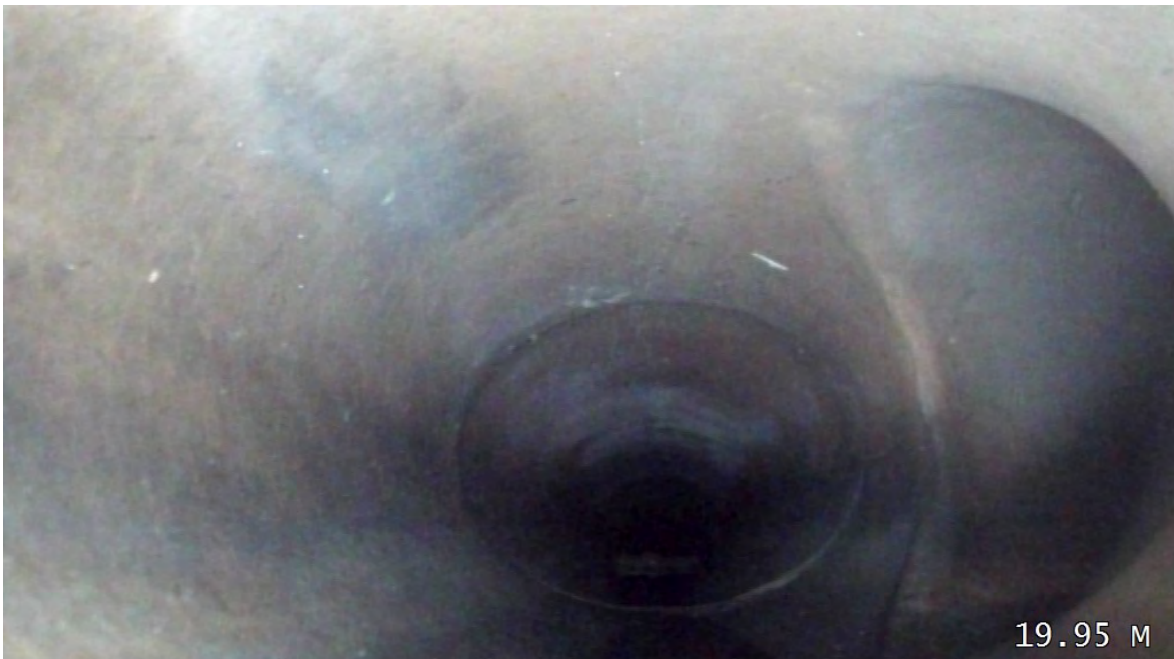
**S11C4**

00:01:39 - 19.95 m  
Junction at 3 o'clock, diameter 150mm

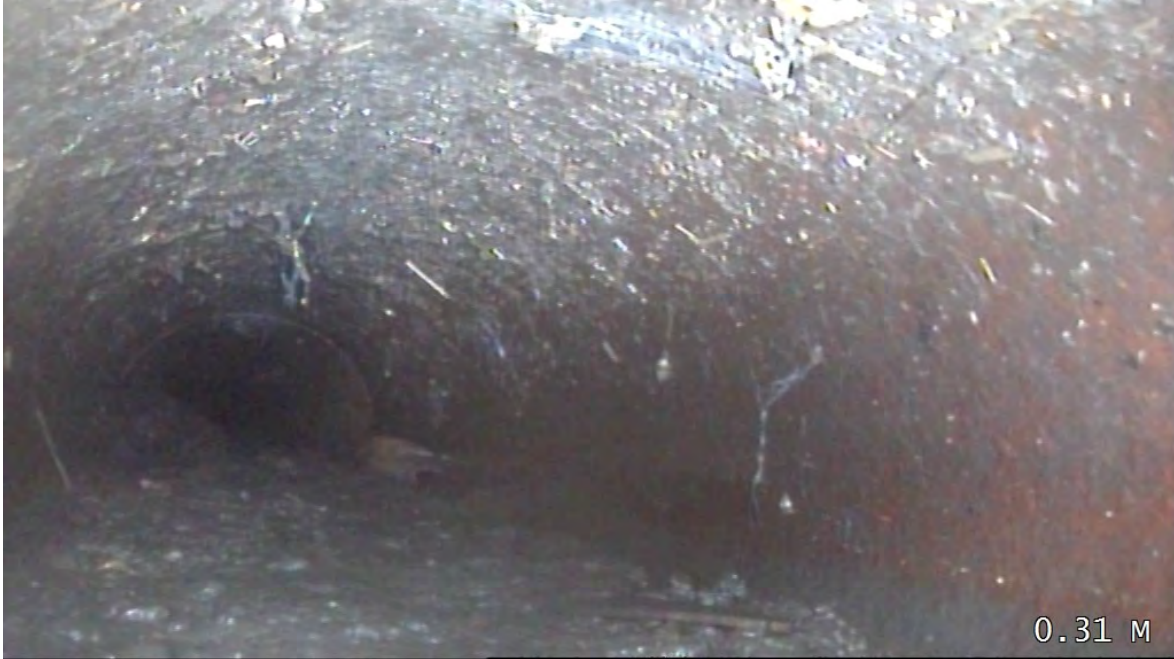
**S13C3**

00:00:04 - 0.31 m

Settled deposits fine 25% cross-sectional area loss

HPWJ required to remove debris, and re-survey for condition of pipe.

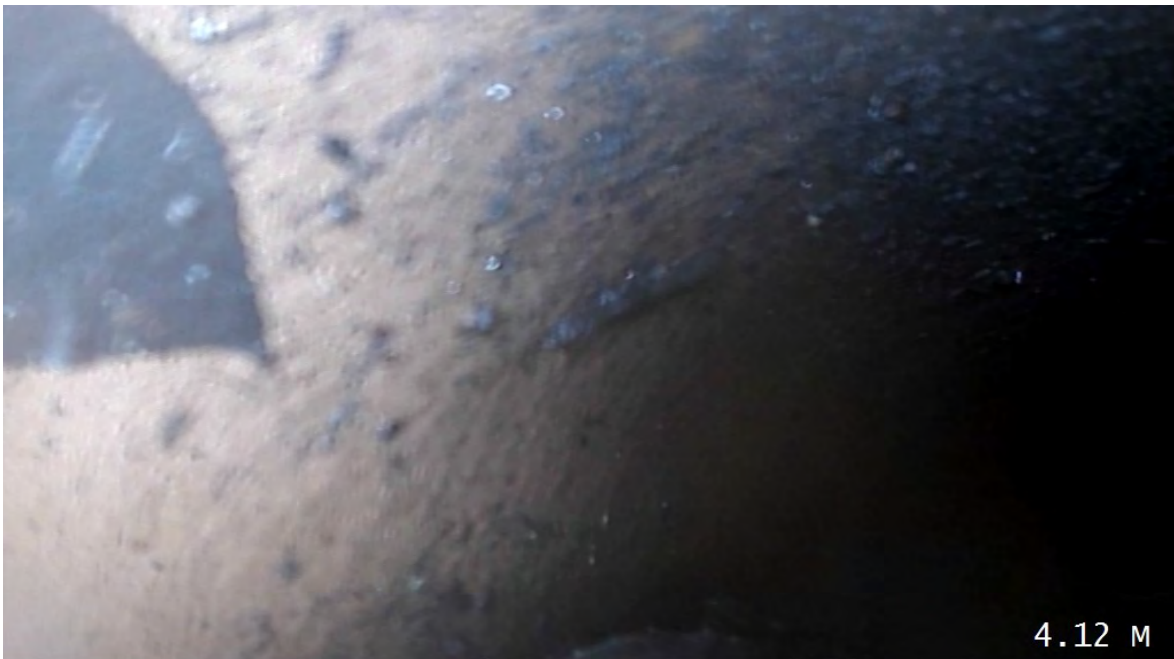
**S13C4**

00:00:30 - 4.12 m

Settled deposits fine 50% cross-sectional area loss

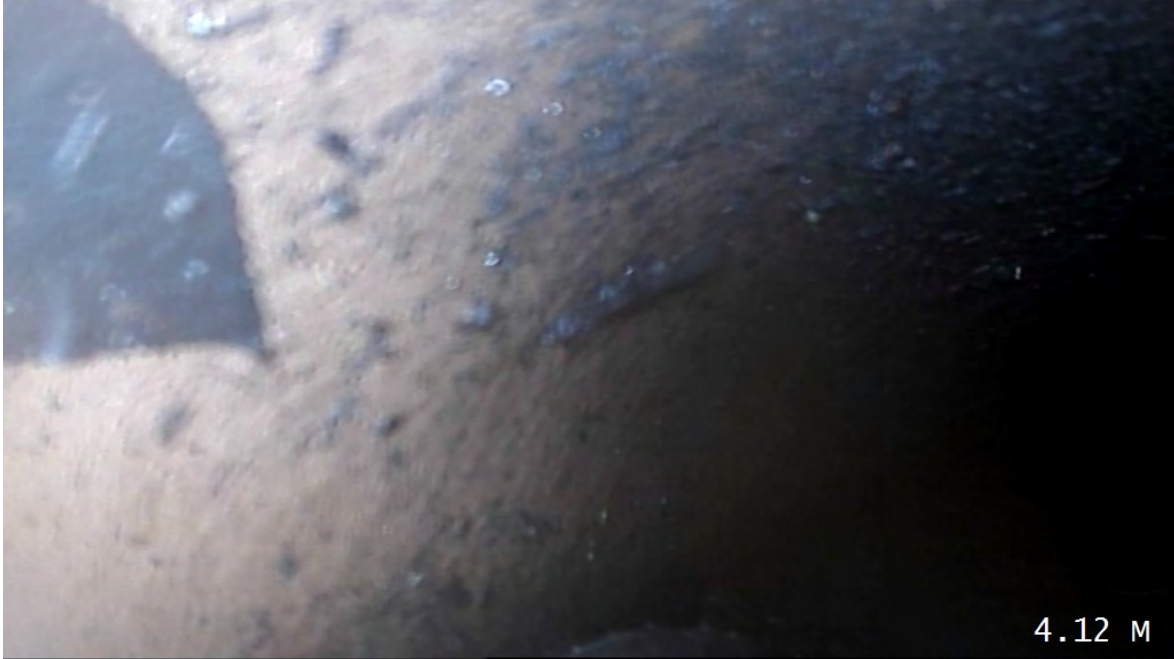
S13C5

00:00:31 - 4.12 m

Survey abandoned - Remark: Unable to continue survey.

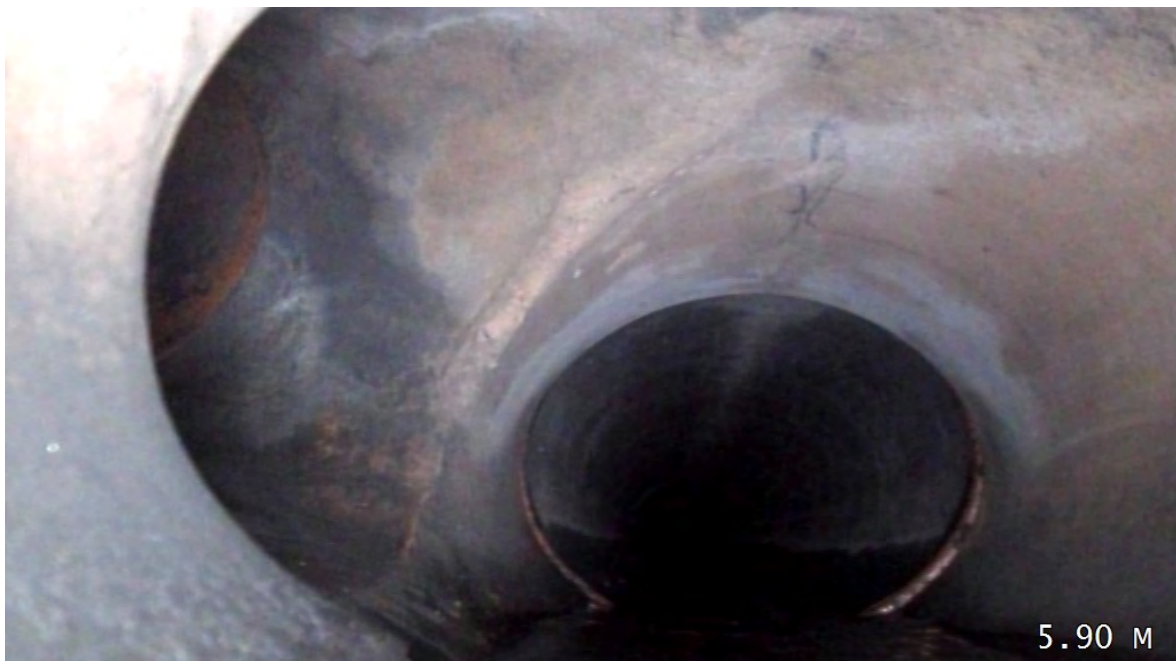
**S14C4**

Junction at 10 o'clock, diameter 150mm

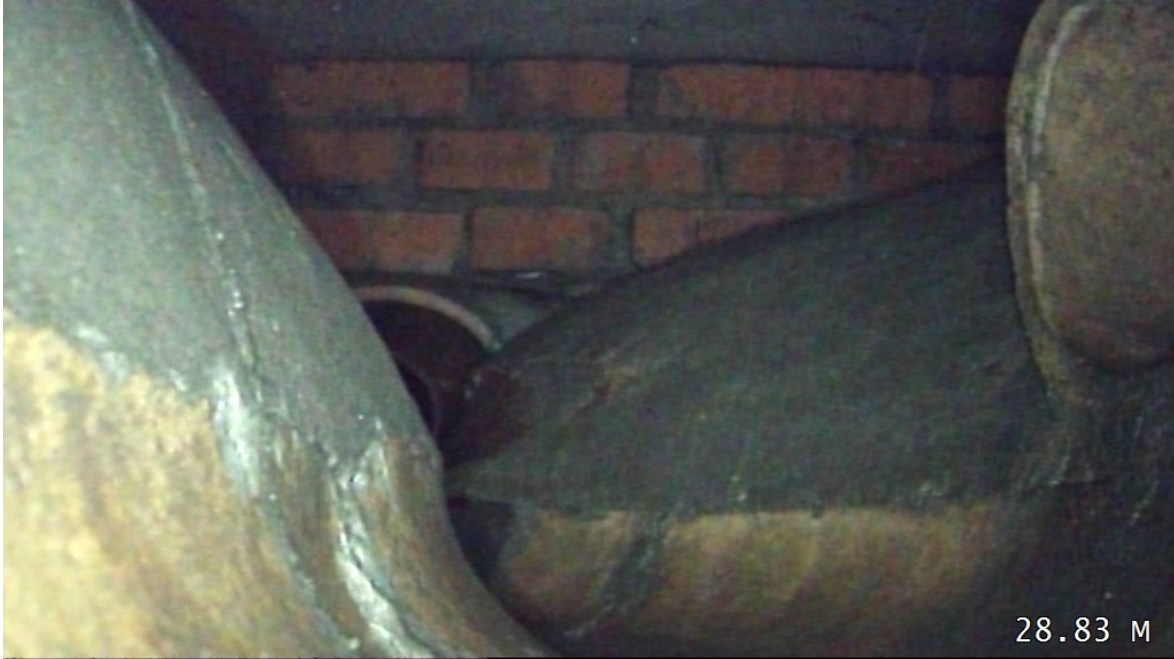
S14C5

Finish node type, manhole, reference SW2/Outflow

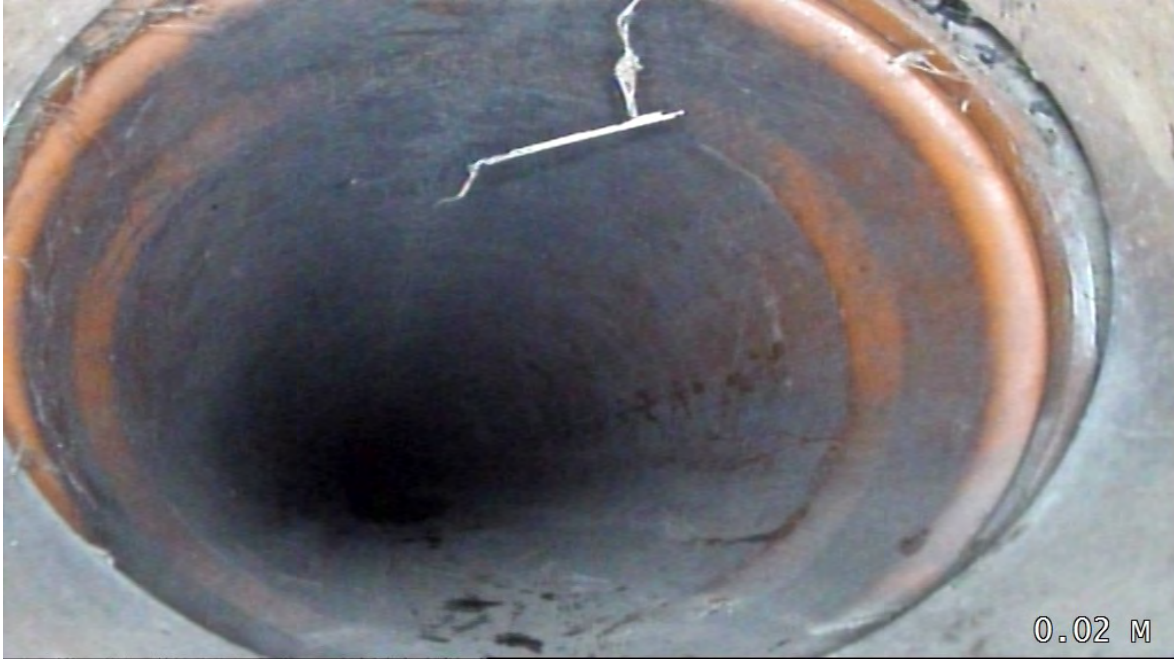
S15C1

Start node type, manhole, reference SW1/Outflow

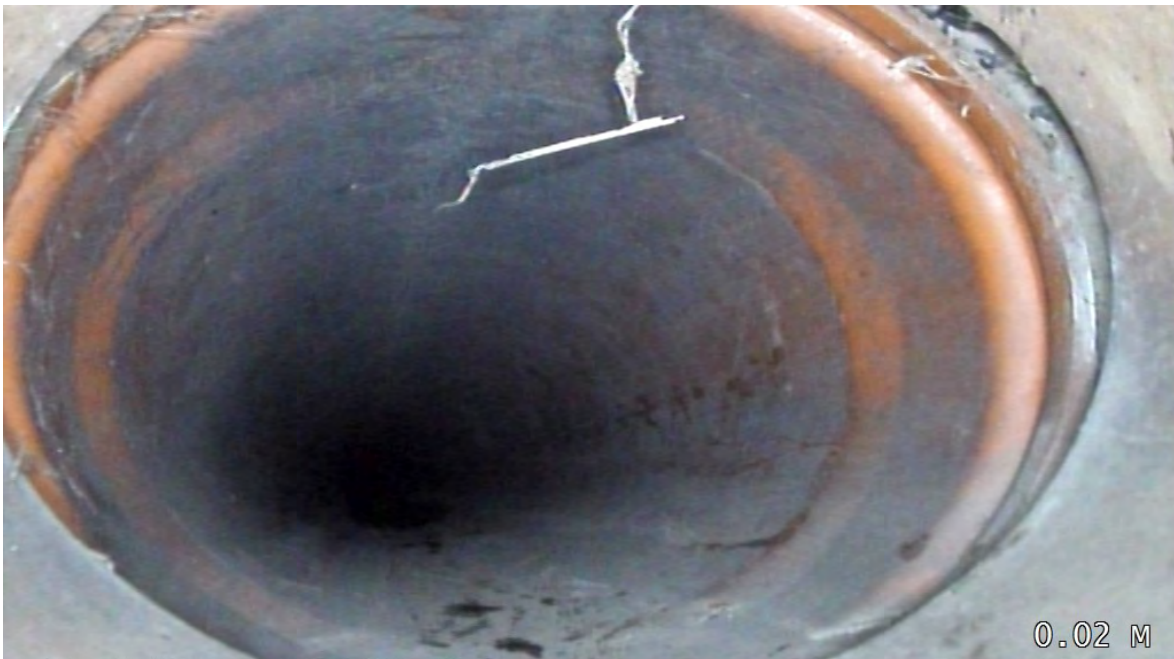
S15C2

Water level 0% height/diameter

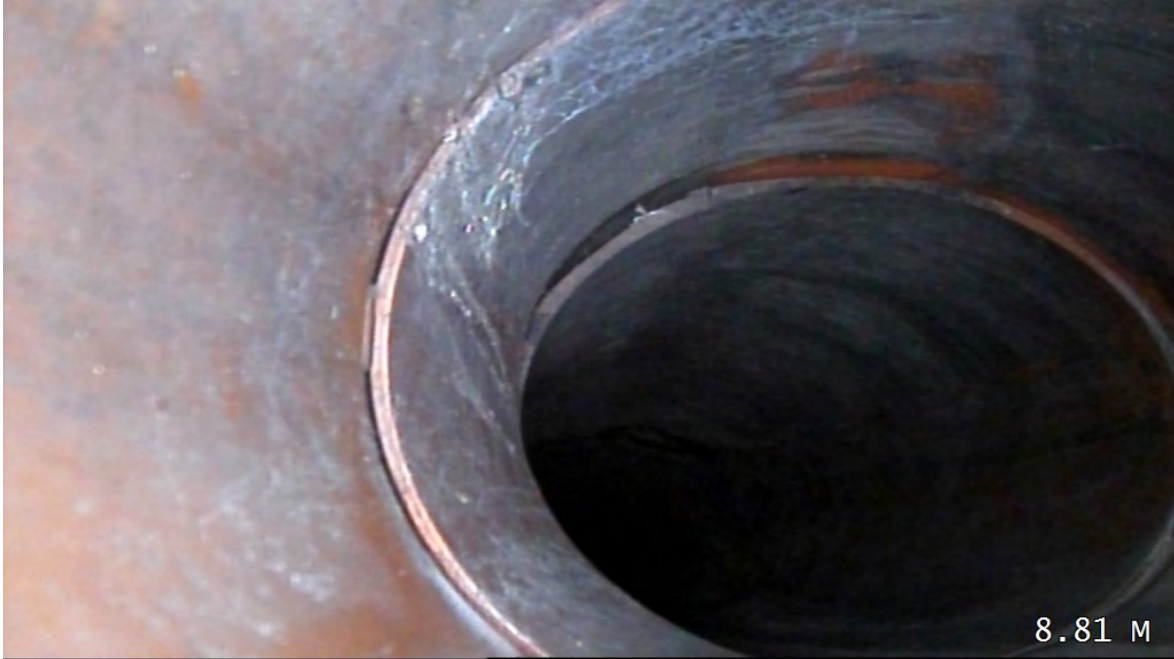
S15C3

00:00:55 - 8.81 m  
Line of drain/sewer deviates left

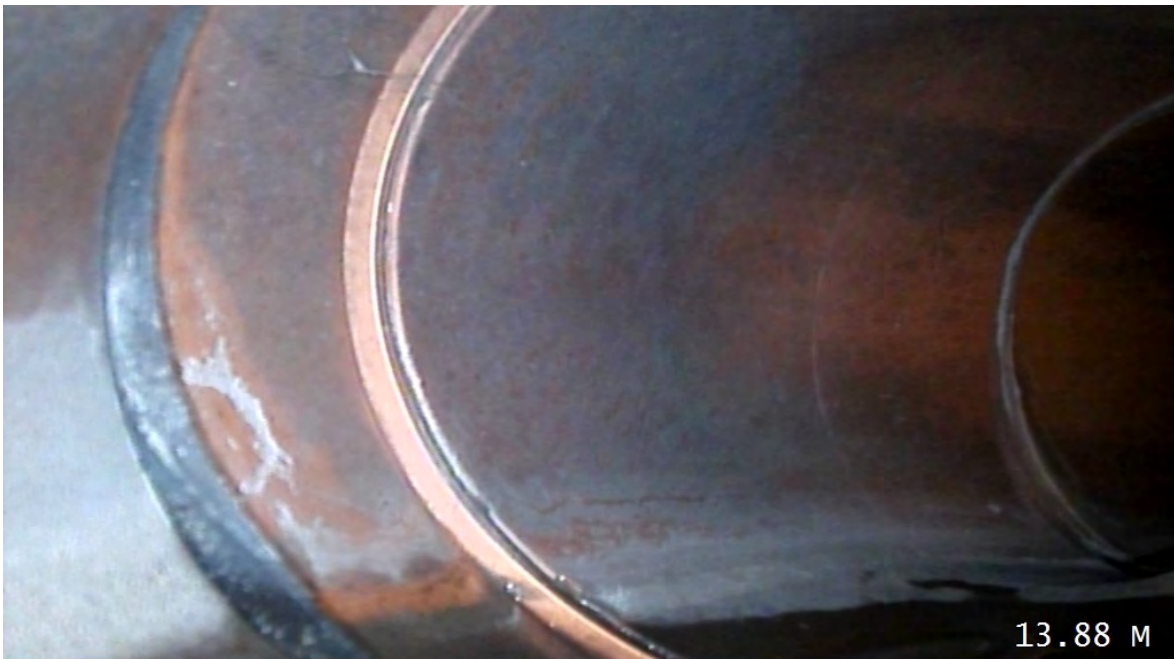
S15C4

00:01:27 - 13.88 m  
Line of drain/sewer deviates right

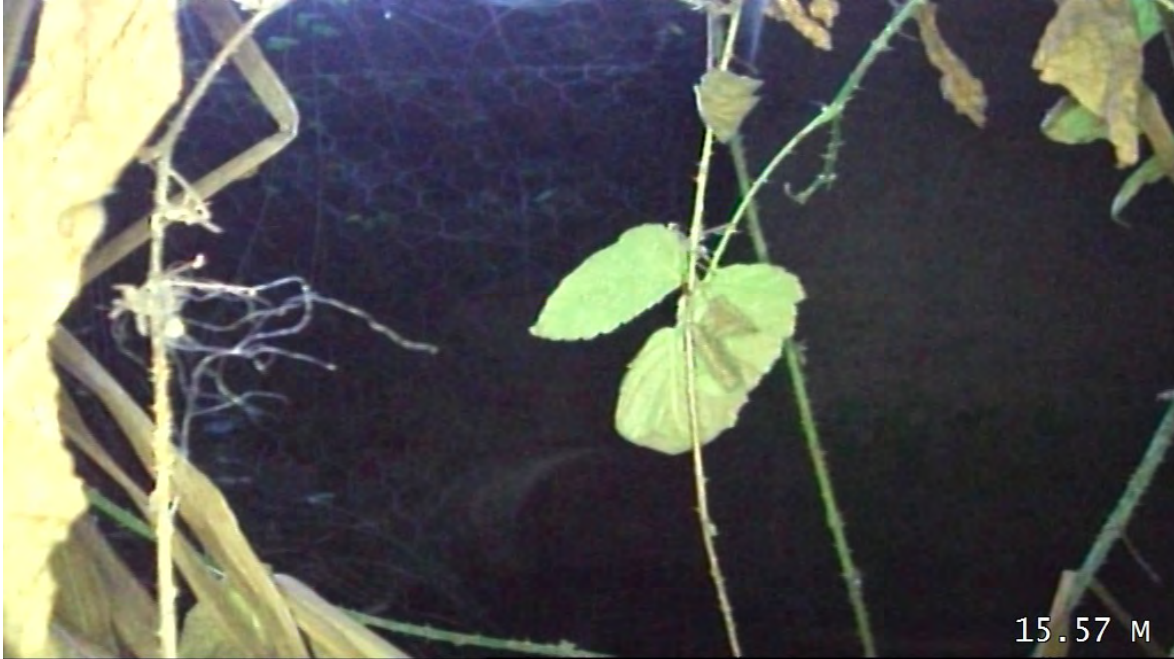
S15C5

Finish node type, outfall, reference Outfall 1
