## Link Engineering

Project No. **251205**

MSCC5 Drain and Sewer Codes (SRM5 Scoring)

After surveying the drainage at Redwing's Lodge, Hinxworth, we recommend a re-visit with HPWJ van pack or a Jet/Vac to clean the lines that were not accessible during the time of survey, remarks at the end of each pipe section will specify the necessary remedial action to take. The main hotel building has two surface runs either side that lead to a rodding eye, however one of these was not able to be located, we assume it is buried. The inspection chambers that would give access to these SW6 and SW5 were UTL. If these covers are raised then that would allow us to confirm the surface run and its features. The restaurant on site uses a grease trap to clean the waste from the kitchen, we recommend that the grease trap and all surrounding drainage is cleared out and thoroughly cleaned then re-surveyed for the pipe condition. Following this, we located a buried manhole to the South East of the restaurant, this should be uncovered, lifted and surveyed.

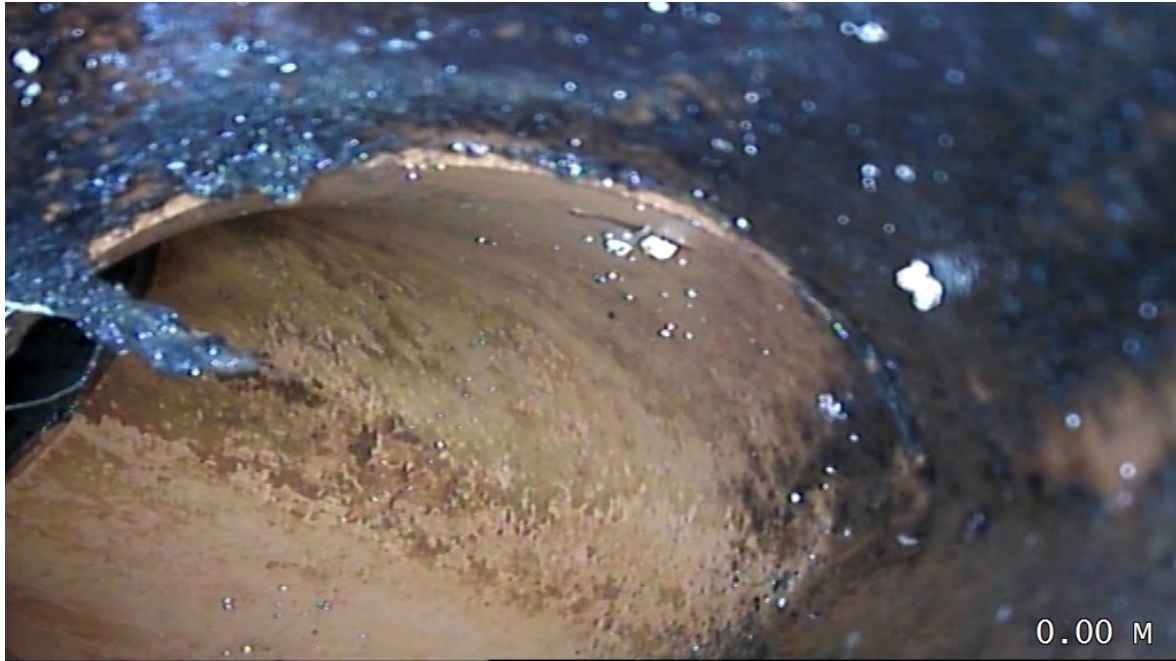
S16C1

Start node type, inspection chamber, reference FW8/Branch A

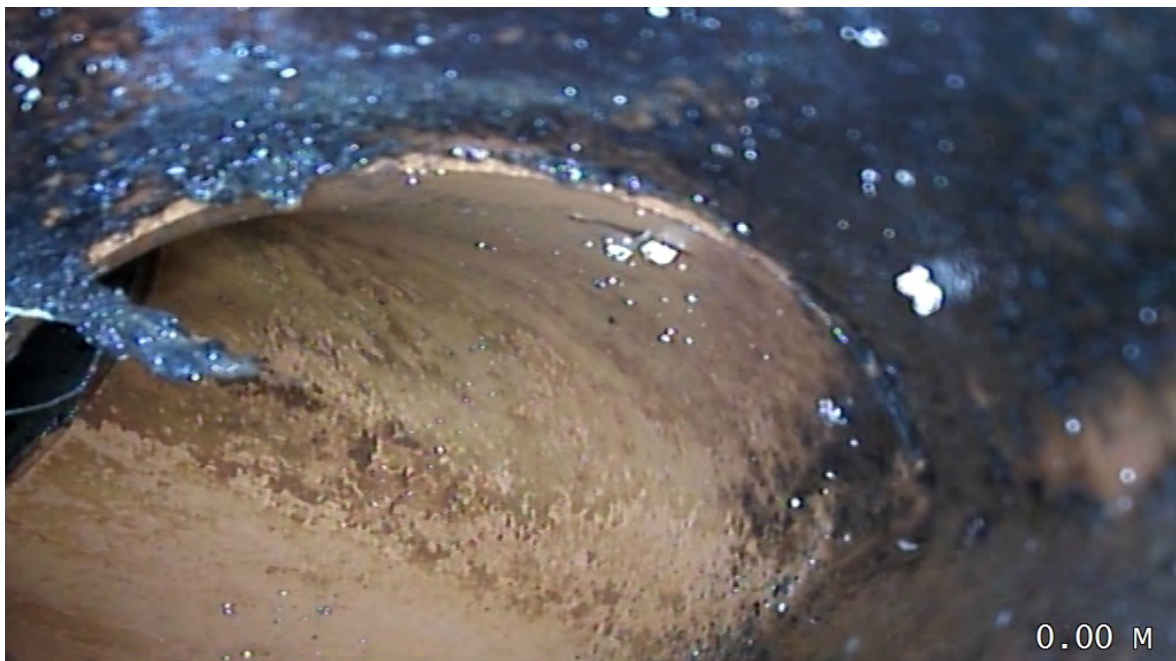
S16C2

Water level 0% height/diameter

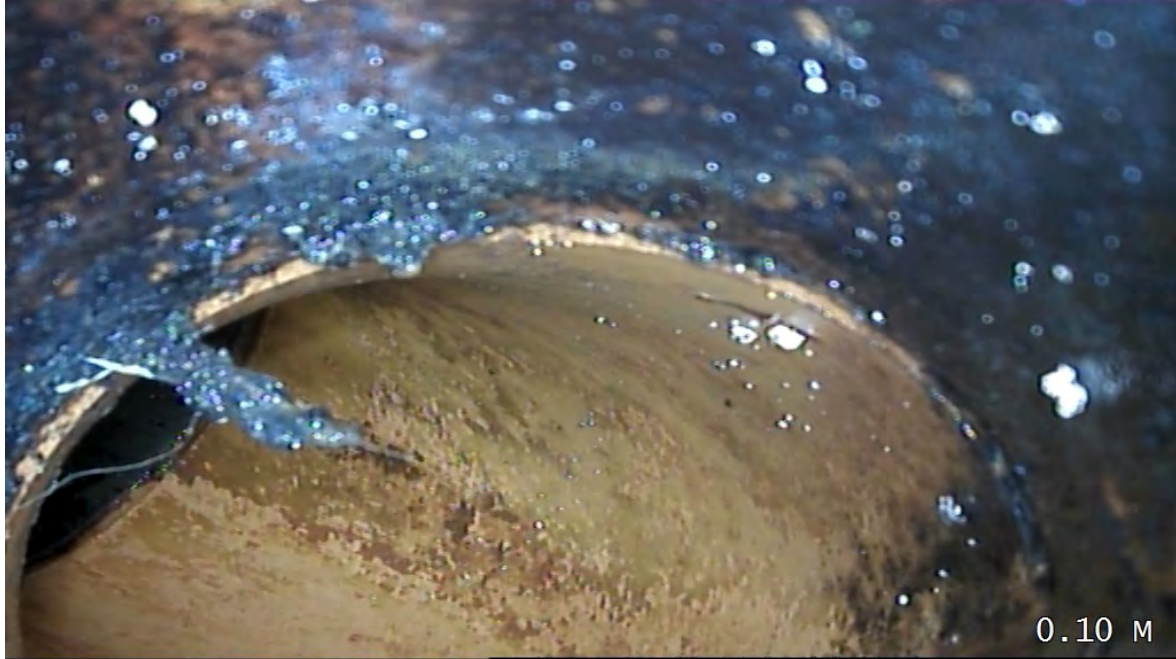
S16C3

00:00:02 - 0.10 m  
Line of drain/sewer deviates left

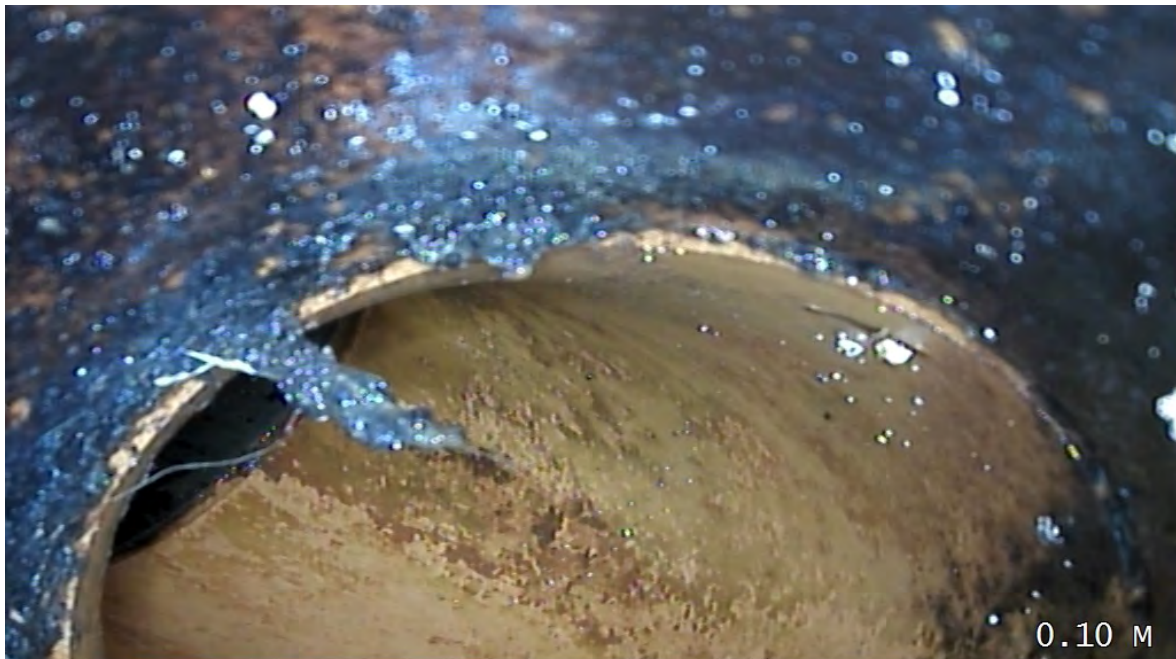
S16C4

00:00:03 - 0.10 m  
Line of drain/sewer deviates up

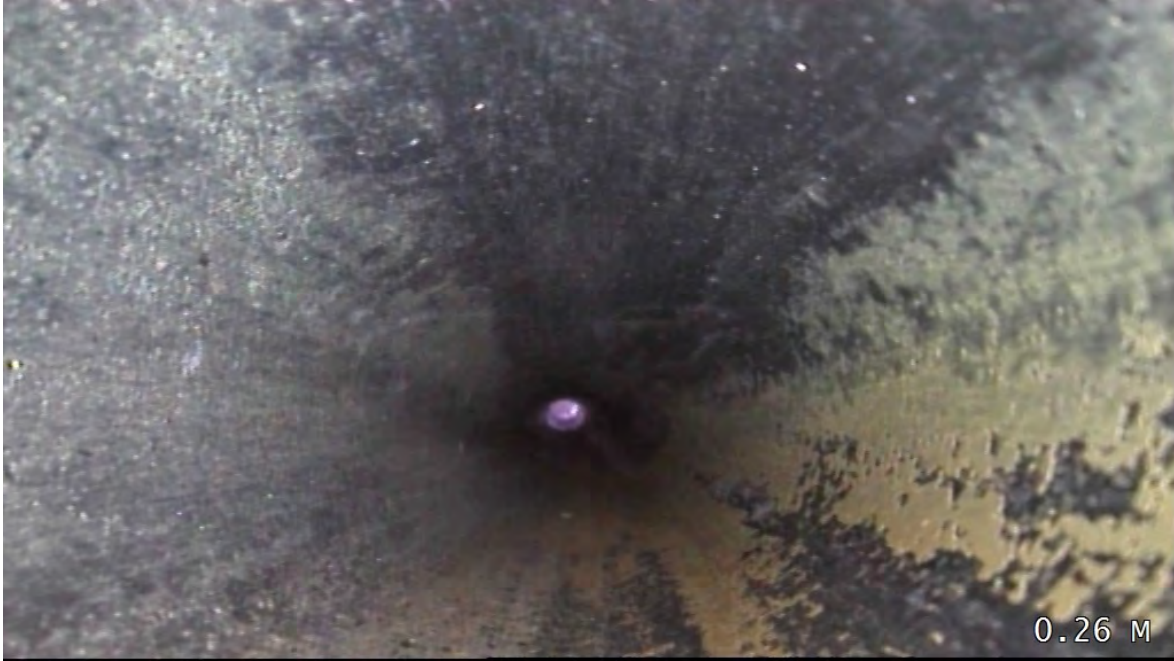
S16C5

Finish node type, major connection without manhole, reference Stack Pipe

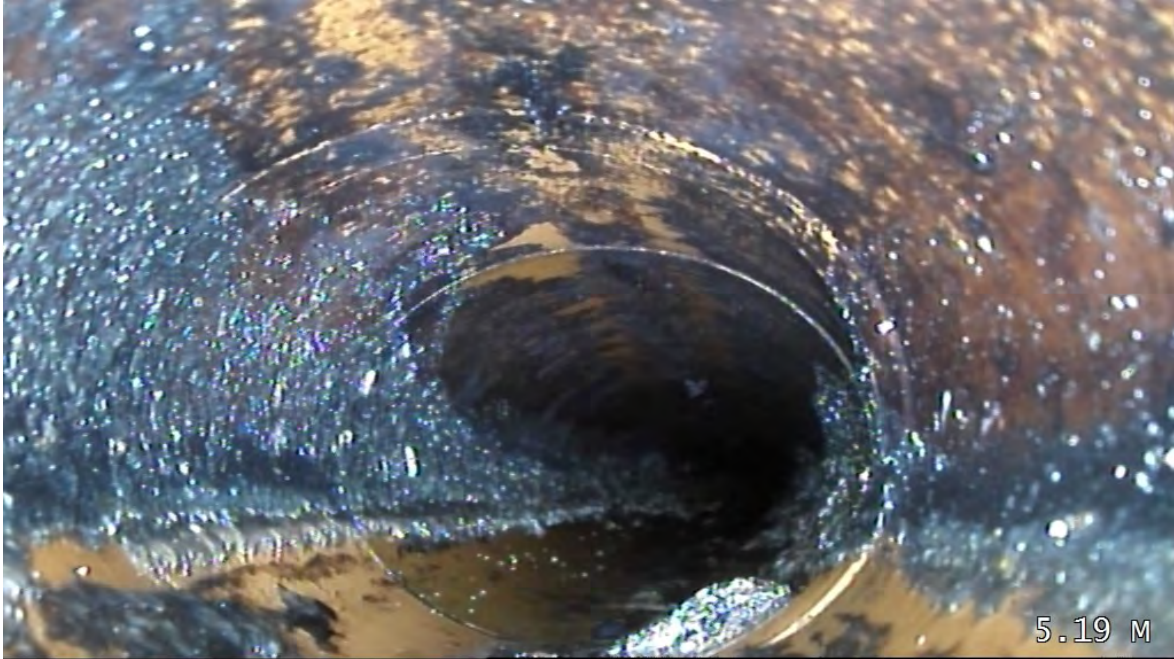
S17C3

00:00:25 - 5.19 m  
Line of drain/sewer deviates right

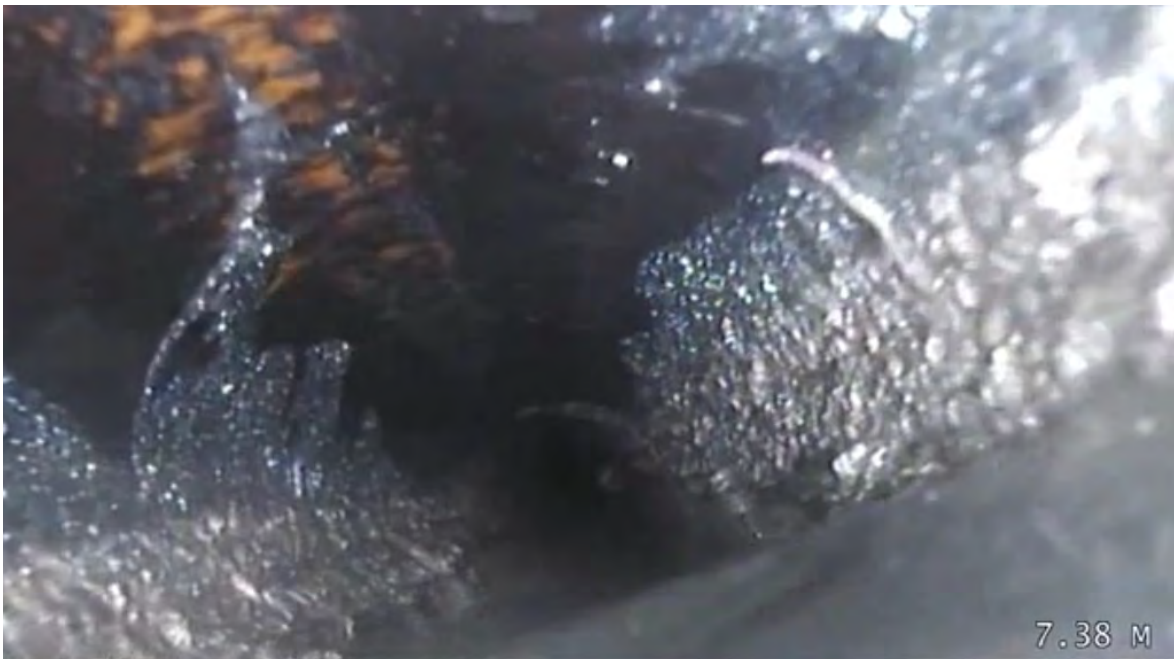
S17C4

00:00:40 - 7.38 m  
Water level 10% height/diameter

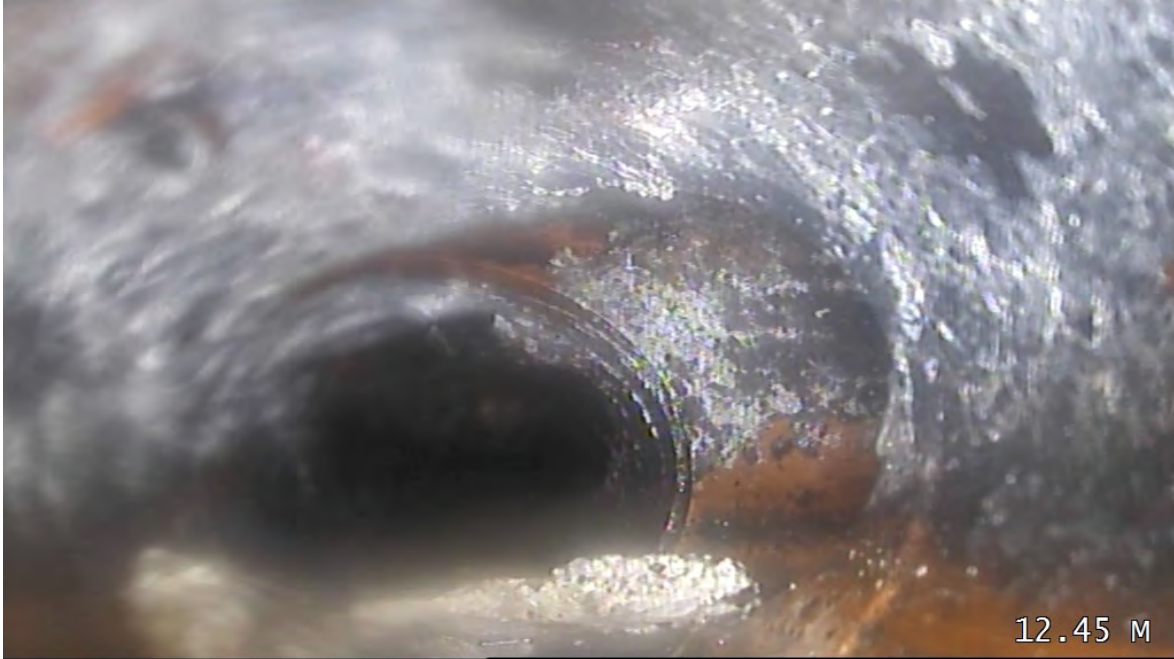
S17C7

00:01:19 - 12.45 m  
Junction at 3 o'clock, diameter 100mm

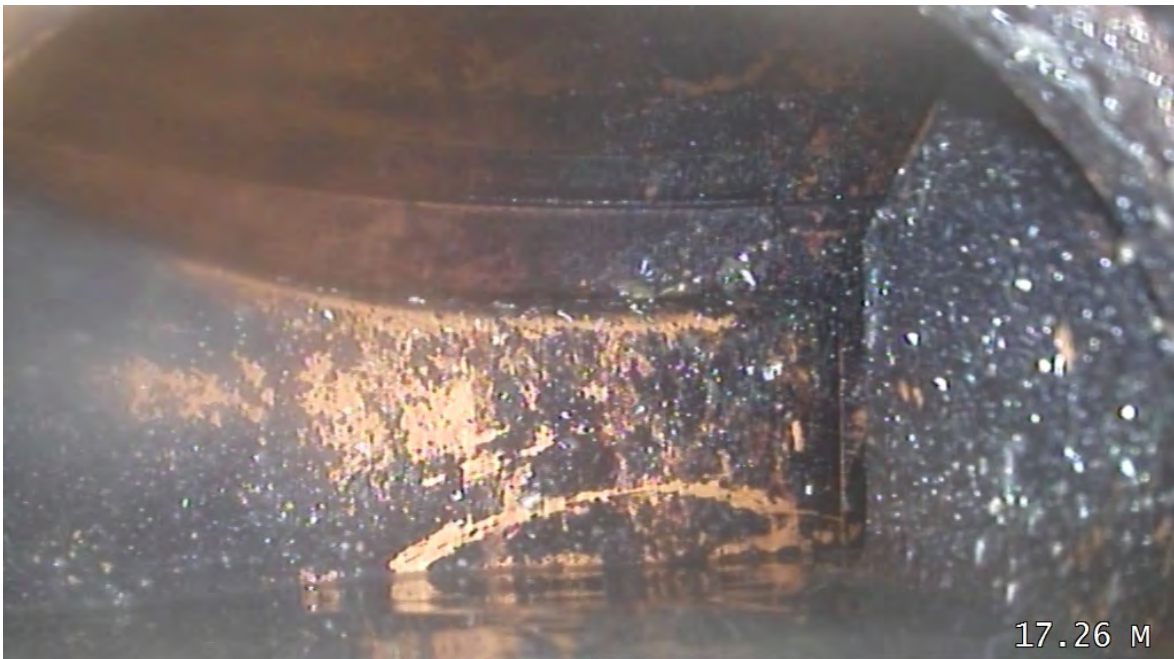
S17C8

00:01:41 - 17.26 m  
Finish node type, inspection chamber, reference FW7/Branch A

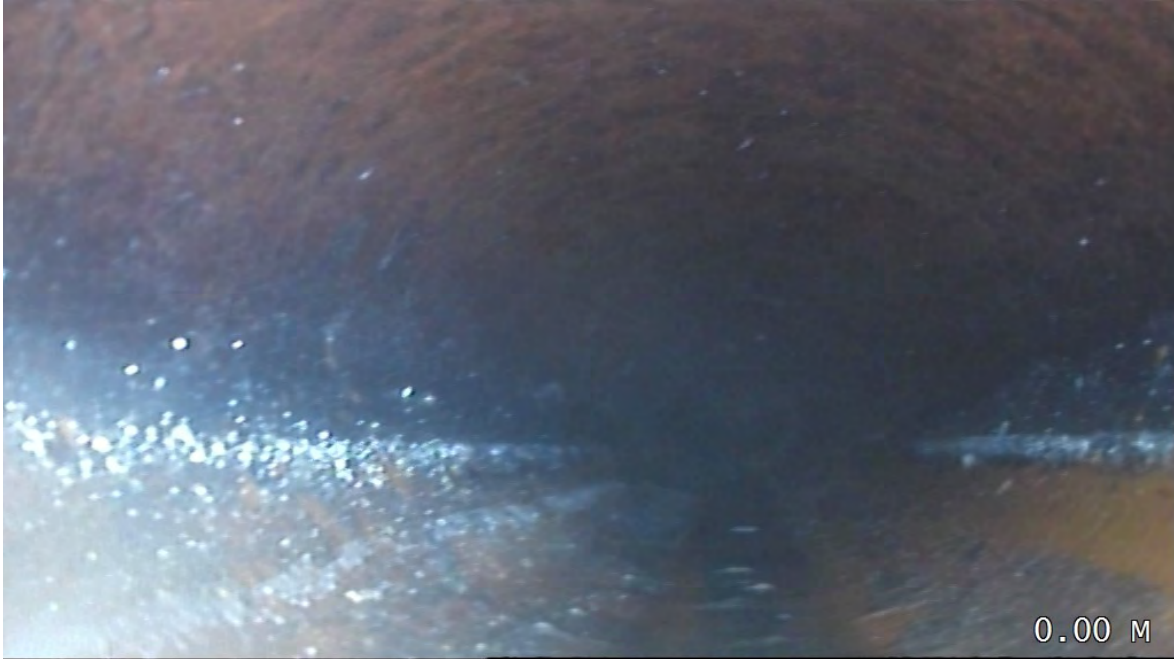
**S18C1**

Start node type, inspection chamber, reference FW6/Branch B

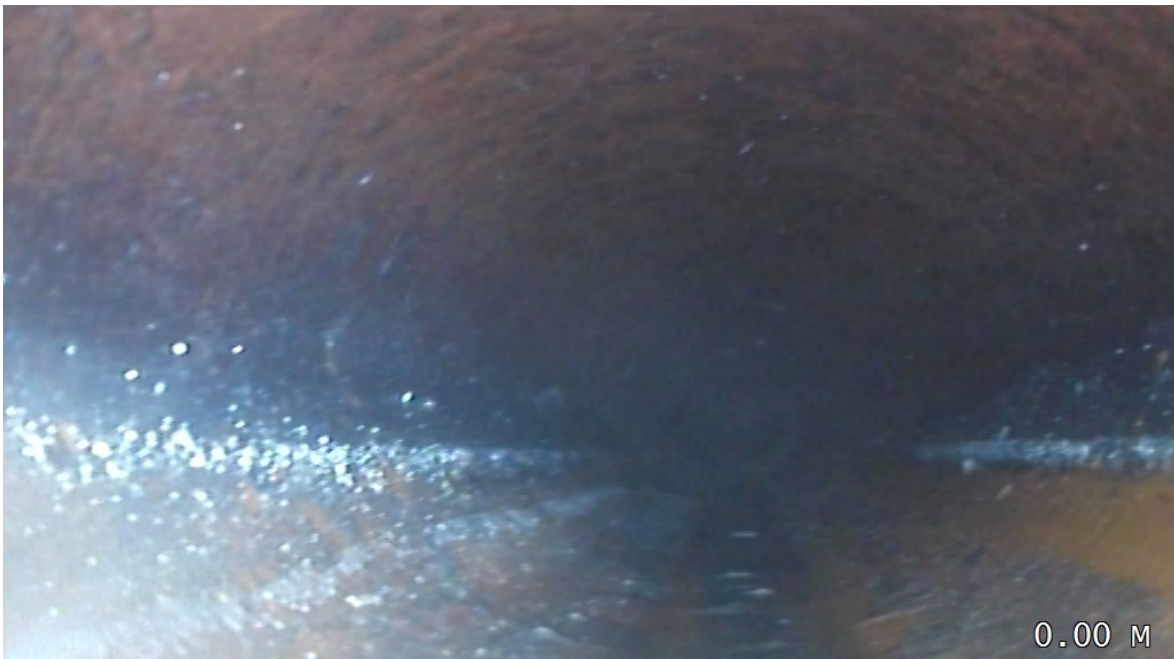
**S18C2**

Water level 0% height/diameter

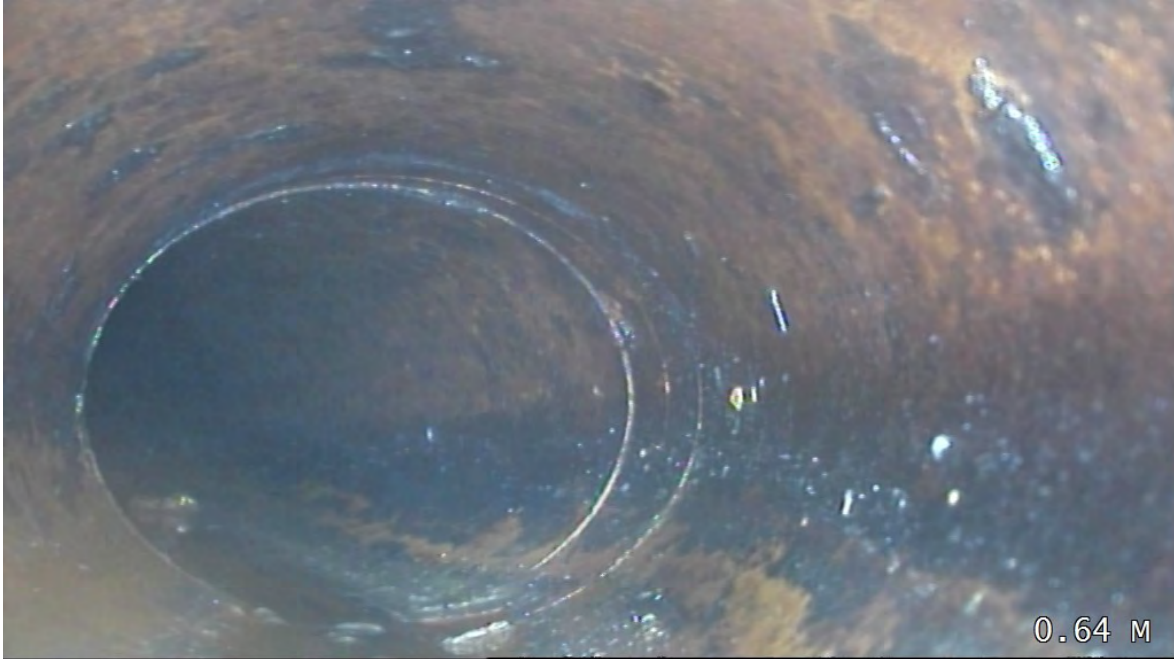
**S18C3**

00:00:06 - 0.67 m  
Line of drain/sewer deviates left

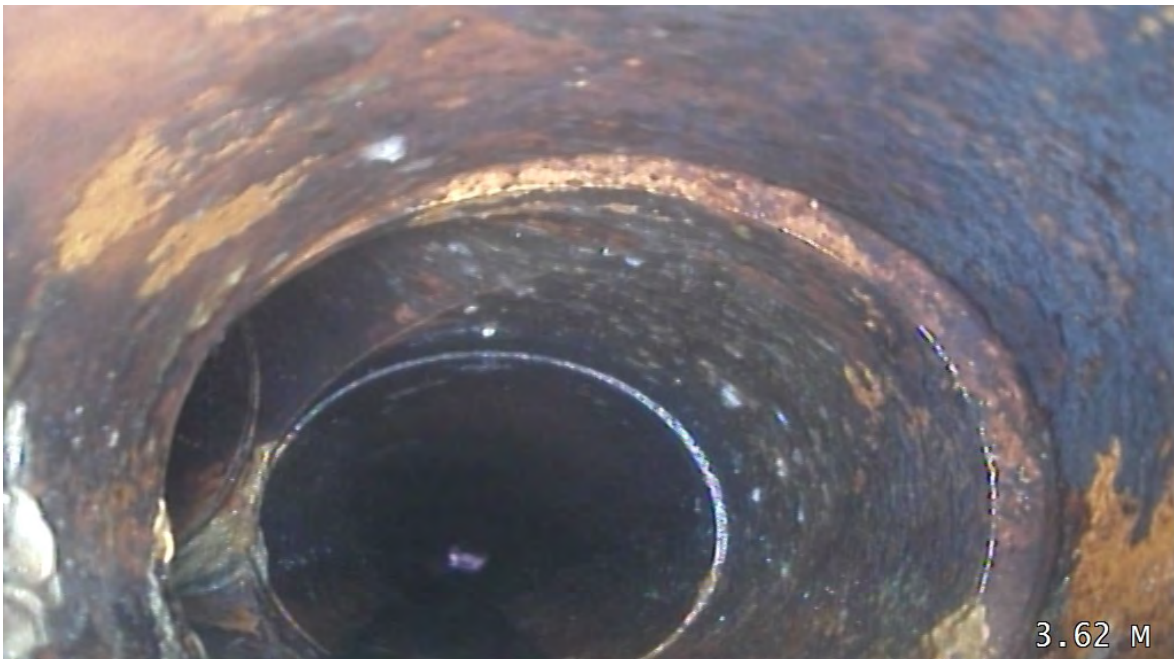
**S18C4**

00:00:20 - 3.62 m  
Junction at 9 o'clock, diameter 100mm

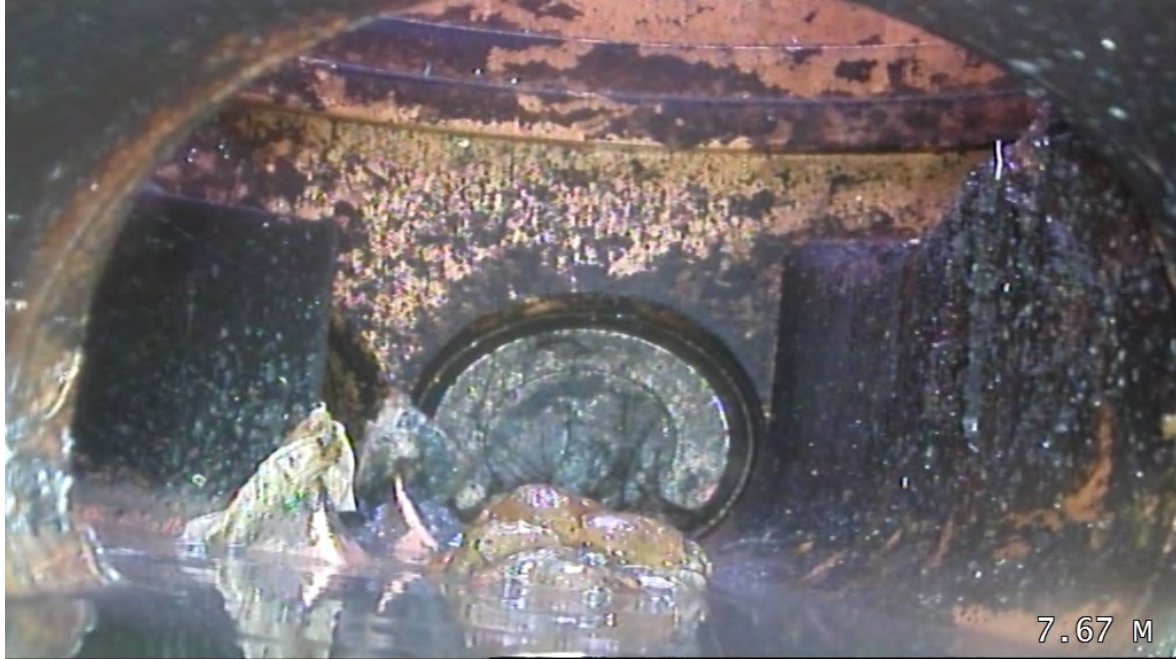
S18C5

Finish node type, inspection chamber, reference FW7/Outflow

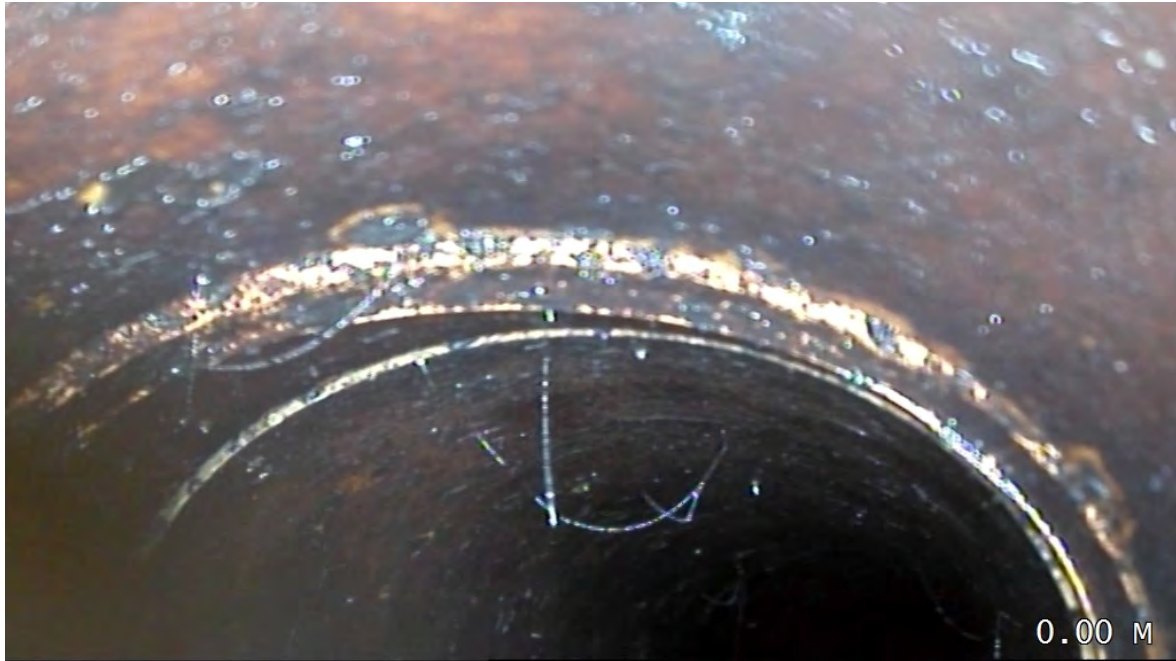
S19C1

Start node type, inspection chamber, reference FW6/Branch A

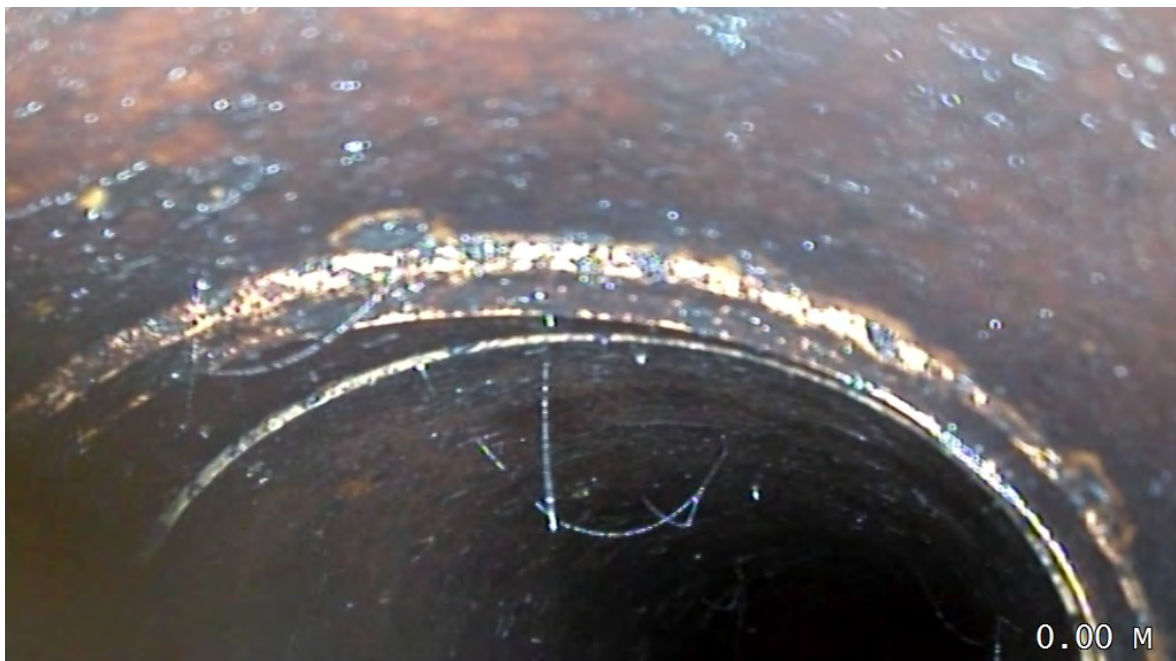
S19C2

Water level 0% height/diameter

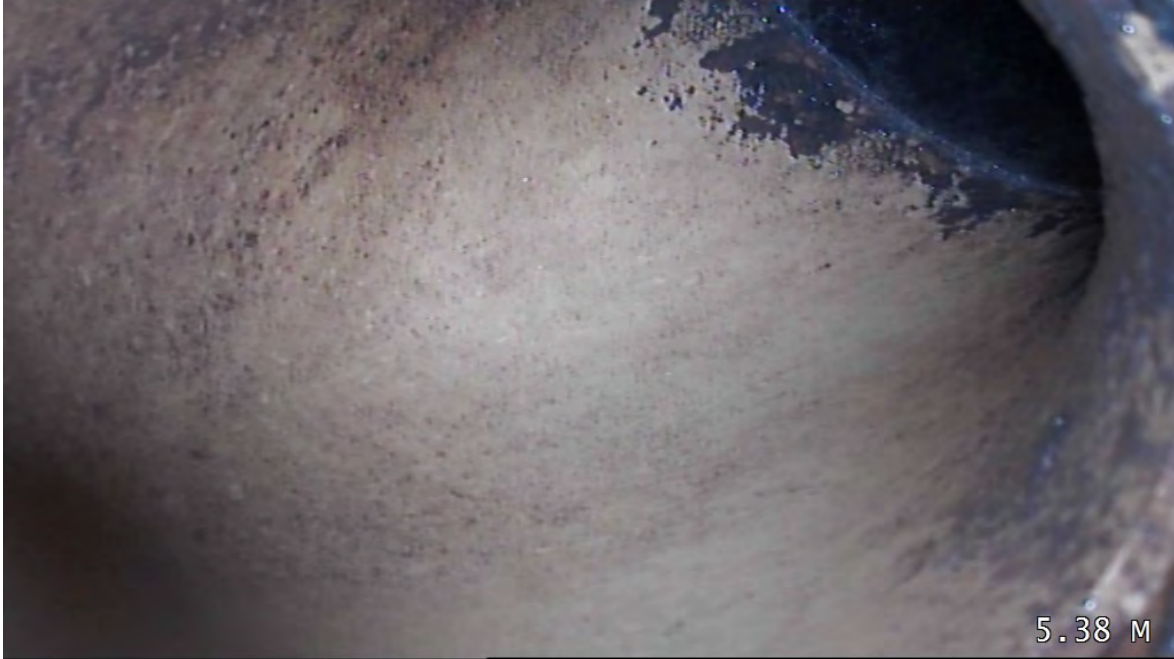
**S19C3**

00:00:29 - 5.38 m  
Line of drain/sewer deviates right

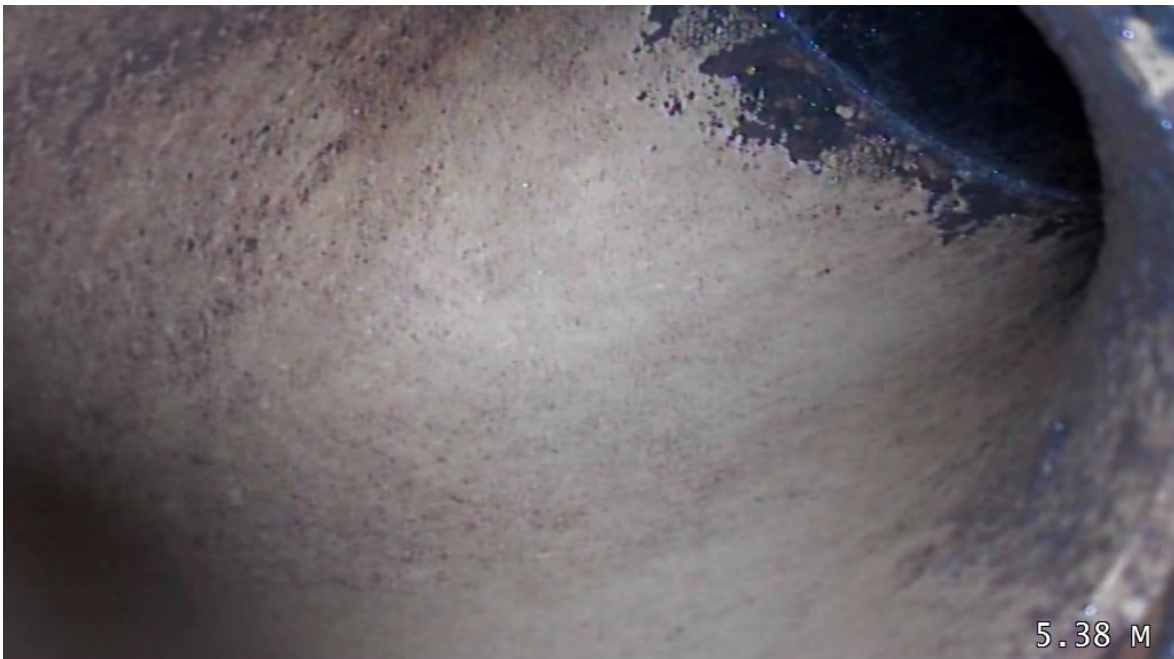
**S19C4**

00:00:30 - 5.38 m  
Line of drain/sewer deviates up

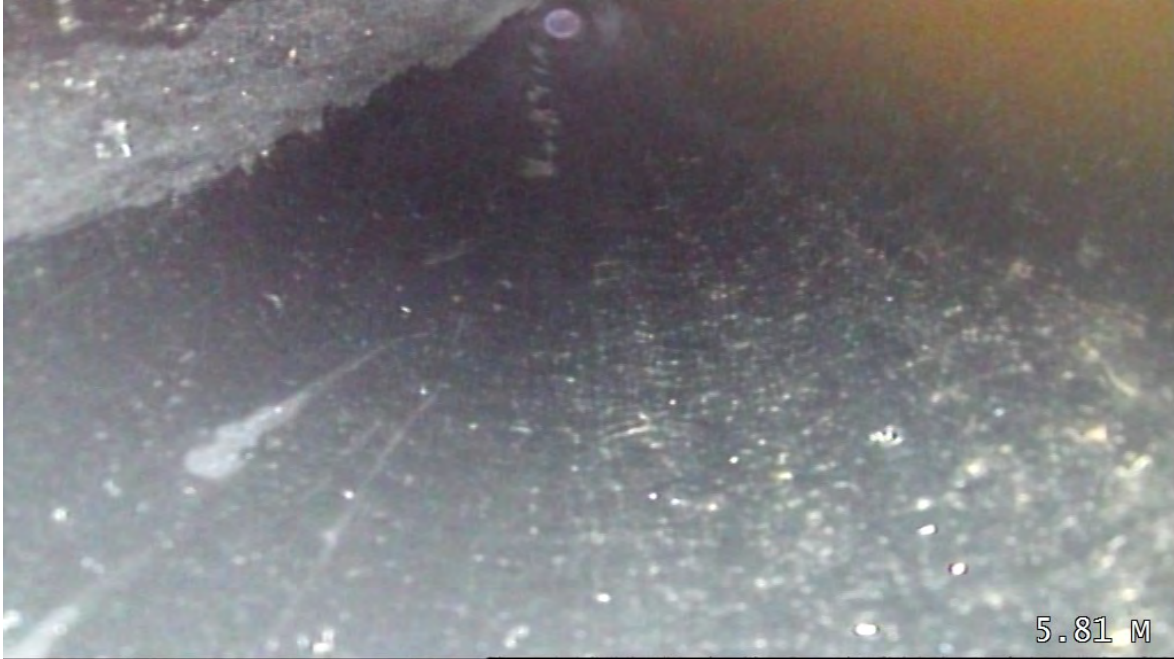
S19C5

Finish node type, major connection without manhole, reference Stack Pipe

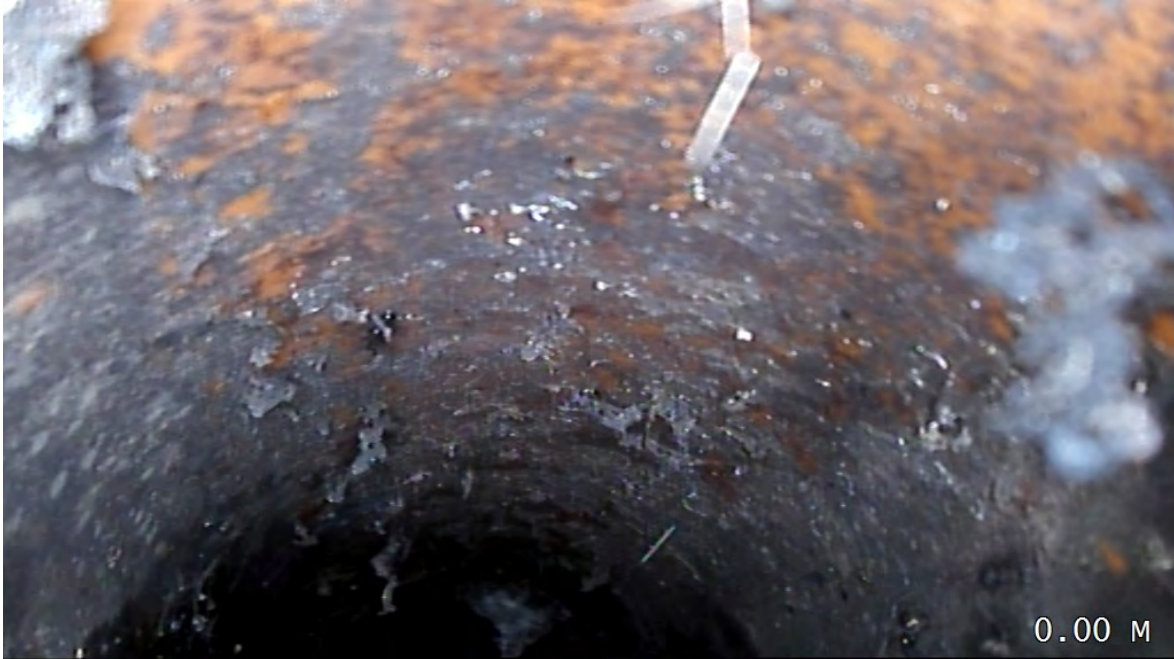
S20C1

Start node type, manhole, reference FW2/Branch D

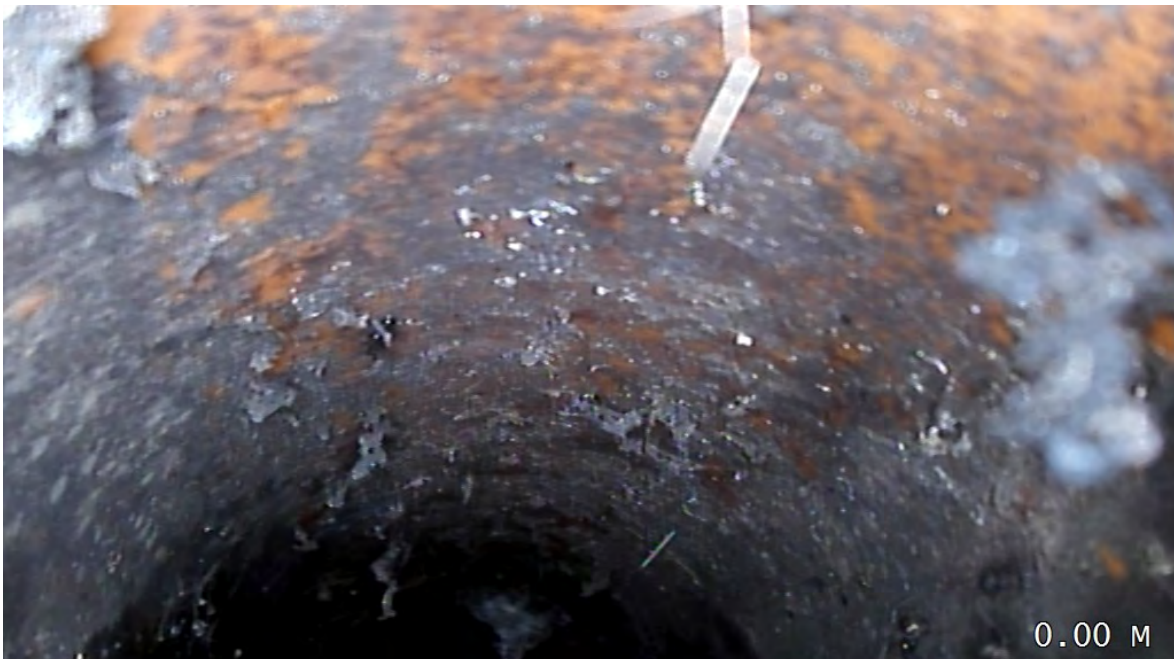
S20C2

Water level 0% height/diameter

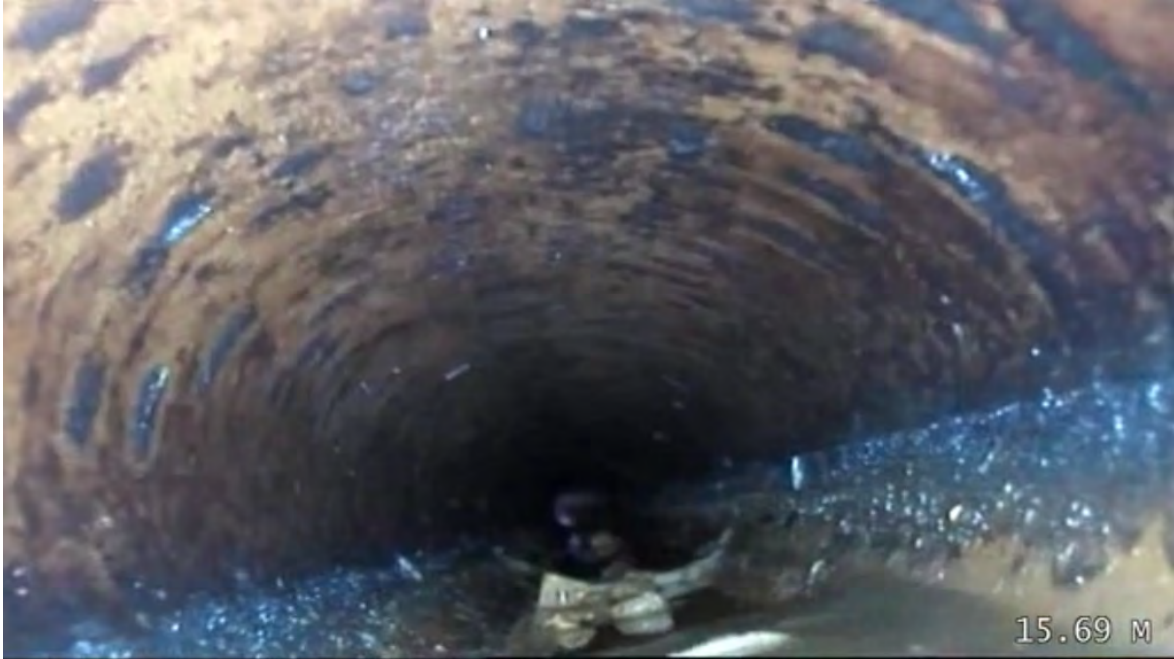
S20C3

Settled deposits coarse 5% cross-sectional area loss

HPWJ recommended to remove deposits.

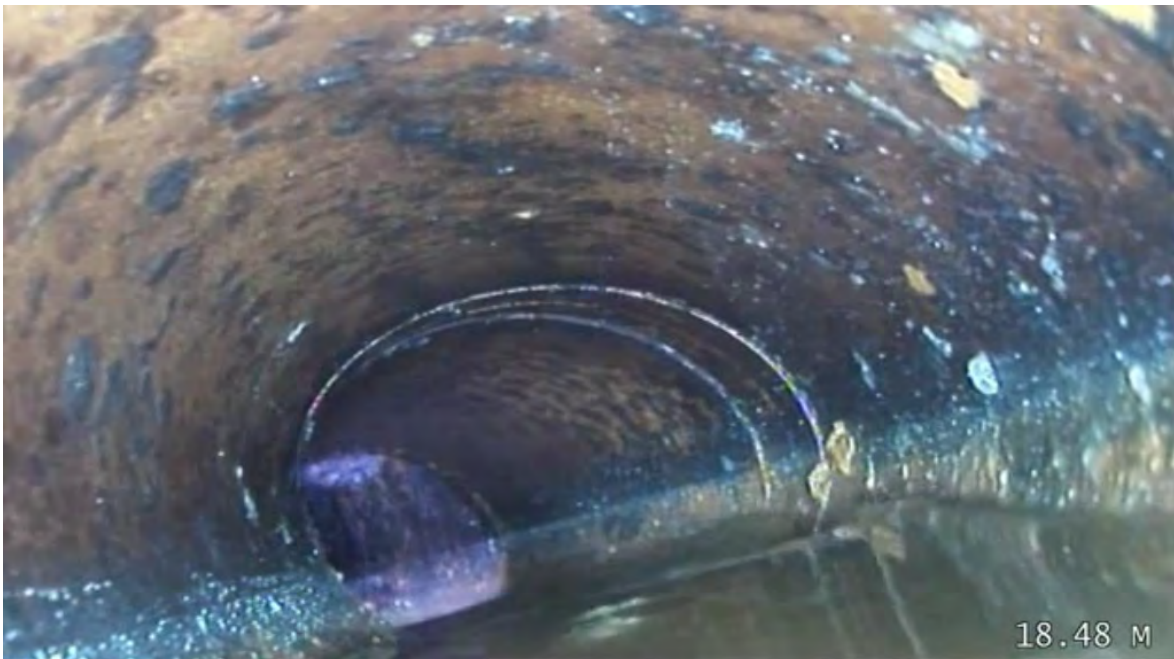
S20C4

Water level 10% height/diameter

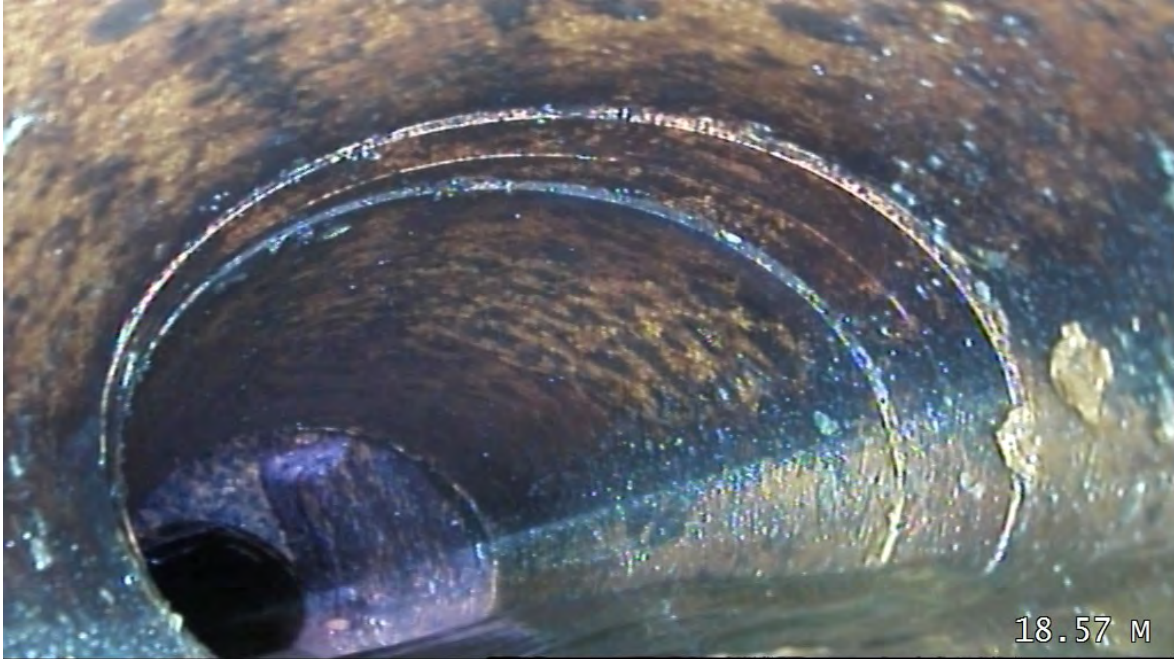
S20C5

00:01:13 - 18.57 m  
Line of drain/sewer deviates left

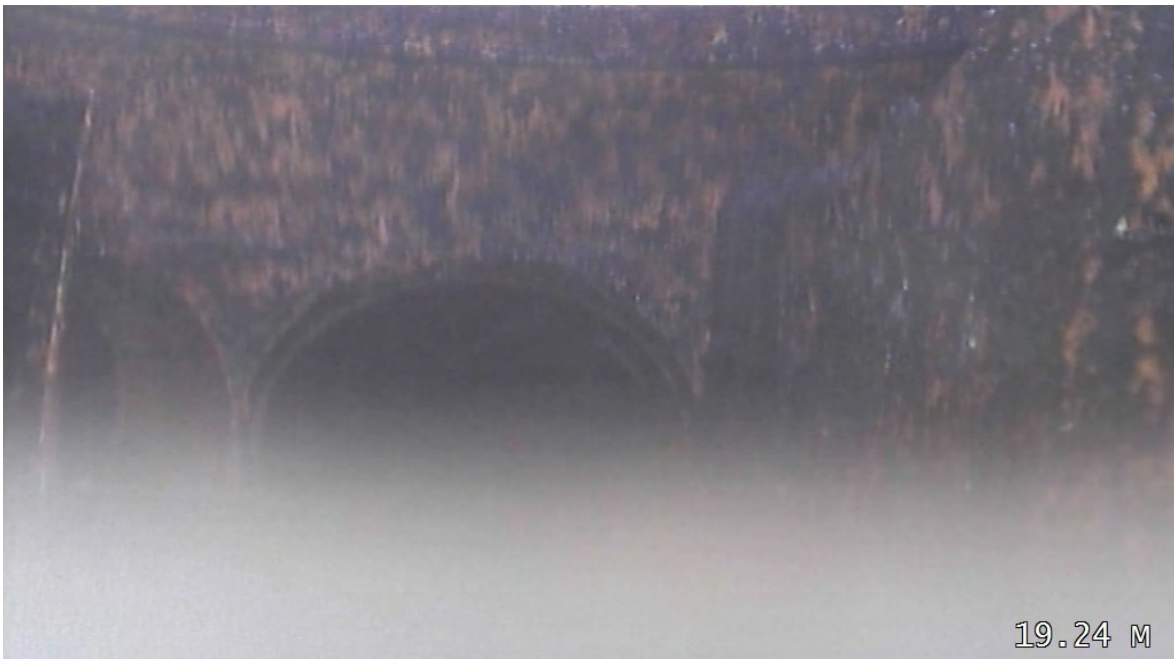
S20C6

00:01:31 - 19.24 m  
Finish node type, manhole, reference FW6/Outflow

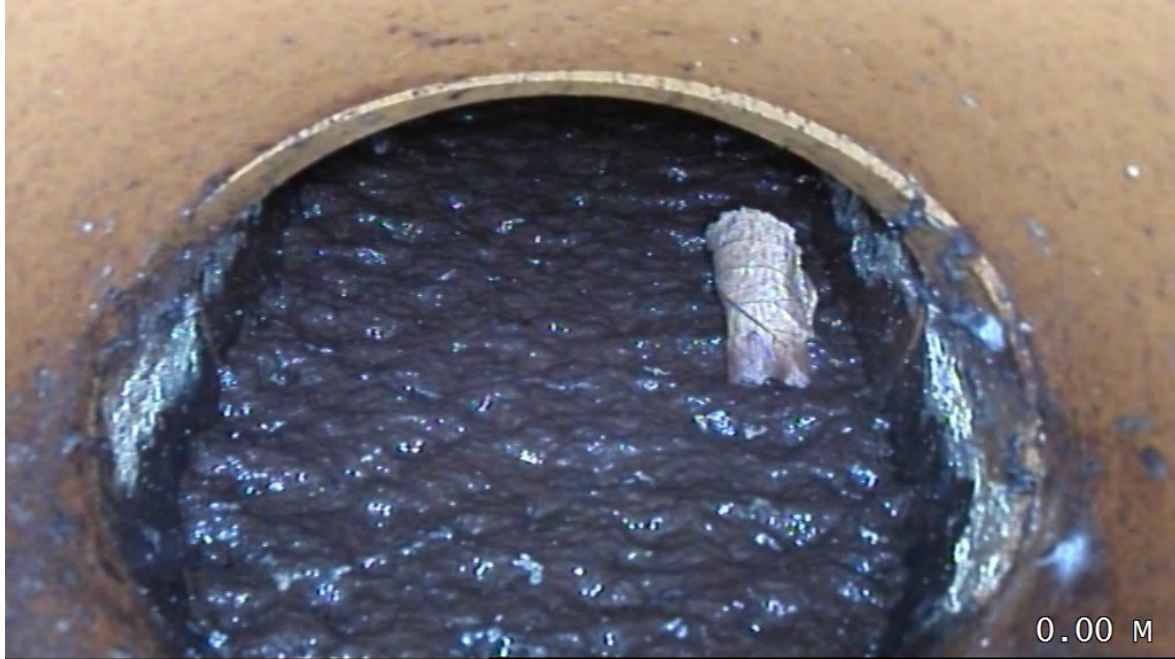
S21C1

00:00:00 - 0.00 m  
Start node type, rodding eye, reference RE02

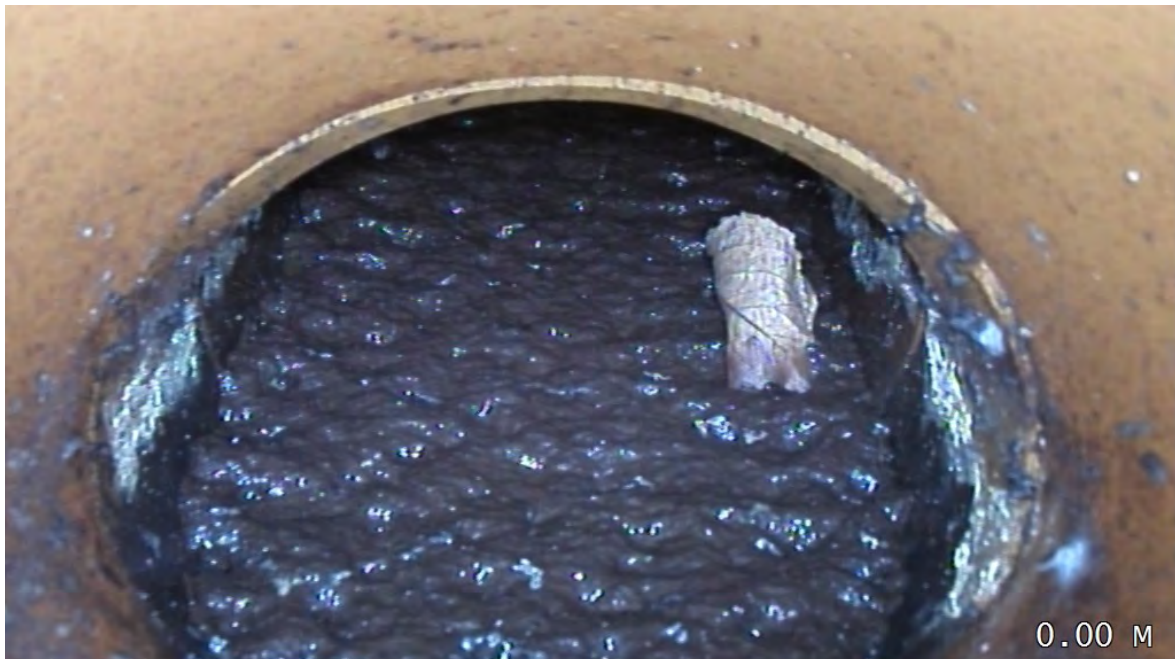
S21C2

00:00:00 - 0.00 m  
Water level 0% height/diameter

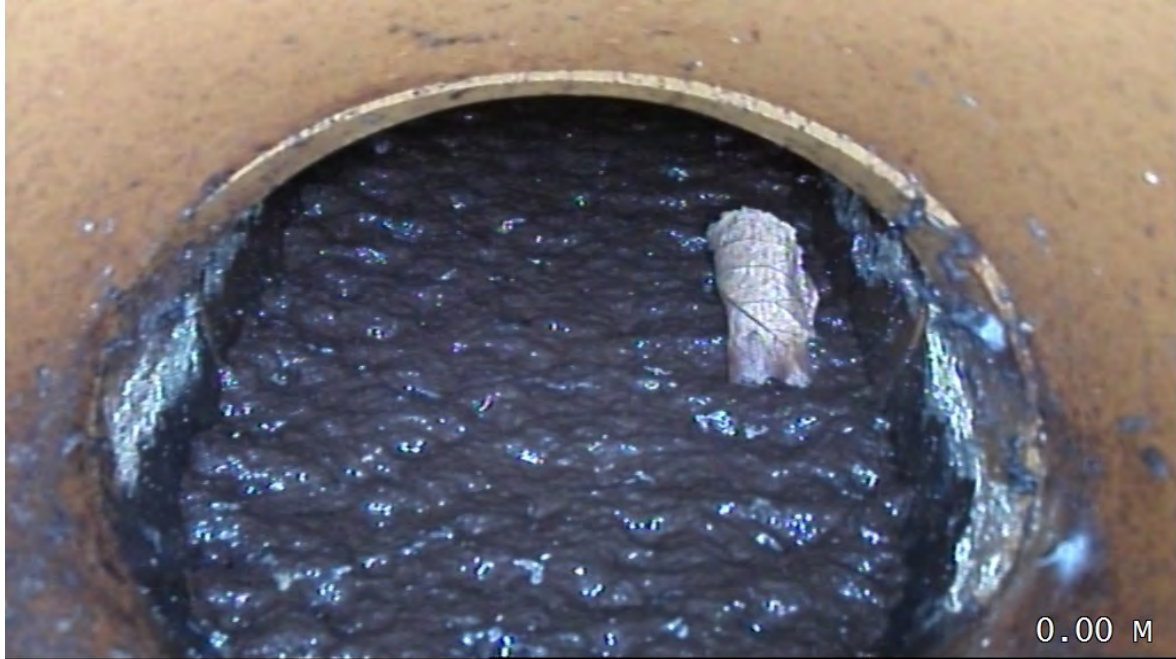
S21C3

00:00:02 - 0.00 m  
Line of drain/sewer deviates up

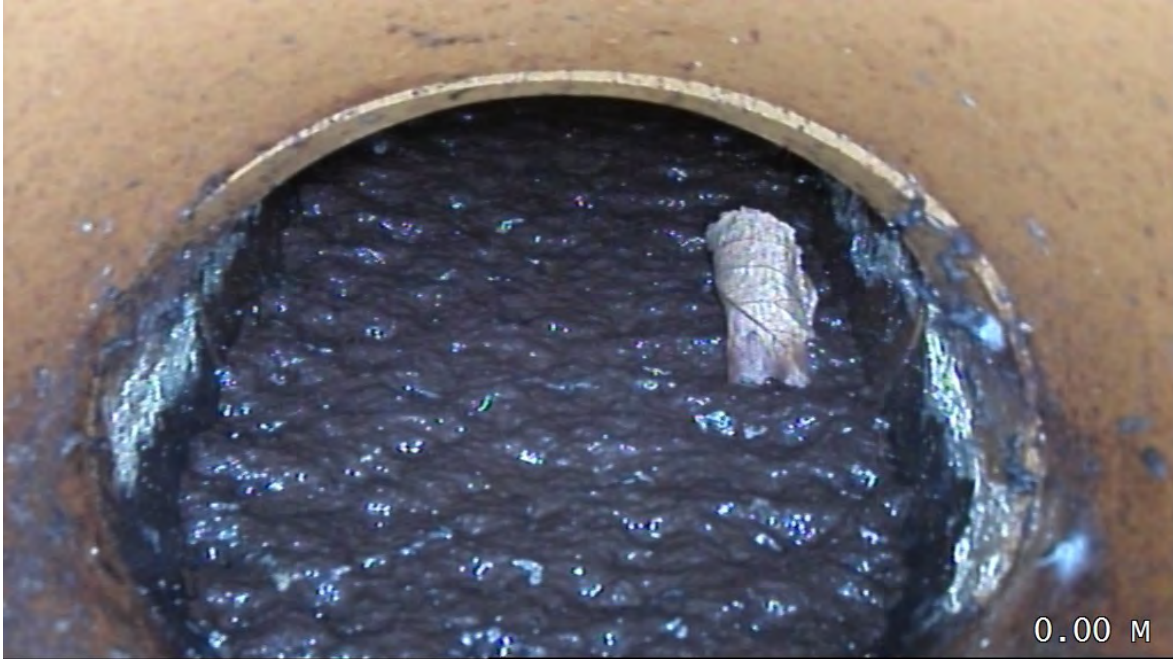
S21C5

Survey abandoned - Remark: Unable to continue survey.

HPWJ required to remove all deposits. Re-survey to determine asset condition.
