## Link Engineering

Project No. **251205**

MSCC5 Drain and Sewer Codes (SRM5 Scoring)

After surveying the drainage at Redwing's Lodge, Hinxworth, we recommend a re-visit with HPWJ van pack or a Jet/Vac to clean the lines that were not accessible during the time of survey, remarks at the end of each pipe section will specify the necessary remedial action to take. The main hotel building has two surface runs either side that lead to a rodding eye, however one of these was not able to be located, we assume it is buried. The inspection chambers that would give access to these SW6 and SW5 were UTL. If these covers are raised then that would allow us to confirm the surface run and its features. The restaurant on site uses a grease trap to clean the waste from the kitchen, we recommend that the grease trap and all surrounding drainage is cleared out and thoroughly cleaned then re-surveyed for the pipe condition. Following this, we located a buried manhole to the South East of the restaurant, this should be uncovered, lifted and surveyed.

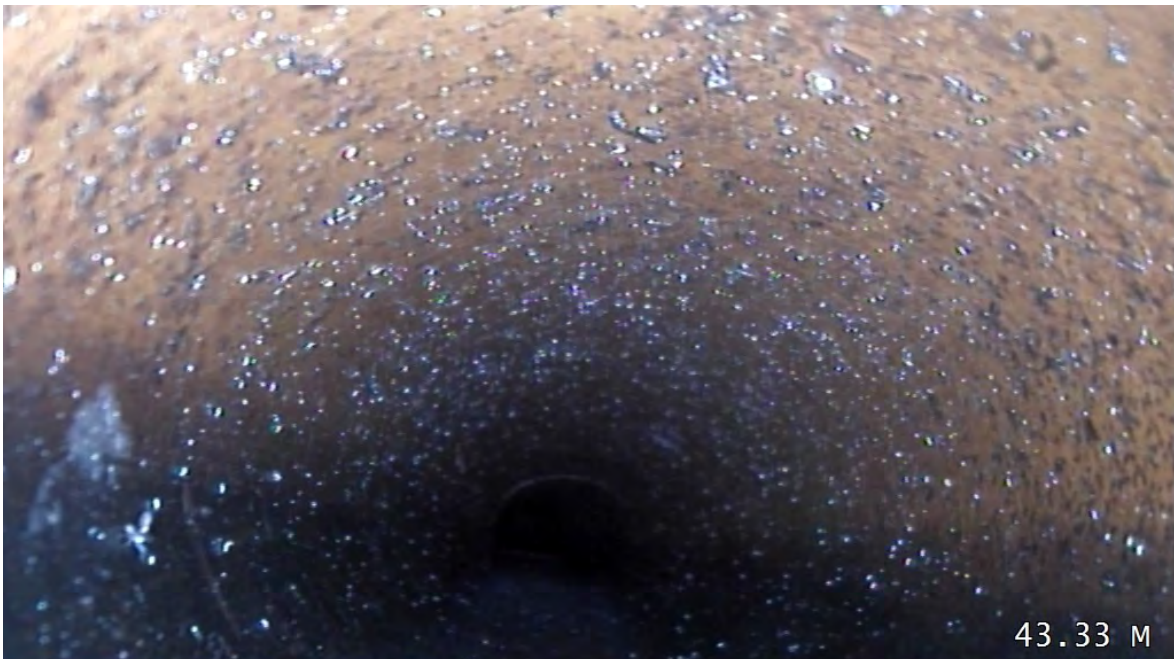
S22C19

00:07:53 - 43.33 m  
Survey abandoned - Remark: Unable to continue survey.

Water level fluctuates, We recommend blocking the flow upstream and using HPWJ to clean the line and re-survey.

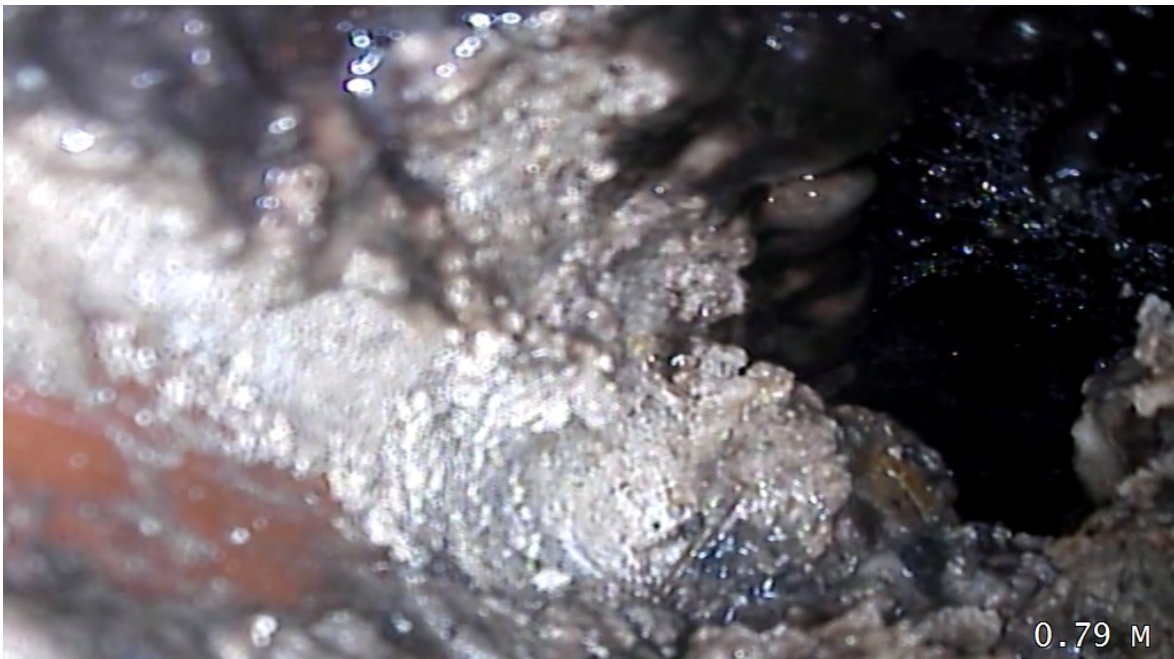
S24C4

00:00:22 - 0.79 m  
Attached deposits, grease from 3 to 11 o'clock 50% cross-sectional area loss

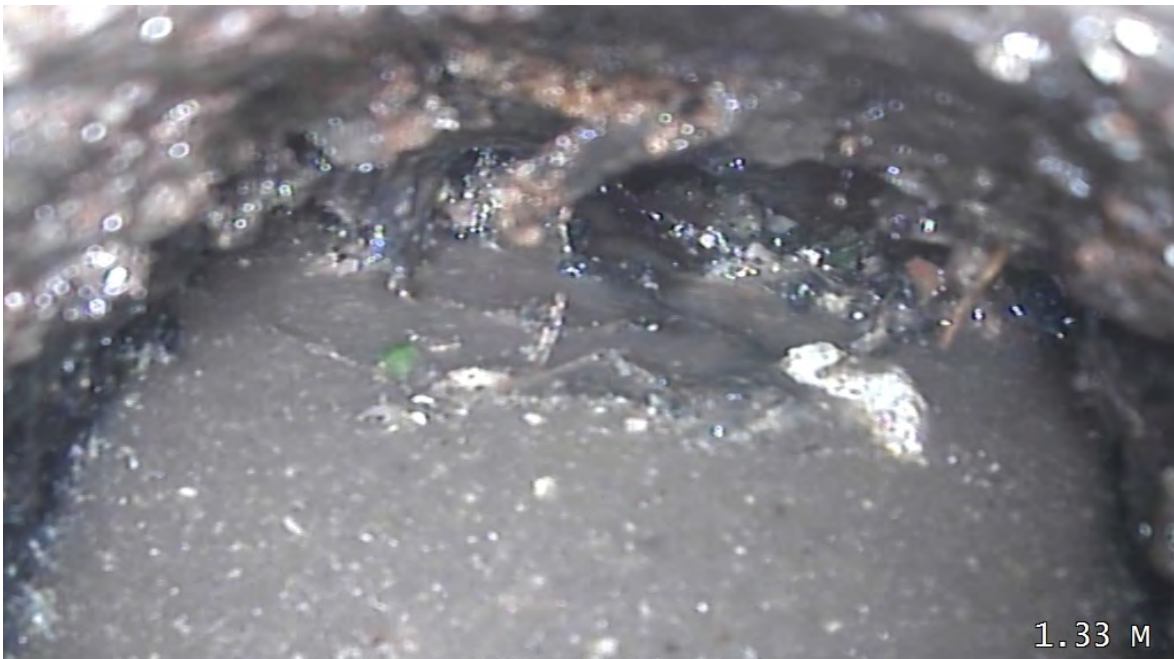
S25C4

00:00:43 - 1.33 m  
Water level 100% height/diameter

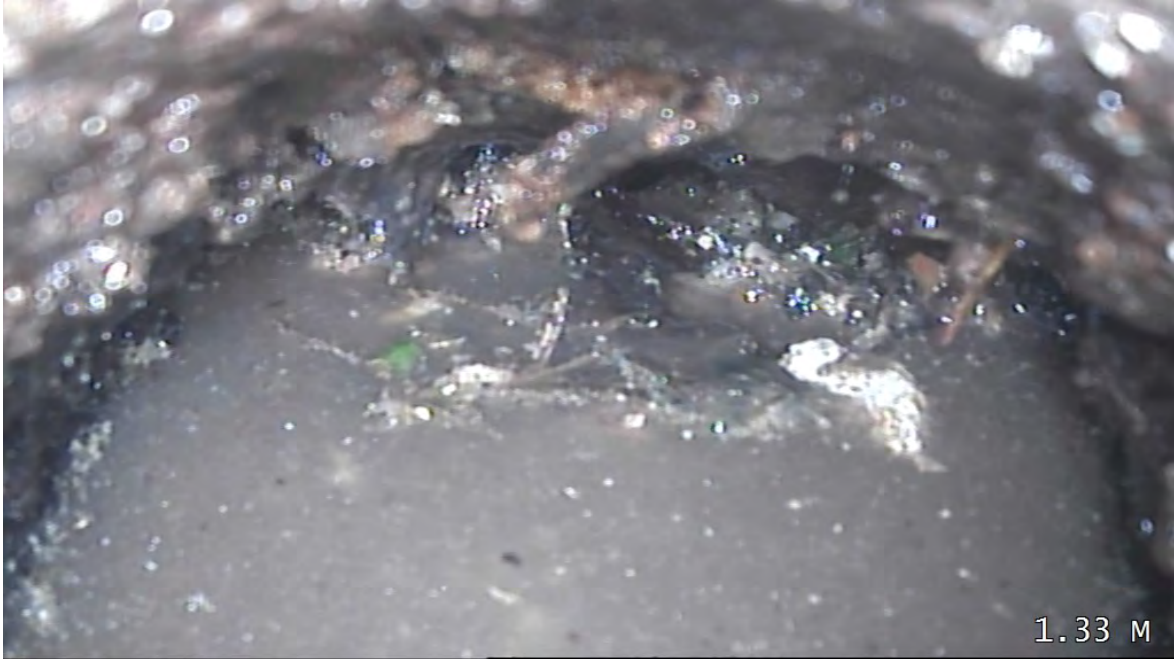
S25C5

Survey abandoned - Remark: Unable to continue survey.

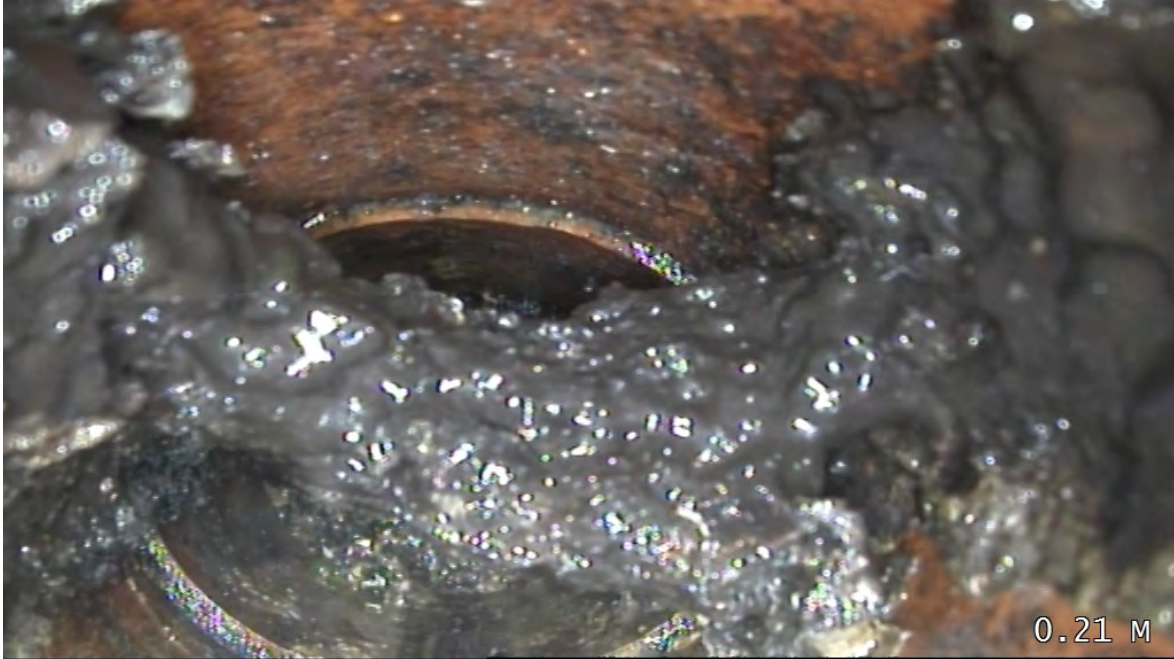
S26C3

Attached deposits, grease from 1 to 10 o'clock 75% cross-sectional area loss

HPWJ recommended to flush through pipe. It is recommended the grease trap is emptied and cleaned.

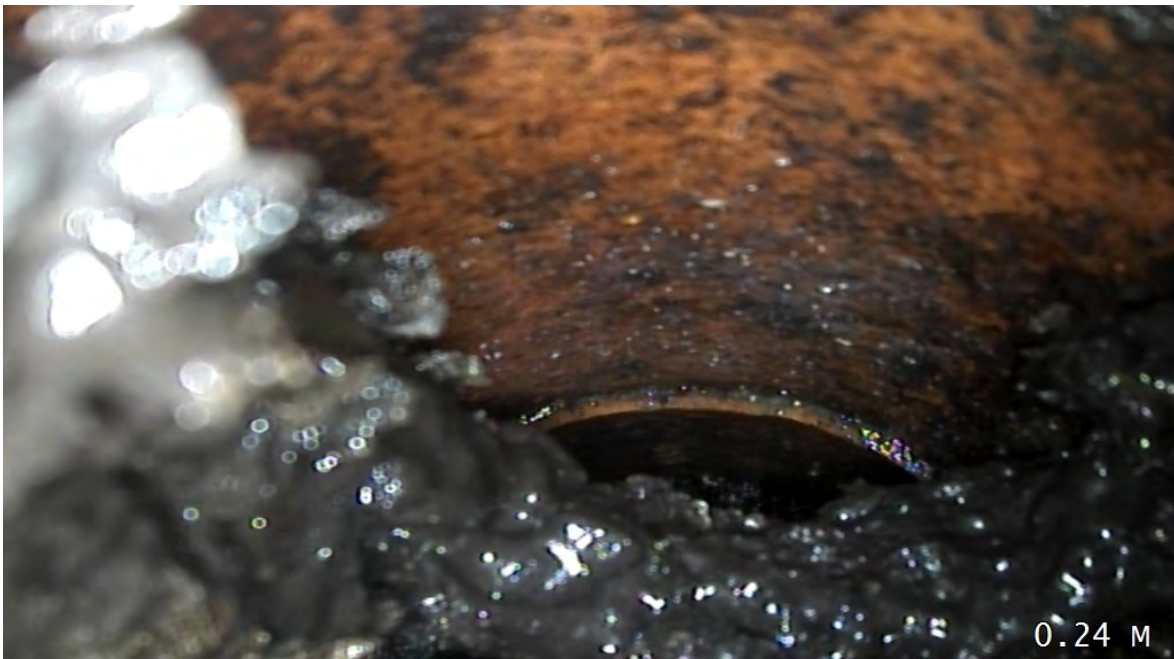
S26C4

00:00:15 - 0.24 m

Survey abandoned - Remark: Unable to continue survey.

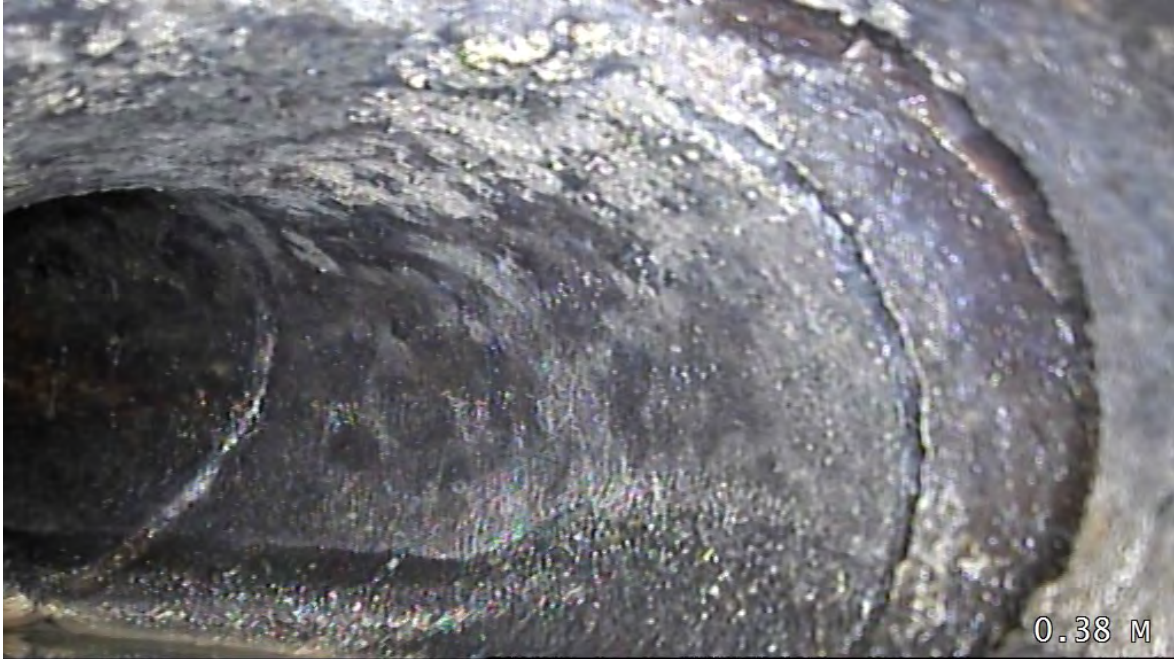
S27C3

00:00:09 - 0.38 m  
Line of drain/sewer deviates left

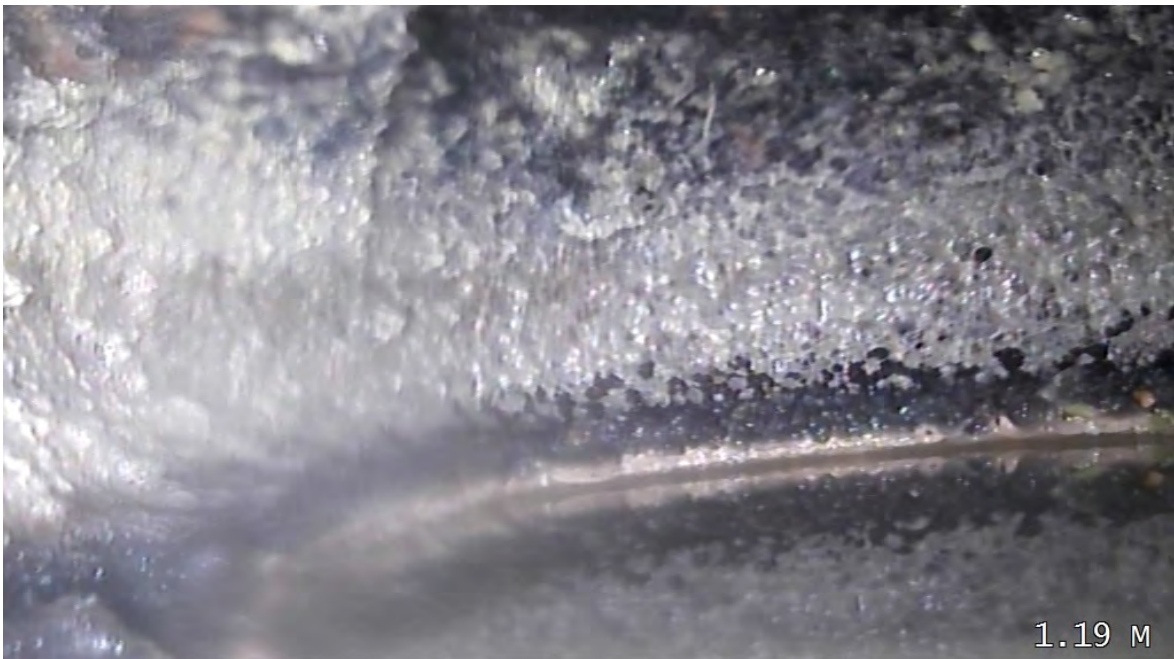
S27C4

00:00:30 - 1.19 m  
Line of drain/sewer deviates down

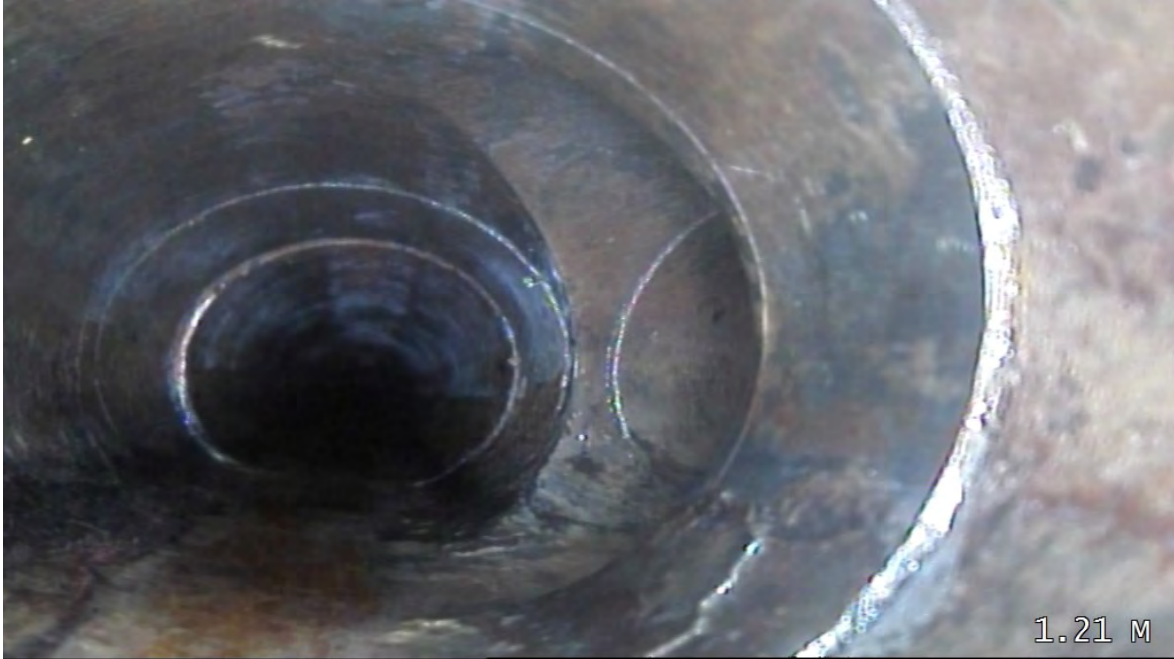
S28C3

00:00:12 - 1.21 m  
Junction at 3 o'clock, diameter 100mm

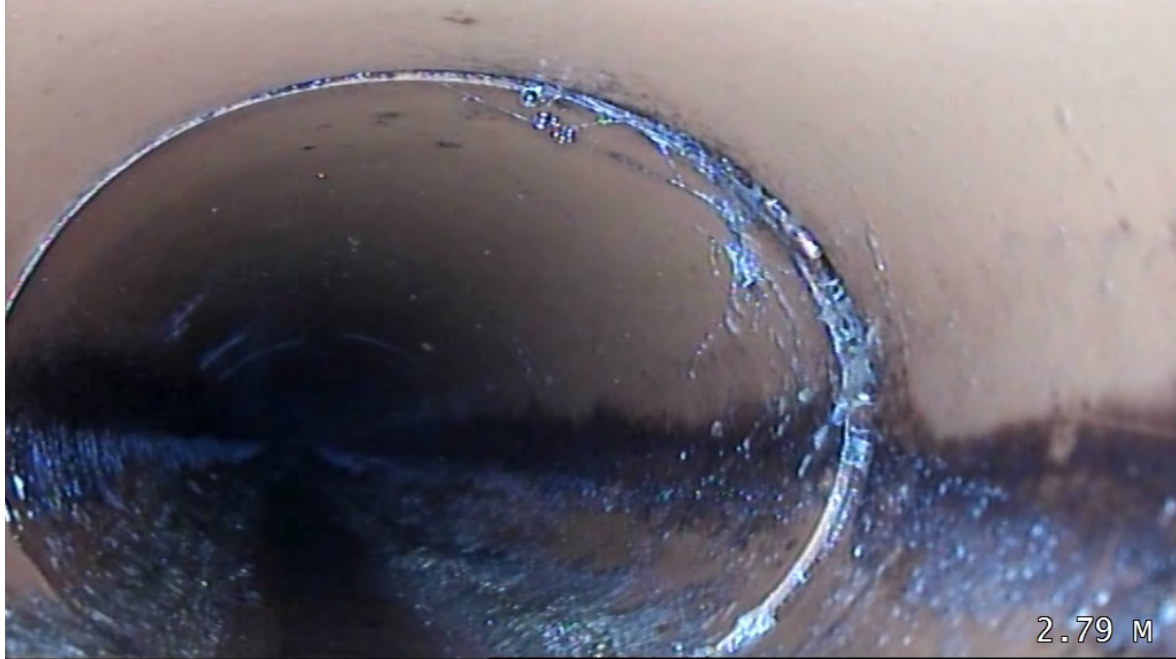
S29C3

00:00:20 - 2.79 m  
Line of drain/sewer deviates left

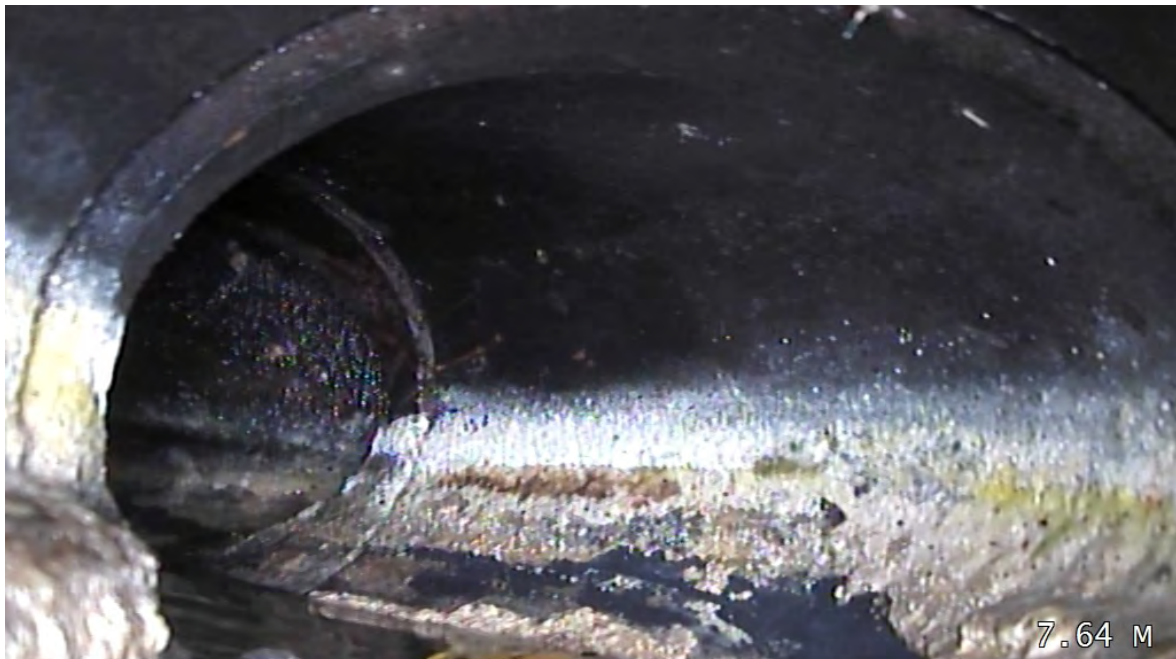
S29C4

00:00:39 - 7.64 m  
Line of drain/sewer deviates left

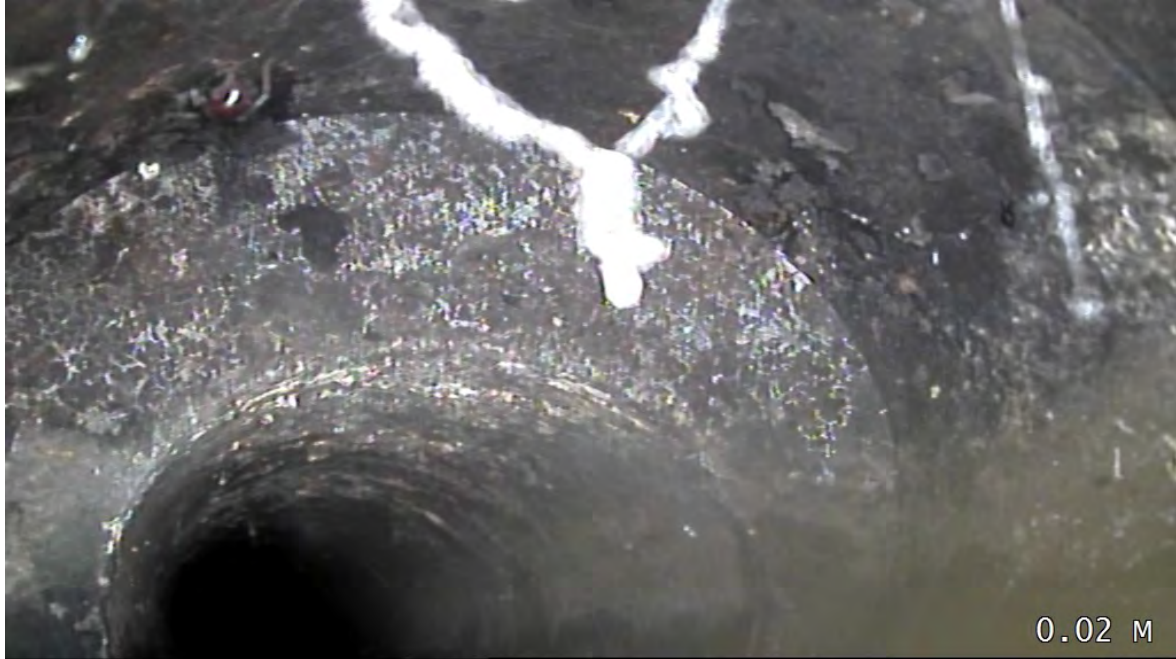
S30C3

00:00:02 - 0.02 m  
Dimensions of drain/sewer changes to 100mm

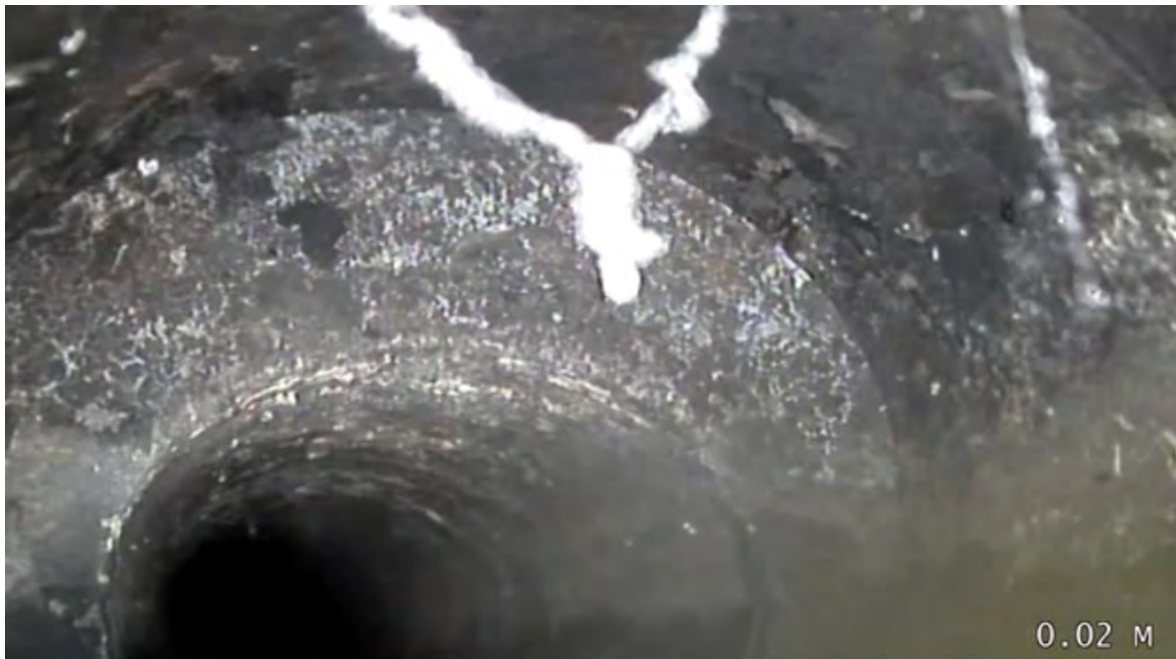
S30C4

00:00:03 - 0.02 m  
Material of drain/sewer changes to polyvinyl chloride at this point

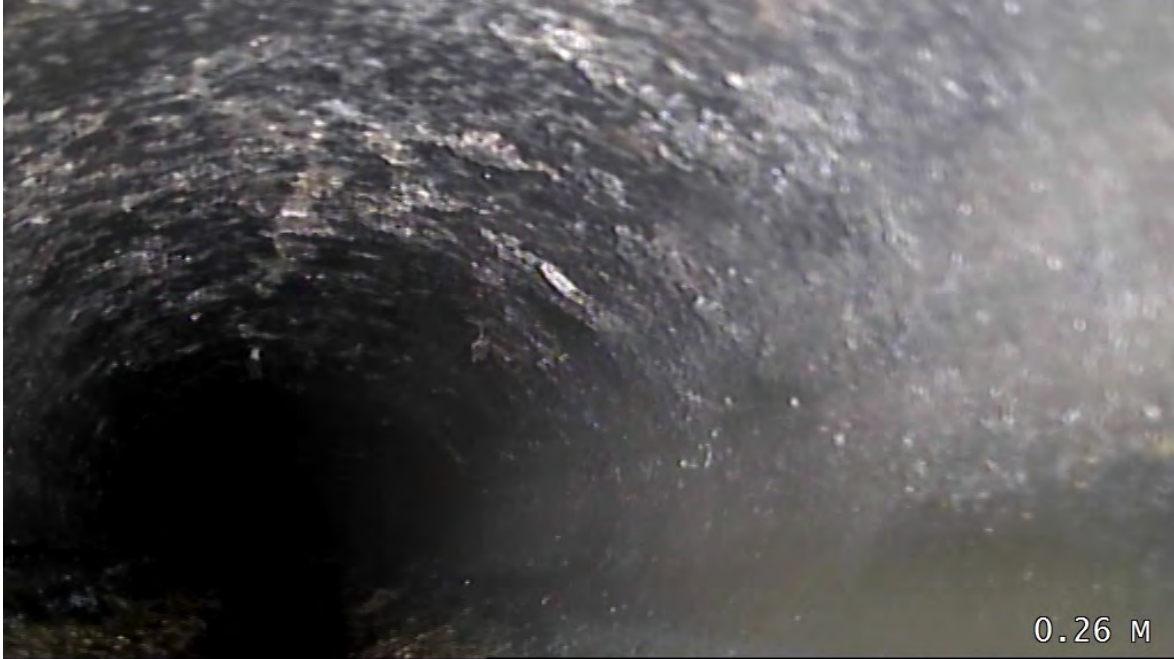
S30C5

00:00:05 - 0.31 m  
Line of drain/sewer deviates left

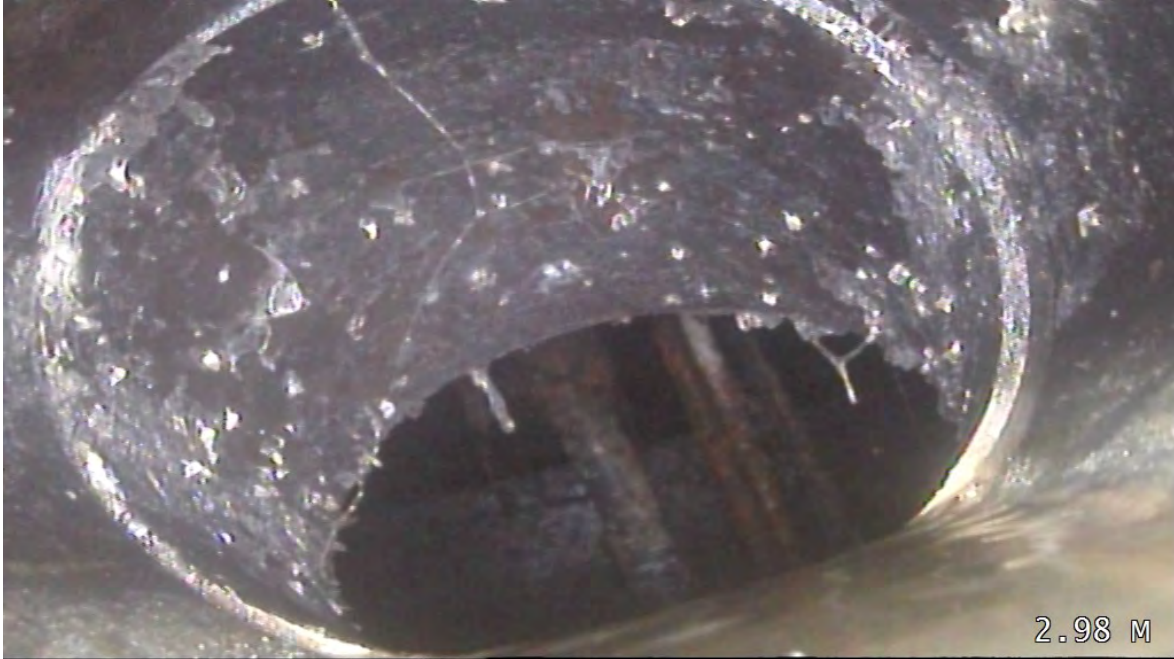
S31C3

00:00:28 - 3.00 m  
Line of drain/sewer deviates down
