**Structural Inspection at  
The Old Manor,  
Shaftenhoe End**

**Structural  
Engineers**  
Cambridge Ltd

**Project 24-722 for  
Mr & Mrs Noblet**

**Roof Inspection, June 2025: Bedroom 51-12**

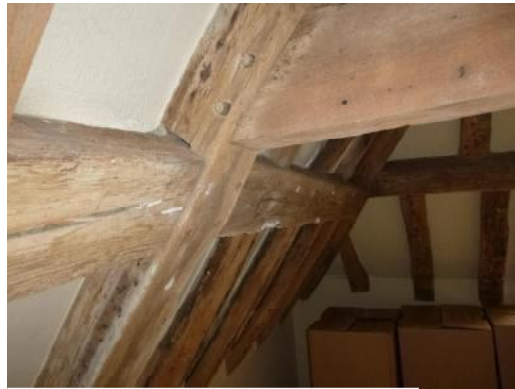
Principal rafter with tenoned purlins and collar (15)

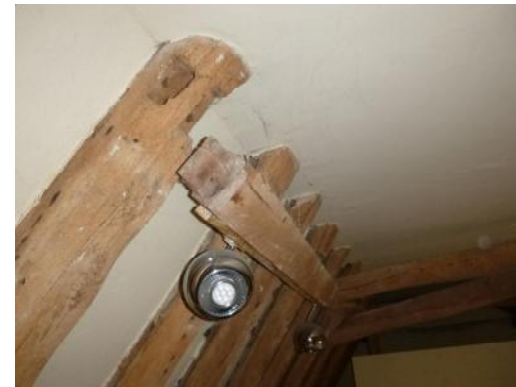
Detached purlin, judged historic (16)

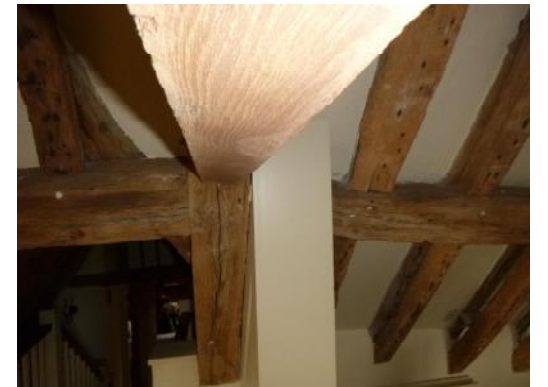
Collar at head height (15)

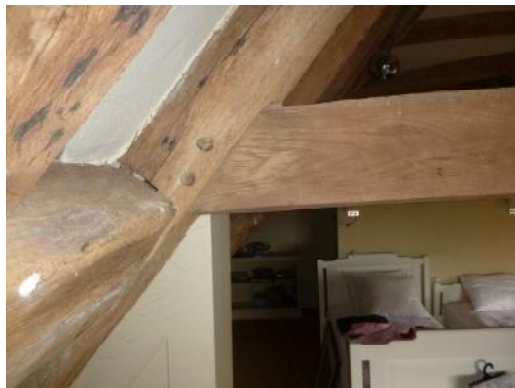
Collar at head height (15)

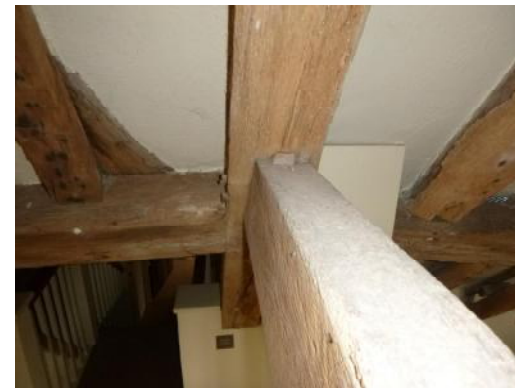
Collar at head height (15)

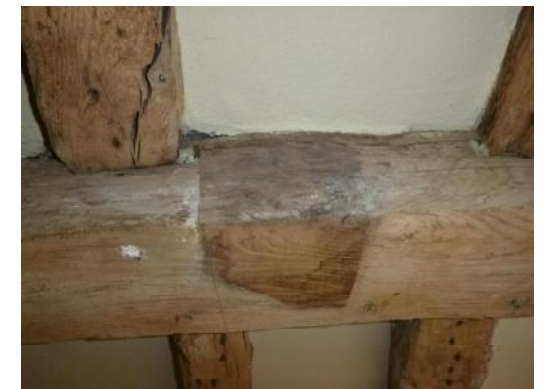
Witness to removal of collar (10)

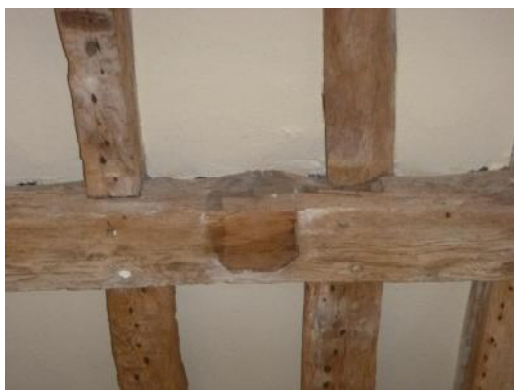
Witness to removal of collar (10)

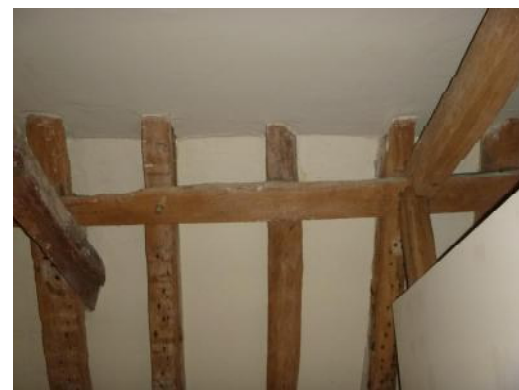
Collars repositioned at high level (11)

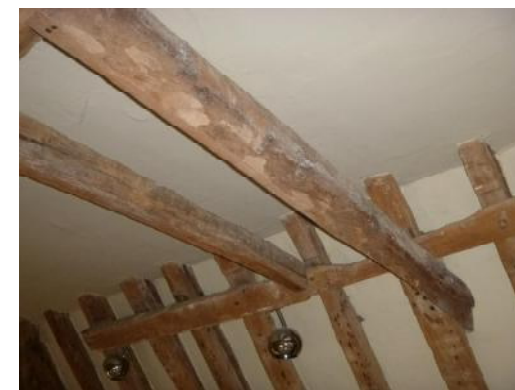
Collars repositioned at high level (11)

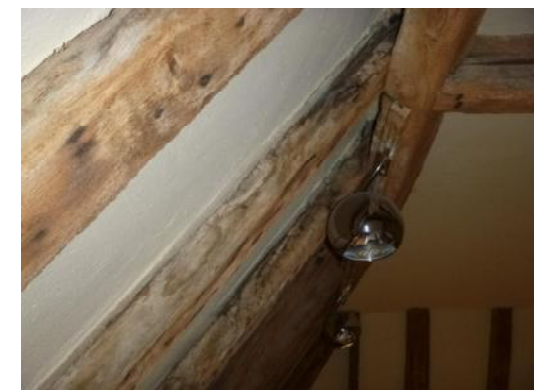
Upper purlin (12)

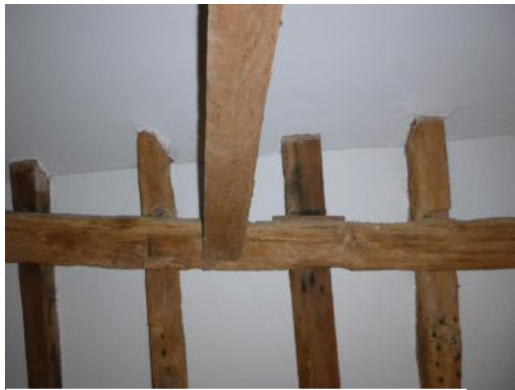
High-level collar (4)

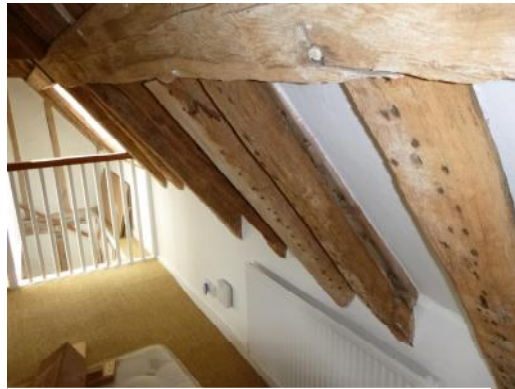
Rear eaves (8)

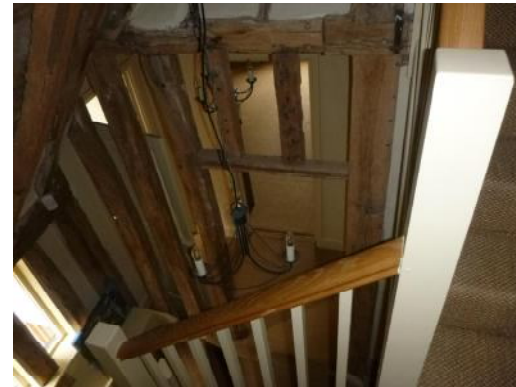
View from stairs showing historic alterations

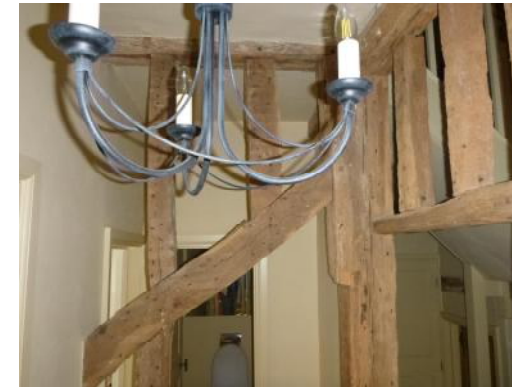
Remnants of former gable, latterly enclosed within stairwell linking buildings

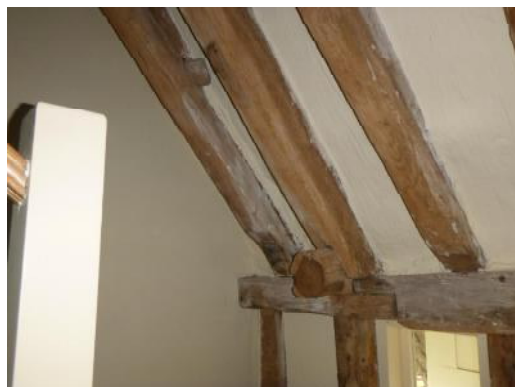
Stub of rail from former gable, severed when stairwell link was constructed

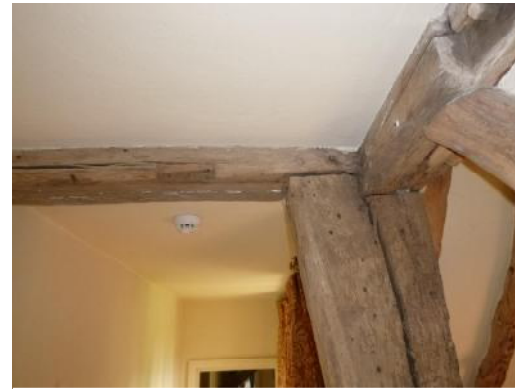
Principal post (8)

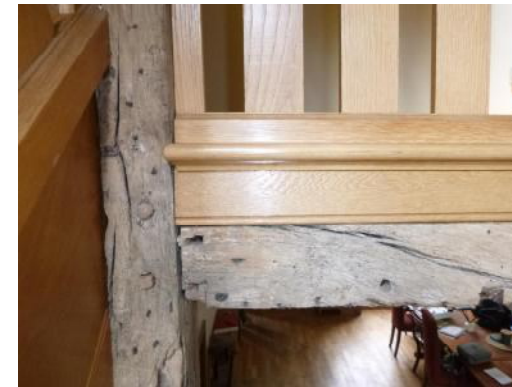
Principal post at head of stair

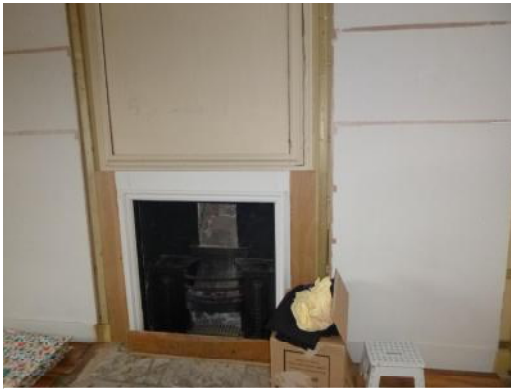
Fireplace in bedroom, with modern linings to walls

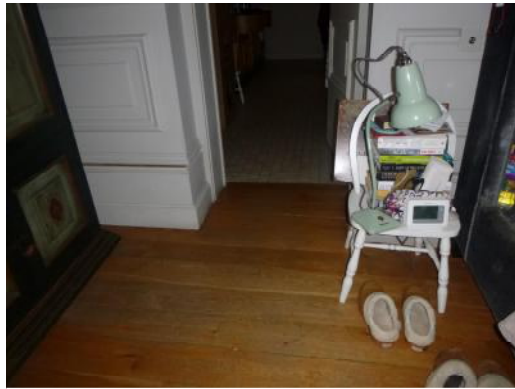
Entrance into modern extension (3)

- 1) Previous repair - no intervention required.
- 2) See architect's specification. No removal of historic fabric involved.
- 3) Judged historic - no intervention required
- 4) Suggests Bressummer was a later introduction, and/or the chimney piece has been rebuilt.
- 5) Repair is structurally ineffective. Consider improvement.
- 6) Previous repair - no intervention required.
- 7) Repair detail required.
- 8) Refer timber specialist report.
- 9) Refer SE Cambridge file 18-042
- 10) Judged historic - structurally inadequate but not suffering movement at present. Monitor.
- 11) Requires Conservation Officer opinion on removal of modern fabric.

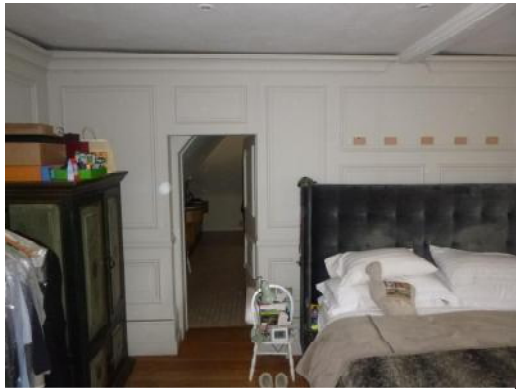
Master bedroom with entrance to extension beyond (3)

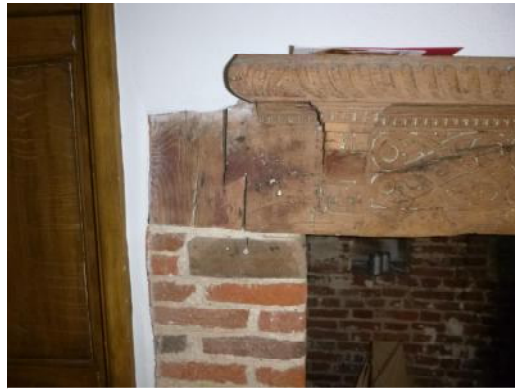
Left end of bressummer over dining room fireplace extended - possibly due to introduction into wider fireplace

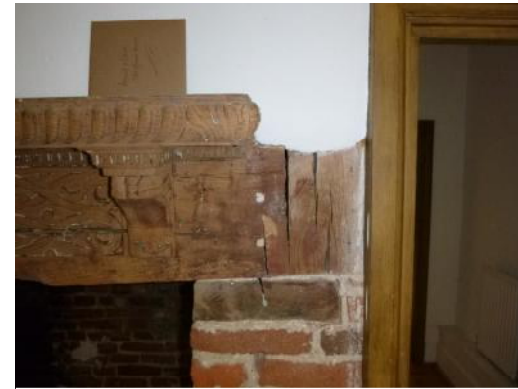
Right end of bressummer (4)

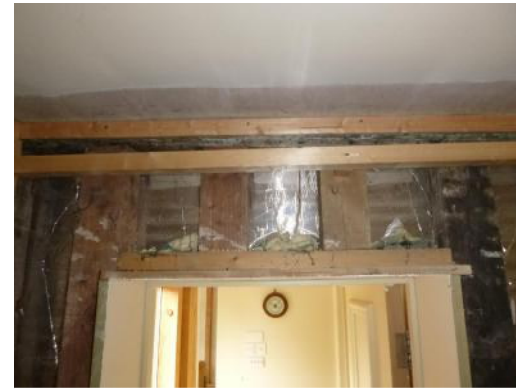
Modern framing to door head

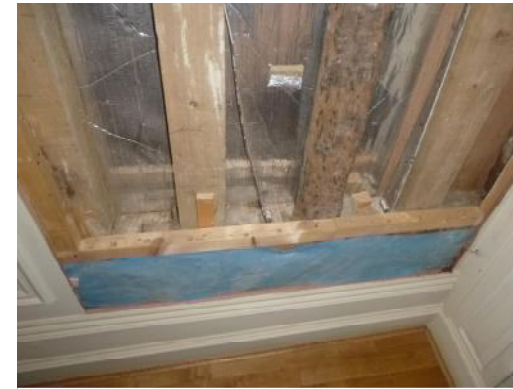
Replacement sole plate (6)

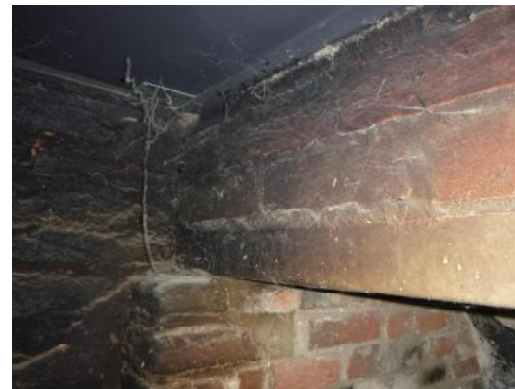
View from inside fireplace, showing concrete lintel supporting withy
