## Asbestos Inspection Report Management Survey

Princess Helena College  
School Lane  
Preston  
Hitchin  
Hertfordshire  
SG4 7RT

Project No: G-03774  
Report Issue: 1  
Date: Aug 2020

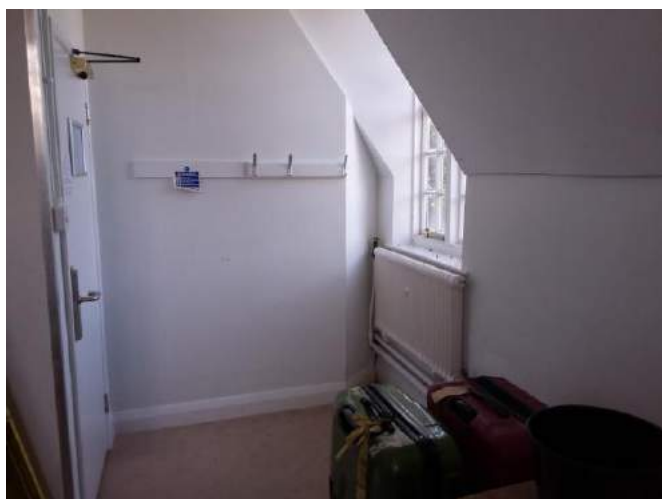
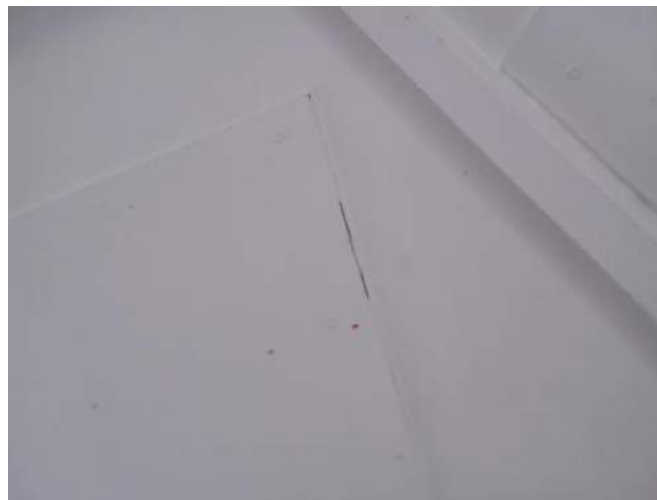
Comments: Insulating board panels to walls

| Action: | No further action required | | |

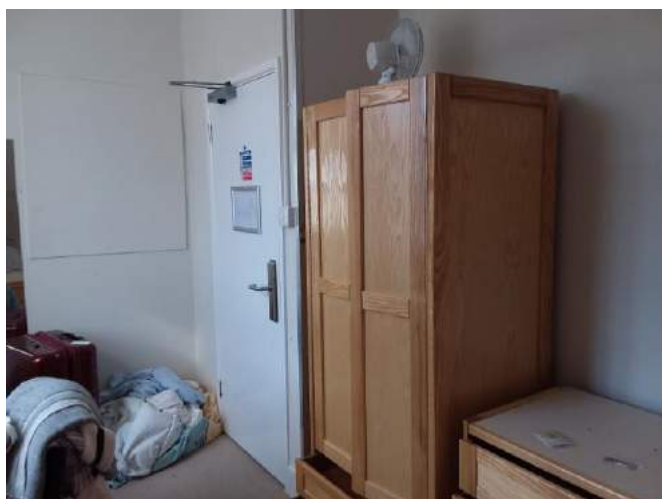
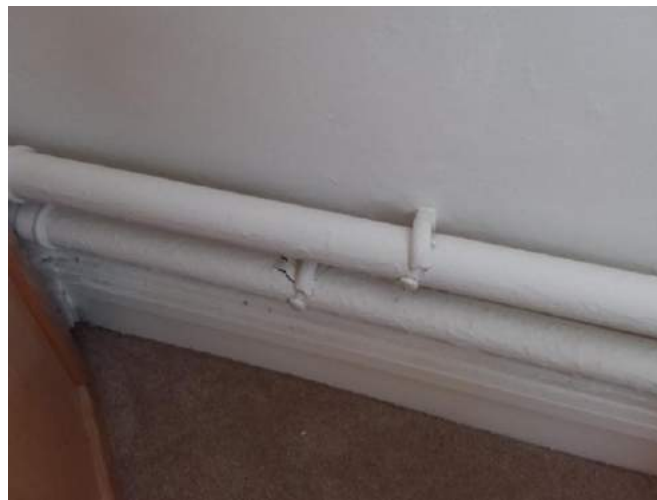
Comments: Paint to pipework

| Action: | No further action required | | |

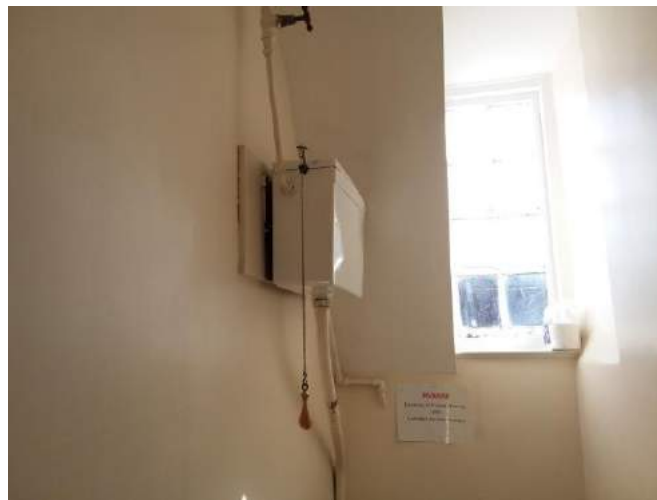
Comments: Thermoplastic toilet cistern

| Action: | No further action required | | |

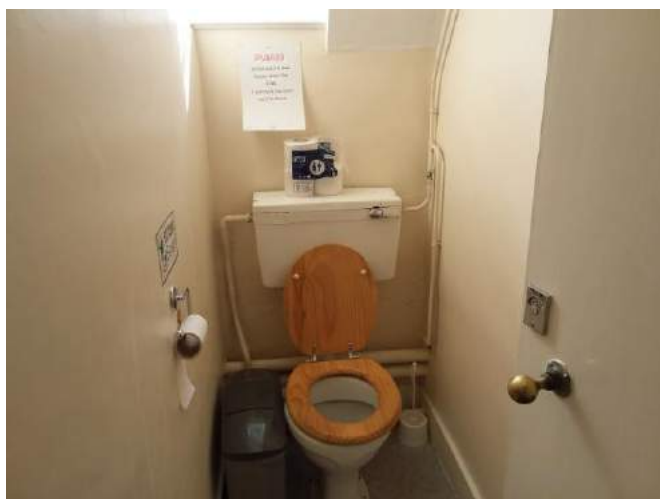
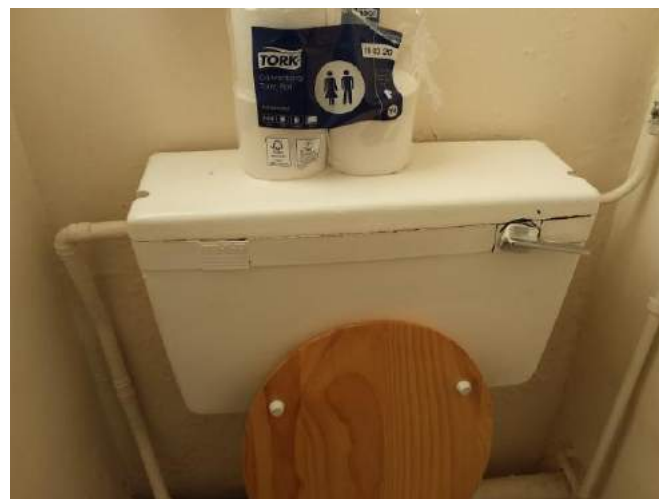
Comments: Thermoplastic toilet cistern

| Action: | No further action required | | |

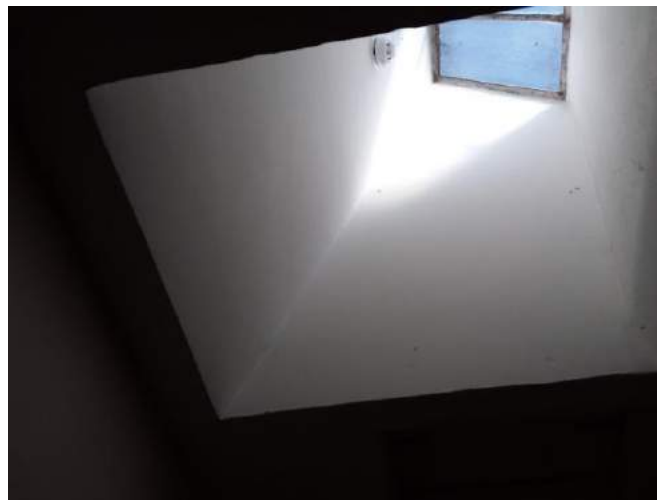
Comments: Insulating board upstand to skylight

| Action: | No further action required | | |

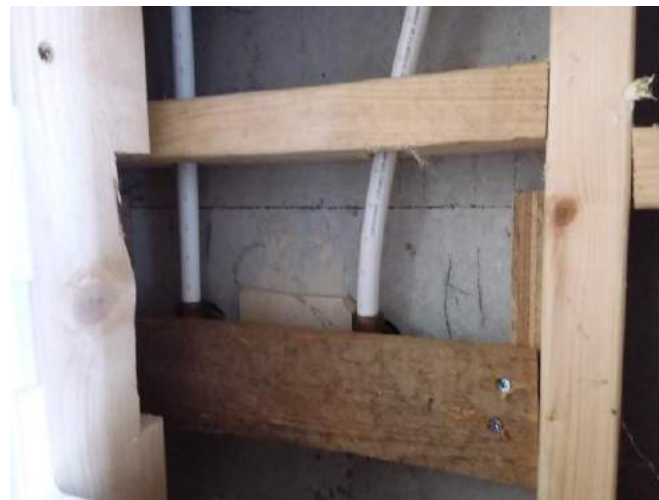
Comments: Insulating board wall beyond showers accessed via access hatch within lobby 1

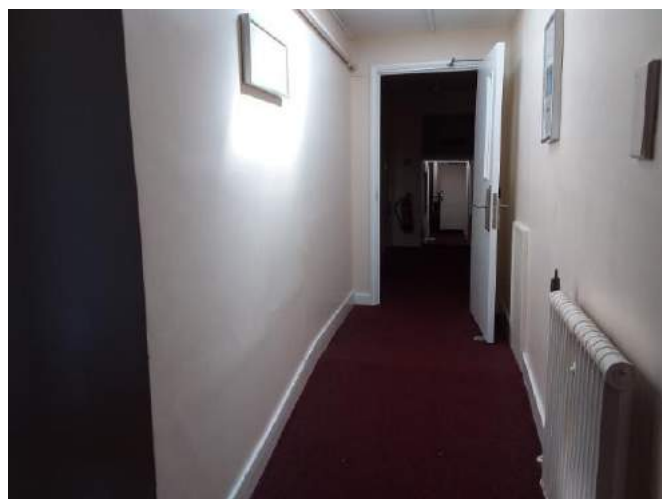
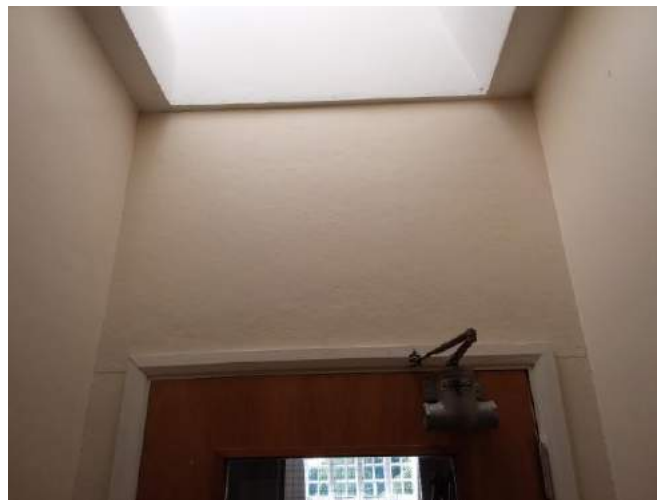
Comments: Asbestos insulating board door surround

| Action: | Monitor and manage | | |

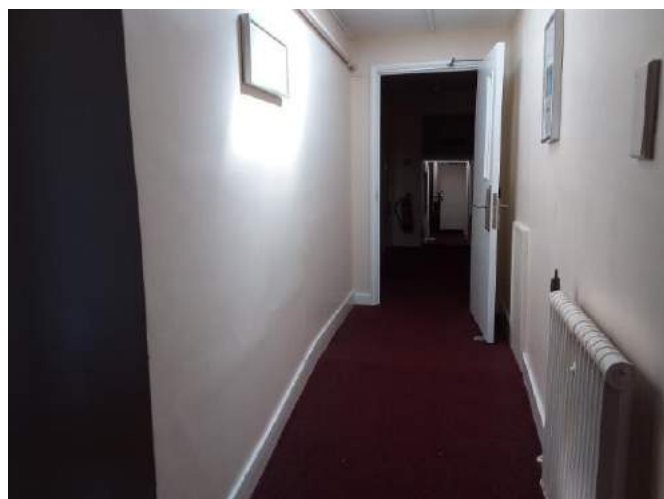
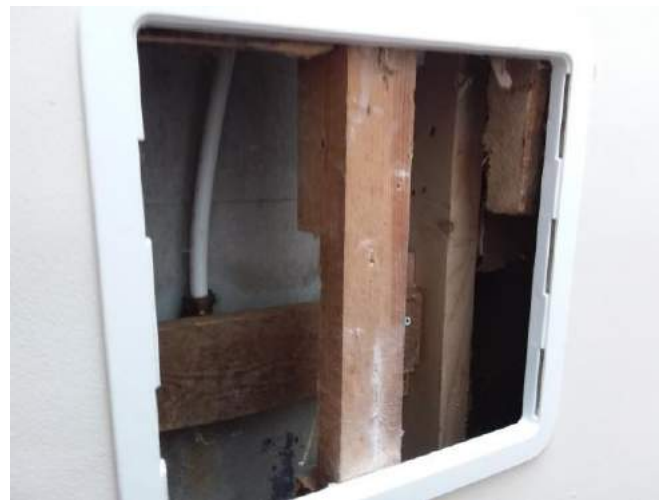
Comments: Insulating board wall beyond showers accessed via access hatch within lobby 1

| Action: | No further action required | | |

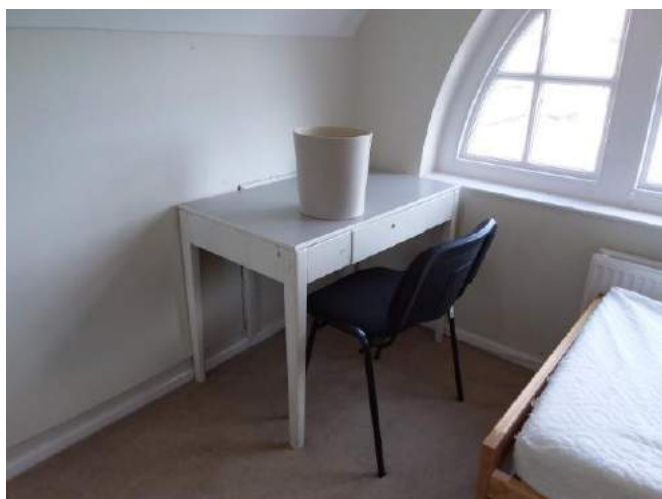
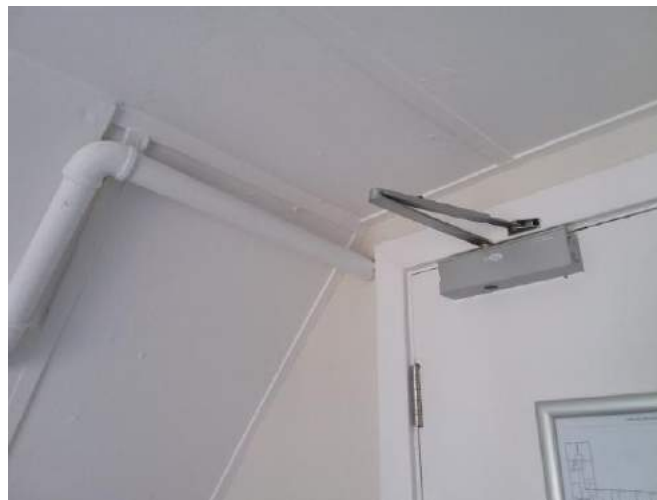
Comments: Insulating board ceiling and wall lining

| Action: | No further action required | | |

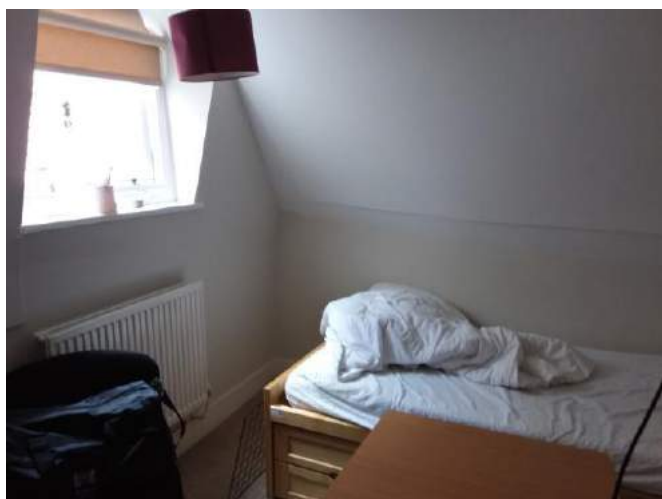
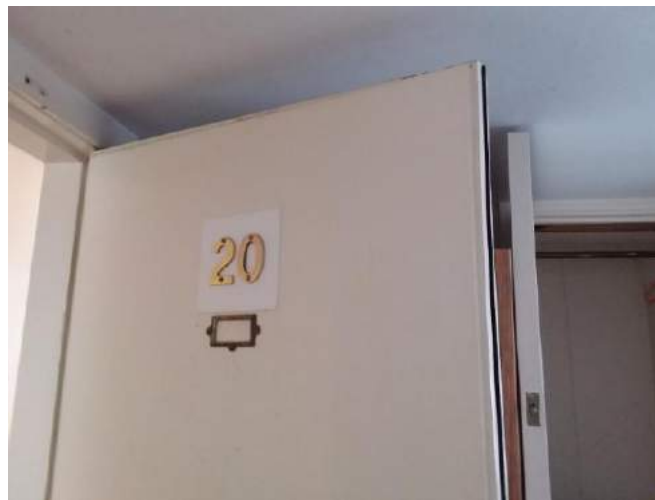
Comments: Insulating board door lining, typical to rooms 18-28

| Action: | No further action required | | |

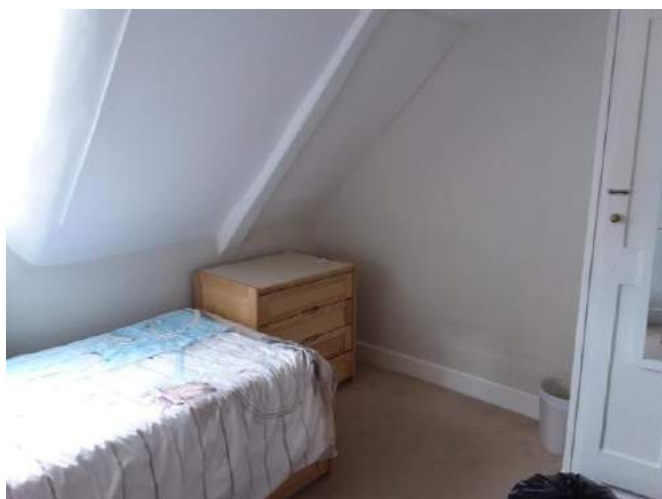
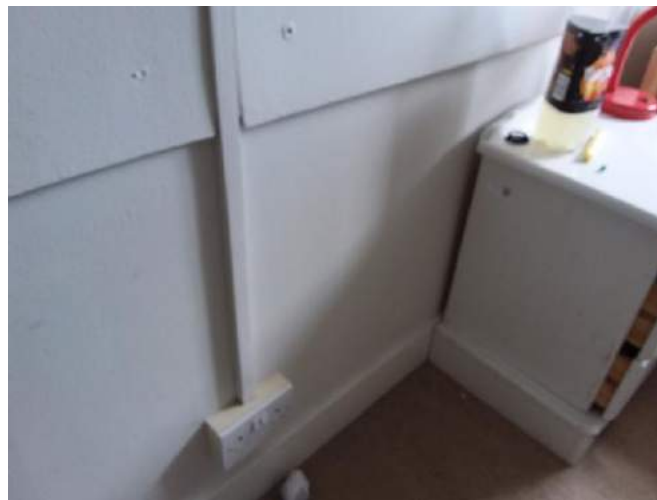
Comments: Insulating board wall partitions

| Action: | No further action required | | |

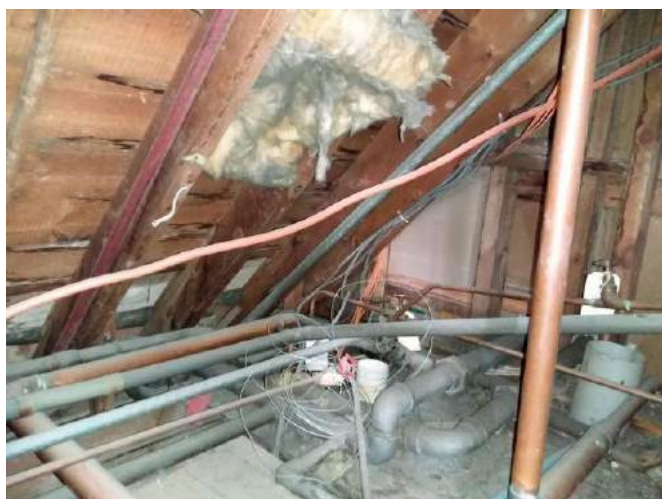
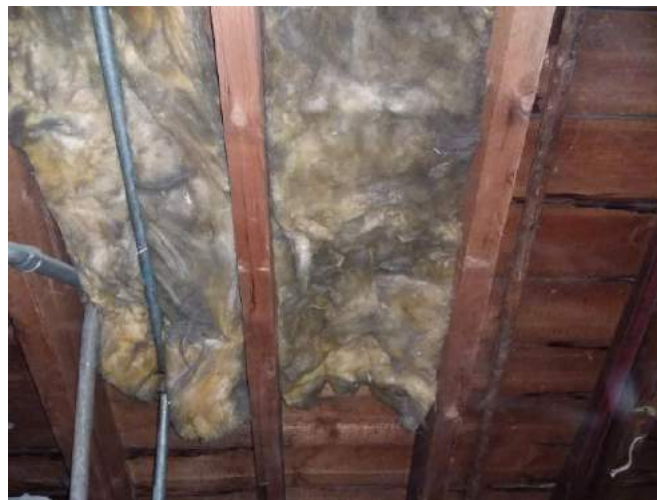
Comments: Insulation to eaves

| Action: | No further action required | | |

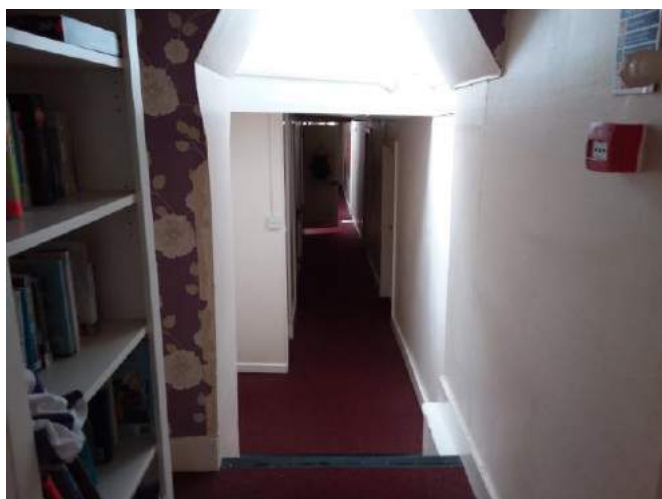
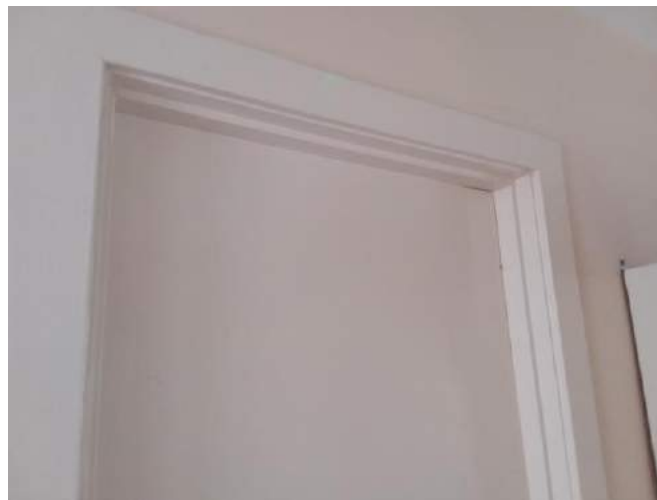
Comments: Insulating board blanking panel

| Action: | No further action required | | |

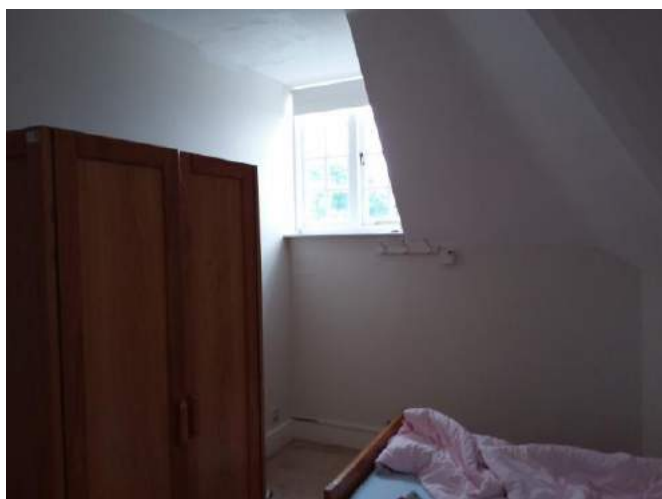
Comments: Insulating board panel to wall

| Action: | No further action required | | |

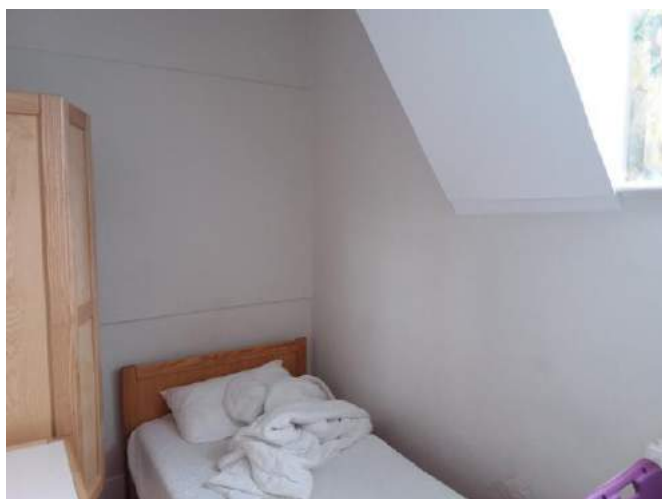
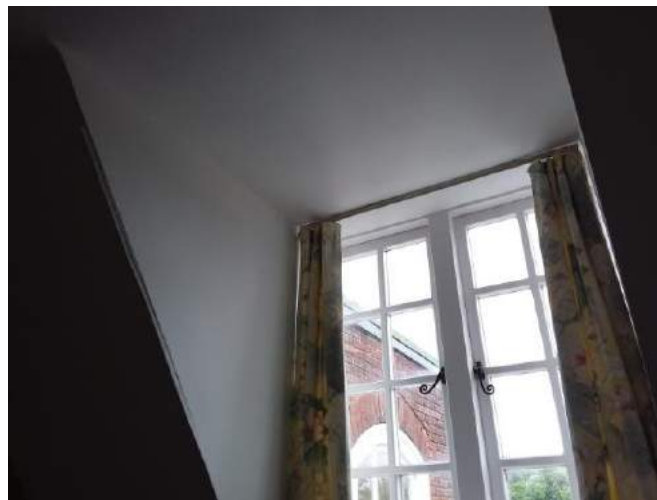
Insulating board lining around window

| Action: | No further action required | | |

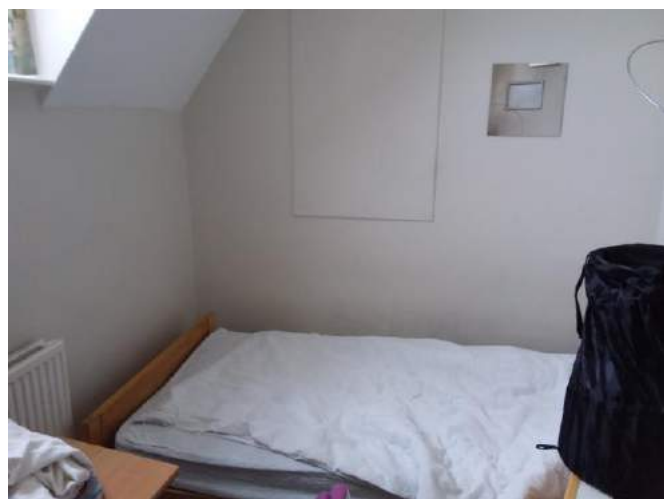
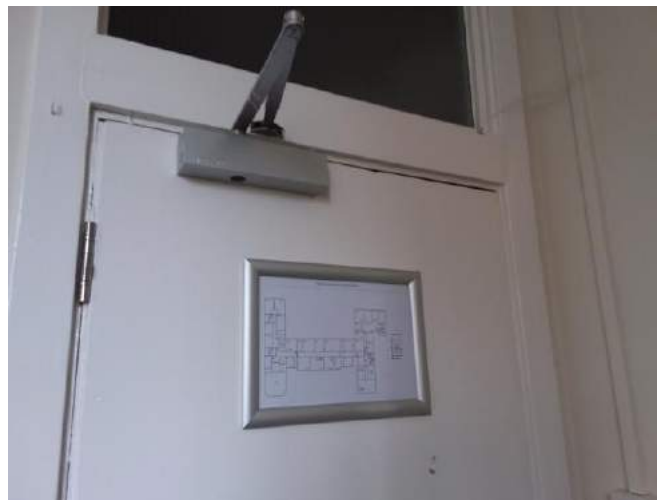
Comments: Insulating board door lining, typical to rooms 29A-32

| Action: | No further action required | | |

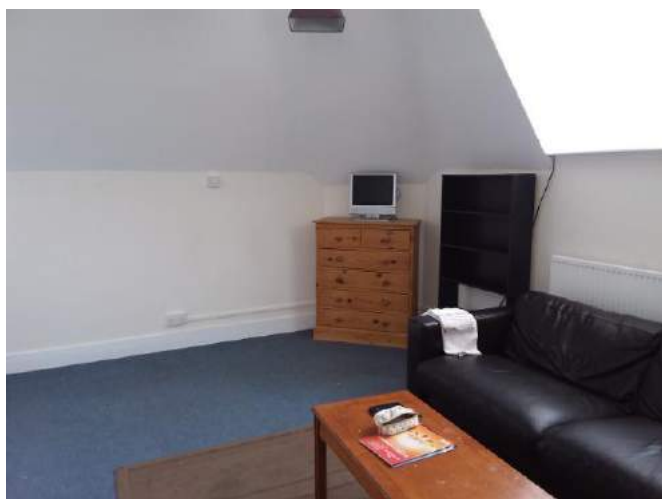
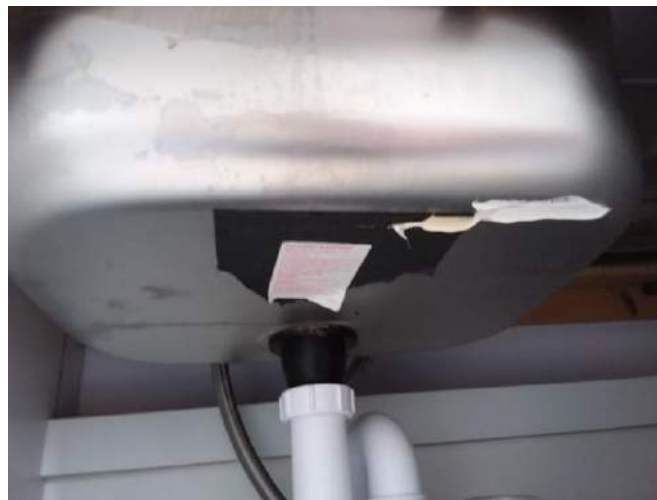
Comments: Bitumen pad to underside of sink

| Action: | No further action required | | |

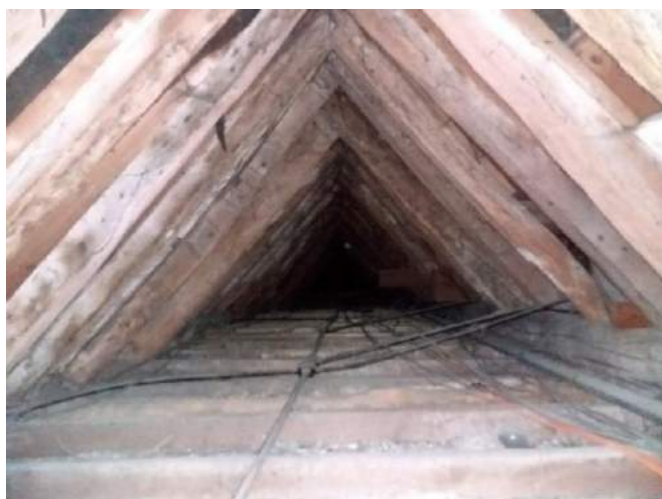
Comments: Bitumen sarking felt to underside of pitched roof

| Action: | No further action required | | |

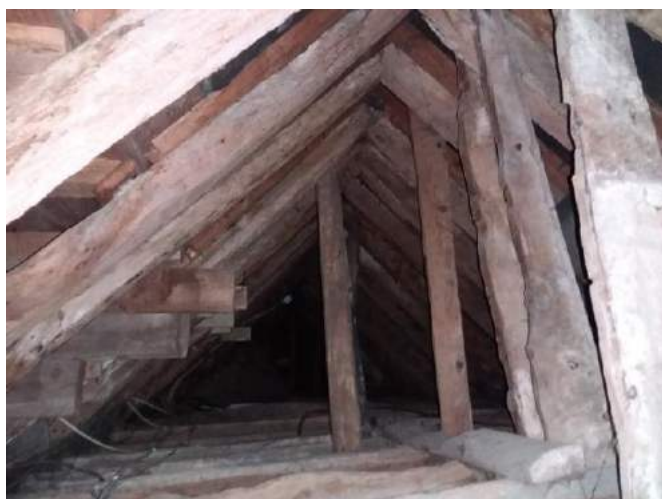
Comments: Bitumen sarking felt to underside of pitched roof

| Action: | No further action required | | |

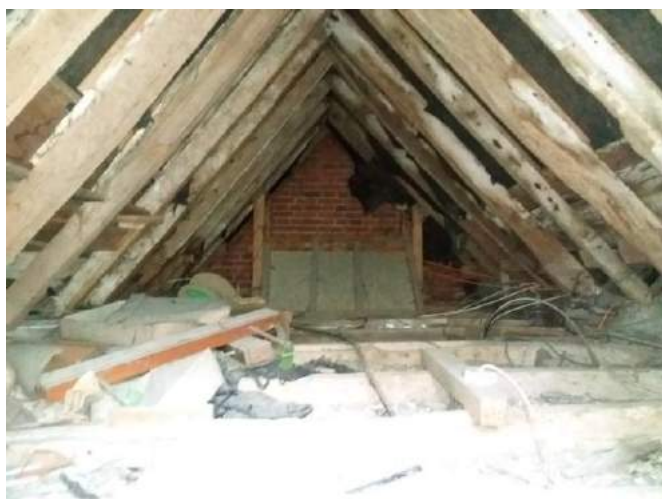
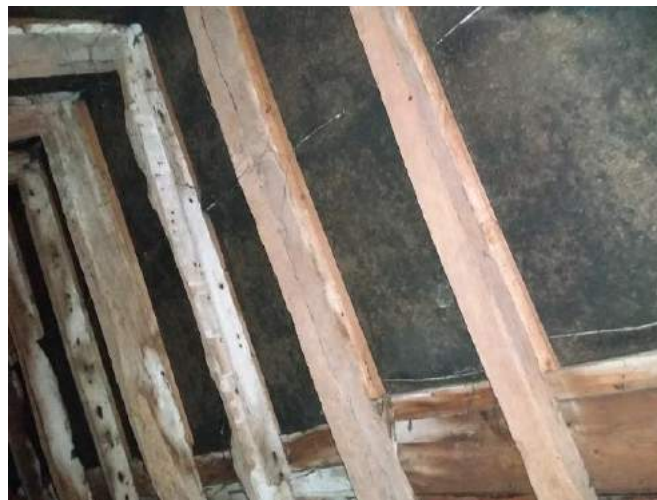
Comments: Bitumen sarking felt to underside of pitched roof

| Action: | No further action required | | |

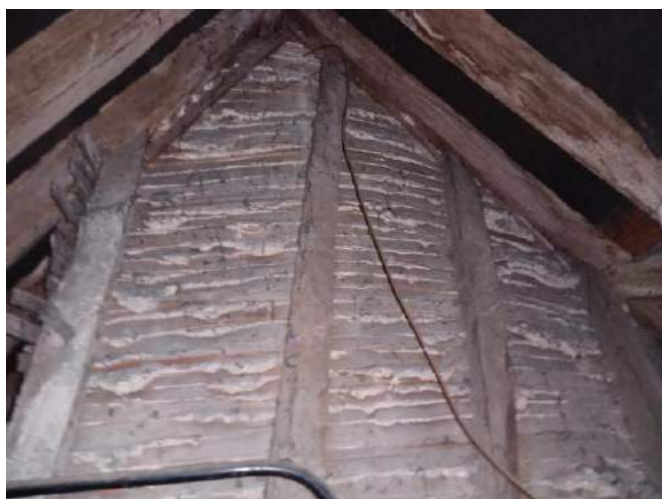
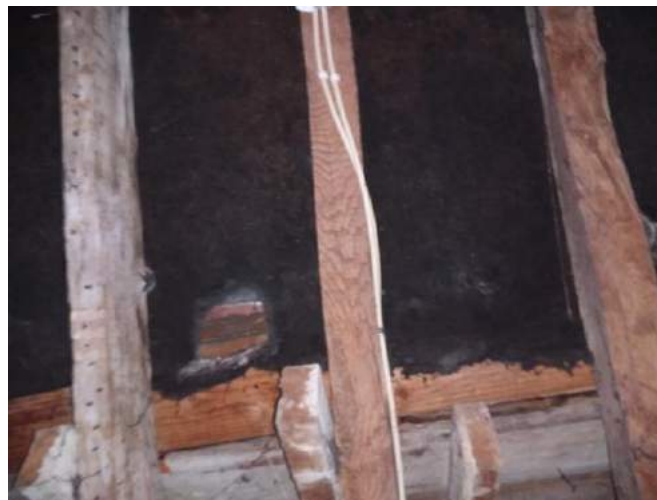
Comments: Bitumen sarking felt to underside of pitched roof

| Action: | No further action required | | |

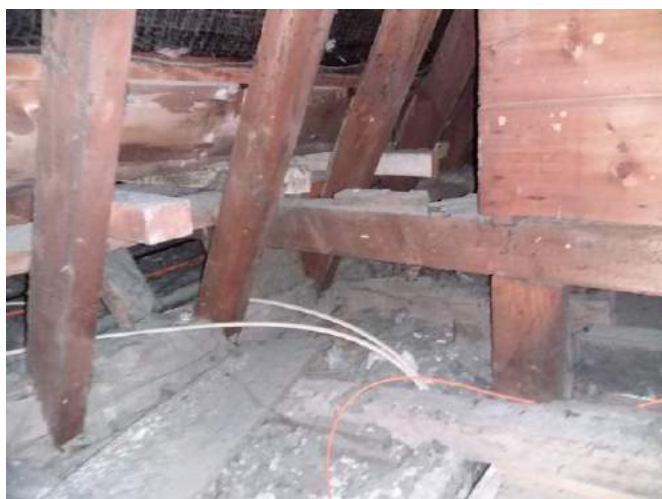
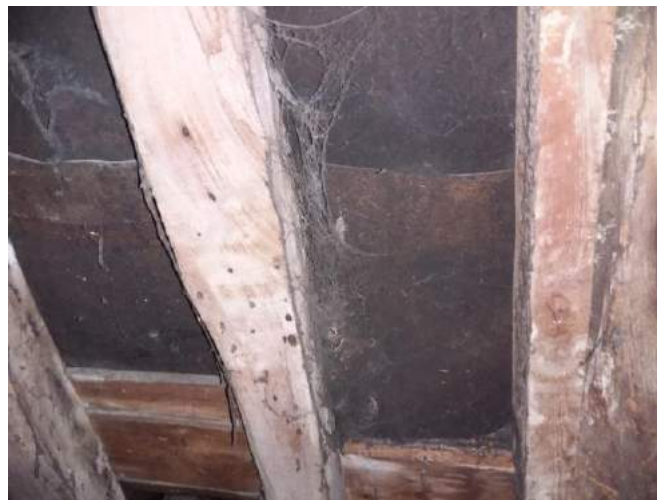
Comments: Bitumen sarking felt to underside of pitched roof

| Action: | No further action required | | |

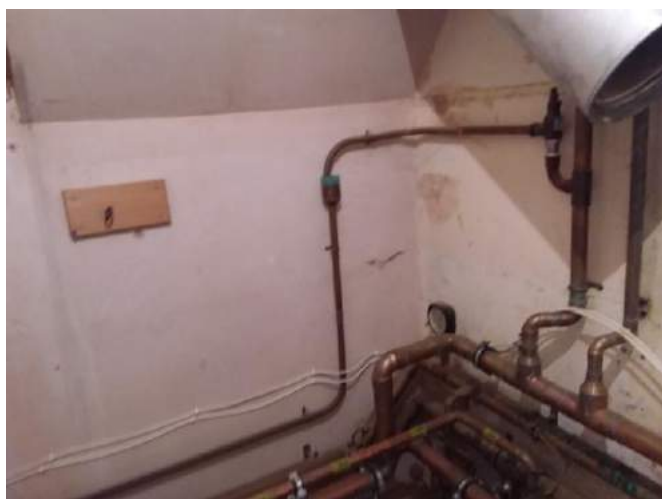
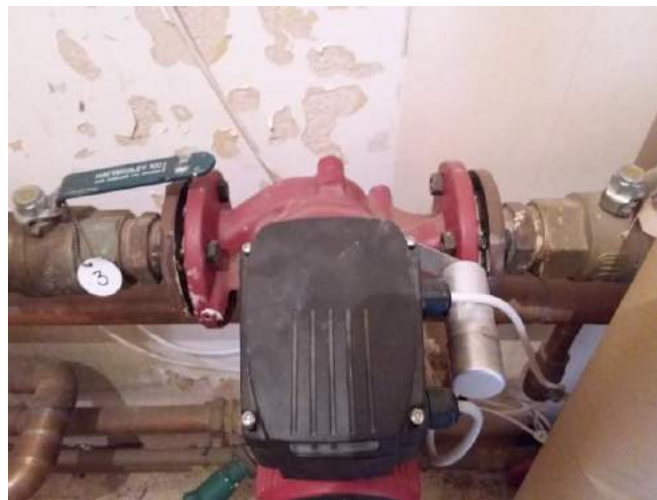
Comments:

Gaskets to pipework

| Action: | No further action required | | |

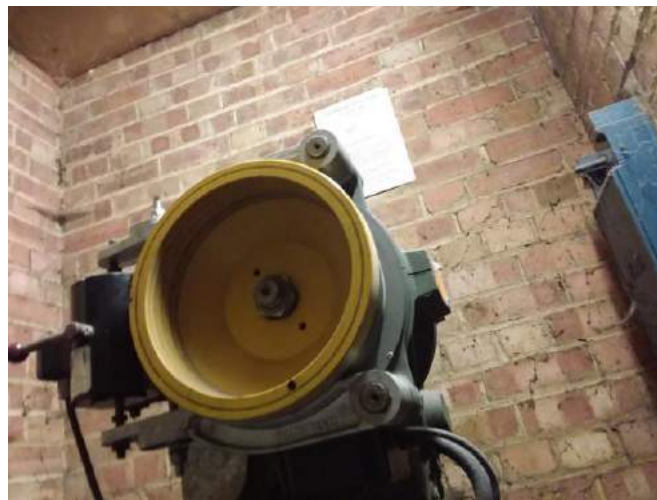
Comments: No access within live lift - presumed brake shoes

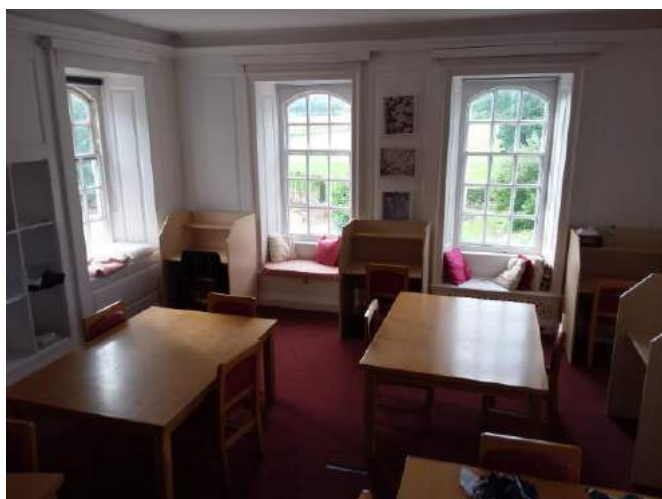
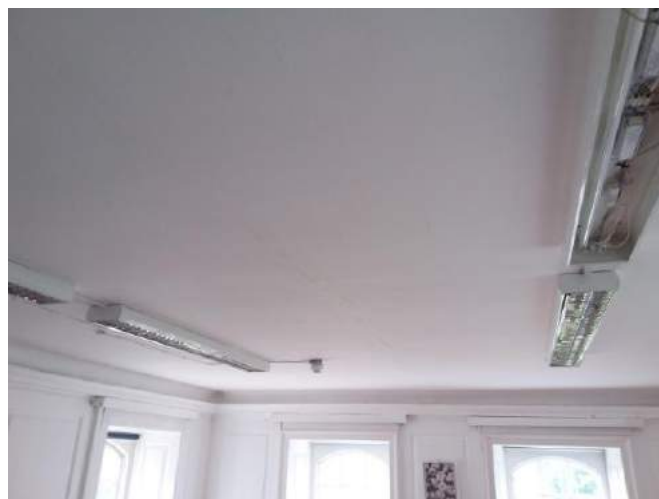
Comments: Insulating board ceiling

| Action: | No further action required | | |

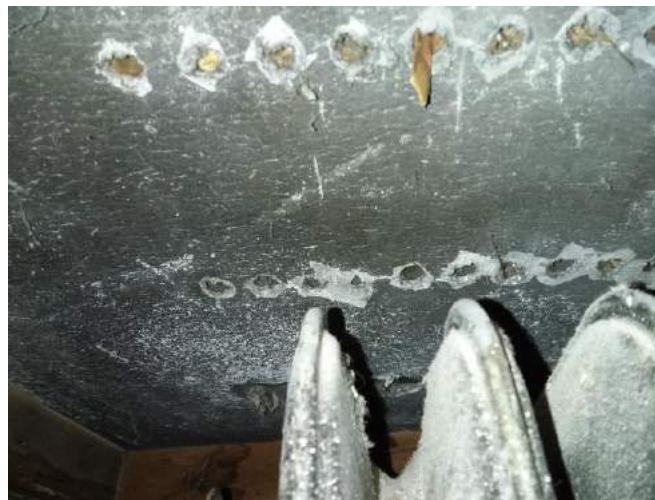
Comments: Asbestos insulating board lining to radiator housing

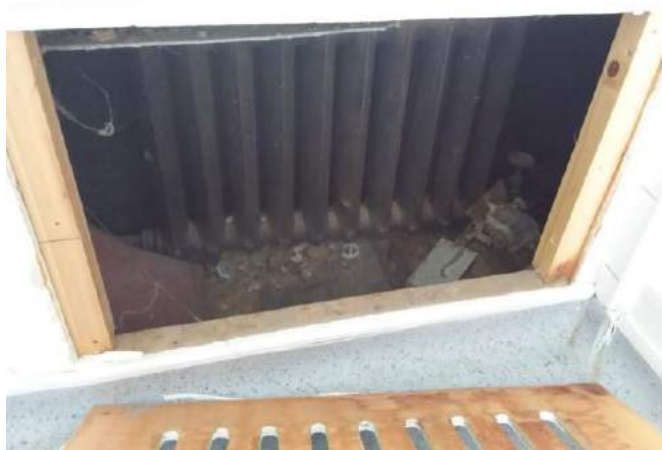
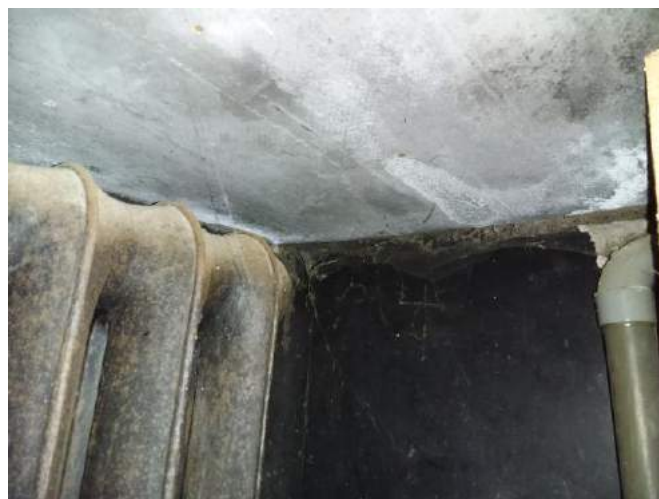
Comments: Asbestos insulating board lining to radiator housing

| Action: | Encapsulate, monitor and manage | | |

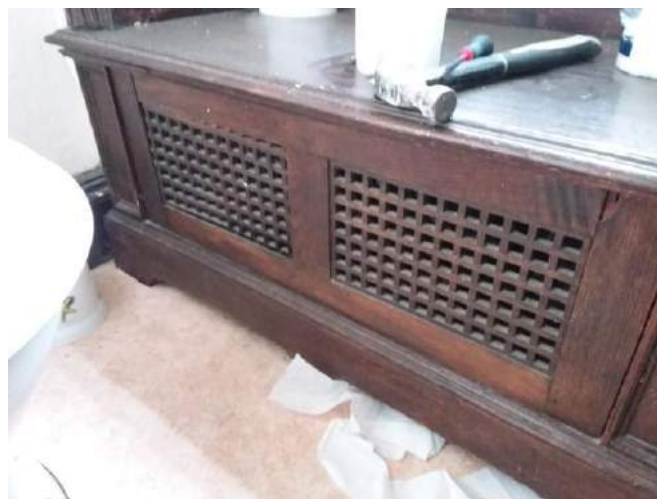
Comments: Asbestos insulating board lining to radiator housing

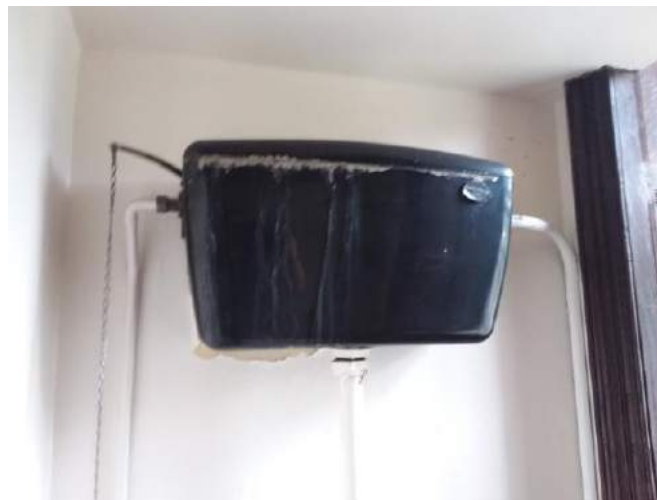
Comments:

Thermoplastic toilet cistern

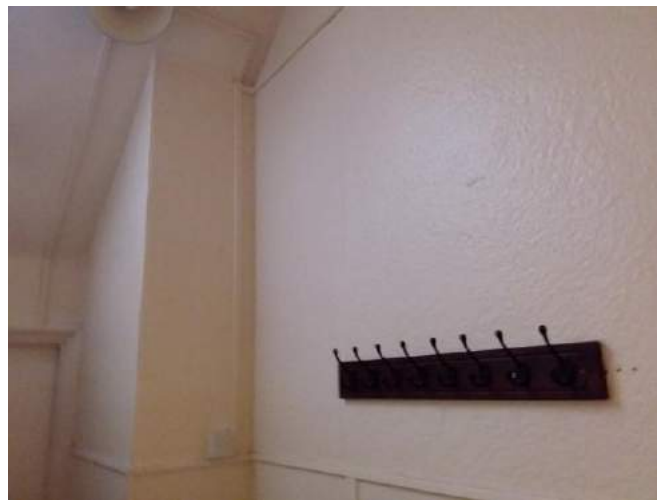
Comments: Insulating board wall lining

| Action: | No further action required | | |

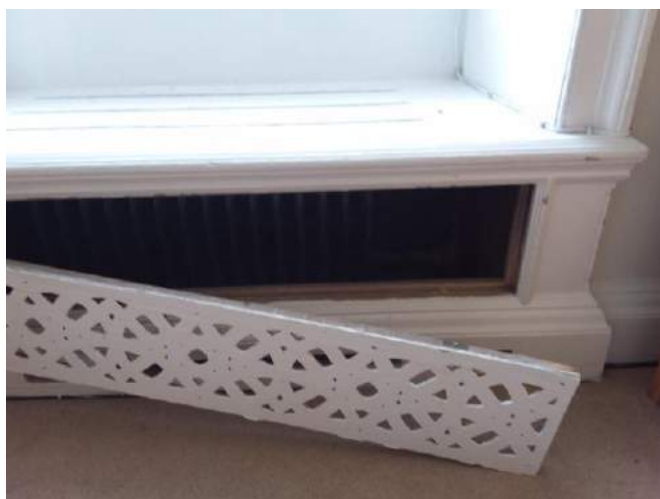
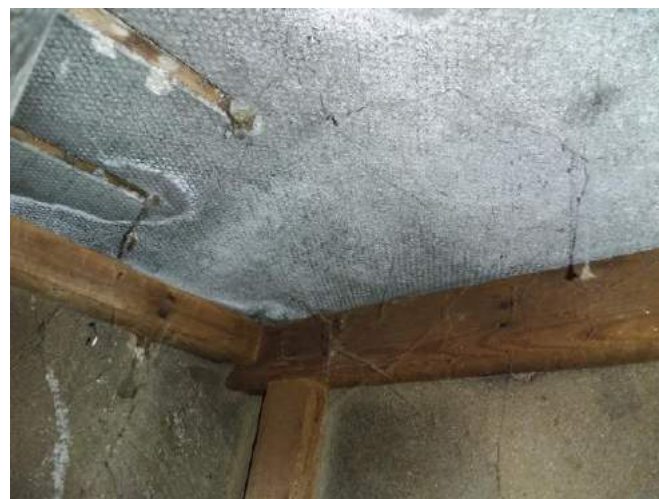
Comments: Asbestos insulating board lining to radiator housing

| Action: | Encapsulate, monitor and manage | | |

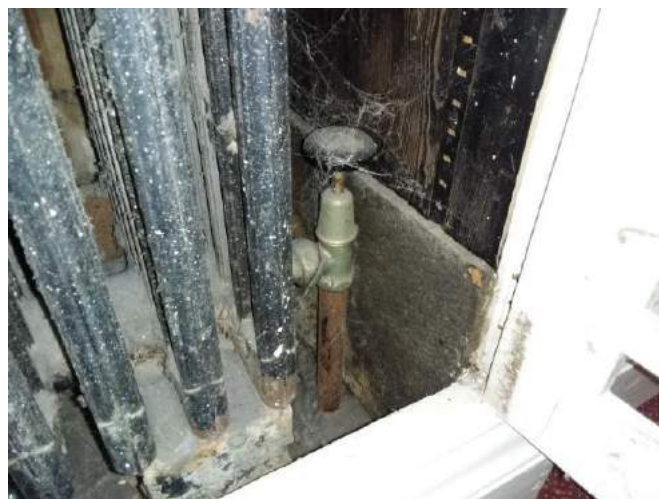
Comments: Insulating board lining within radiator housing

| Action: | No further action required | | |

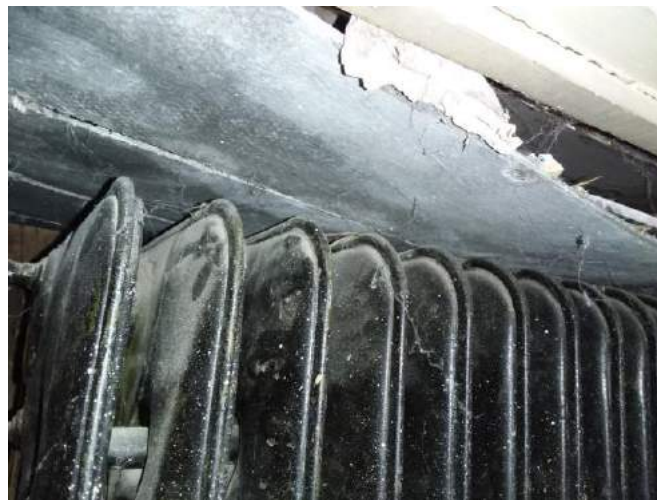
Comments: Asbestos insulating board lining to radiator housing

| Action: | Repair, encapsulate, monitor and manage | | |

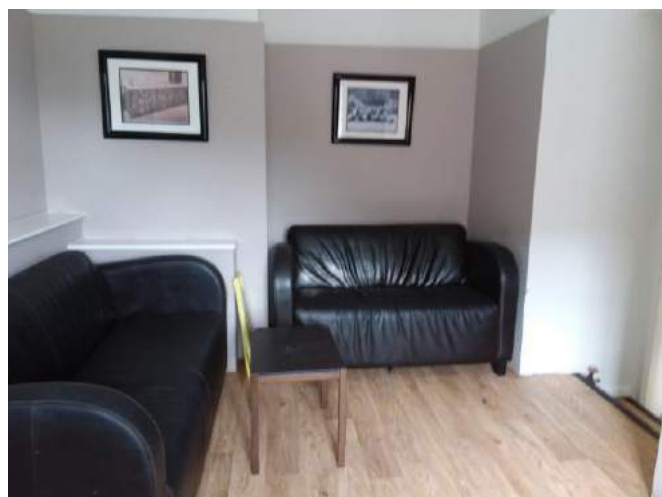
Comments: Asbestos insulating board door lining

| Action: | Encapsulate, monitor and manage | | |

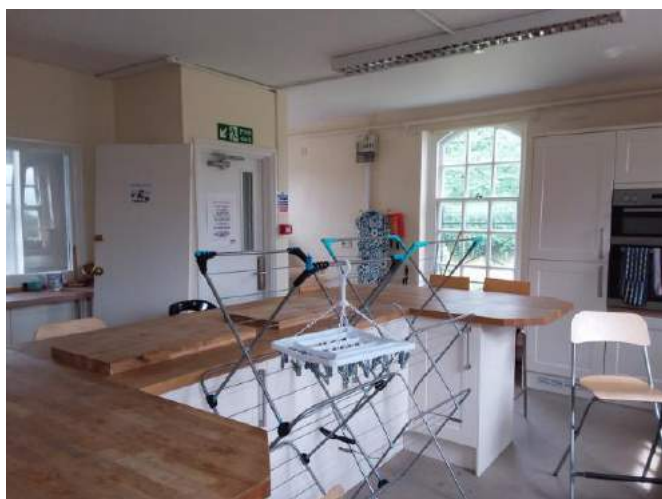
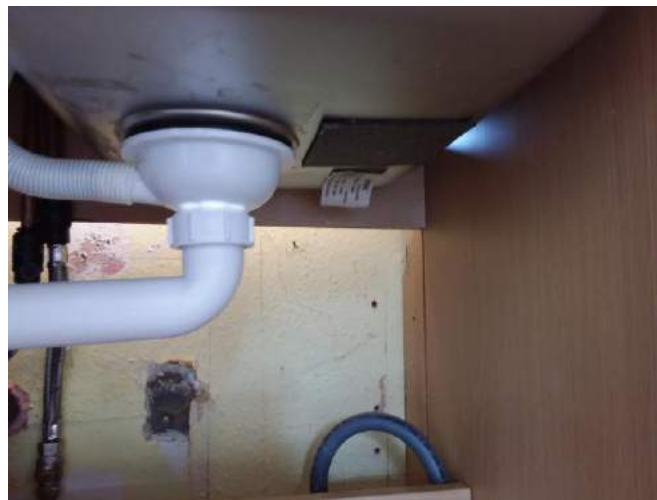
Comments: Bitumen pad to underside of sink

| Action: | No further action required | | |

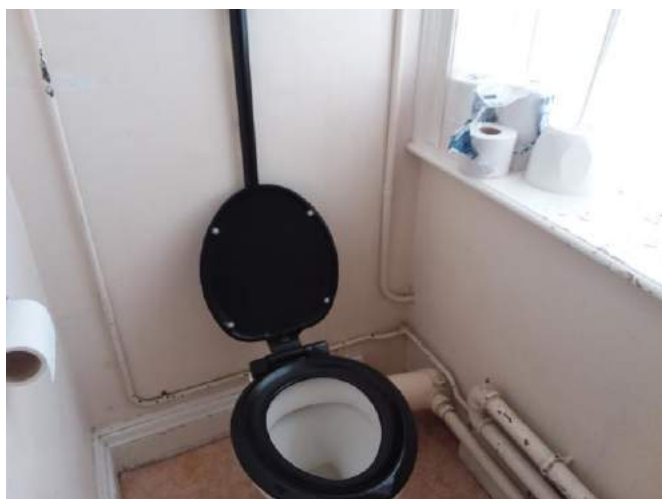
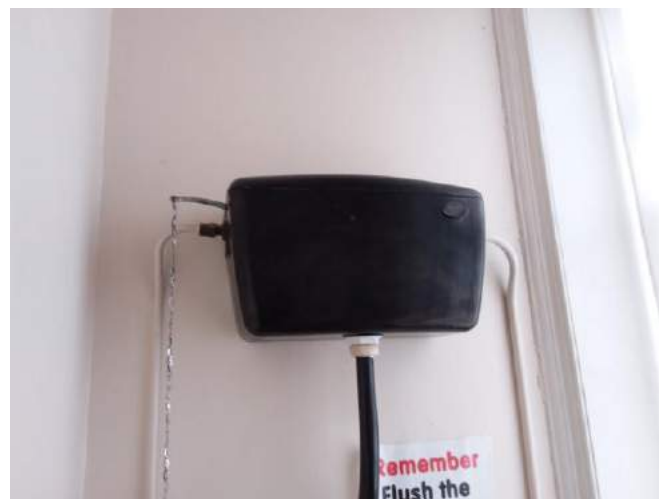
Comments: Thermoplastic toilet cistern

| Action: | Monitor and manage | | |

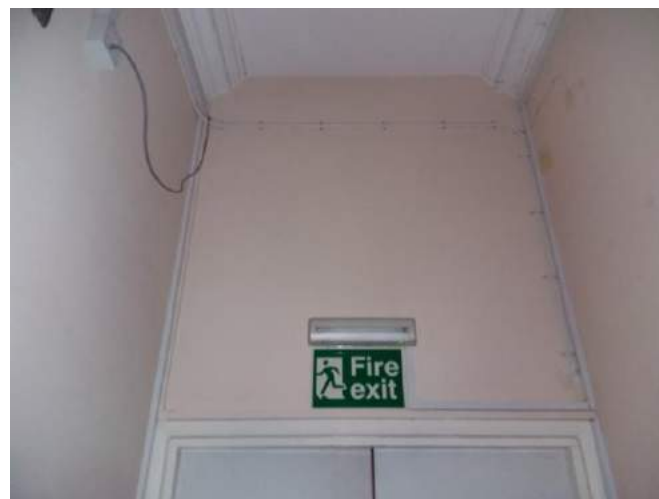
Comments: Asbestos insulating board door head panel

| Action: | Monitor and manage | | |

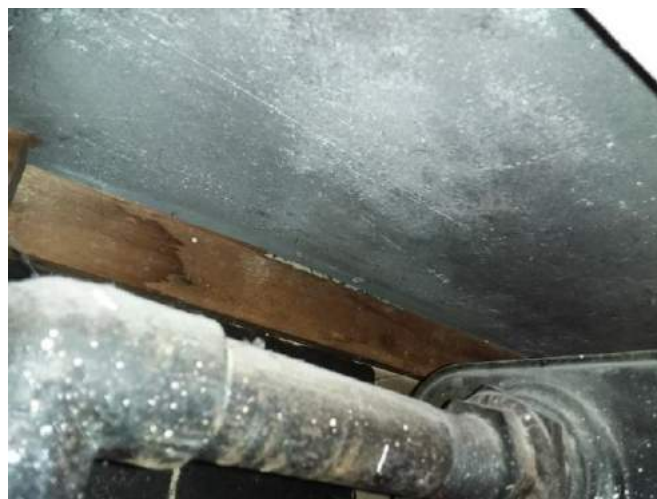
Comments: Asbestos insulating board lining to radiator housing

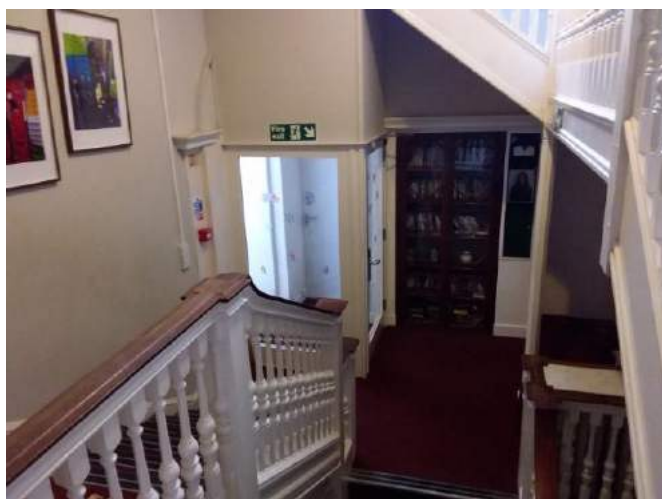
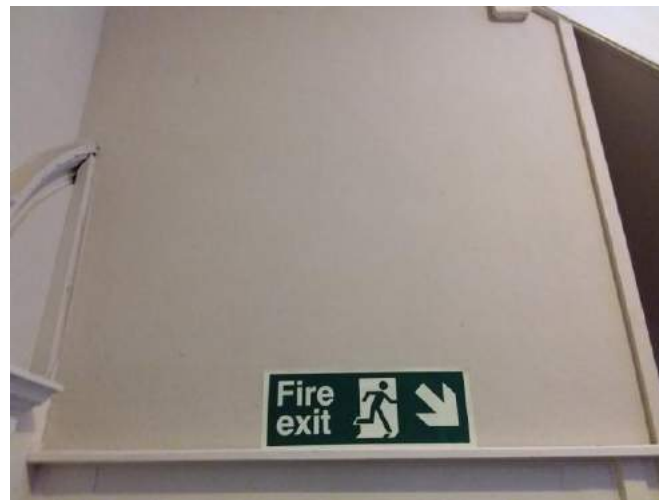
Comments: Asbestos insulating board door head panel

| Action: | Monitor and manage | | |

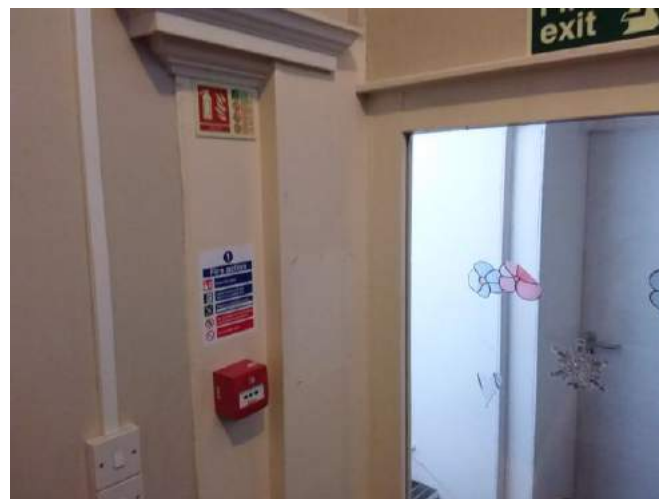
Comments: Asbestos insulating board infill panel to wall

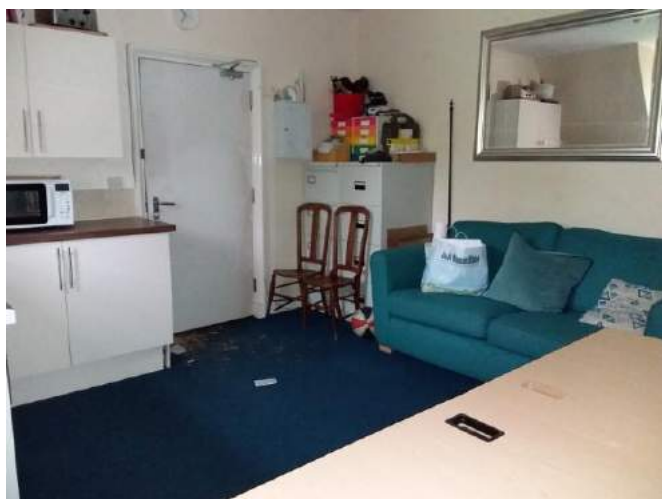
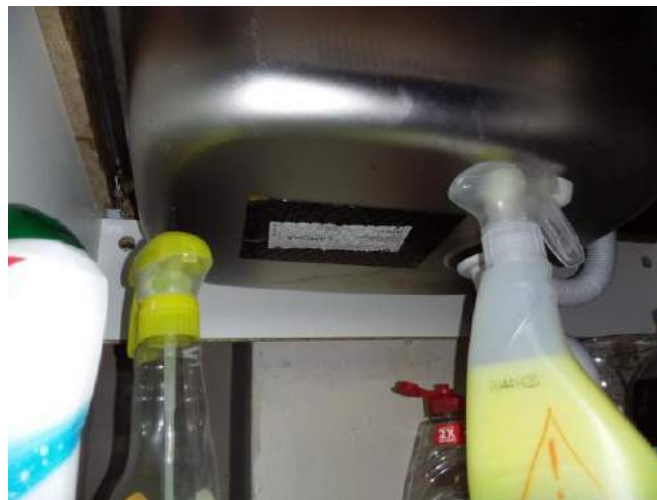
Comments: Bitumen pad to underside of sink

| Action: | No further action required | | |

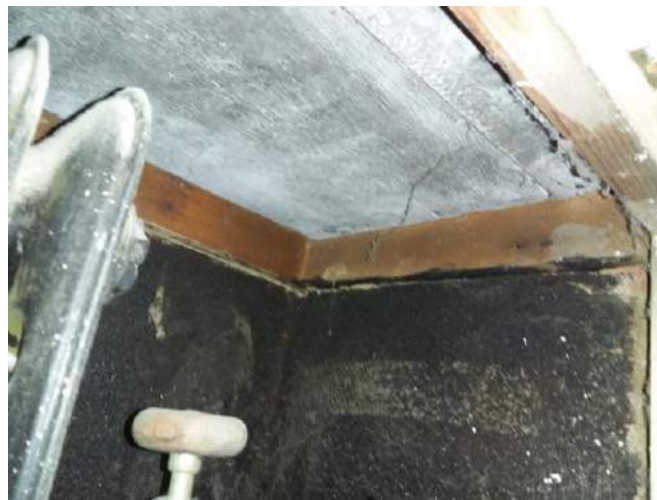
Comments: Asbestos insulating board lining to radiator housing

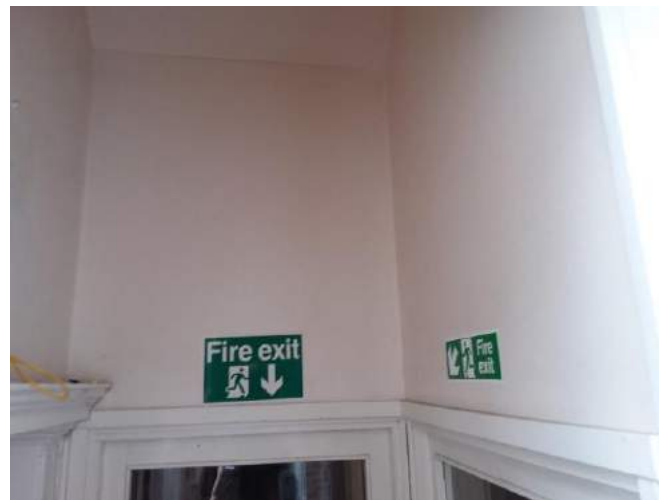
Comments: Asbestos insulating board door head panel

| Floor: | 1st Floor | Damage: | Good condition 0 |
