## Asbestos Inspection Report Management Survey

Princess Helena College  
School Lane  
Preston  
Hitchin  
Hertfordshire  
SG4 7RT

Project No: G-03774  
Report Issue: 1  
Date: Aug 2020

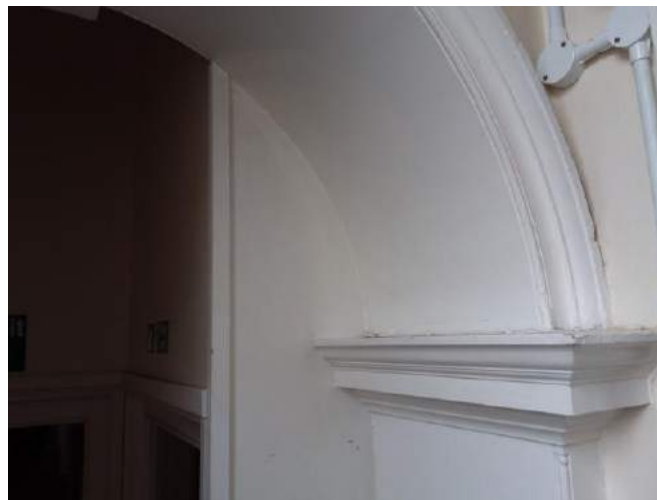
Comments: Asbestos insulating board infill panel to wall

| Floor: | 1st Floor | Damage: | N/A |

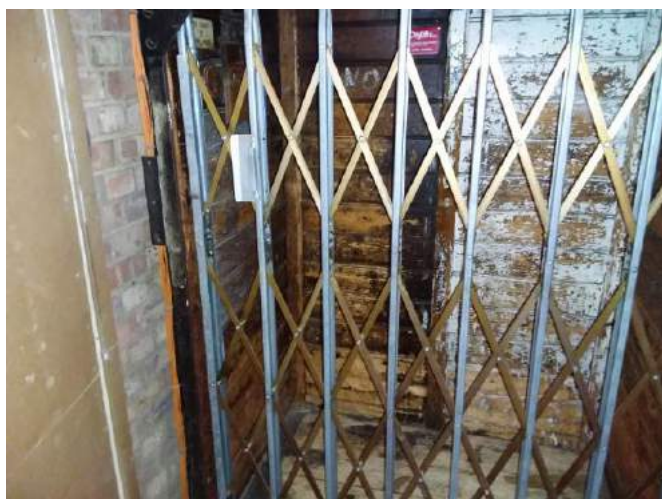
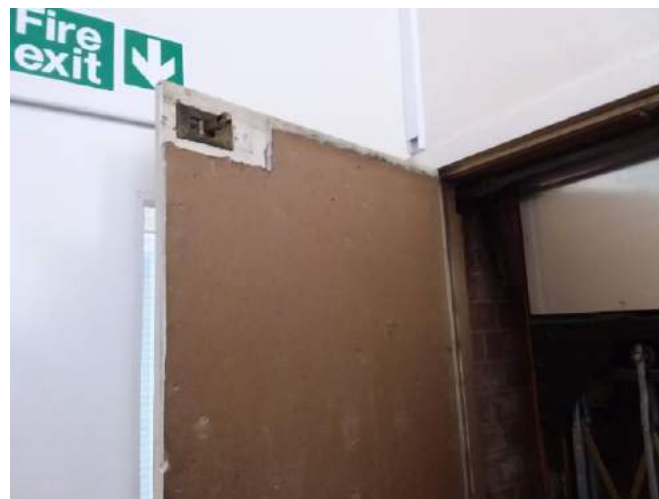
Comments: Insulating board door lining

| Floor: | 1st Floor | Damage: | N/A |

| Action: | No further action required | | |

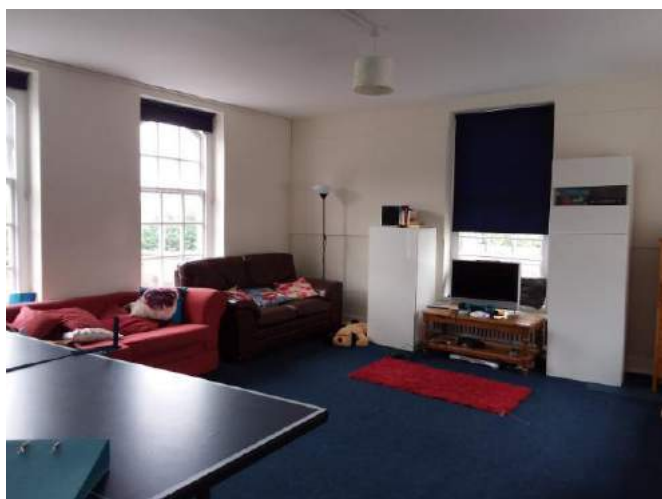
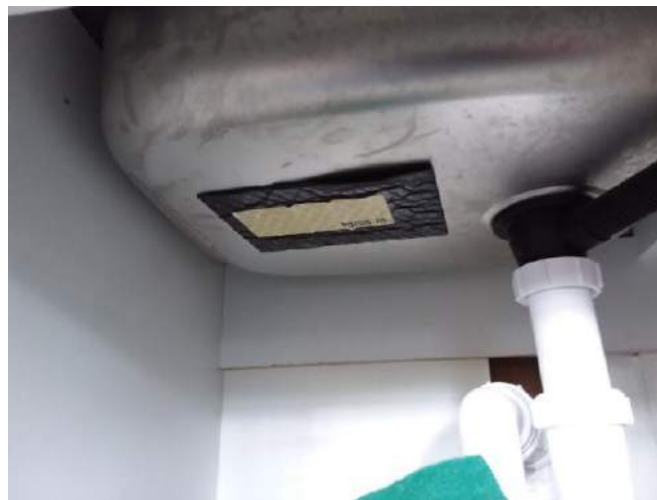
Comments: Bitumen pad to underside of sink

| Floor: | 1st Floor | Damage: | Good condition 0 |

| Action: | Monitor and manage | | |

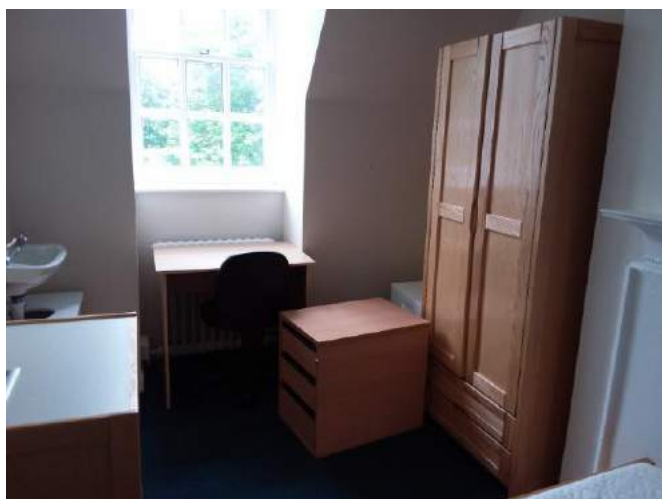
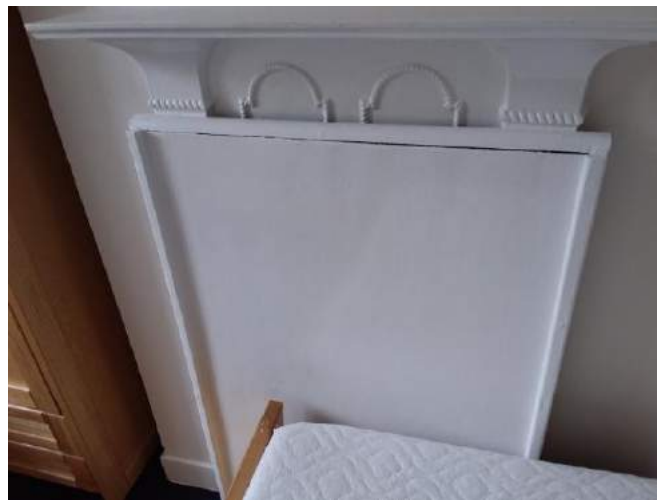
Comments: Cement panel over fireplace

| Floor: | 1st Floor | Damage: | N/A |

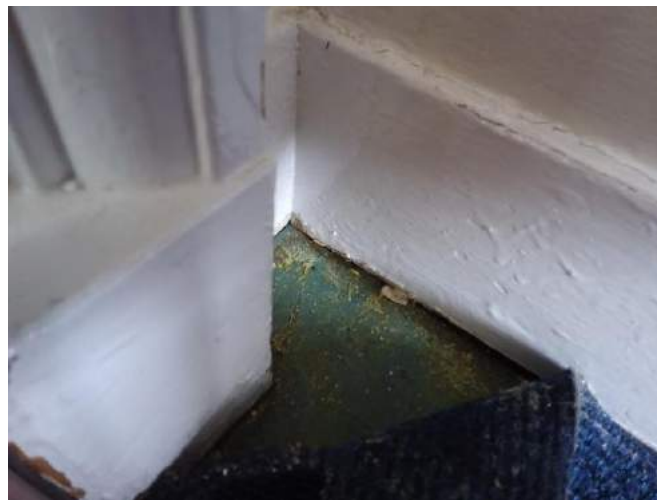
Comments: Vinyl floor covering beneath carpet

| Floor: | 1st Floor | Damage: | N/A |

| Action: | No further action required | | |

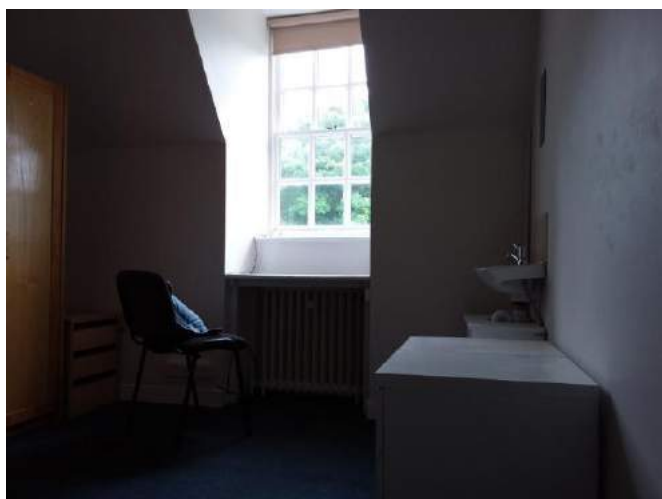
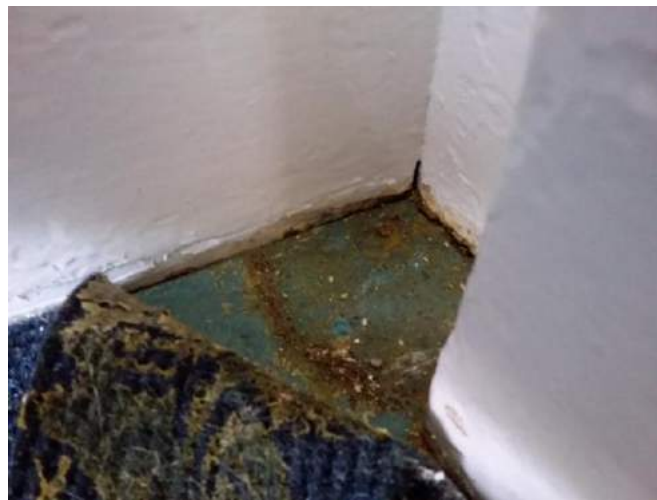
Comments: Vinyl floor covering beneath carpet

| Floor: | 1st Floor | Damage: | Good condition 0 |

| Action: | Monitor and manage | | |

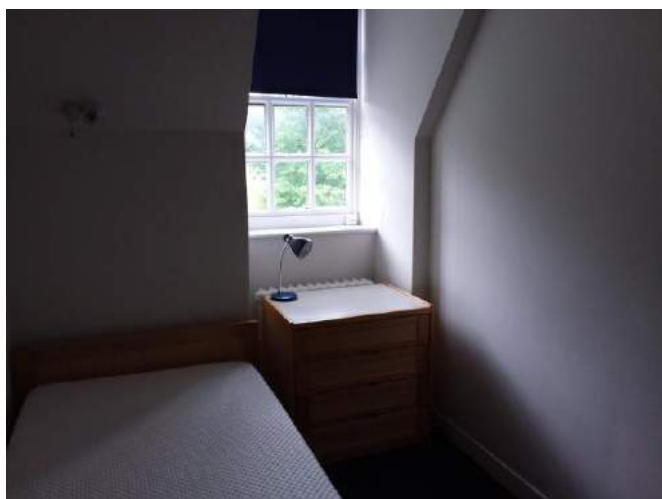
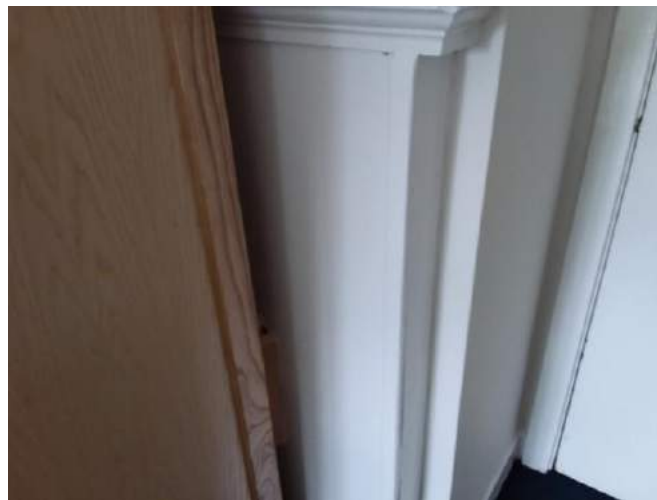
Comments: Cement panel over fireplace

| Floor: | 1st Floor | Damage: | N/A |

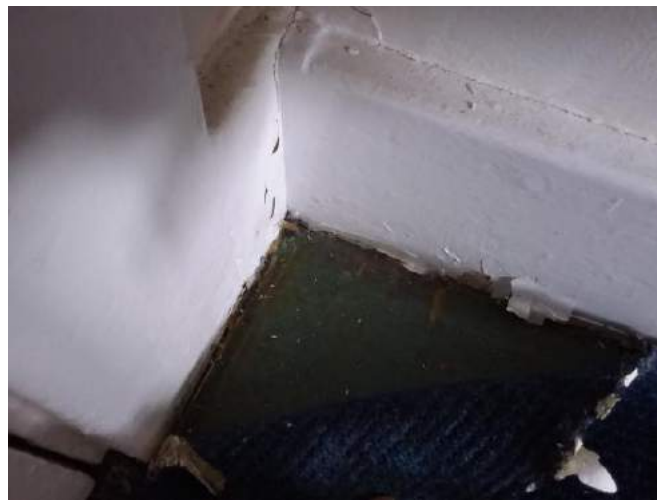
Comments: Vinyl floor covering beneath carpet

| Floor: | 1st Floor | Damage: | N/A |

| Action: | No further action required | | |

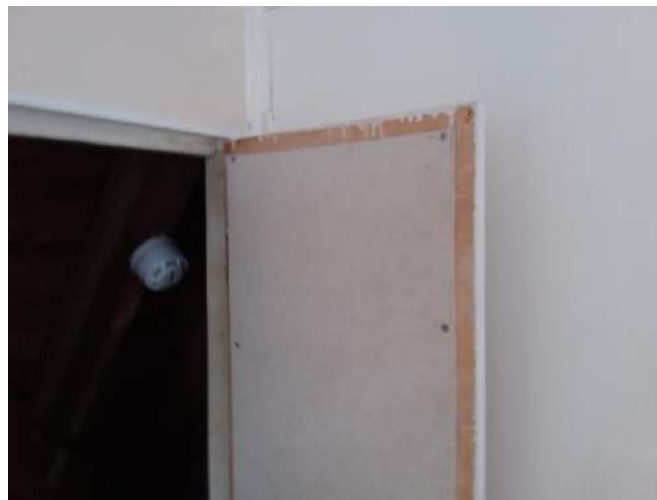
Comments: Insulating board door lining

| Floor: | 1st Floor | Damage: | Good condition 0 |

| Action: | Monitor and manage | | |

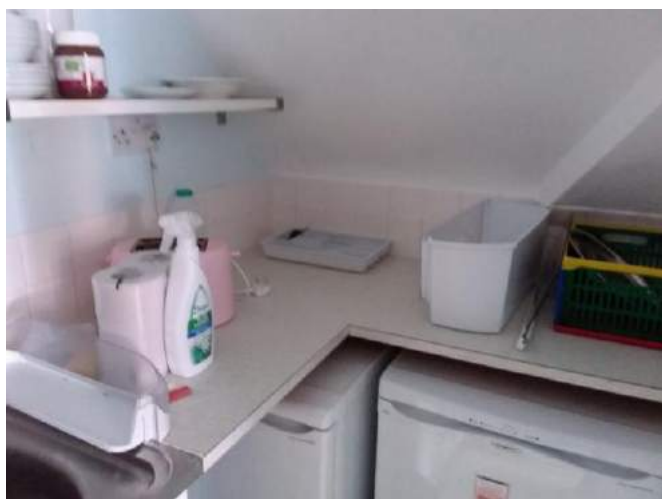
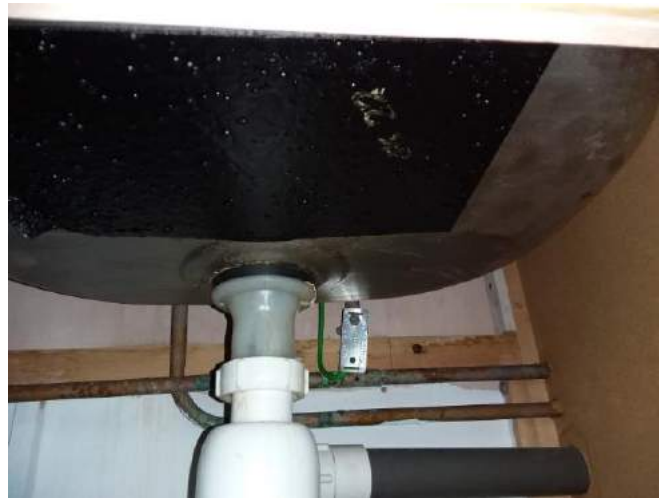
Comments: Bitumen pad to underside of sink

| Floor: | 1st Floor | Damage: | Low damage 1 |

| Action: | Encapsulate, monitor and manage | | |

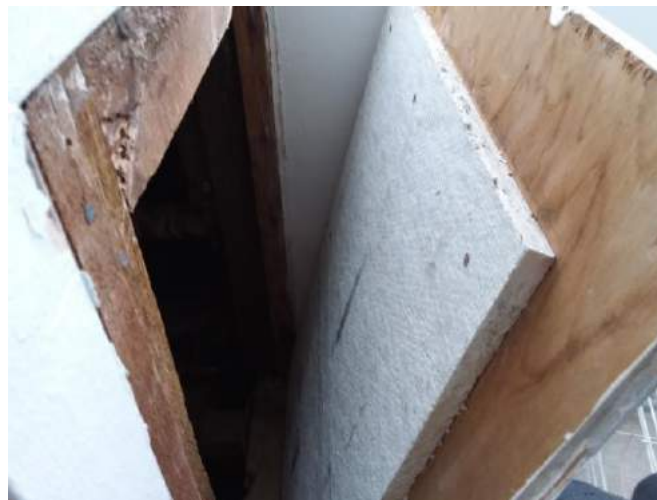
Comments: Asbestos insulating board lining to timber boxing

| Floor: | 1st Floor | Damage: | N/A |

| Action: | No further action required | | |

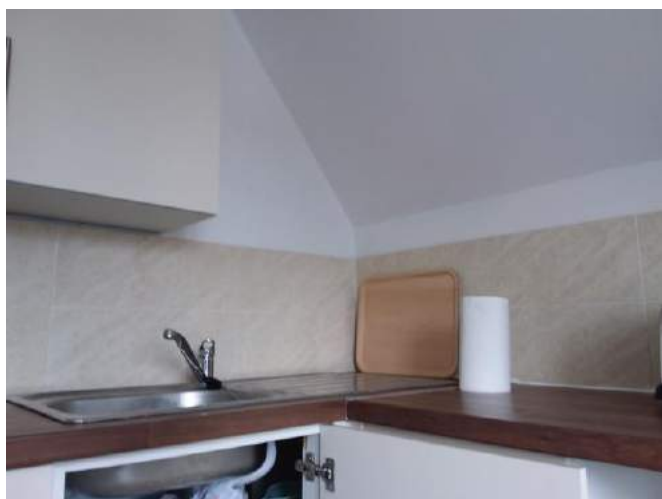
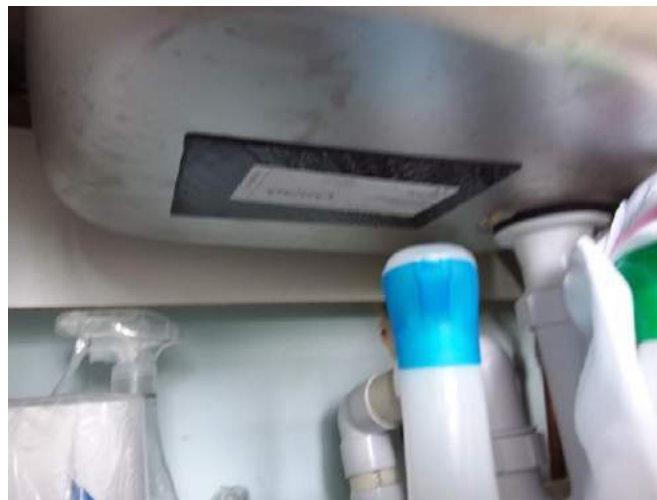
Comments: Bitumen pad to underside of sink

| Floor: | 1st Floor | Damage: | Good condition 0 |

| Action: | Encapsulate, monitor and manage | | |

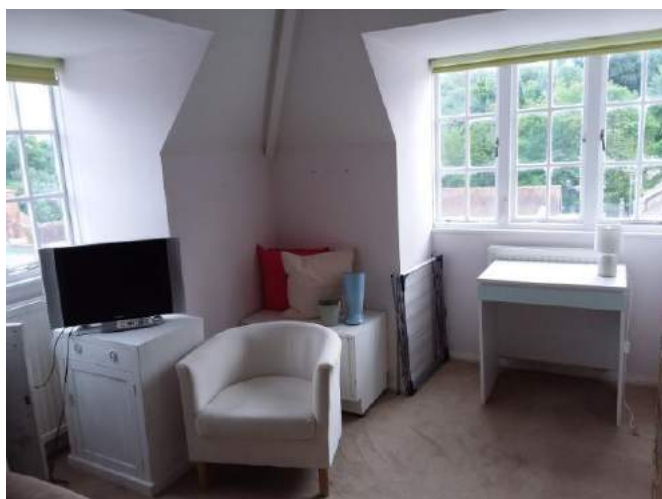
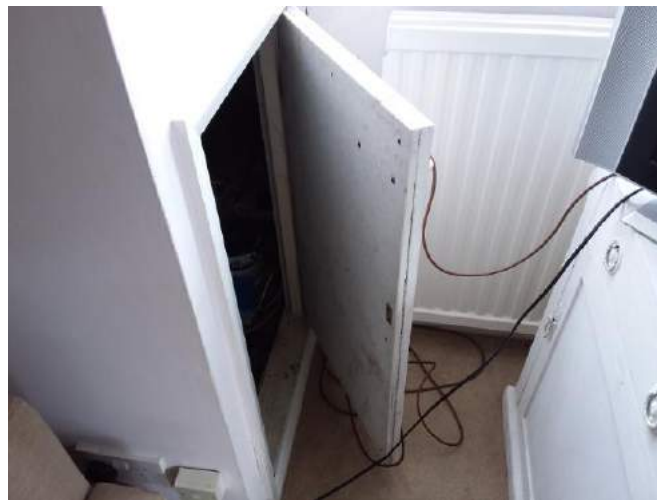
Comments: Asbestos insulating board door lining to wall void

| Floor: | 1st Floor | Damage: | Good condition 0 |

| Action: | Encapsulate, monitor and manage | | |

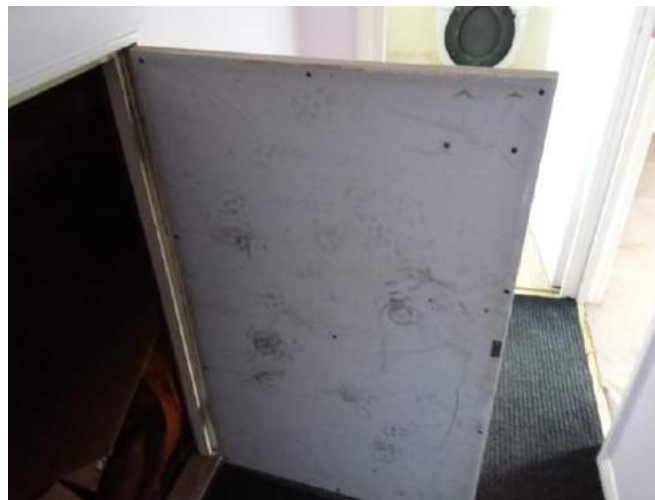
Comments: Asbestos insulating board door lining to wall void

| Floor: | 1st Floor | Damage: | Low damage 1 |

| Action: | Encapsulate, monitor and manage | | |

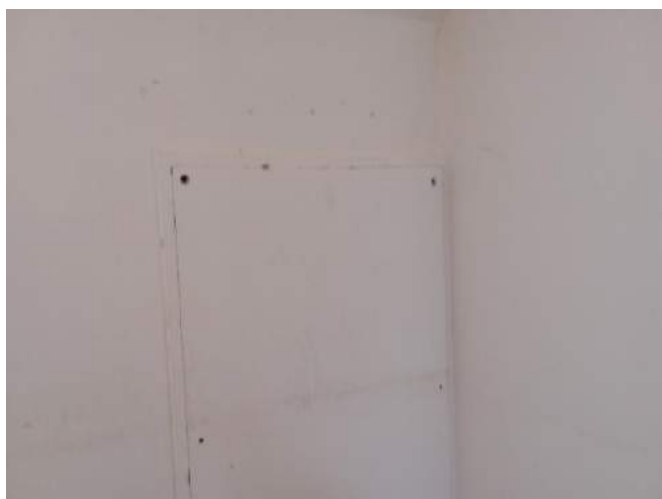
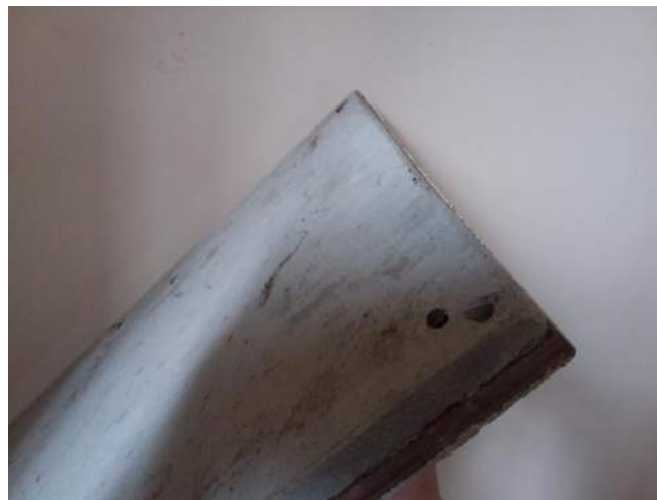
Comments: Asbestos insulating board lining to back of timber access hatch

| Floor: | 1st Floor | Damage: | Good condition 0 |

| Action: | Monitor and manage | | |

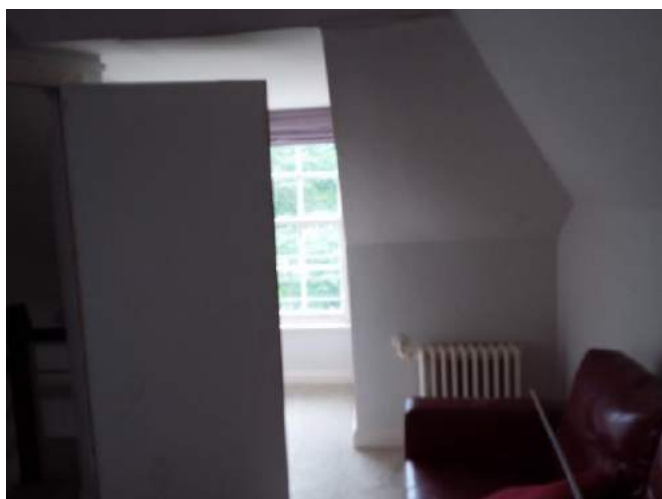
Comments: Asbestos insulating board door lining to redundant door

| Floor: | 1st Floor | Damage: | N/A |

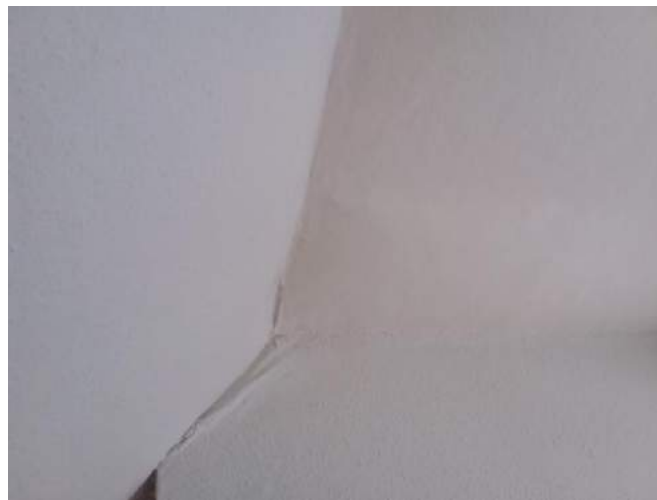
Comments: Insulating board ceiling and wall lining

| Floor: | 1st Floor | Damage: | N/A |

| Action: | No further action required | | |

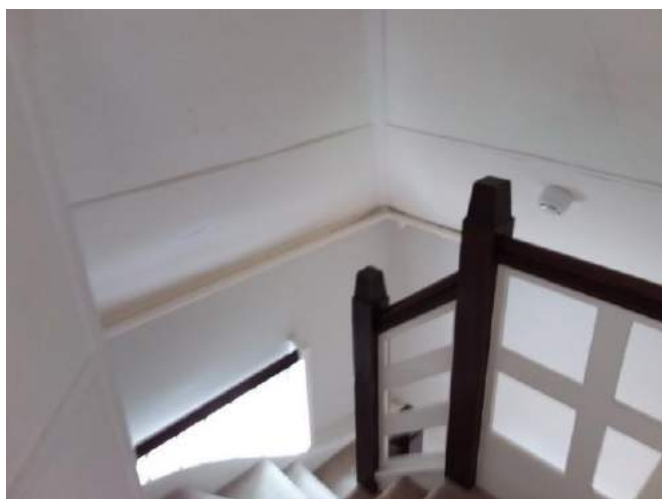
Comments: Insulating board ceiling and wall panels

| Floor: | 1st Floor | Damage: | Low damage 1 |

| Action: | Encapsulate, monitor and manage | | |

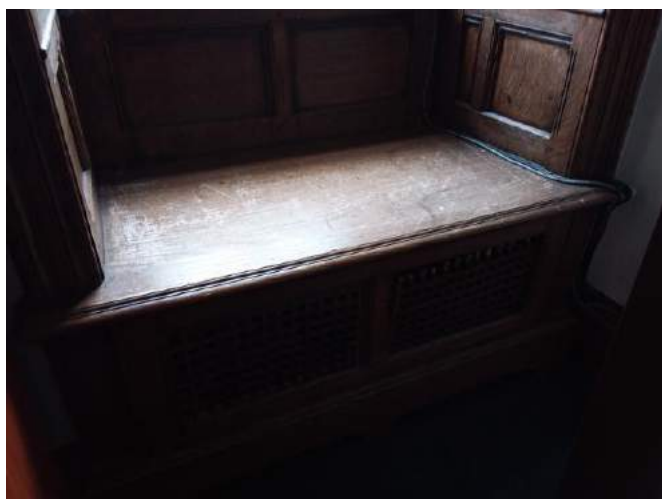
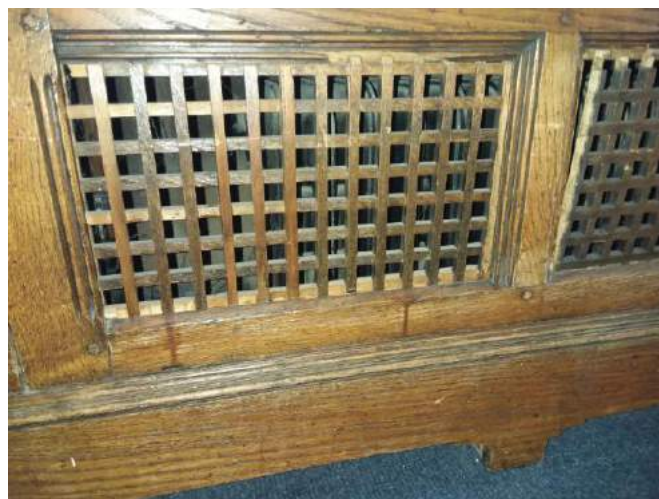
Comments: Asbestos insulating board lining to radiator housing

| Floor: | Ground Floor Mezzanine | Damage: | N/A |

| Action: | No further action required | | |

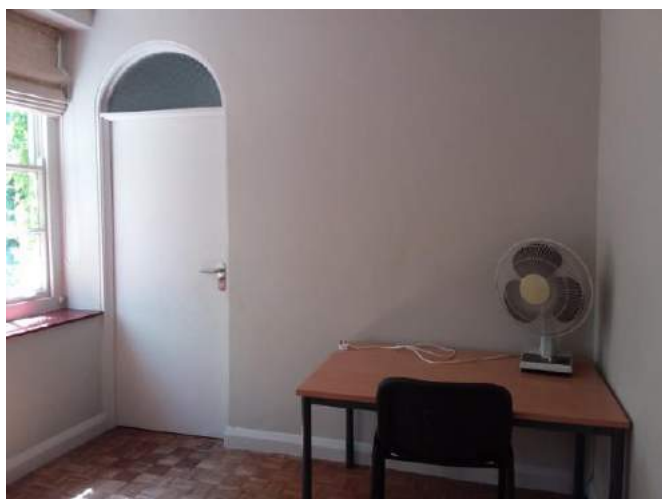
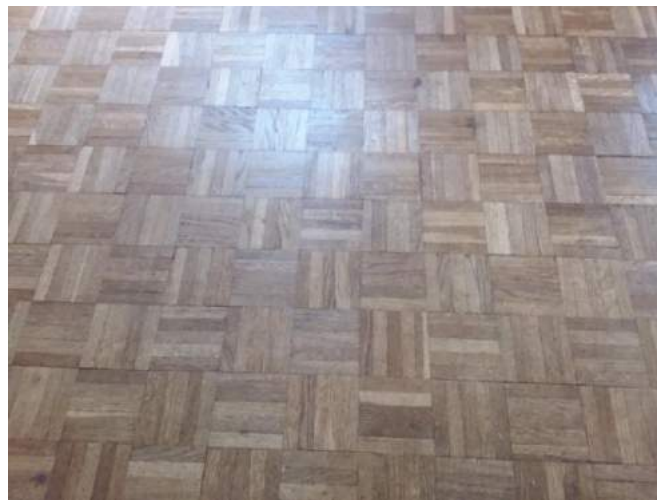
Comments: Bitumen adhesive to parquet flooring

| Floor: | Ground Floor Mezzanine | Damage: | N/A |

| Action: | No further action required | | |

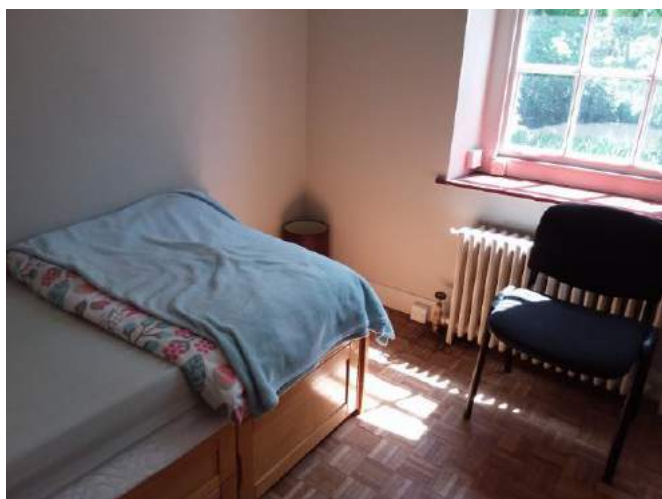
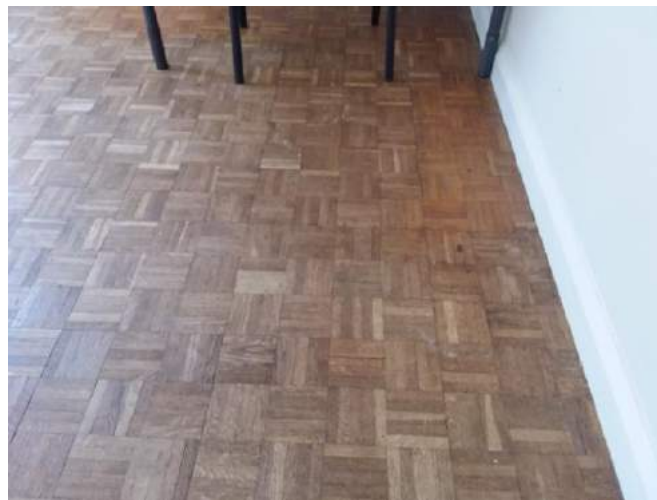
Comments: Bitumen adhesive to parquet flooring

| Floor: | Ground Floor Mezzanine | Damage: | N/A |

| Action: | No further action required | | |

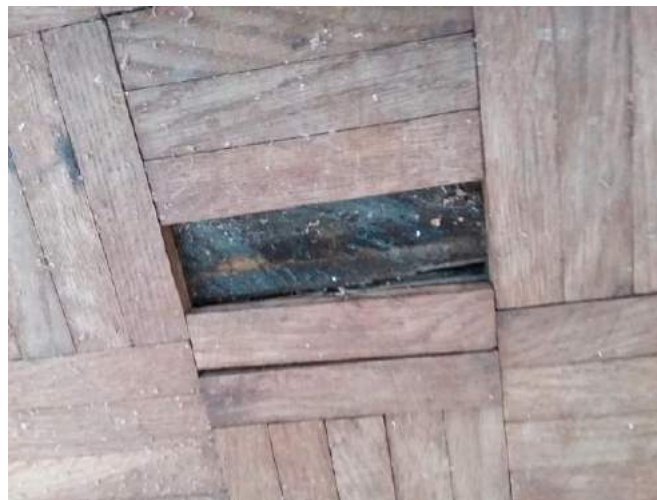
Comments: Bitumen adhesive to parquet flooring

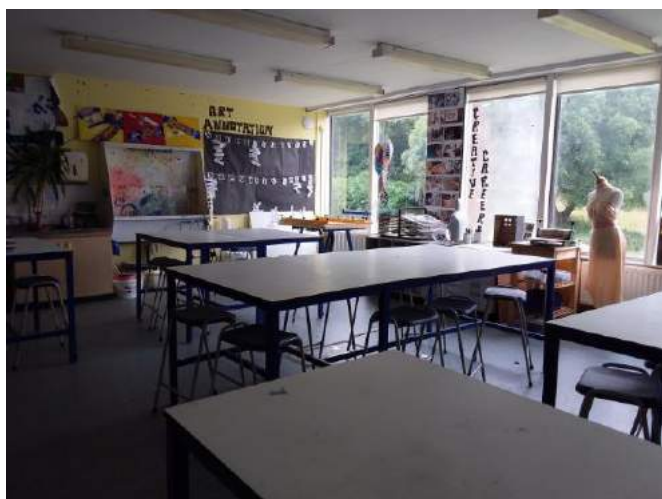
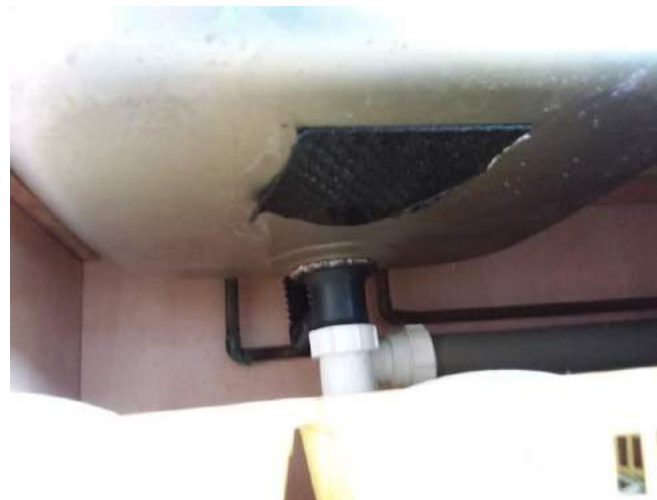
Comments: Bitumen pad to underside of sink

| Action: | No further action required | | |

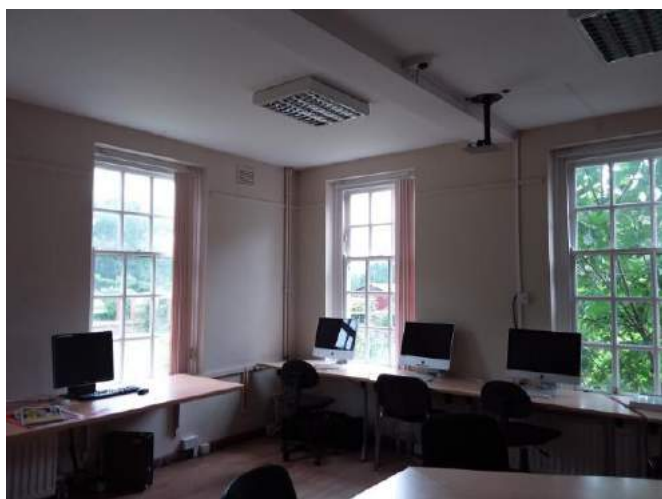
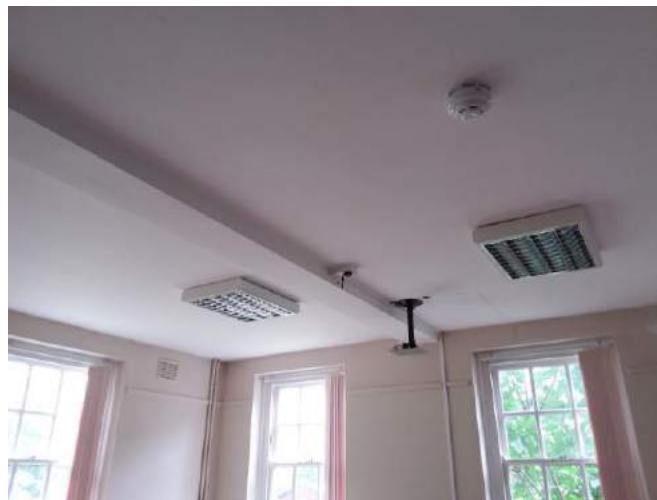
Comments: Insulating board cladding to beams

| Action: | Encapsulate, monitor and manage | | |

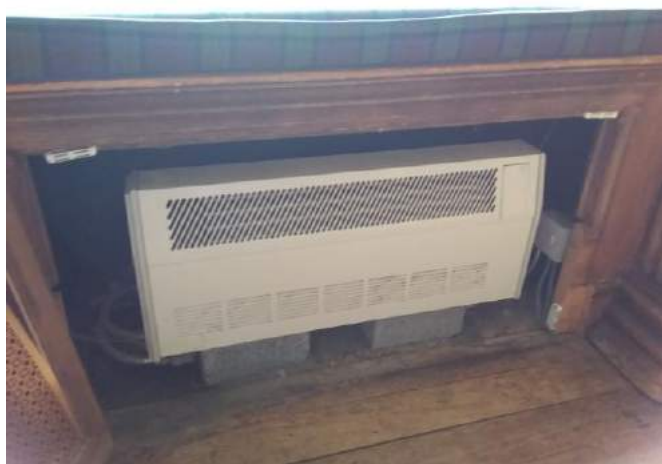
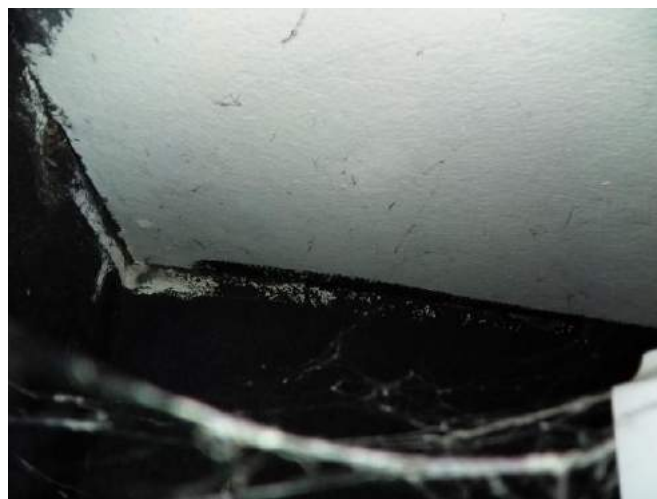
Comments: Asbestos insulating board lining to radiator housing

| Action: | Encapsulate, monitor and manage | | |

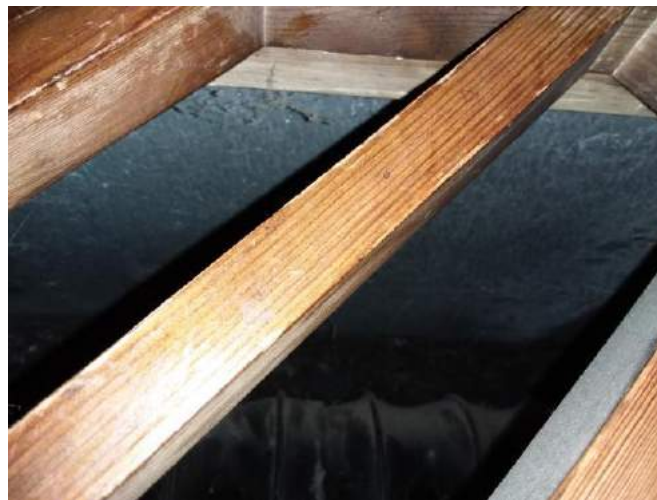
Comments: Asbestos insulating board lining to radiator housing

| Action: | Encapsulate, monitor and manage | | |

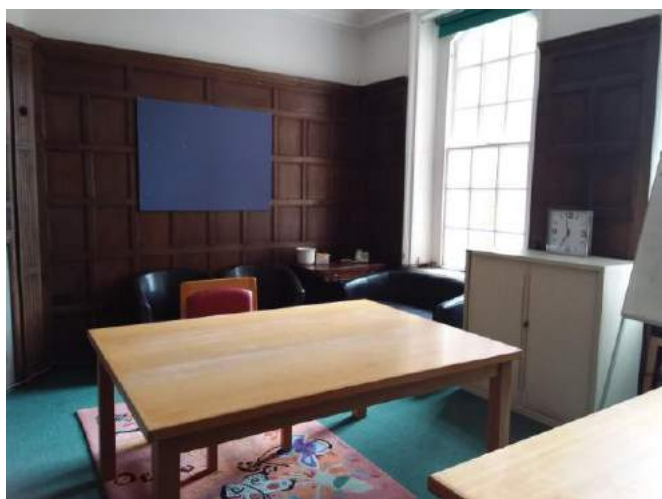
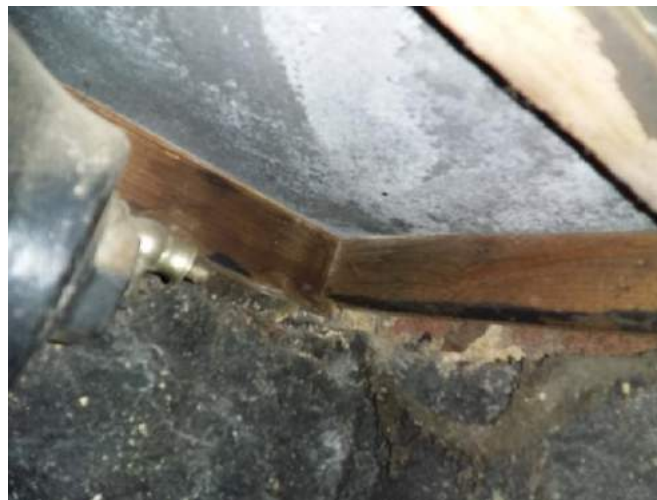
Comments: Asbestos insulating board lining to radiator housing

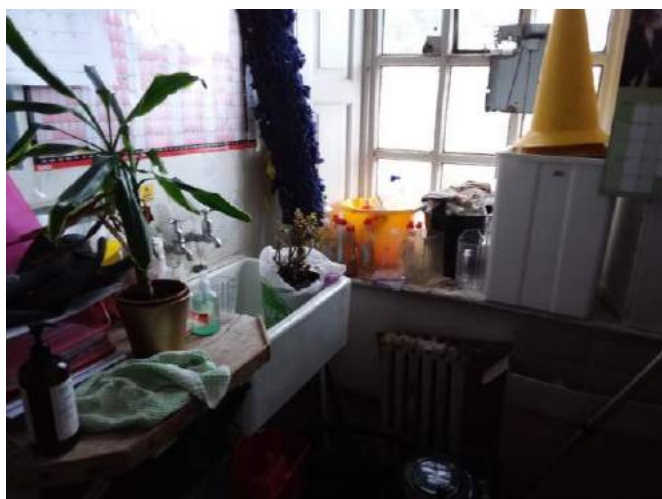
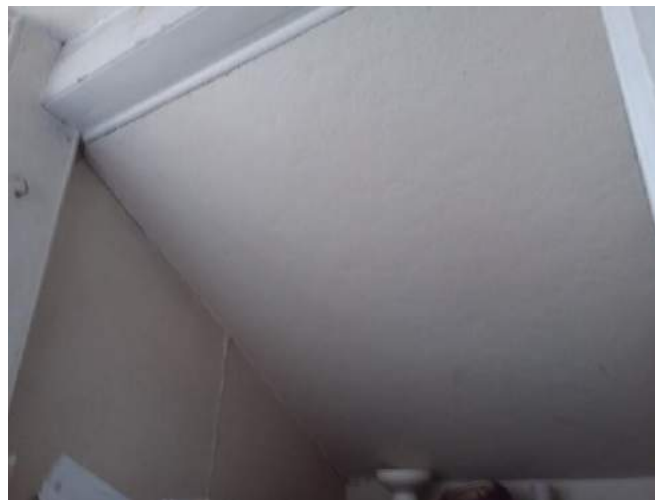
Comments: Insulating board lining to underside of stairs

| Action: | Encapsulate, monitor and manage | | |

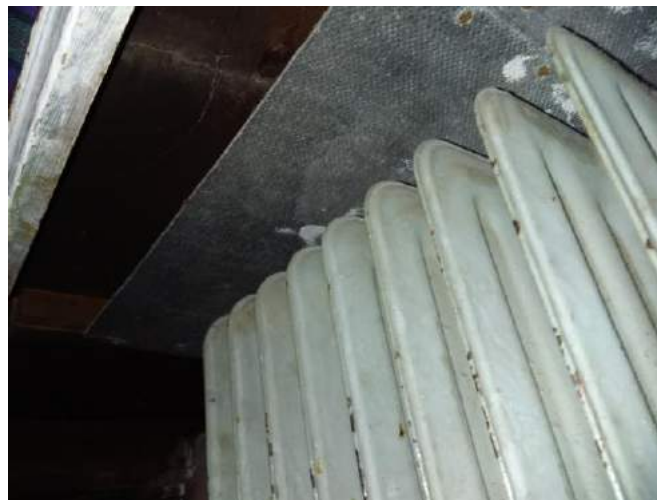
Comments: Asbestos insulating board lining to underside of shelf

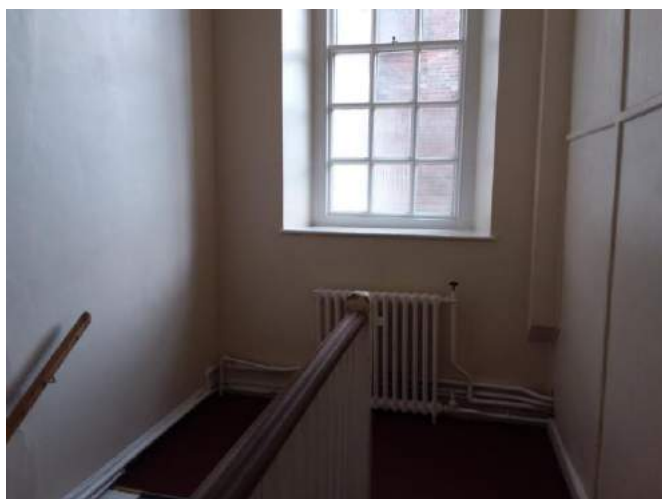
Comments: Insulating board wall panels

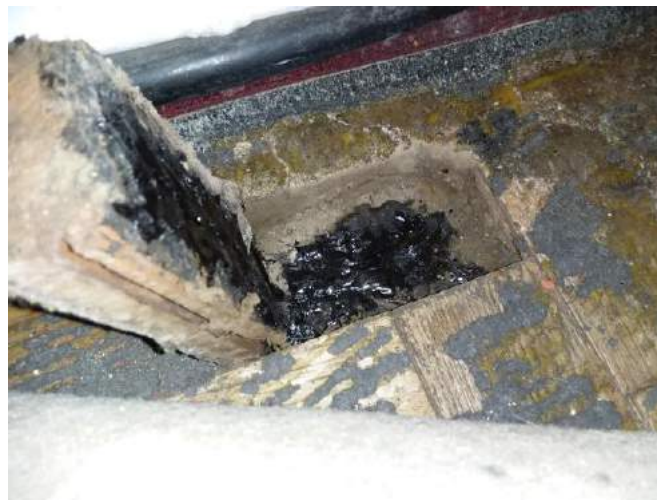
Comments: Bitumen adhesive to parquet flooring beneath carpet

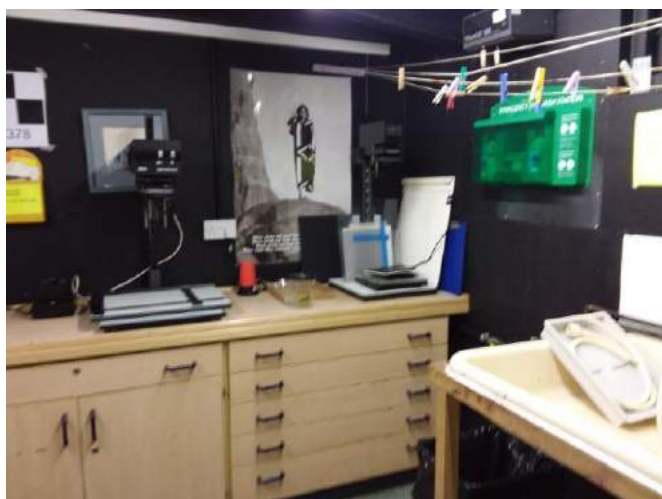
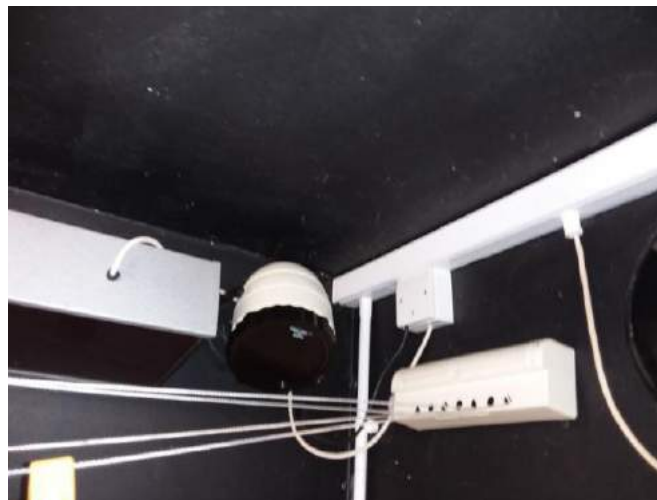
Comments: Insulating board ceiling and wall lining

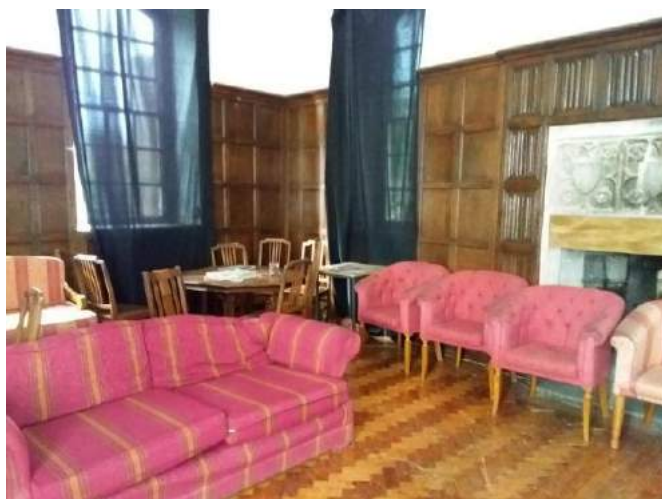
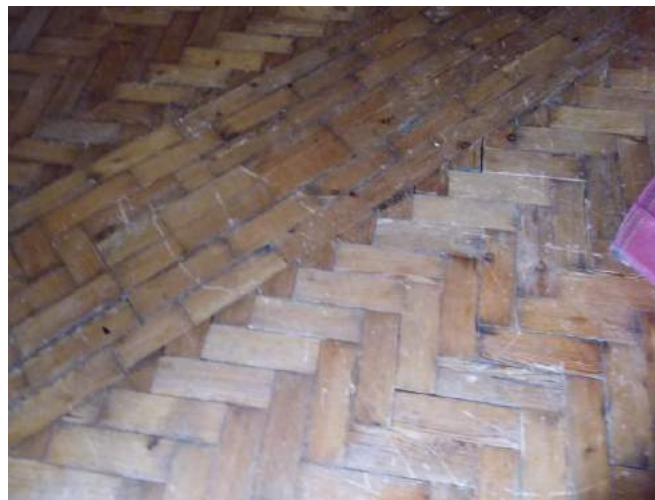
Comments: Bitumen adhesive to parquet flooring beneath carpet

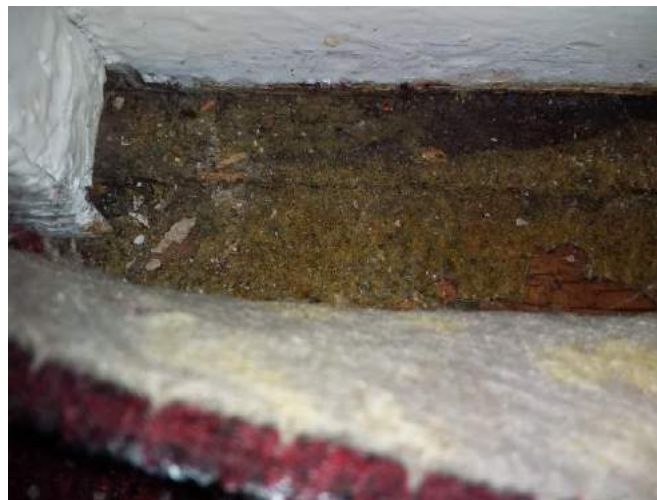
Comments: Bitumen adhesive to parquet flooring beneath carpet

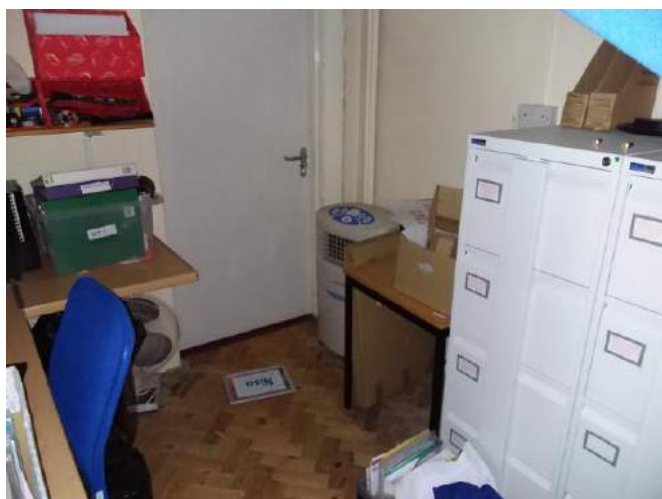
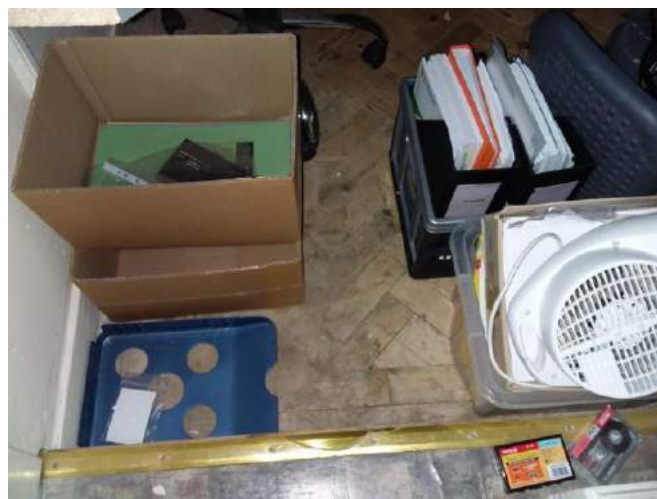
Comments: Bitumen adhesive to parquet flooring beneath carpet

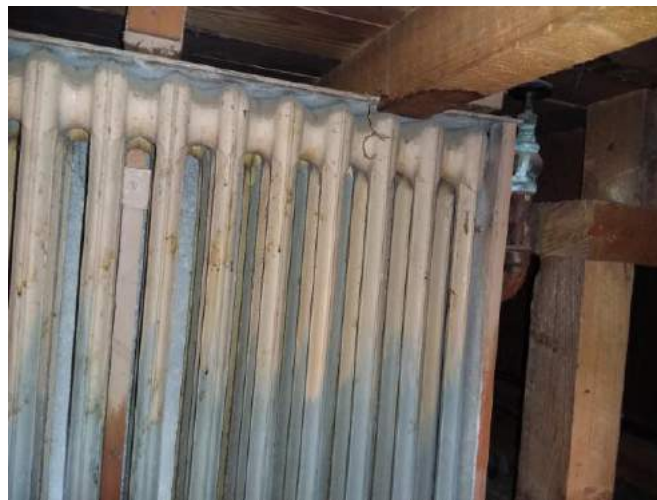
Comments: Cement lining to radiators beneath stage

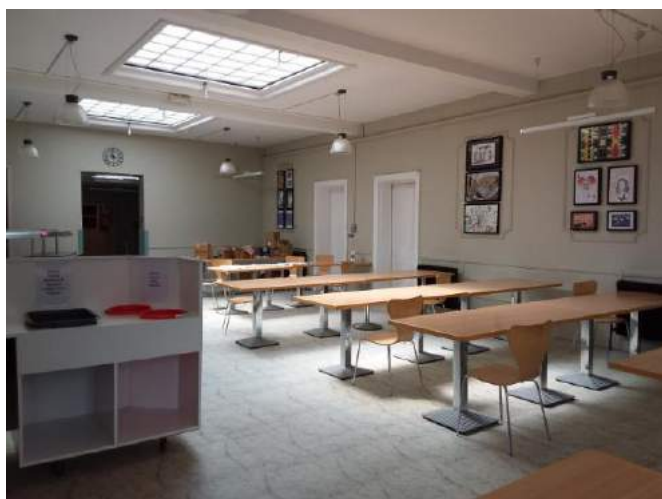
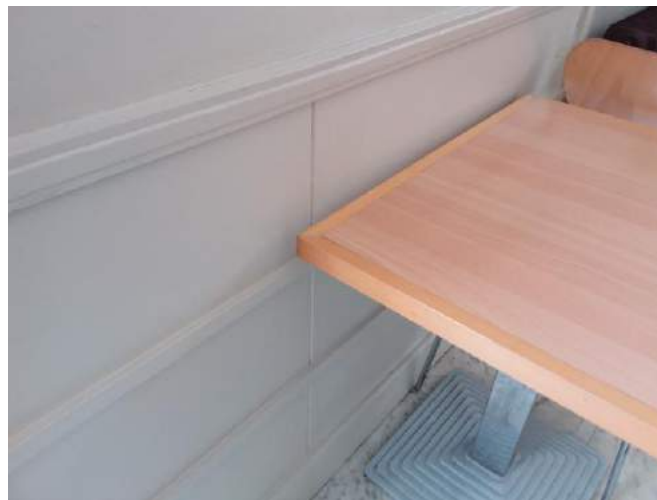
Comments: Insulating board wall lining at low level

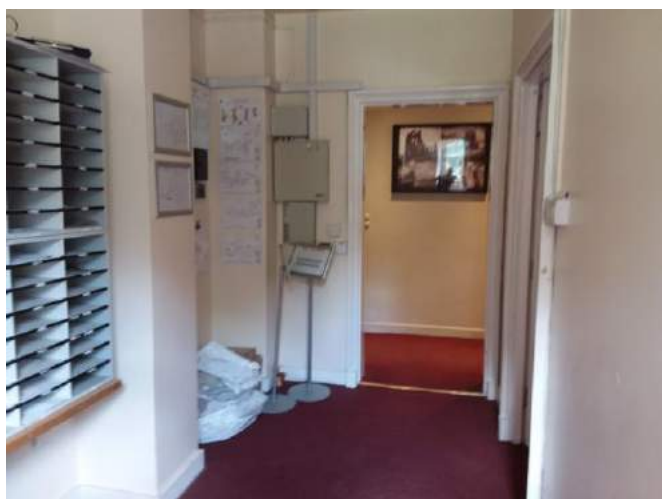
Comments: Bitumen adhesive to parquet flooring beneath carpet

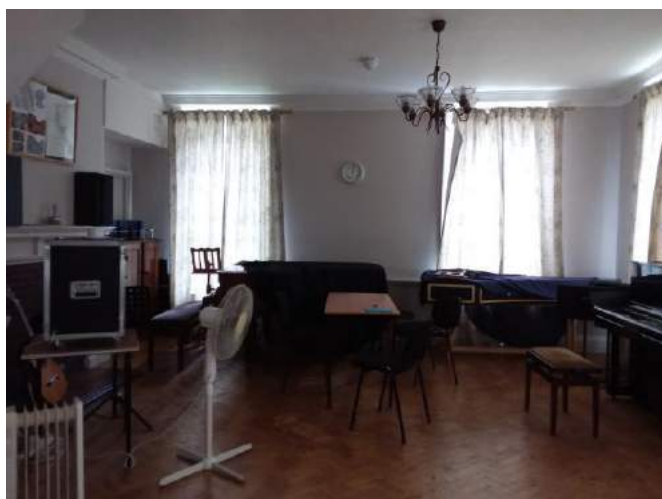
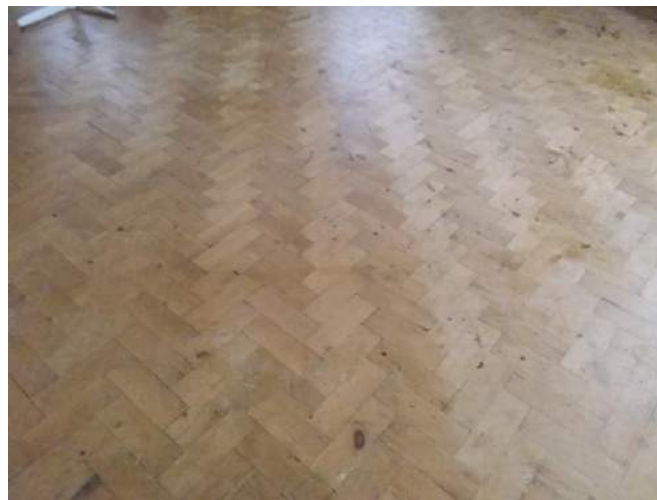
Comments: Bitumen adhesive to parquet flooring

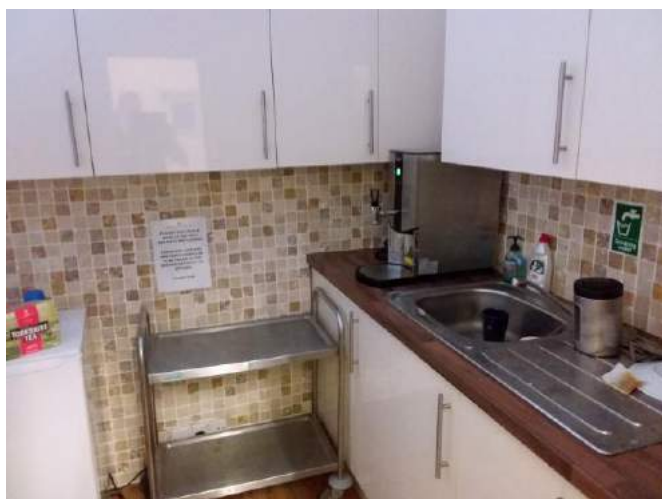
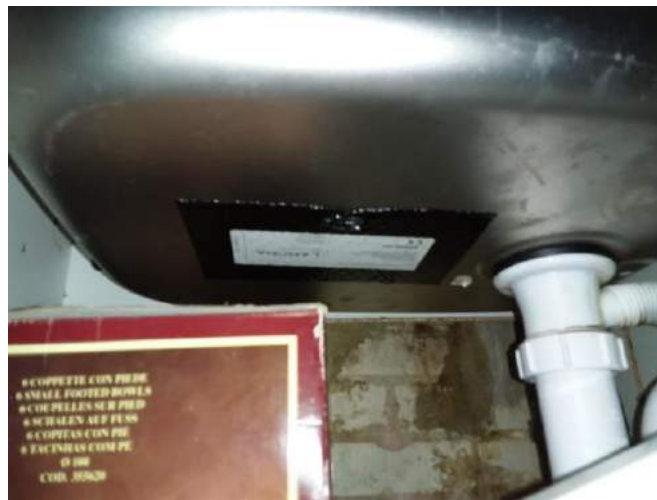
Comments: Bitumen pad to underside of sink

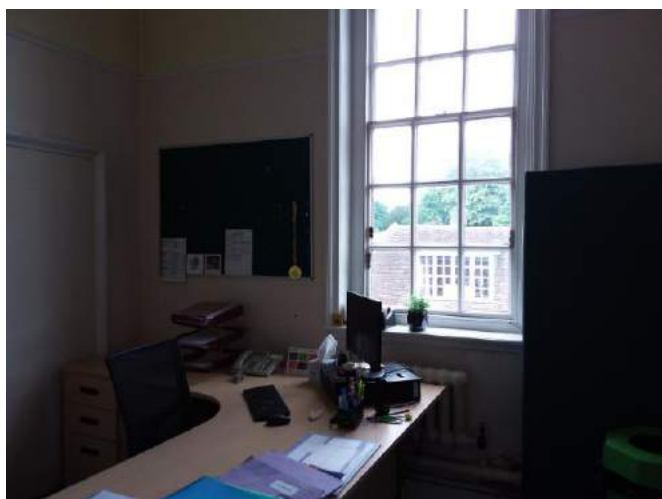
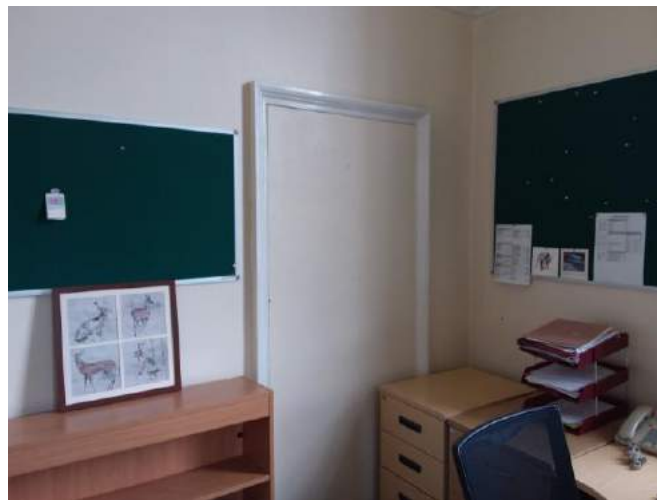
Comments: Insulating board blanking panel over door

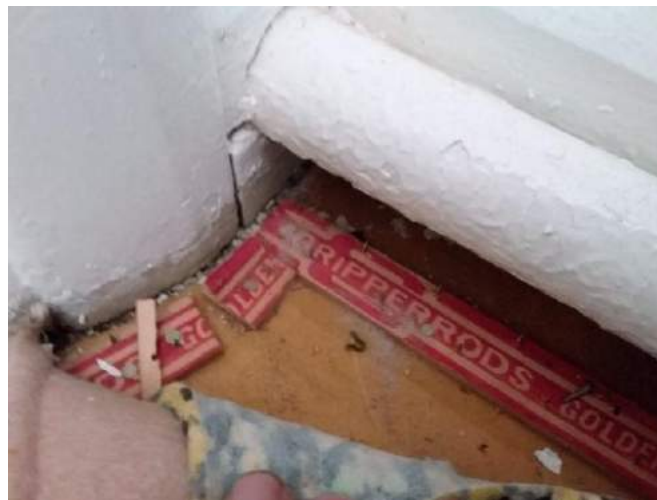
Comments: Vinyl floor covering beneath carpet
