## Asbestos Inspection Report Management Survey

Princess Helena College  
School Lane  
Preston  
Hitchin  
Hertfordshire  
SG4 7RT

Project No: G-03774  
Report Issue: 1  
Date: Aug 2020

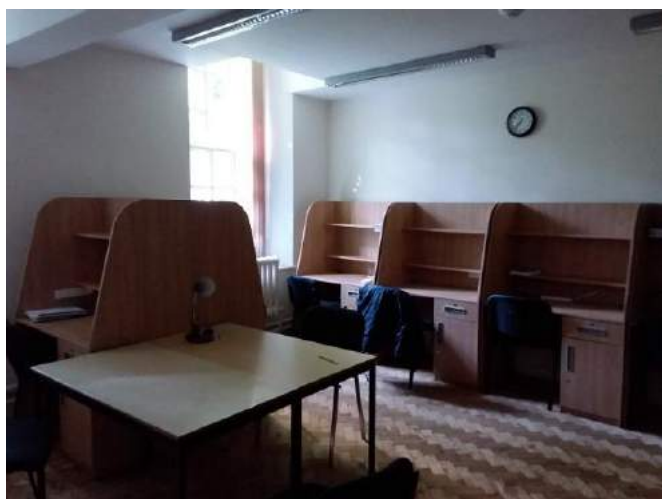
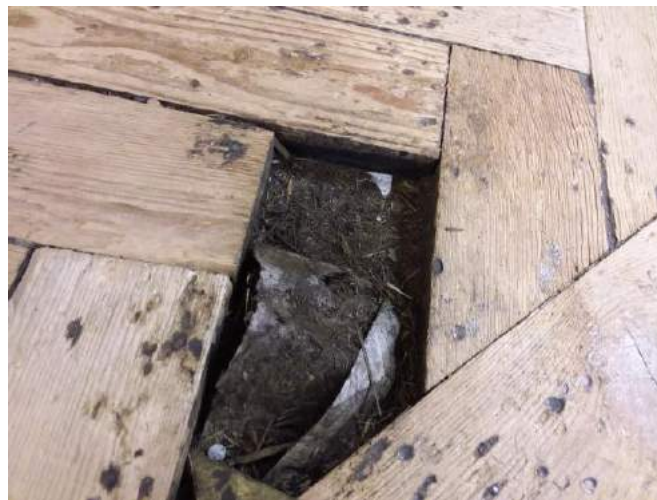
Comments: Bitumen adhesive to parquet flooring

| Floor: | Basement | Damage: | N/A |

| Action: | No further action required | | |

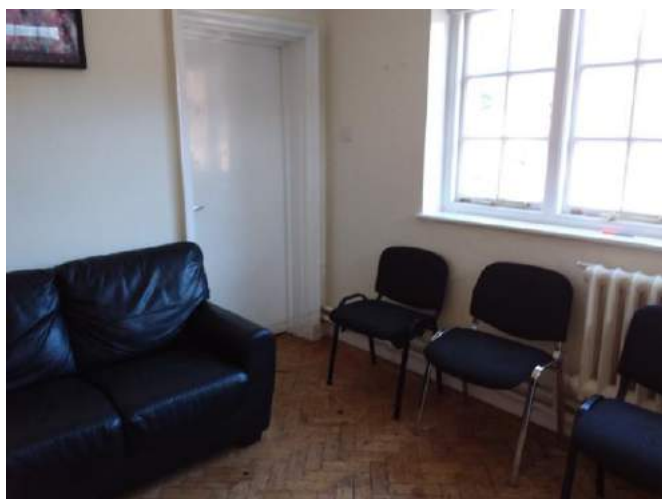
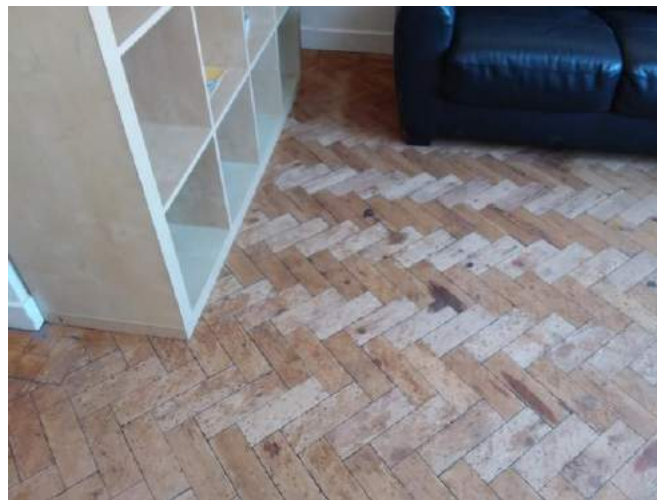
Comments: Bitumen adhesive to parquet flooring

| Floor: | Basement | Damage: | N/A |

| Action: | No further action required | | |

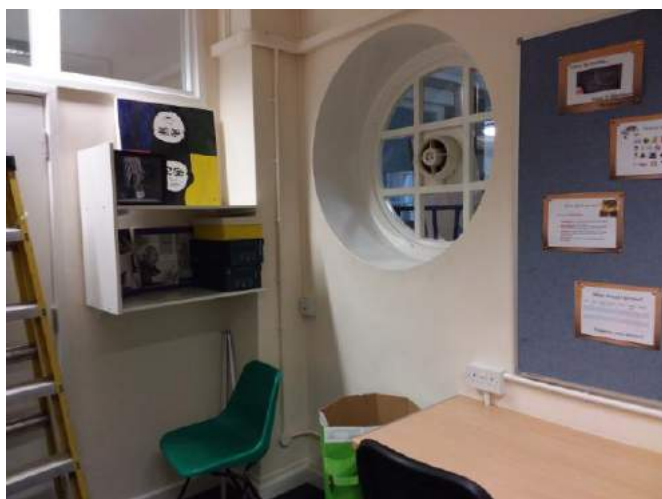
Comments: Insulating board lining to cupboard and cupboard shelves

| Floor: | Basement | Damage: | N/A |

| Action: | No further action required | | |

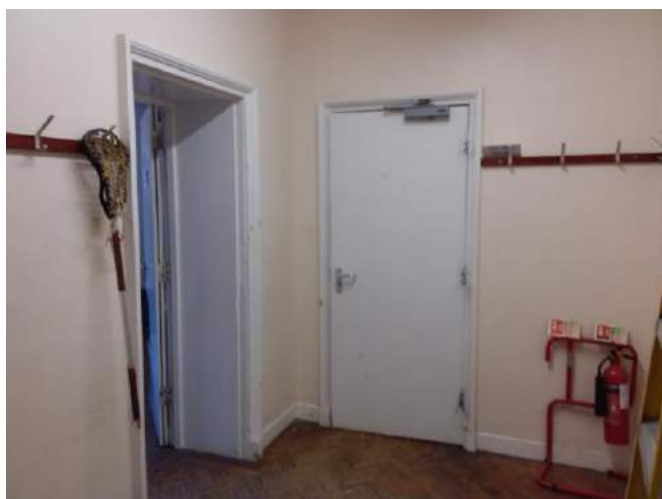
Comments: Bitumen adhesive to parquet flooring

| Floor: | Basement | Damage: | N/A |

| Action: | No further action required | | |

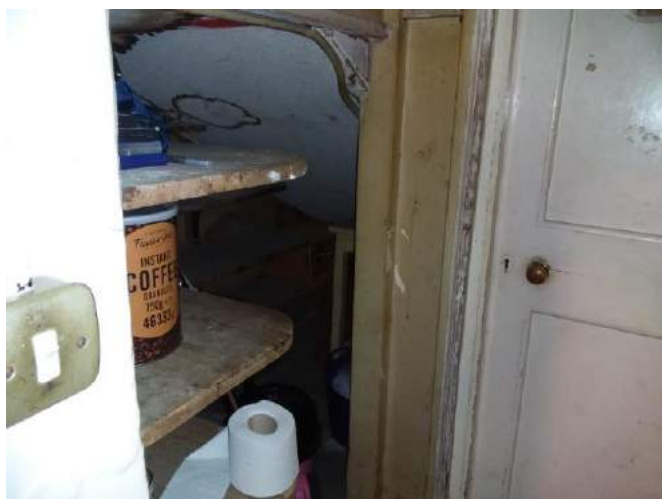
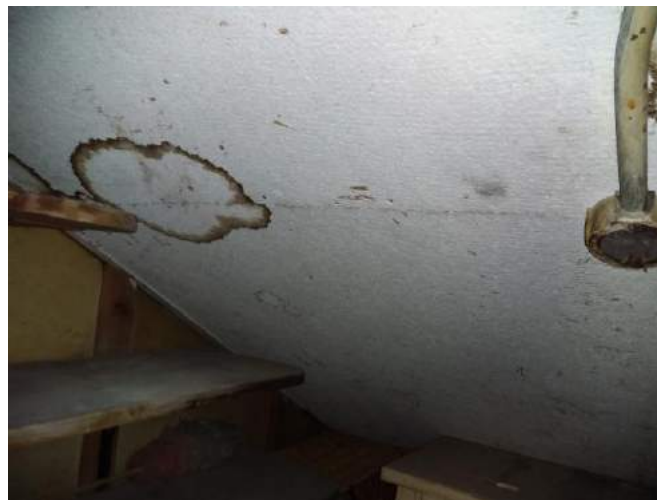
Comments: Insulating board lining to underside of stairs

| Floor: | Basement | Damage: | Good condition 0 |

| Action: | Monitor and manage | | |

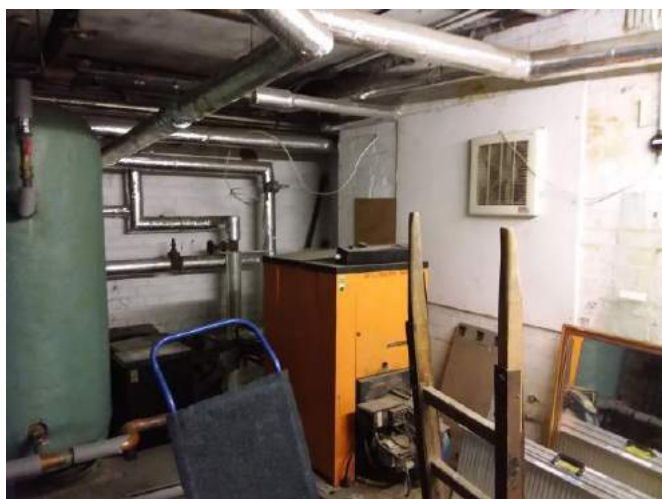
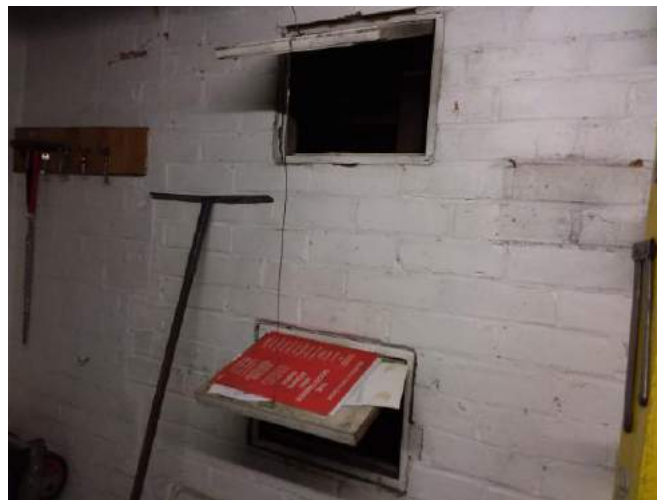
Comments: Cement lining to 2 x wall hatches

| Floor: | Basement | Damage: | N/A |

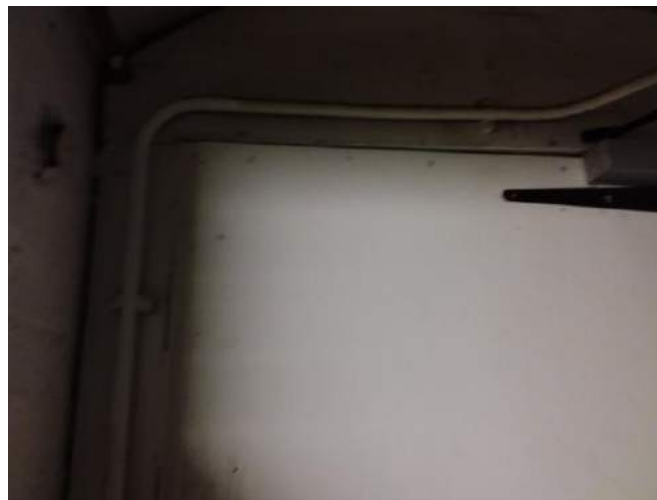
Comments: Insulating board door lining

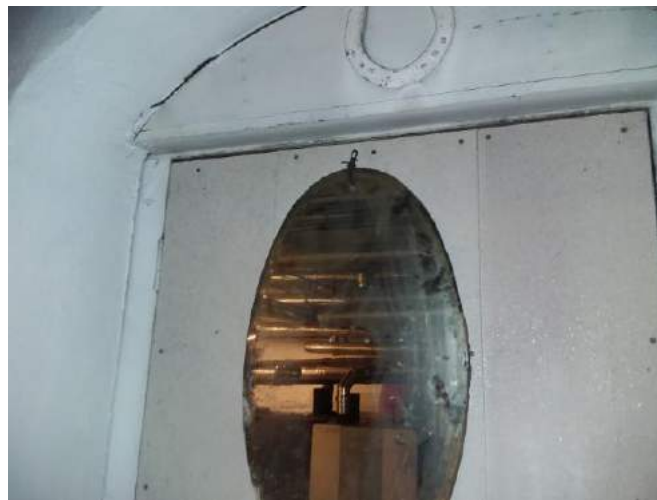
Comments: Insulating board door lining

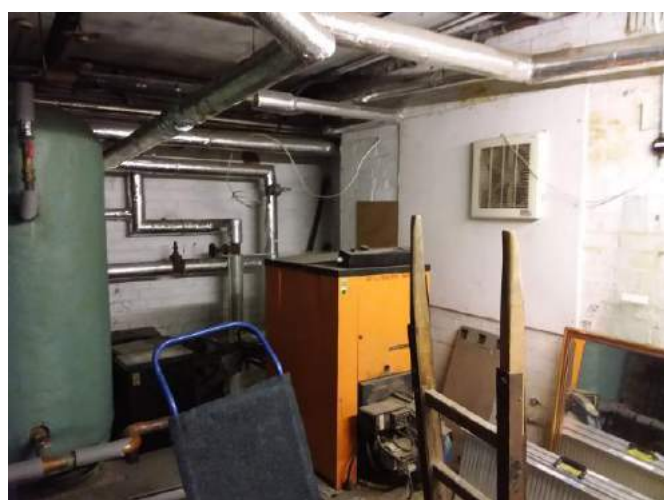
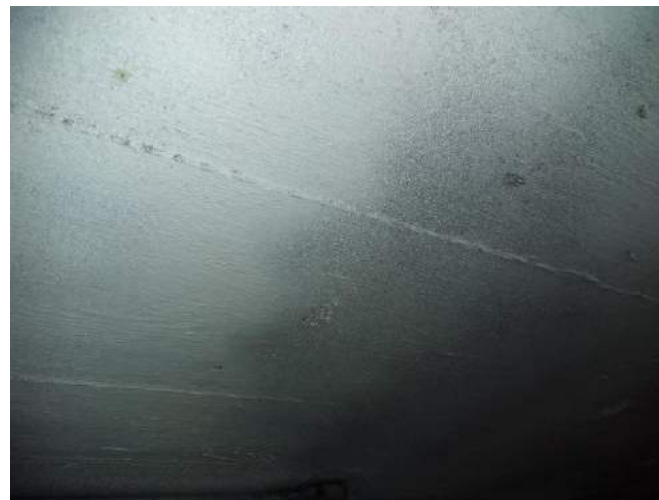
Comments: Thermal insulation residue to ceiling (small amounts over 60m<sup>2</sup> ceiling surface area)

| Floor: | Basement | Damage: | Good condition 0 |

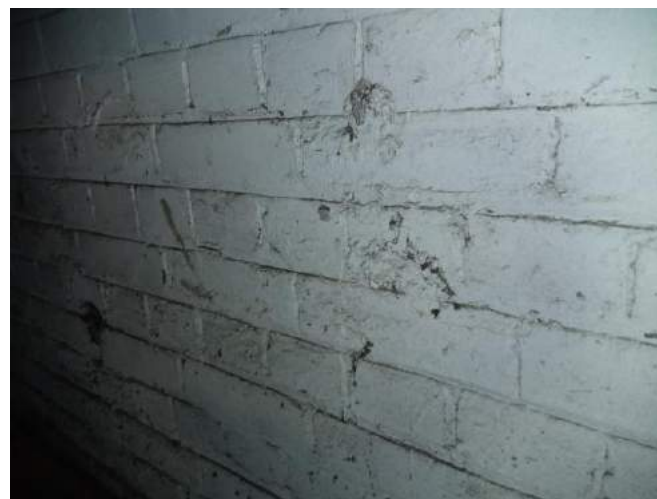
Comments: Thermal insulation residue to wall (small amounts over 16m<sup>2</sup> wall surface area)

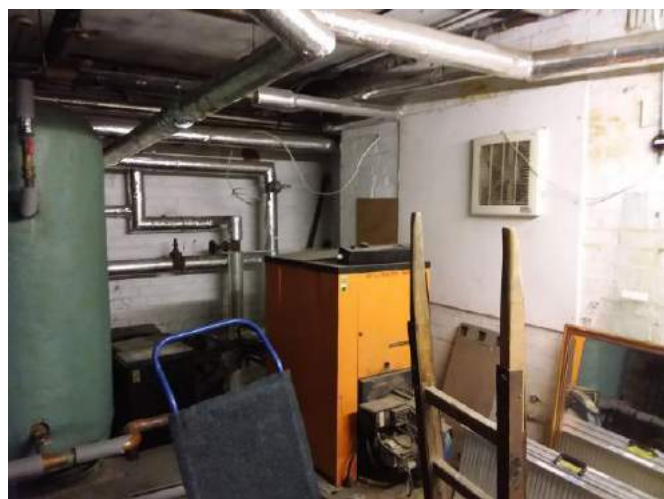
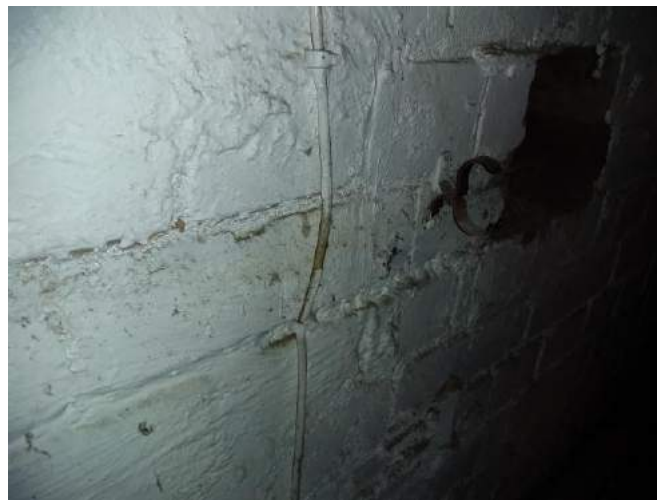
Comments: Thermal insulation residue to wall (small amounts over 16m<sup>2</sup> wall surface area)

| Floor: | Basement | Damage: | Good condition 0 |

| Action: | Monitor and manage | | |

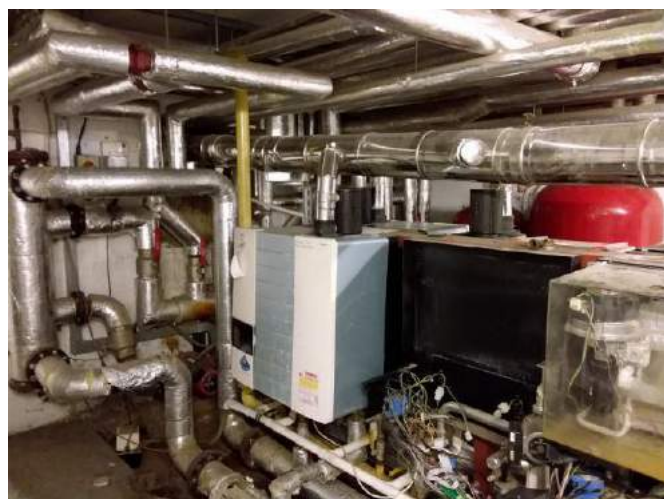
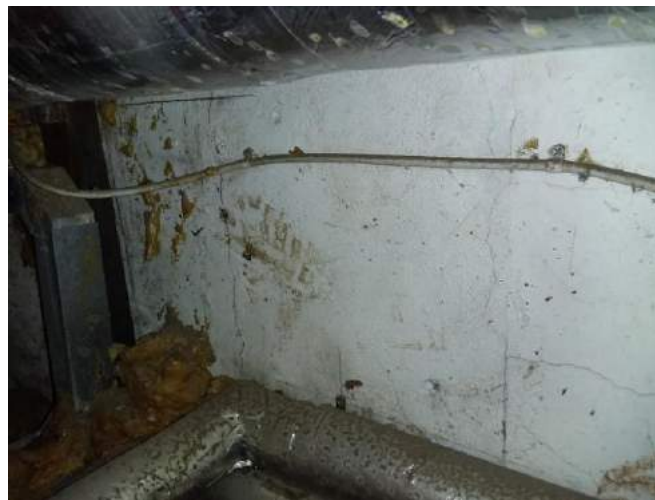
Comments: Thermal insulation residue to wall (small amounts over 24m<sup>2</sup> wall surface area)

| Floor: | Basement | Damage: | Good condition 0 |

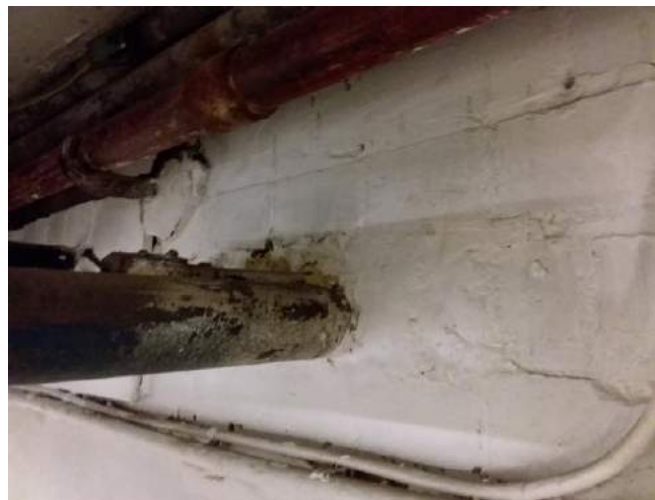
Comments: Thermal insulation residue to wall (small amounts over 24m<sup>2</sup> wall surface area)

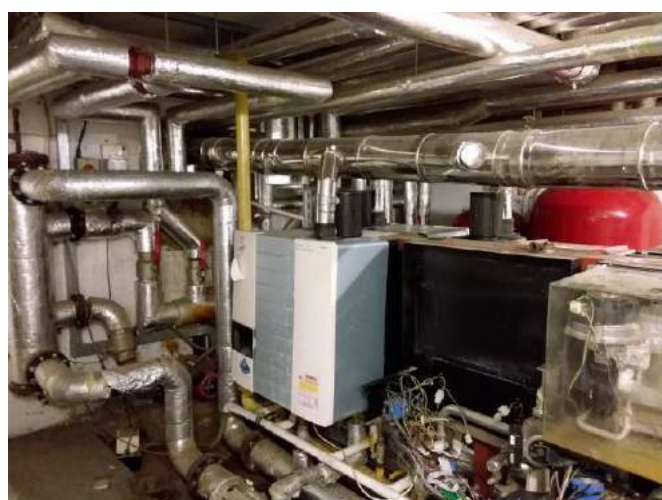
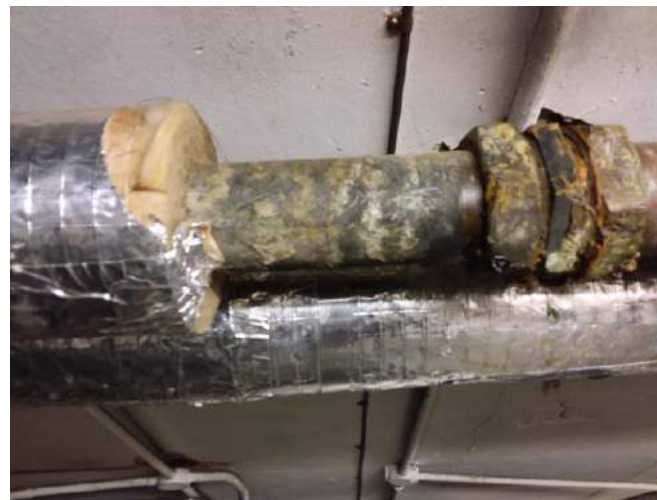
Comments: Thermal insulation residue to pipework (small amounts beneath MMMF insulation )

| Floor: | Basement | Damage: | N/A |

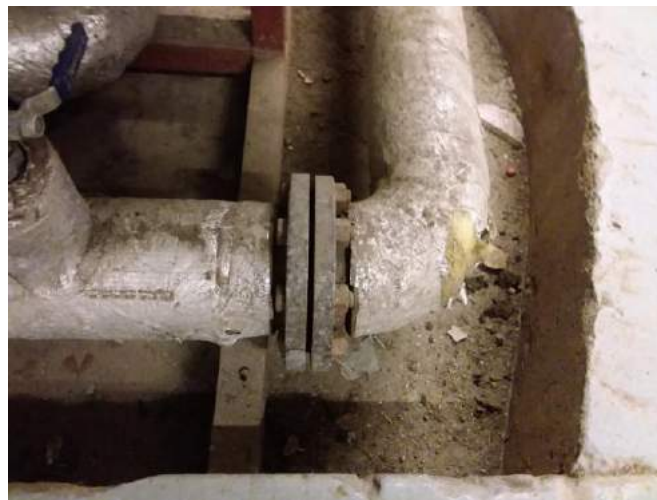
Comments: Gaskets to pipework

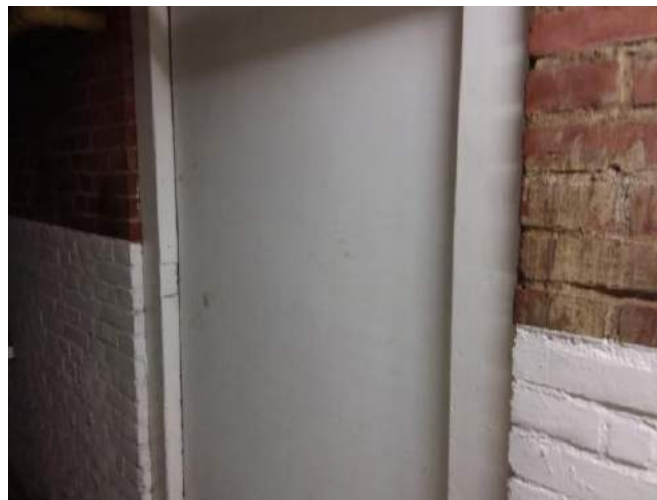
Comments: Insulating board door lining

| Floor: | Basement | Damage: | Good condition 0 |

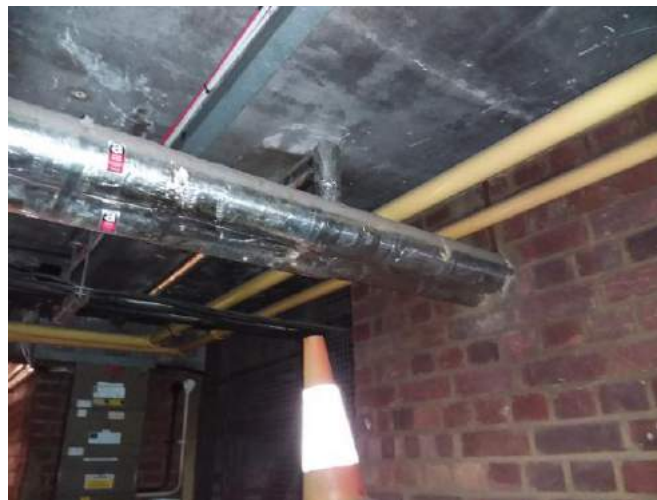
Comments: Thermal insulation residue to pipework (small amounts beneath MMMF insulation)

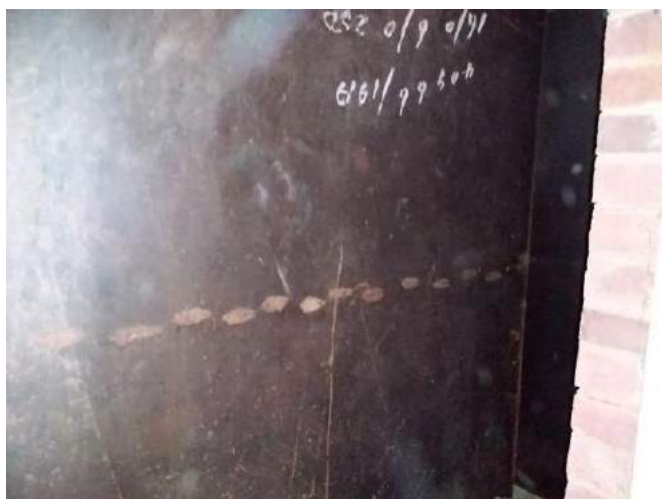
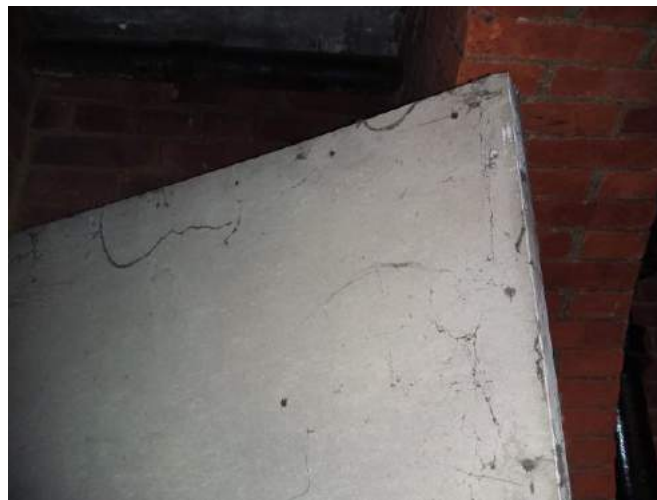
Comments: Asbestos insulating board door lining

| Floor: | Basement | Damage: | Good condition 0 |

| Action: | Monitor and manage | | |

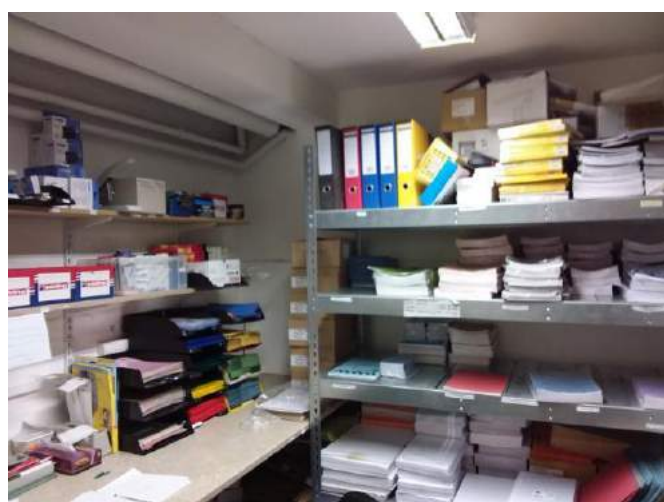
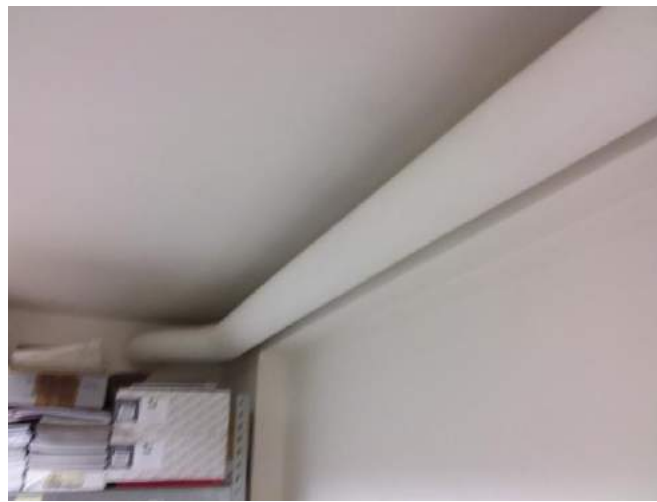
Comments: Thermal insulation to pipework

| Floor: | Basement | Damage: | Good condition 0 |

| Action: | Monitor and manage | | |

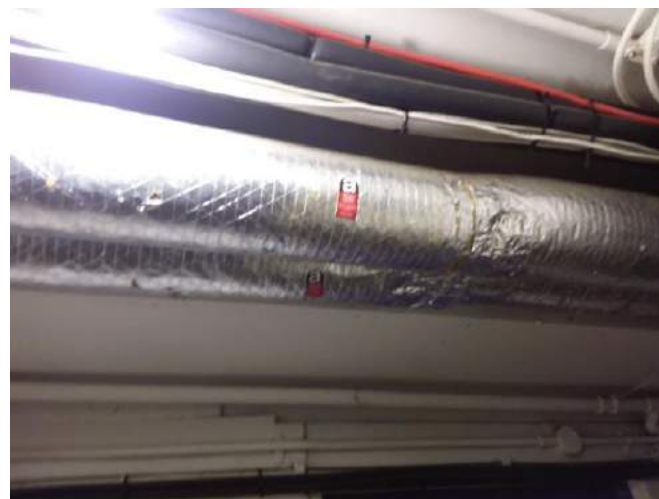
Comments: Thermal insulation residue to pipework (small amounts beneath MMMF insulation)

| Floor: | Basement | Damage: | Good condition 0 |

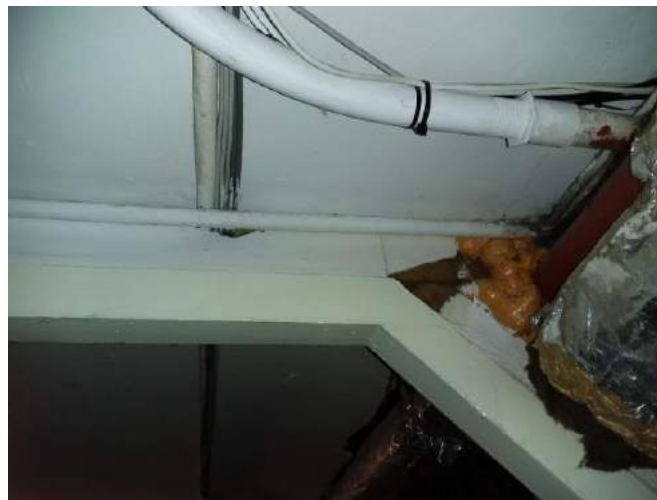
Comments: Cement door head panel

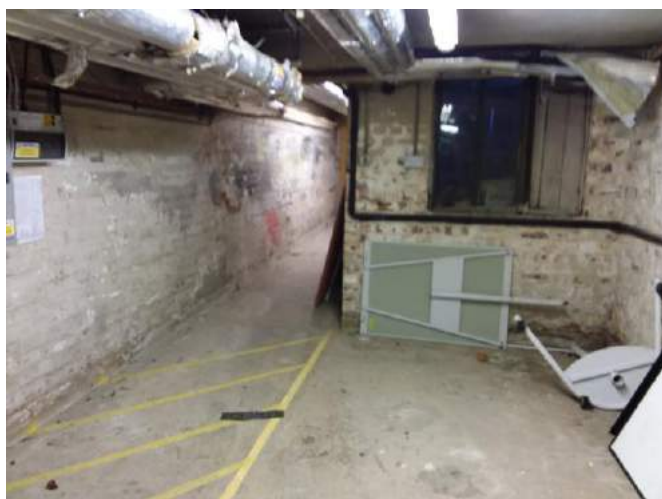
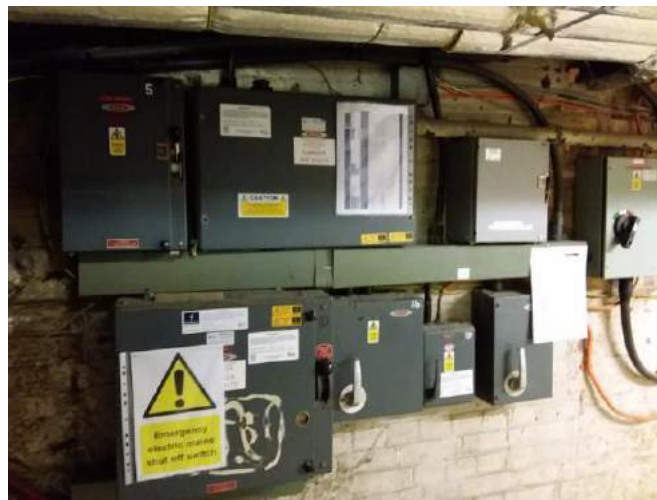
Comments: No access within live electrical units - strongly presumed woven textile flashguards

| Action: | Monitor and manage | | |

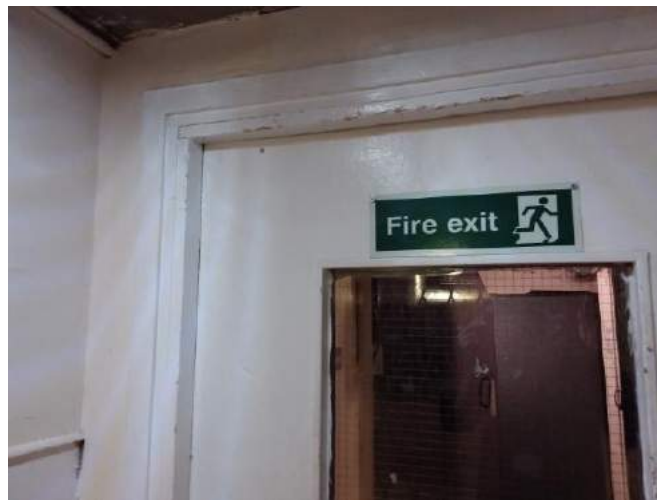
Comments: Insulating board door lining

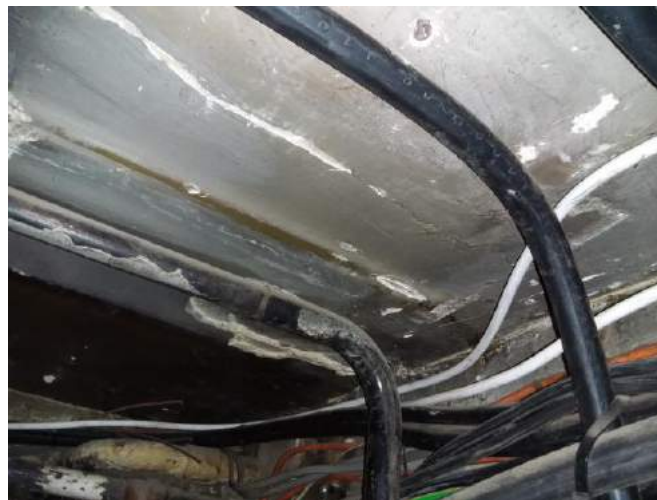
Comments: Thermal insulation residue to ceiling (small amounts over 16m<sup>2</sup> ceiling surface area)

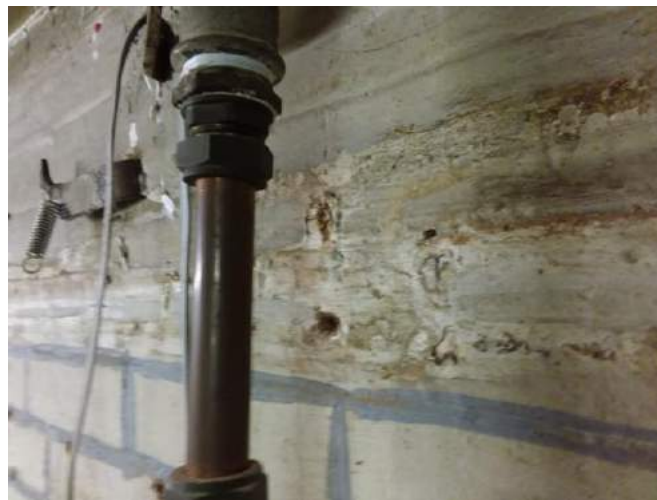
Comments: Thermal insulation residue to wall

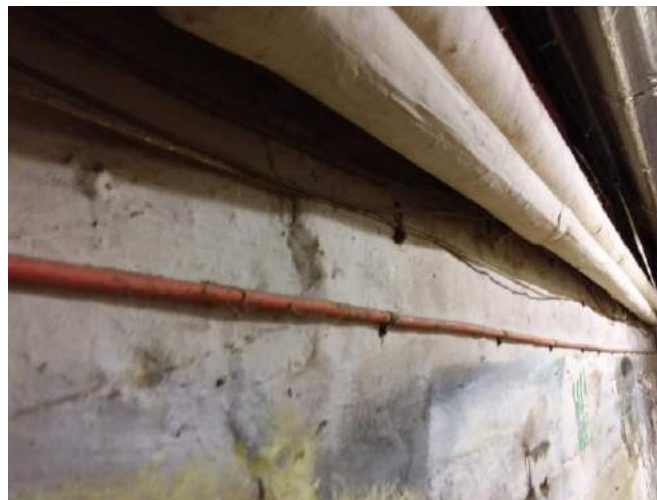
Comments: Thermal insulation residue to wall (small amounts over 48m<sup>2</sup> wall surface area)

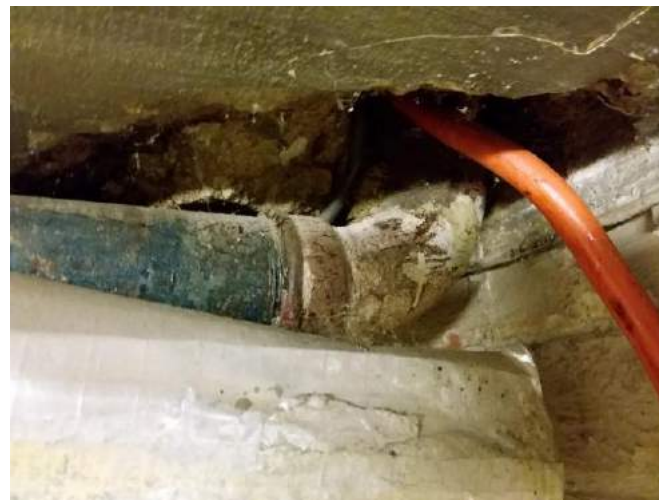
Comments: Thermal insulation residue to pipework (small amounts beneath MMMF insulation)

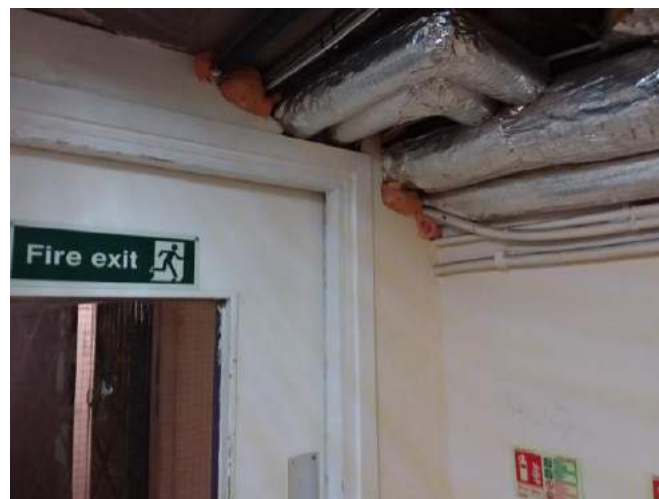
Comments: Asbestos insulating board door surround

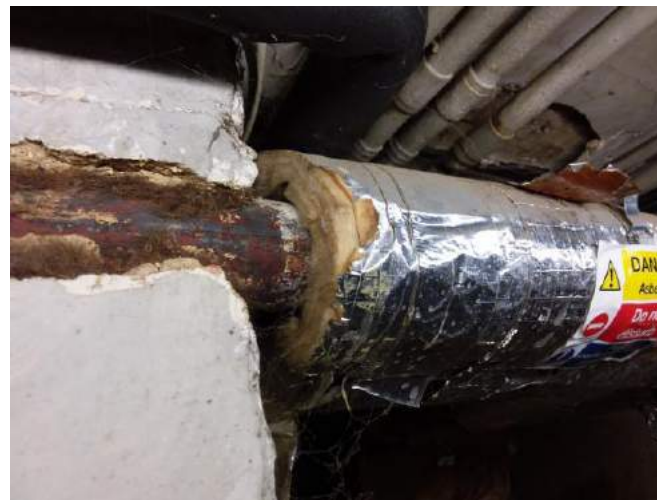
Comments: Thermal insulation residue to pipework (small amounts beneath MMMF insulation)

| Action: | Monitor and manage | | |

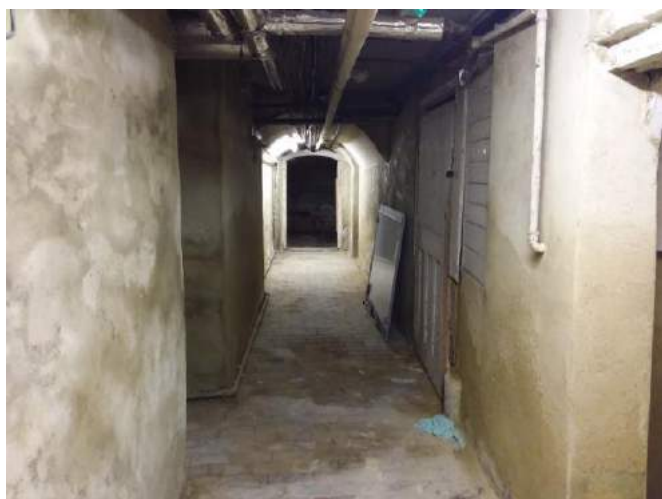
Comments: Thermal insulation residue to ceiling (small amounts over 6m<sup>2</sup> ceiling surface area)

| Action: | Monitor and manage | | |

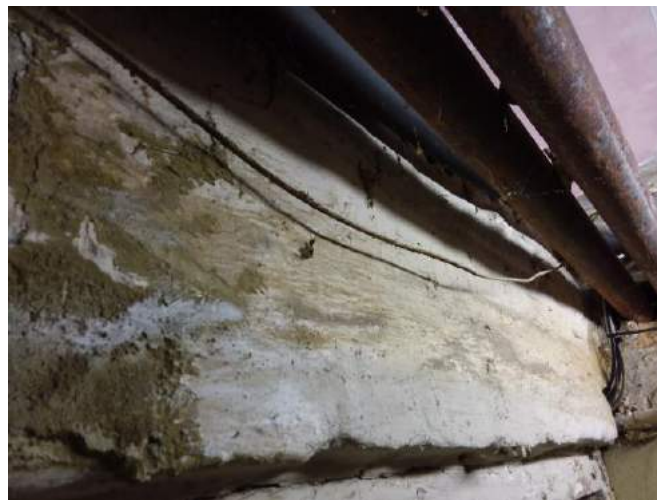
Comments: Thermal insulation residue to wall (small amounts over 10m<sup>2</sup> wall surface area)

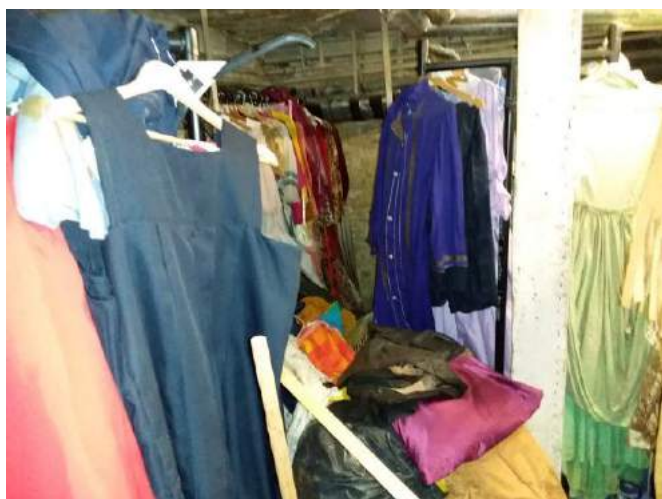
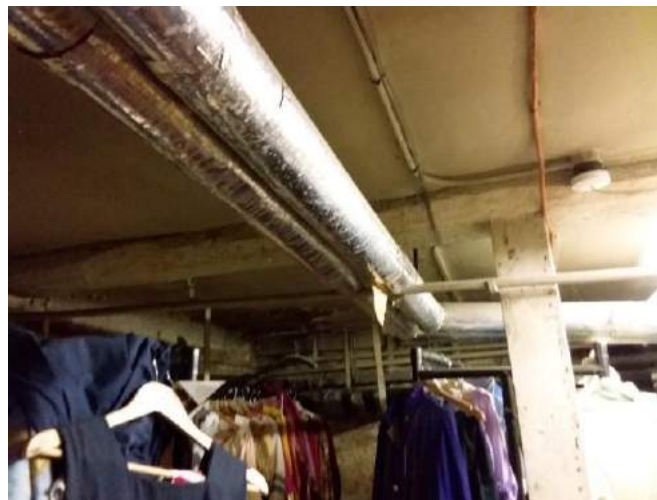
Comments: Thermal insulation residue to pipework (small amounts beneath MMMF insulation)

| Action: | Monitor and manage | | |

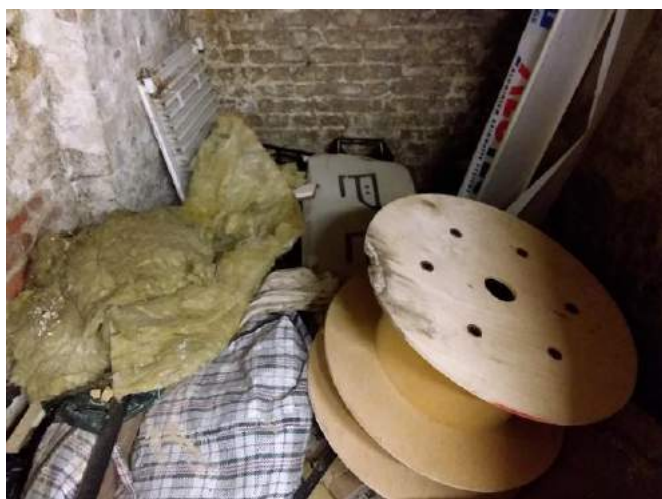
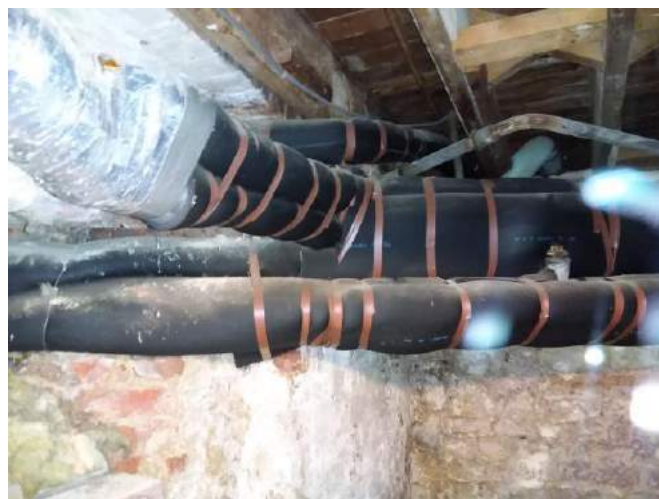
Comments: Thermal insulation residue to pipework (small amounts beneath MMMF and foam insulation)

| Action: | Monitor and manage | | |

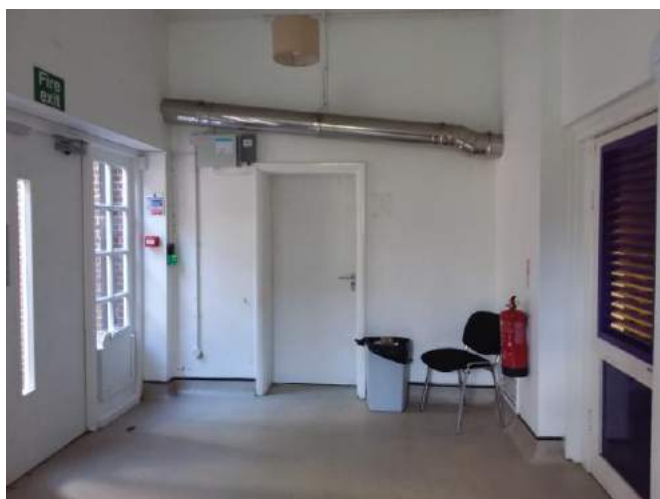
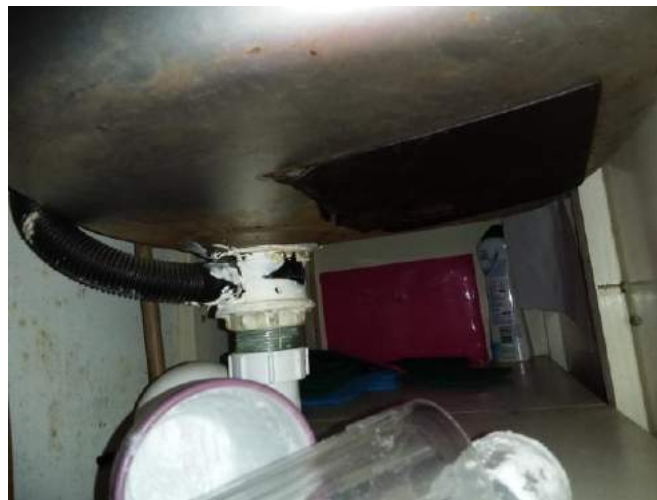
Comments: Bitumen pad to underside of sink

| Action: | No further action required | | |

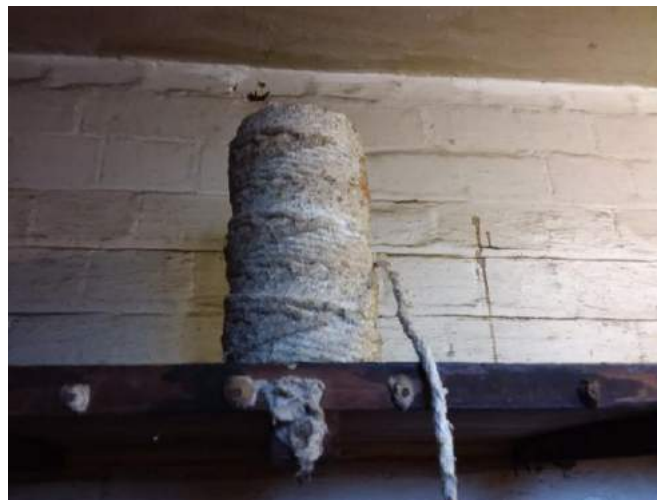
Comments: Disused rope yarn to shelf

Action: Remove following HSE guidelines

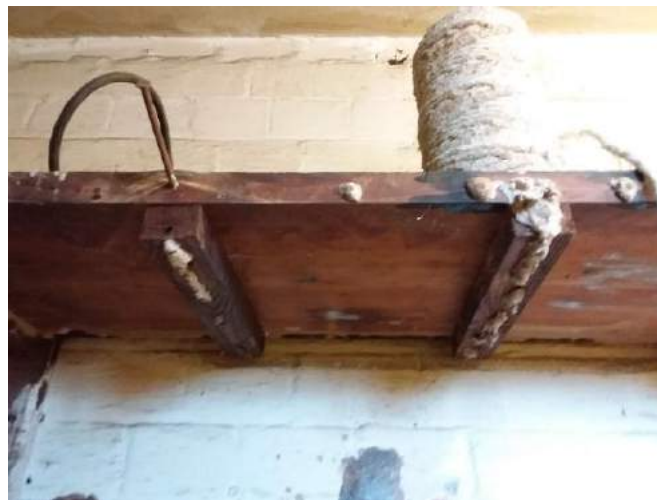
Comments: Asbestos insulating board residue to shelf

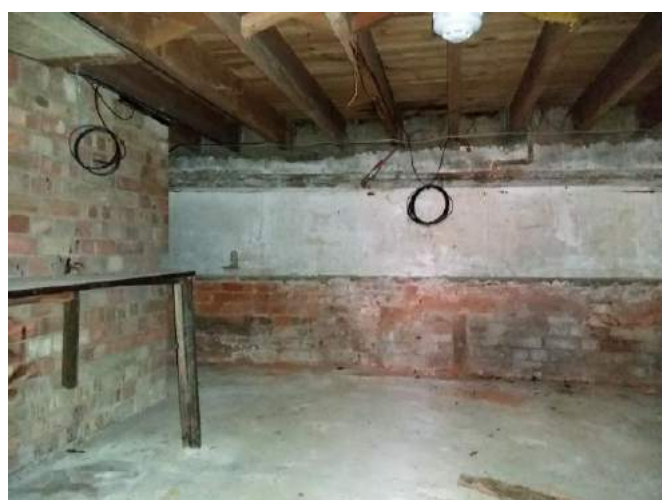
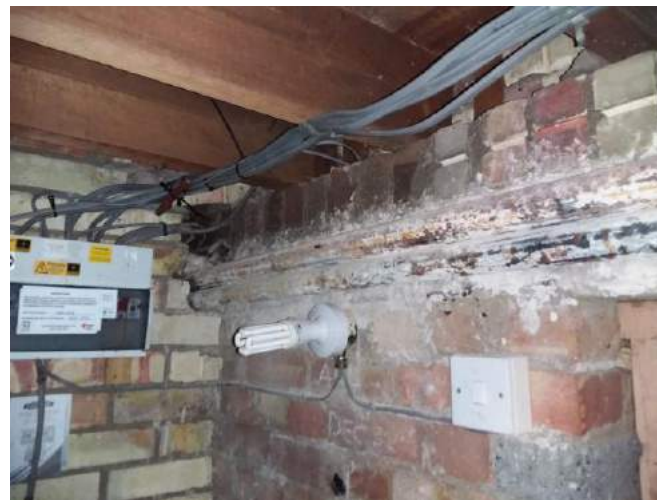
| Floor: | Basement | Damage: | High damage 3 |

Comments: Thermal insulation residue to pipework and associated walls

| Action: | Encapsulate, monitor and manage | | |

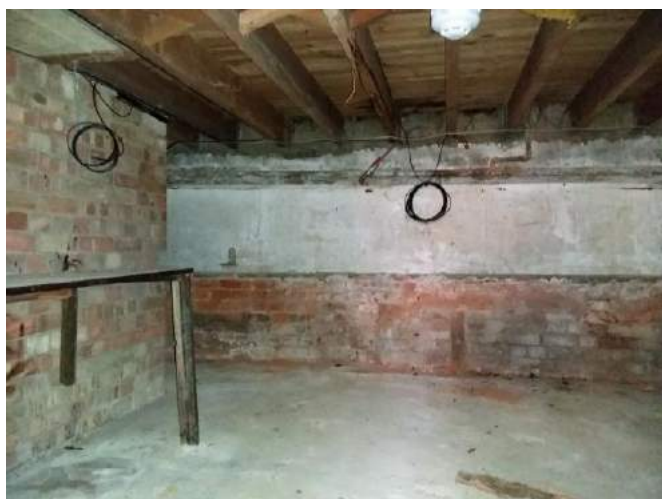
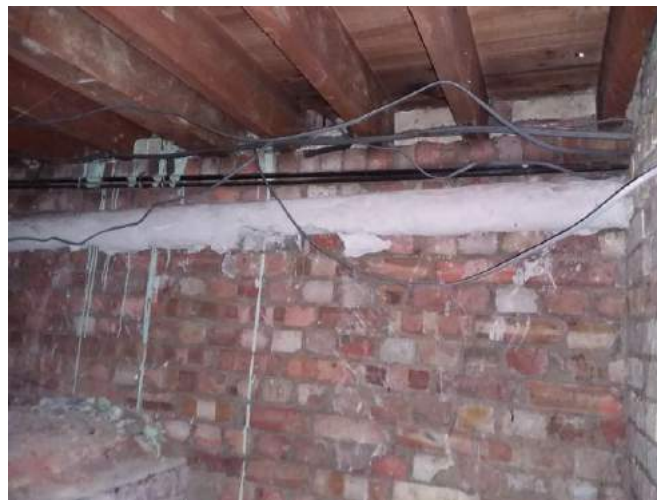
| Floor: | Basement | Damage: | High damage 3 |

Comments: Thermal insulation to pipework

| Action: | Encapsulate, monitor and manage | | |

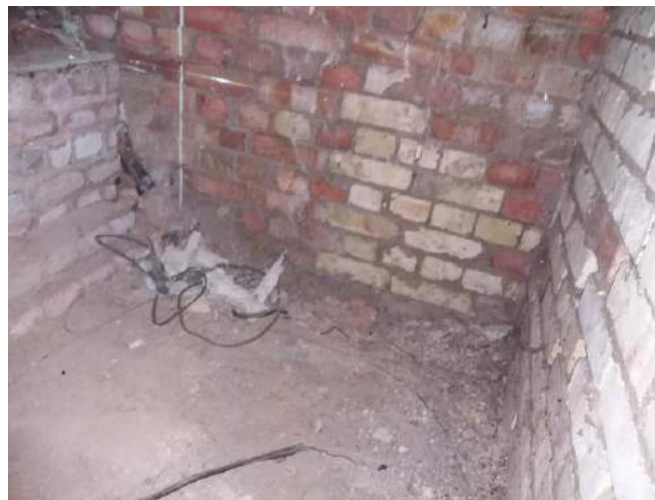
| Floor: | Basement | Damage: | Visible asbestos debris 3 |

Comments: Thermal insulation debris to floor

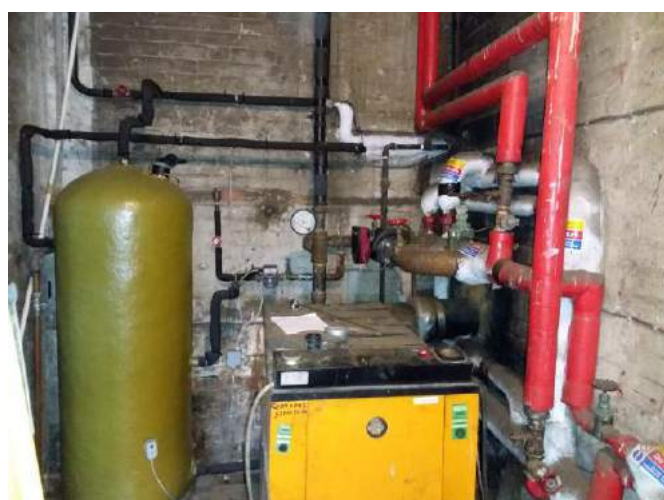
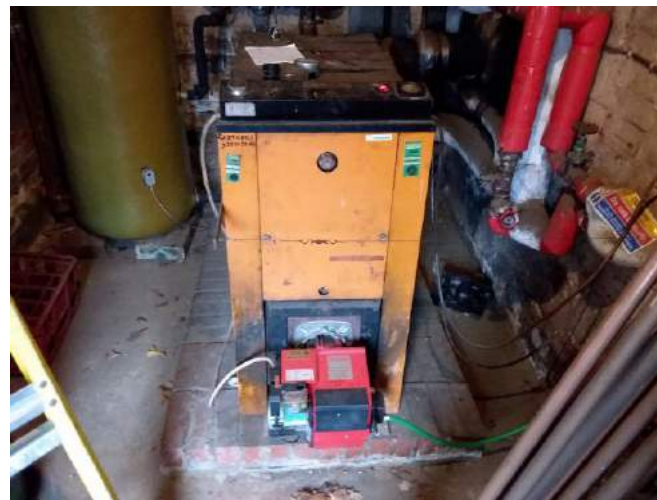
Comments: No access within boiler - presumed internal mastics/gaskets

| Action: | Monitor and manage | | |

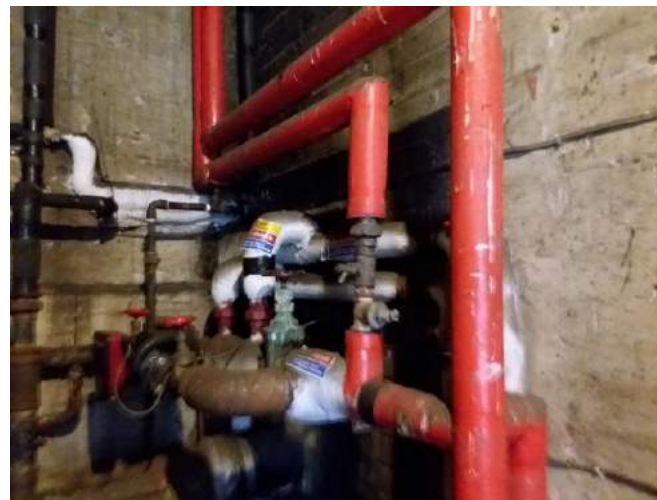
Comments: Thermal insulation to pipework

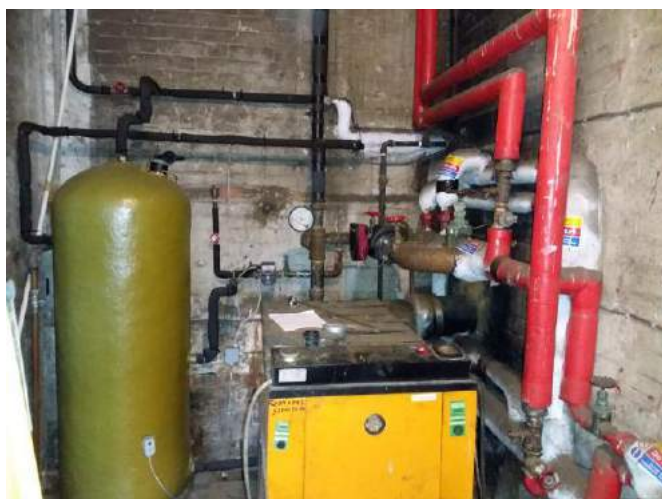
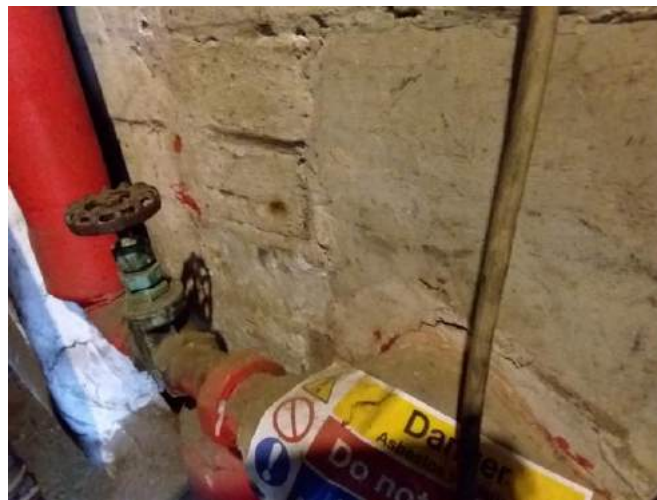
| Floor: | Basement | Damage: | High damage 3 |

Comments: Thermal insulation residue to wall (small amounts over 24m<sup>2</sup> wall surface area)

| Action: | Encapsulate, monitor and manage | | |

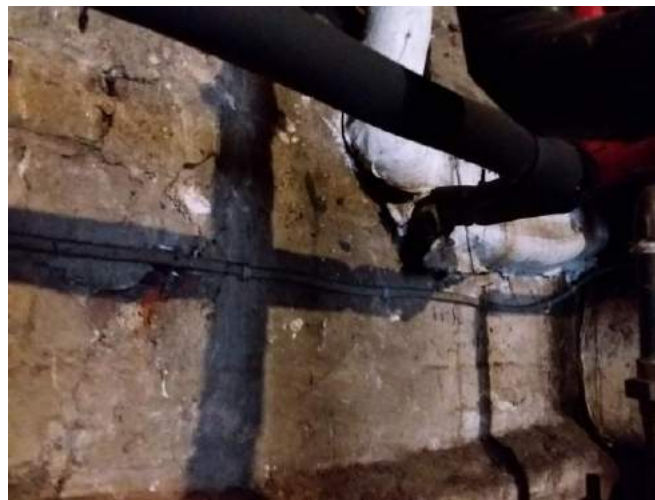
| Floor: | Basement | Damage: | High damage 3 |

Comments: Thermal insulation residue to wall (small amounts over 24m<sup>2</sup> wall surface area)

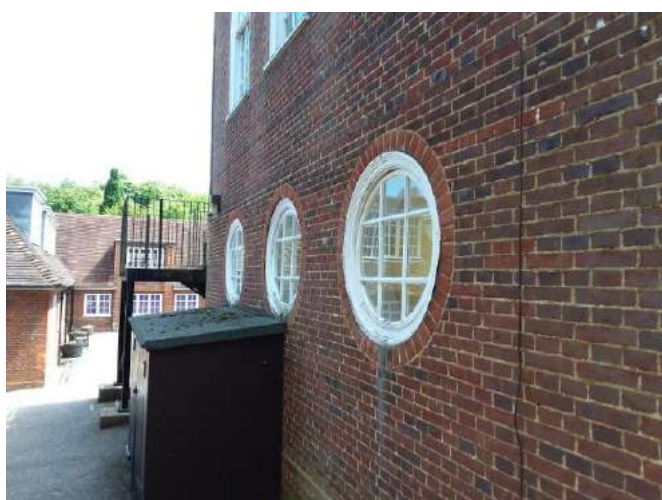
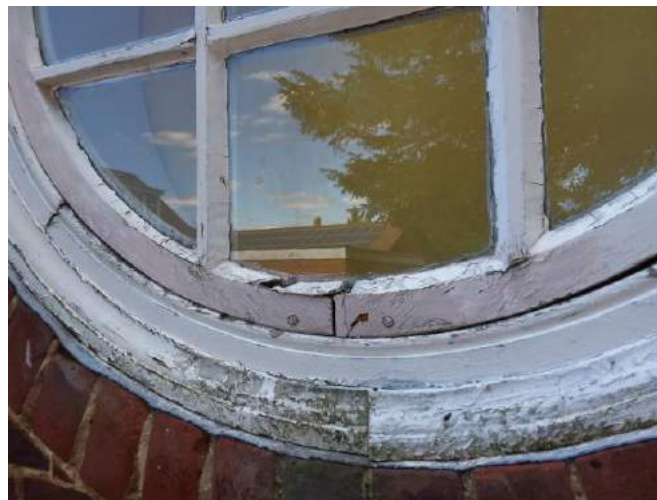
Comments: Putty to all external windows

| Action: | No further action required | | |

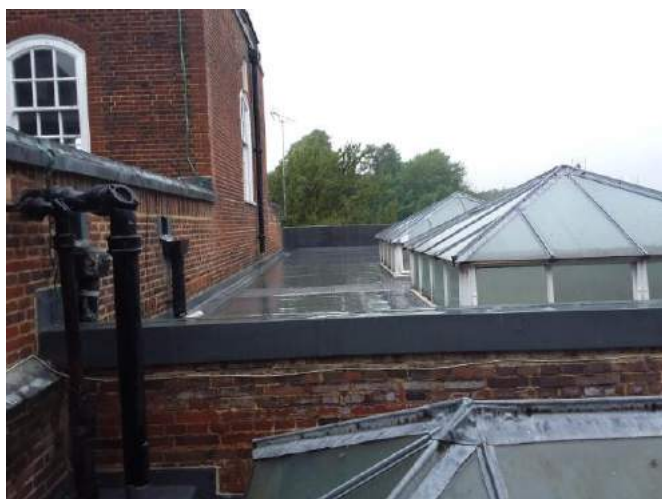
Comments: No access to skylight without causing damage under a Management survey - presumed rope gaskets

| Action: | Monitor and manage | | |

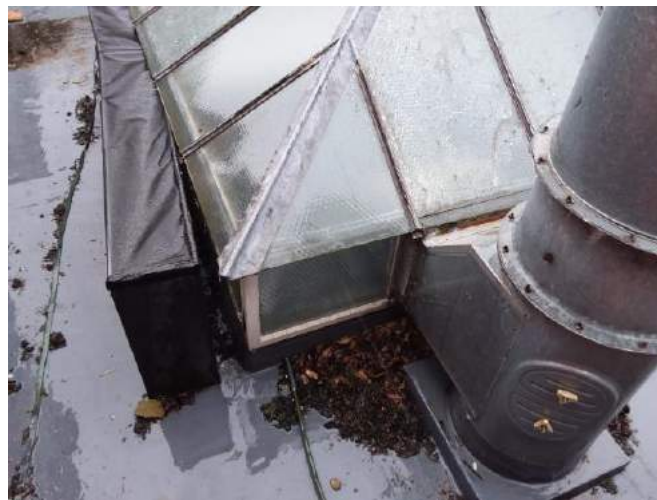
Comments: Putty to all skylights

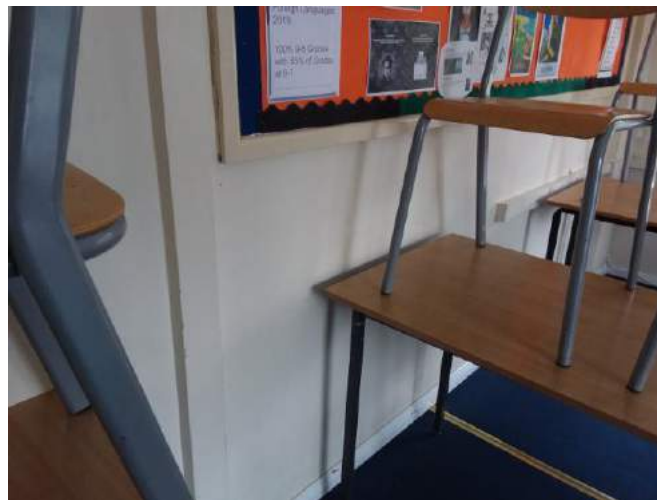
Comments: Insulating board wall partitons

| Action: | No further action required | | |
