## Asbestos Inspection Report Management Survey

Princess Helena College  
School Lane  
Preston  
Hitchin  
Hertfordshire  
SG4 7RT

Project No: G-03774  
Report Issue: 1  
Date: Aug 2020

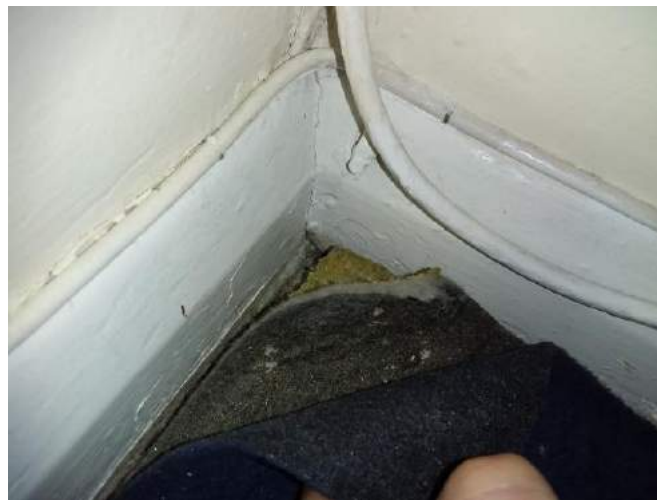
Comments: Vinyl floor covering (grey) beneath carpet

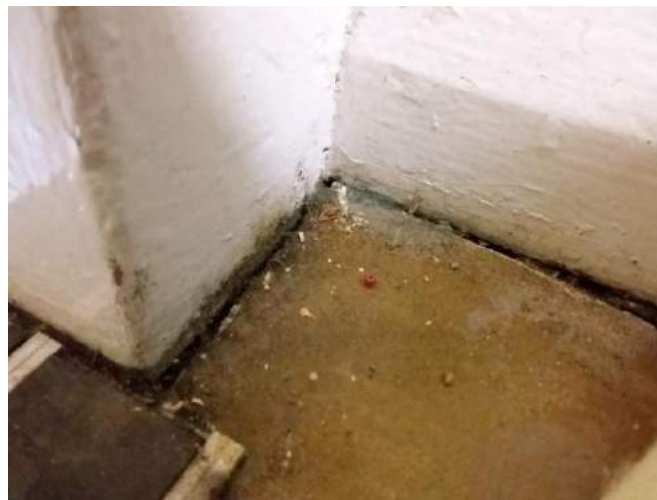
Comments: Vinyl floor covering (grey) beneath carpet

| Action: | No further action required | | |

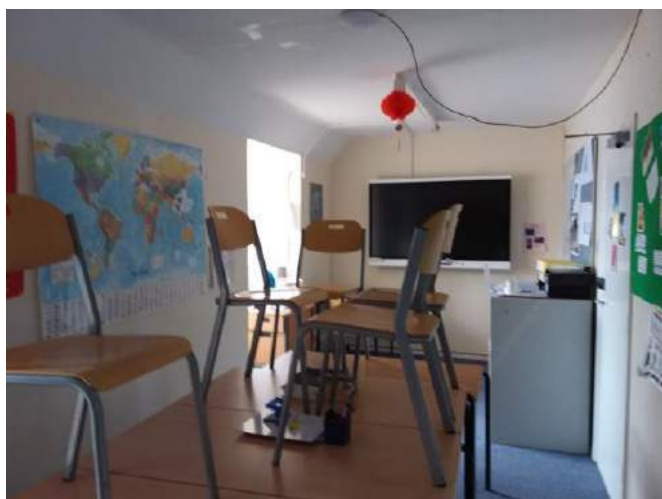
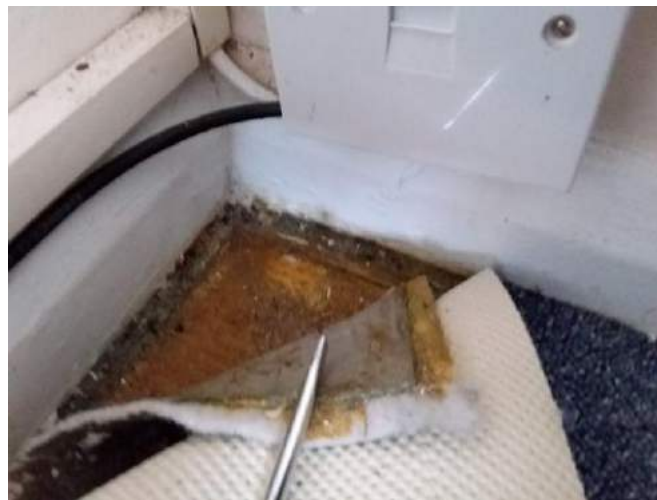
Comments: Vinyl floor covering (grey) beneath carpet

| Action: | No further action required | | |

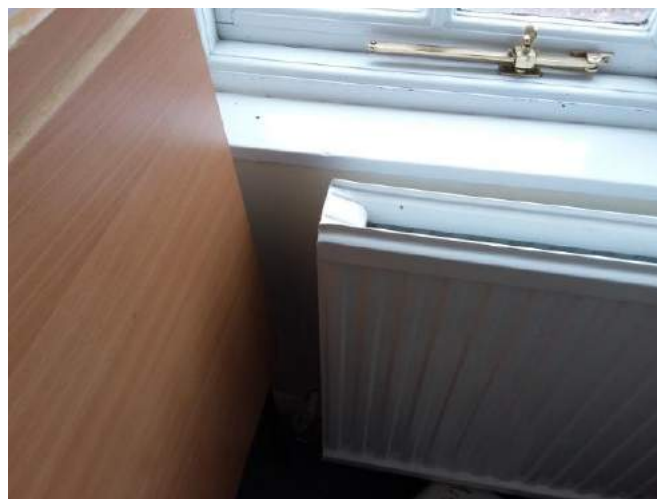
Comments: Insulating board wall lining beyond radiator

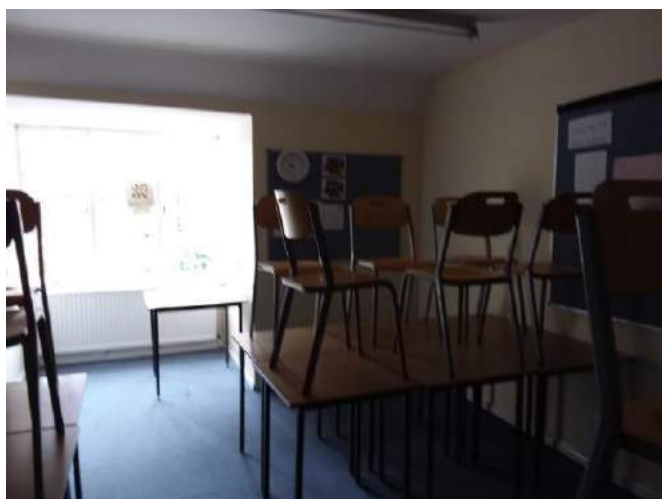
Comments: Vinyl floor covering (grey) beneath carpet tiles

| Action: | No further action required | | |

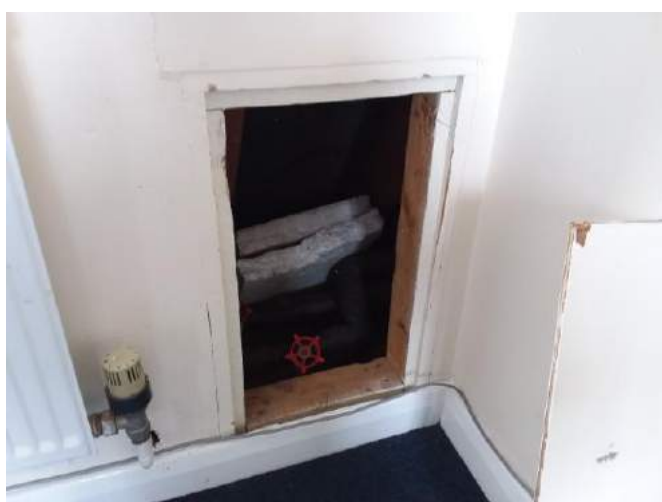
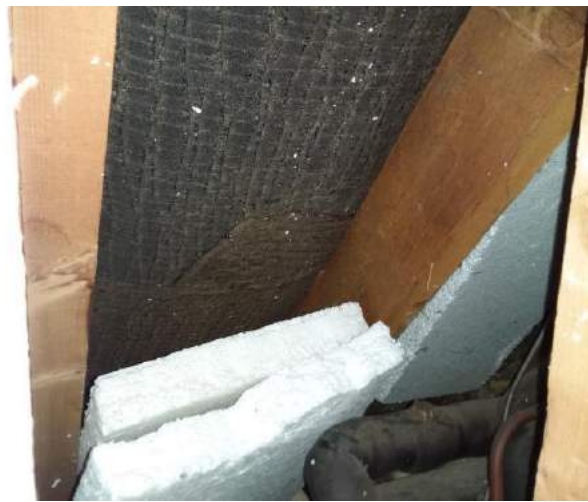
Comments: Bitumen sarking felt within eaves

| Action: | No further action required | | |

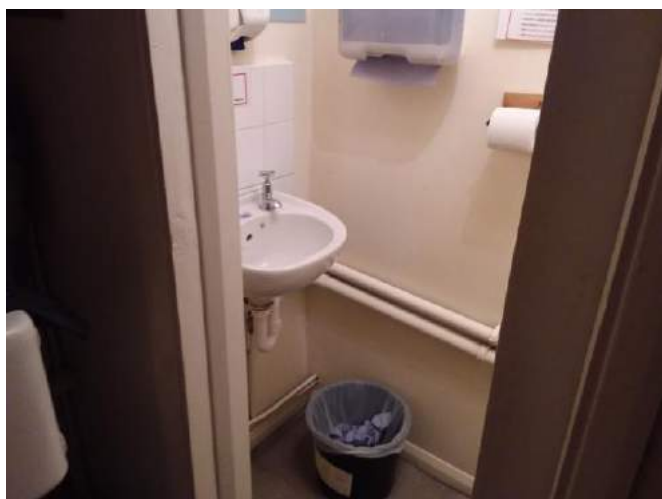
Comments: Vinyl floor covering (grey)

| Action: | No further action required | | |

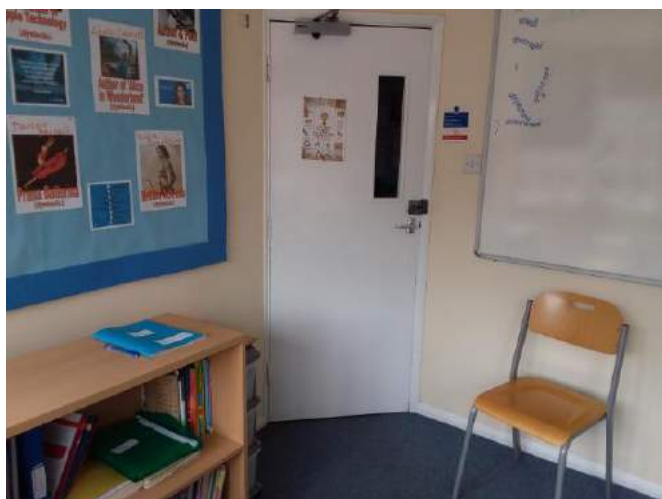
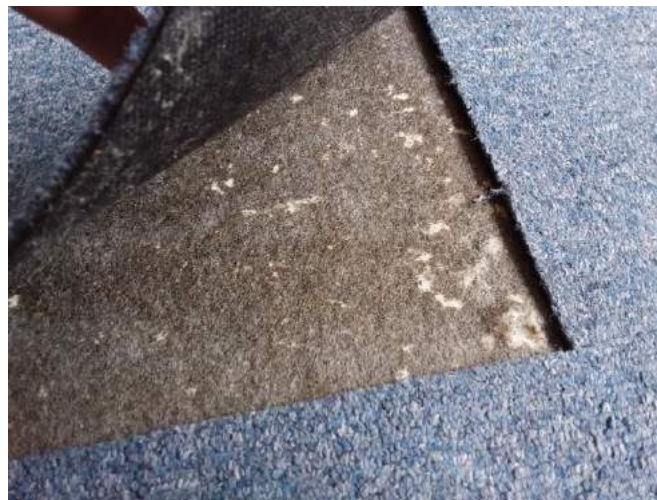
Comments: Vinyl floor covering (grey) beneath carpet tiles

| Action: | No further action required | | |

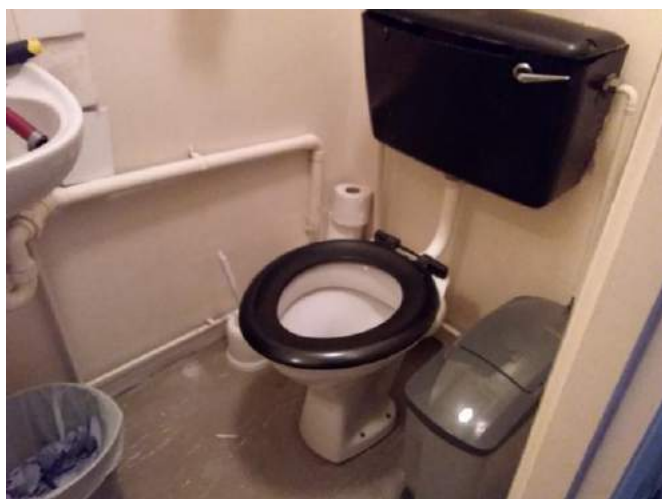
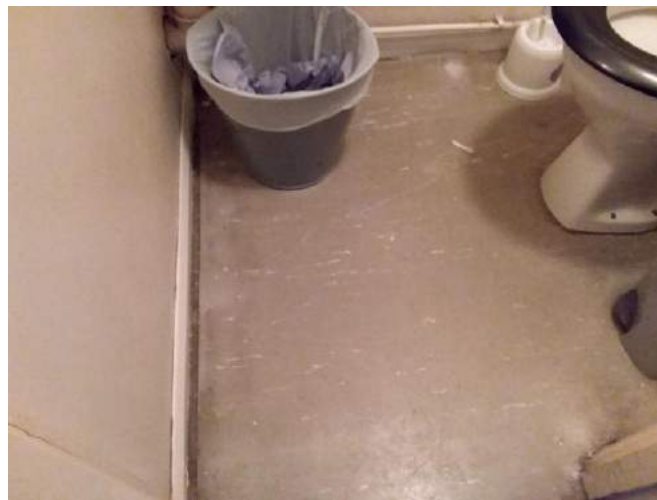
Comments: Vinyl floor covering (grey)

| Action: | No further action required | | |

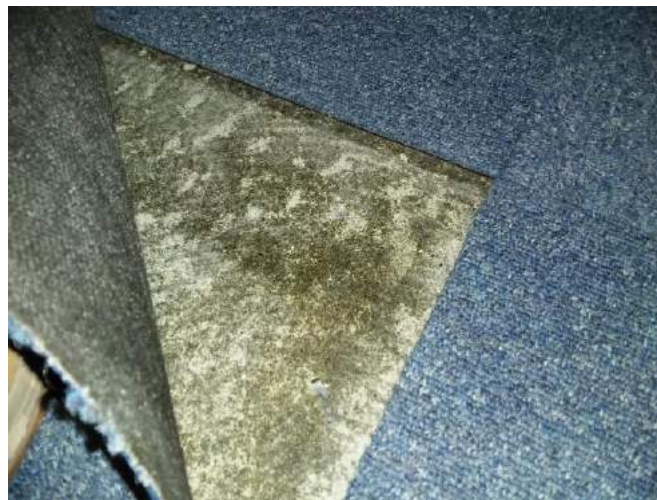
Comments: Vinyl floor covering (grey) beneath carpet tiles

| Action: | No further action required | | |

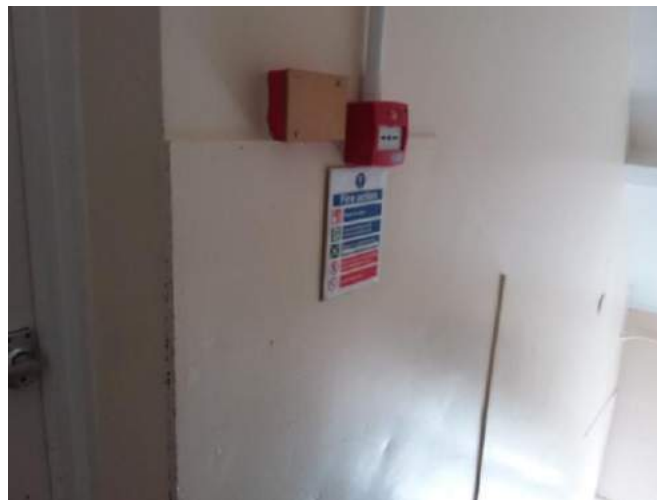
Comments: Insulating board wall lining

| Action: | No further action required | | |

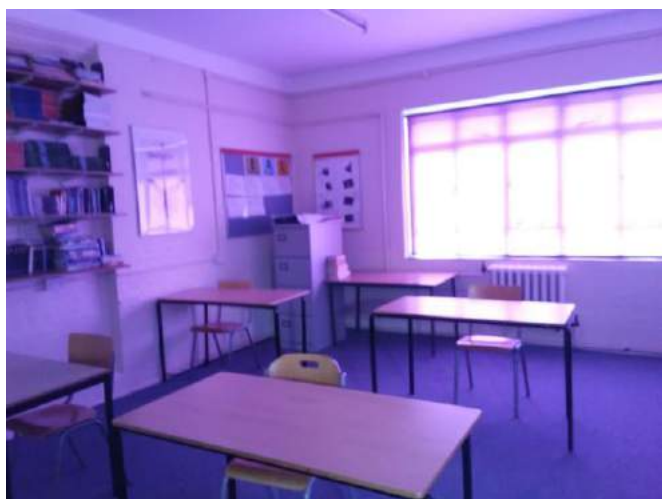
Comments: Insulating board lining to top of wall

| Action: | No further action required | | |

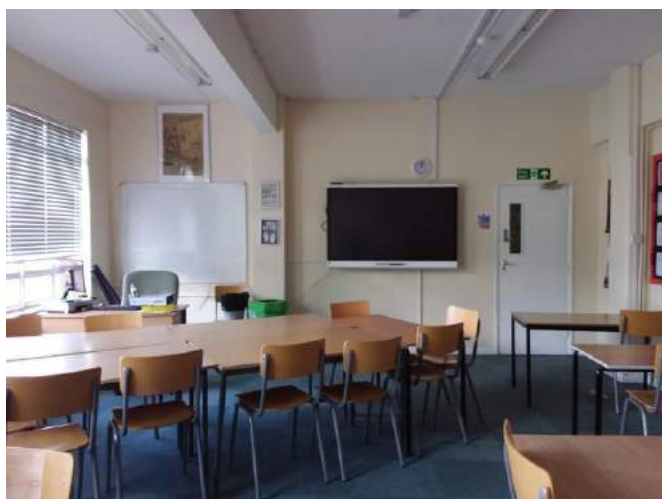
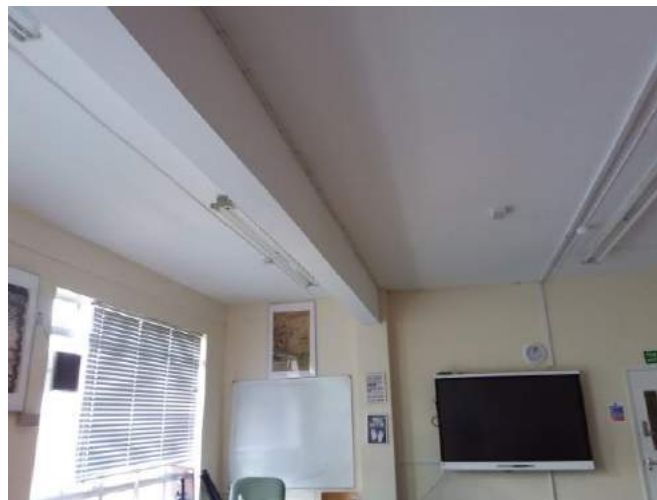
Comments: Insulating board cladding to beam

| Action: | No further action required | | |

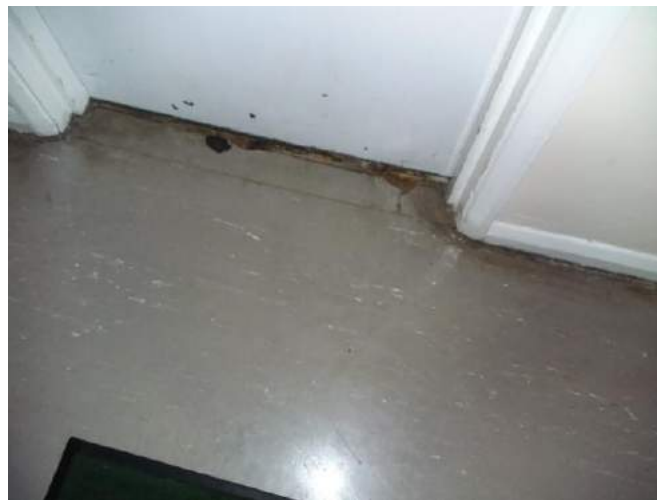
Comments: Vinyl floor covering (grey)

| Action: | No further action required | | |

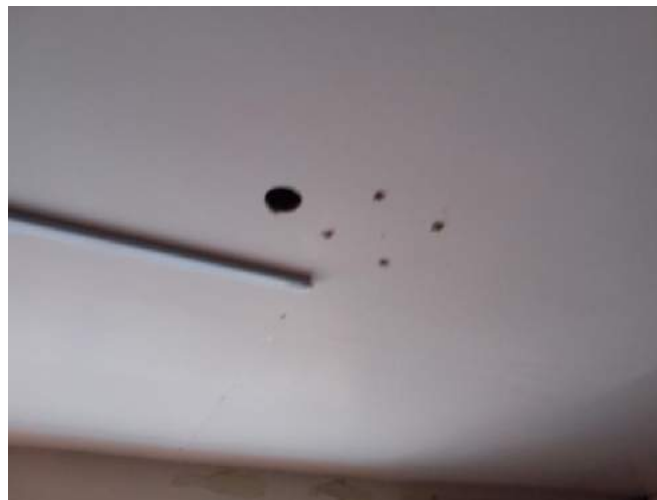
Comments: Insulating board ceiling

| Action: | No further action required | | |

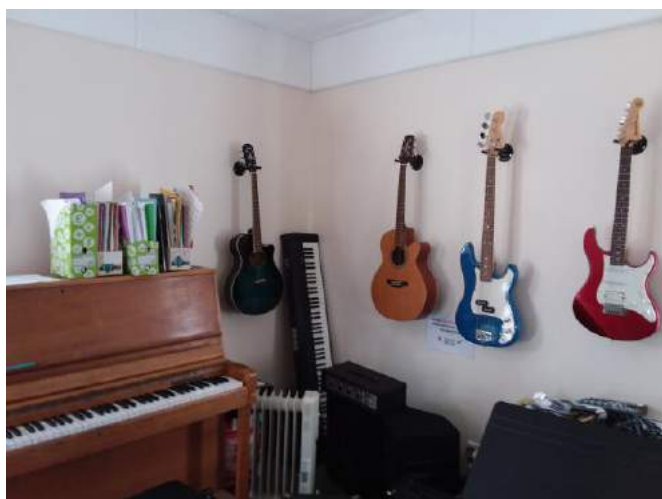
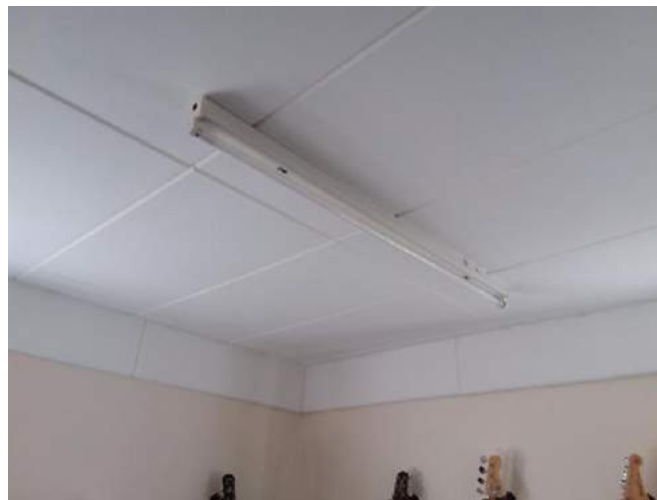
Comments: Insulating board ceiling and wall lining

| Action: | No further action required | | |

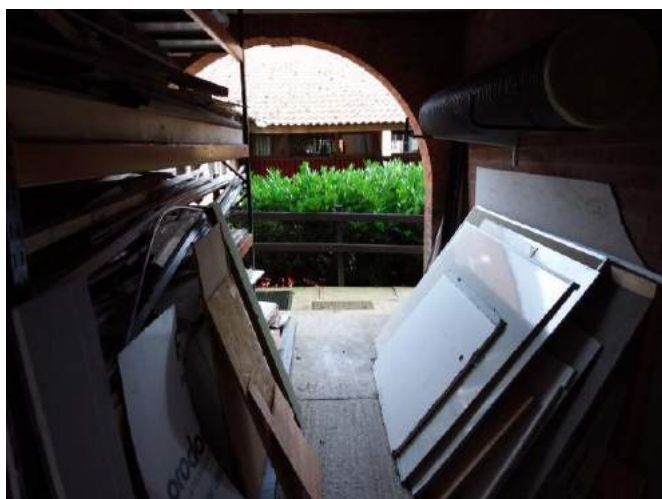
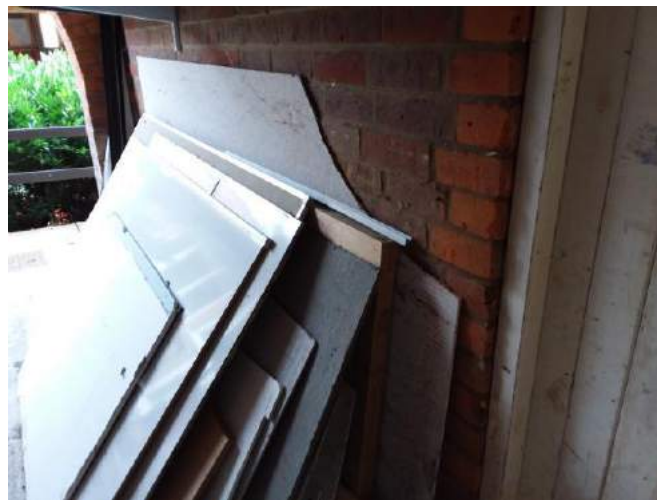
Comments: Redundant insulating board panels

| Action: | No further action required | | |

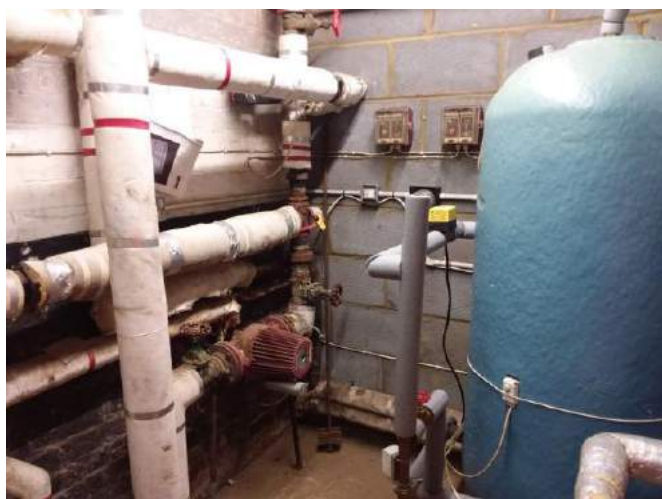
Thermal insulation residue to pipework (small amounts beneath MMMF insulation).  
Limited access beyond MMMF insulation to pipework without causing significant damage under management survey

| Action: | Monitor and manage | | |

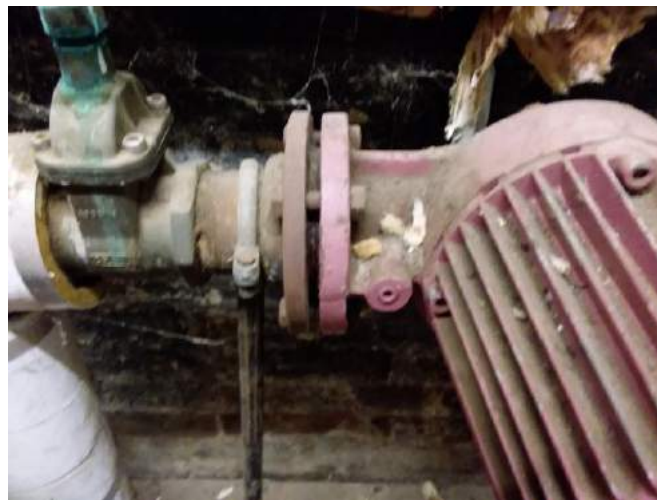
Comments: CAF gaskets to pipework

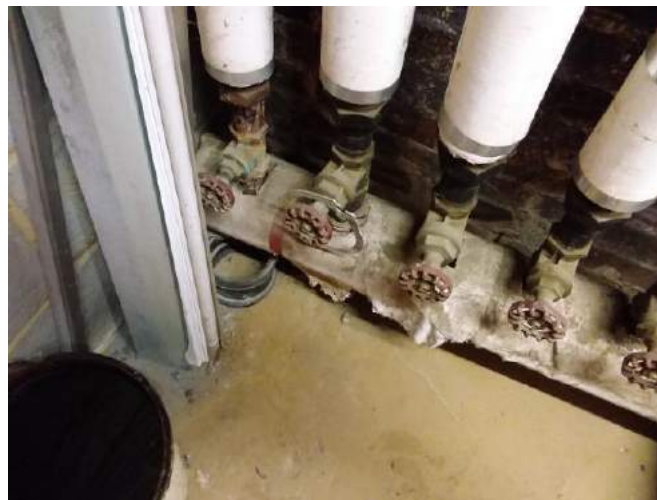
Comments: Redundant CAF gasket

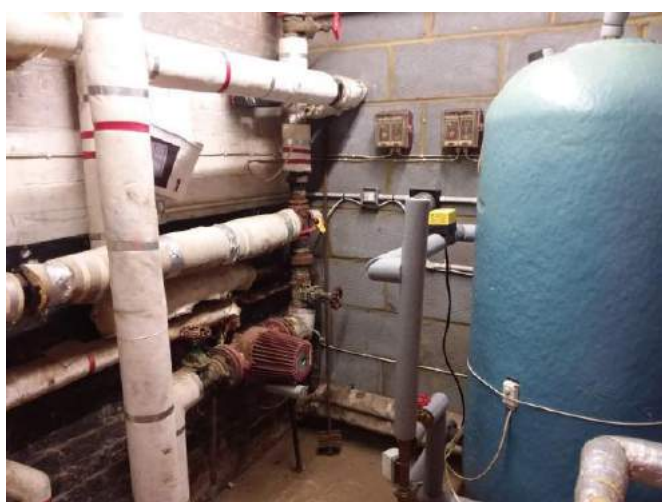
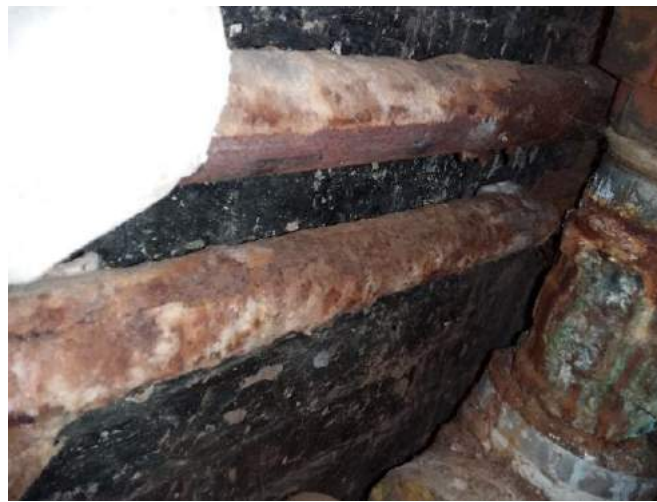
Comments: Insulation residue to exposed pipework

| Action: | No further action required | | |

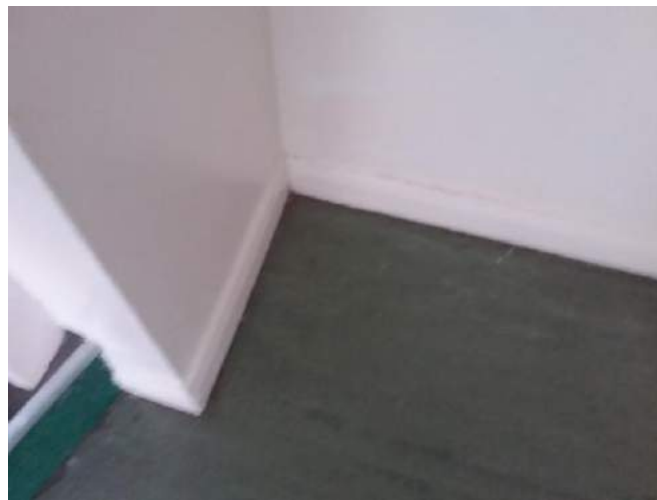
Comments: Vinyl floor covering

| Action: | No further action required | | |

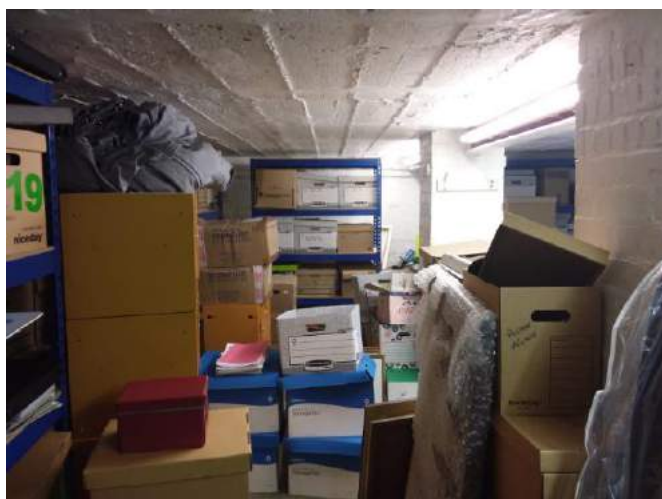
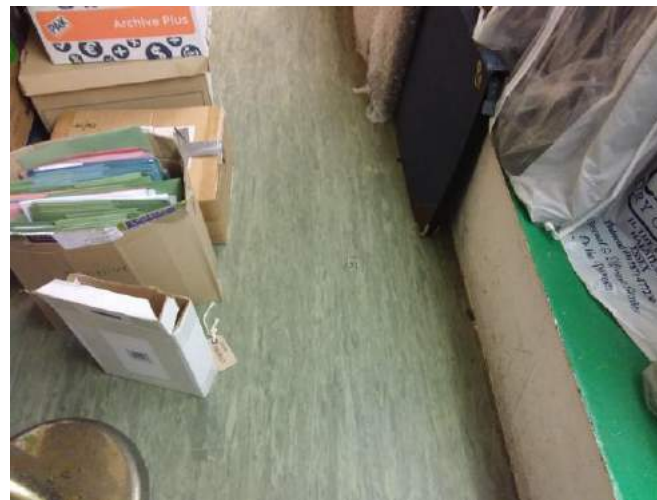
Comments: Vinyl floor covering (grey)

| Action: | No further action required | | |

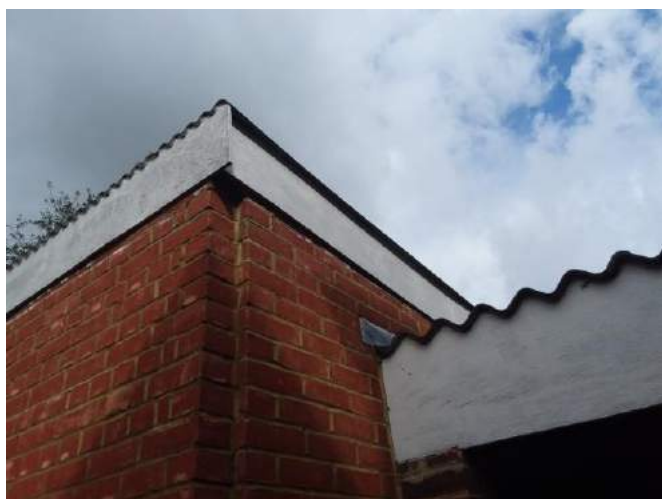
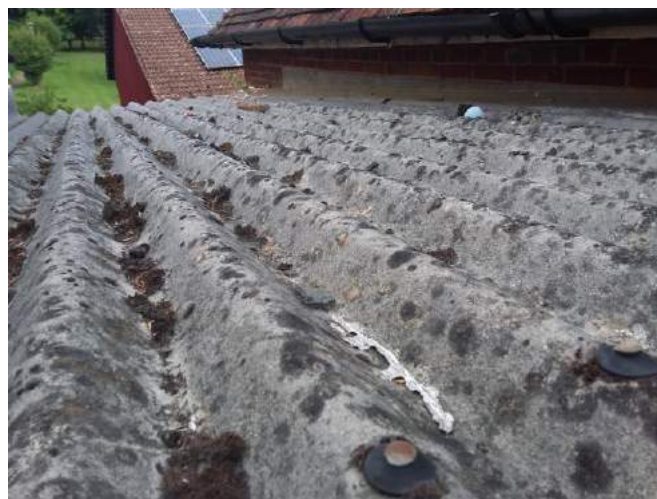
Comments: Corrugated cement roof sheets

| Action: | No further action required | | |

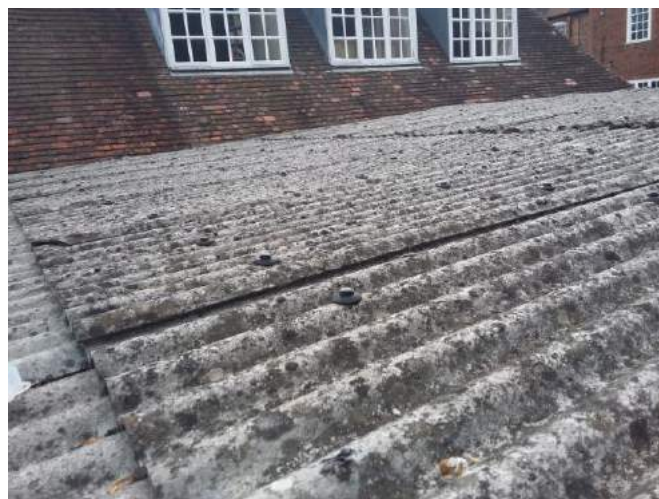
Comments: Corrugated cement roof sheets

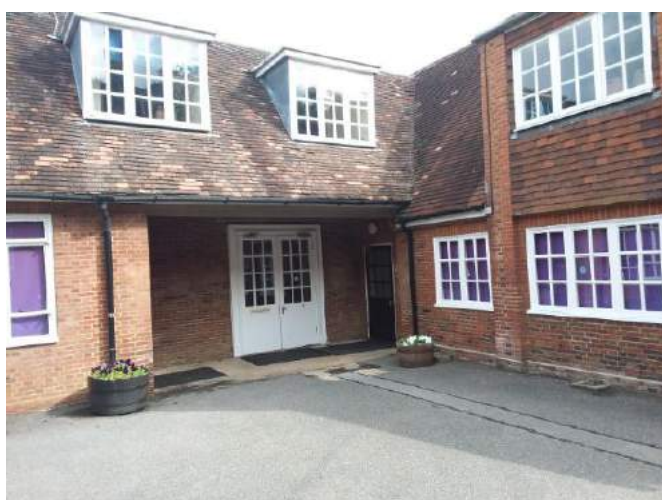
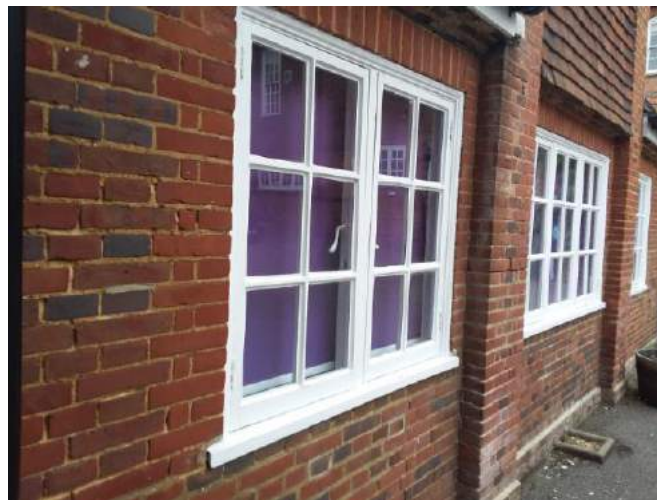
Comments: Putty to all windows

| Action: | No further action required | | |

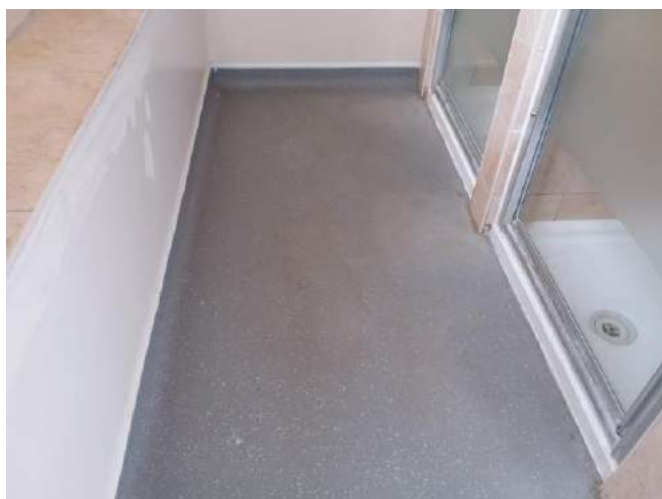
Comments: No access beneath modern vinyl floor covering without causing damage under management survey

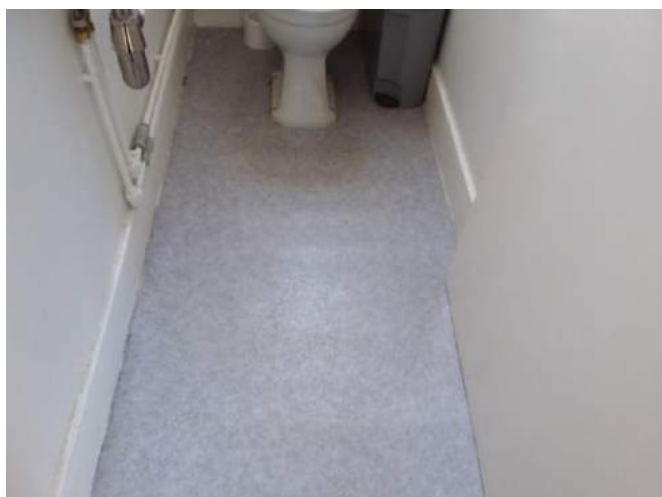
Comments: No access beneath modern vinyl floor covering without causing damage under management survey

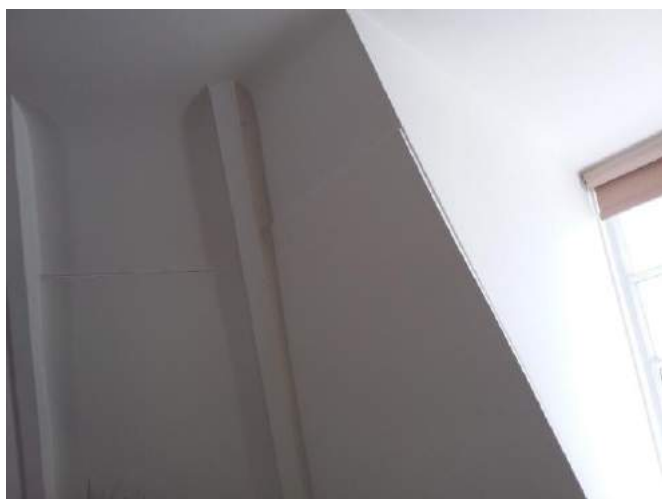
Comments: View of fibreboard wall panels (no asbestos detected)

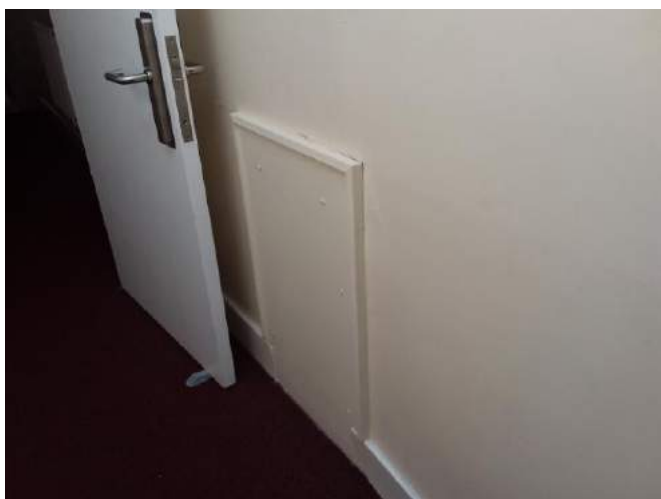
No access beyond timber wall panel without causing significant damage under management survey (sealed to wall)

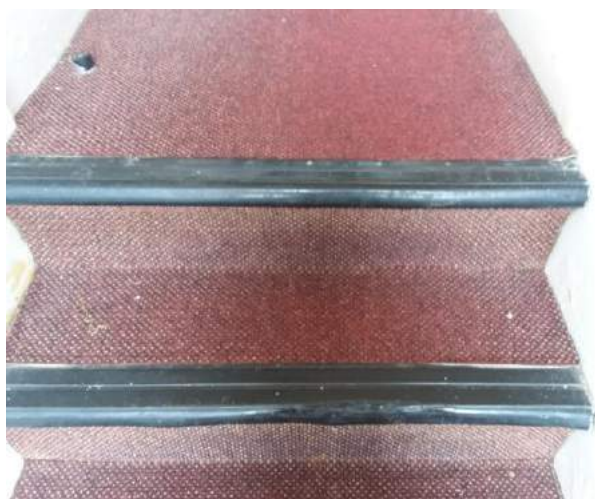
Comments: View of rubber stair nosings (no asbestos detected)

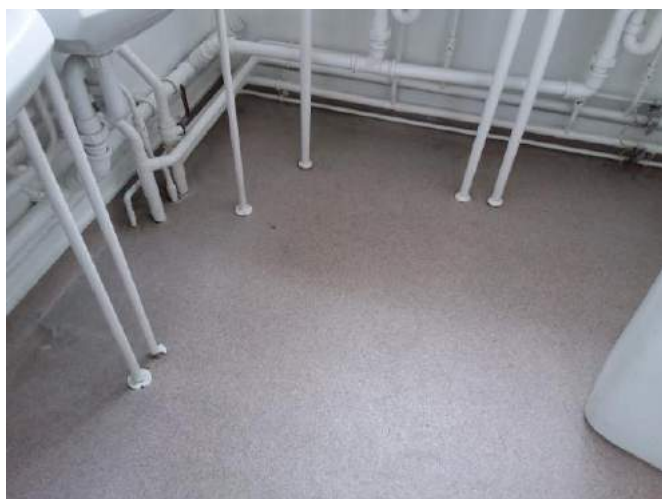
Comments: No access beneath modern vinyl floor covering without causing damage under management survey

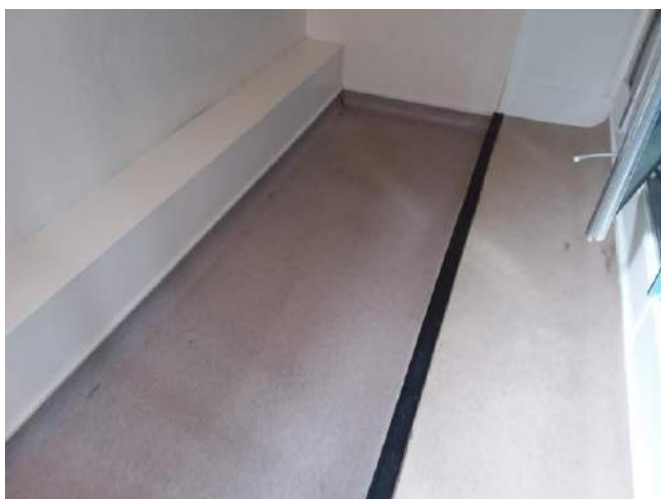
Comments: No access beneath modern vinyl floor covering without causing damage under management survey

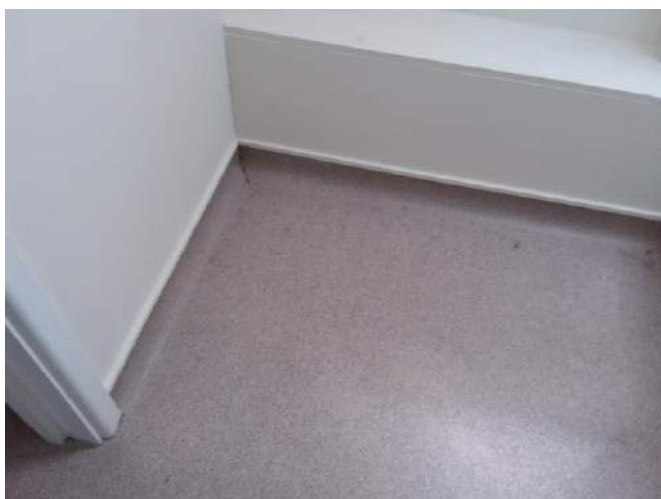
Comments: No access beneath modern vinyl floor covering without causing damage under management survey
