Site Address: Princess Helena College, School Lane, Preston, Hitchin, Hertfordshire, SG4 7RT

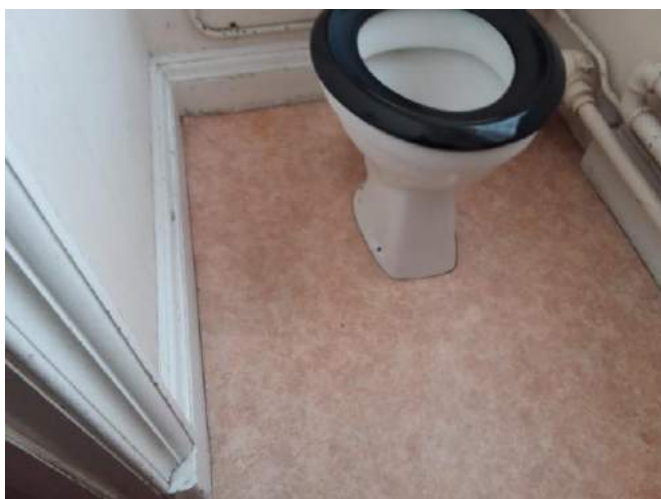
Comments: No access beneath modern vinyl floor covering without causing damage under management survey

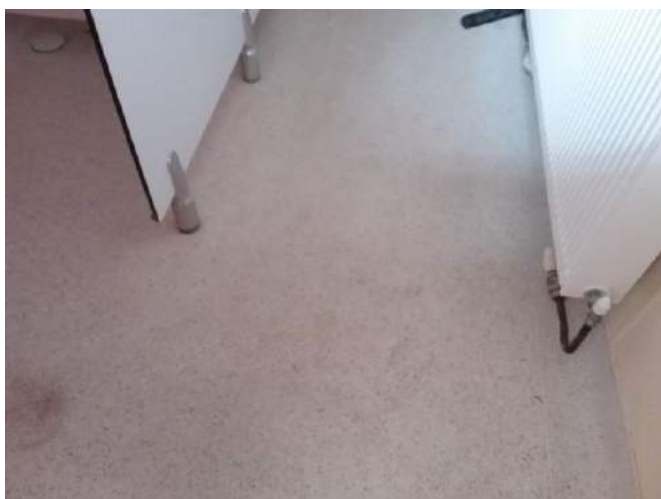
Comments: No access beneath modern vinyl floor covering without causing damage under management survey

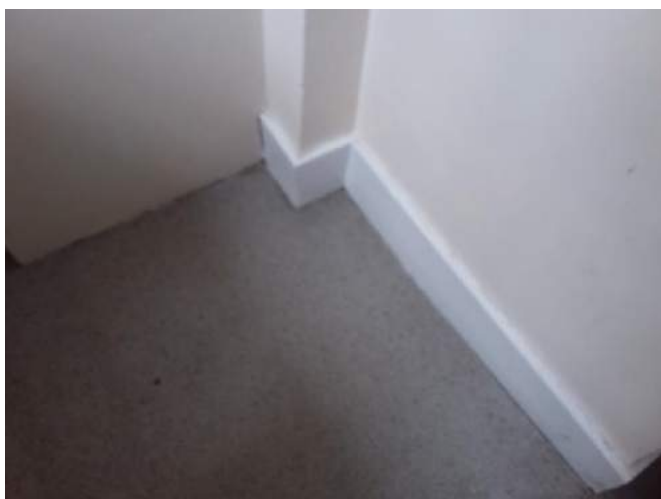
Comments: No access beneath modern vinyl floor covering without causing damage under management survey

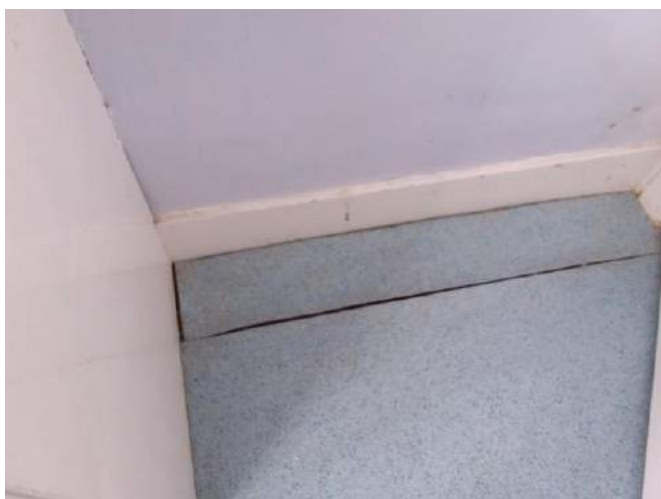
Comments: Access gained beneath damaged vinyl floor covering (no asbestos detected)

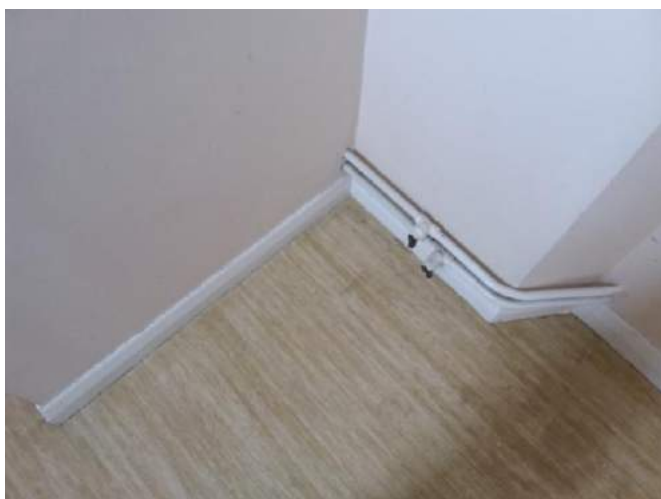
Comments: No access beneath modern vinyl floor covering without causing damage under management survey

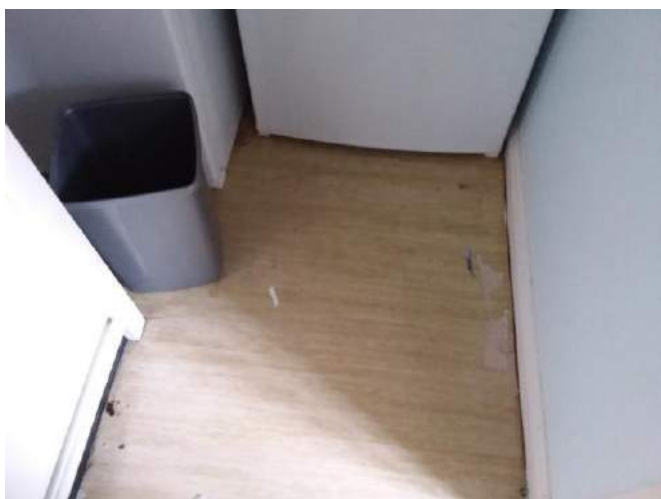
Comments: No access beneath modern vinyl floor covering without causing damage under a Management survey

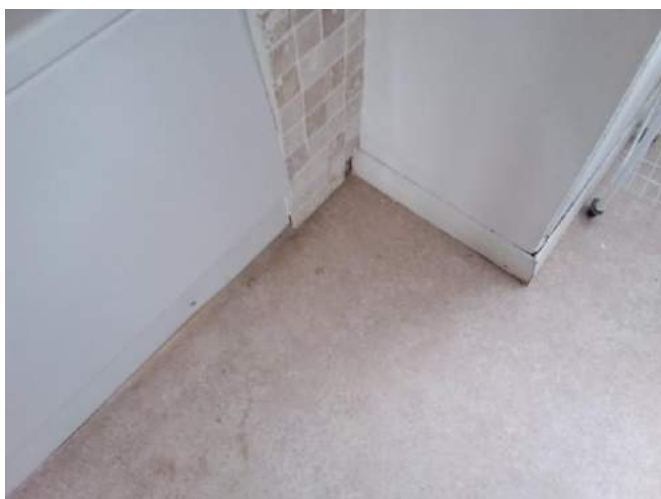
Comments: No access beneath modern vinyl floor covering without causing damage under management survey

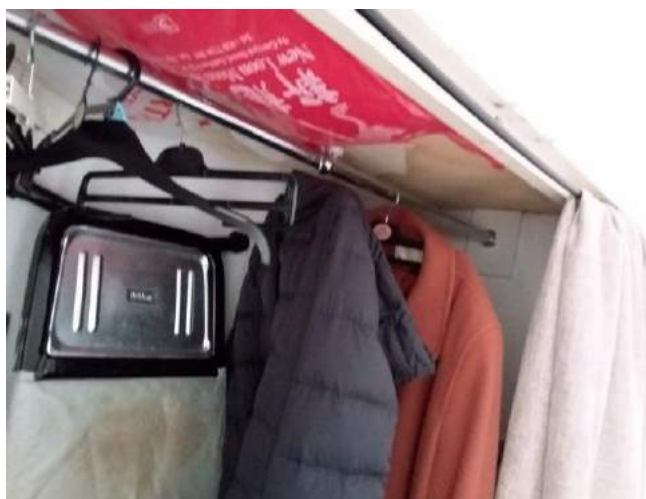
Comments: View of timber ceiling to cupboard (no asbestos detected)

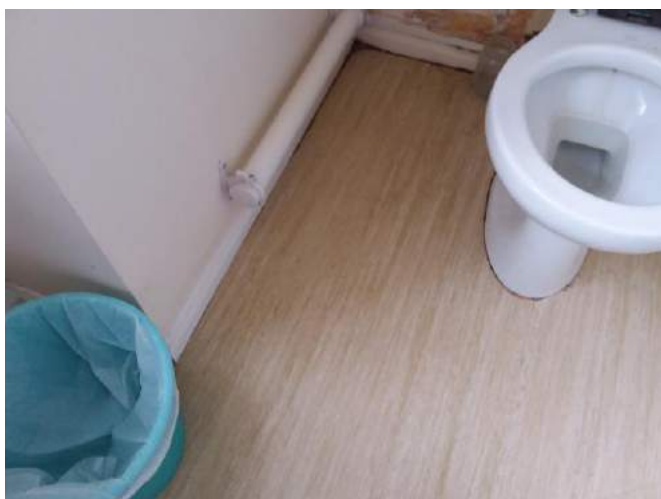
Comments: No access beneath modern vinyl floor covering without causing damage under management survey

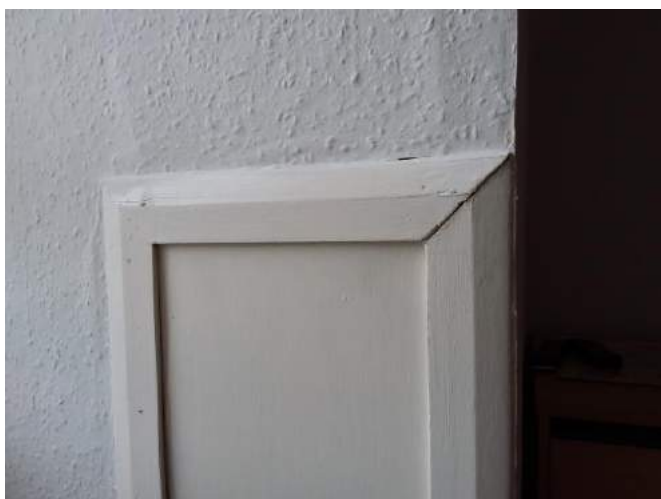
Comments: No access beyond timber wall panel without causing significant damage under a Management survey

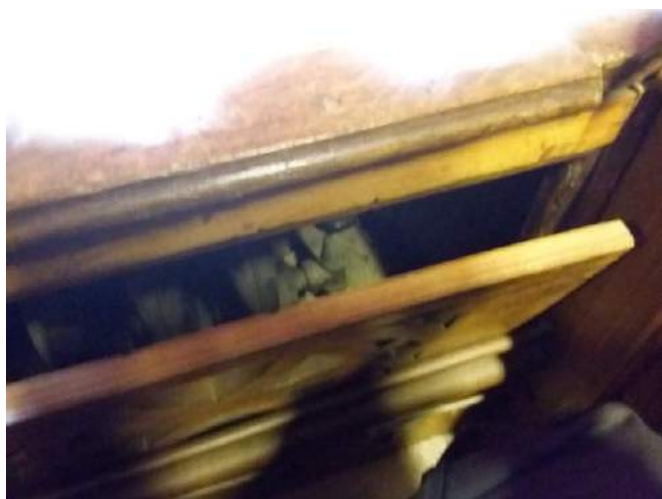
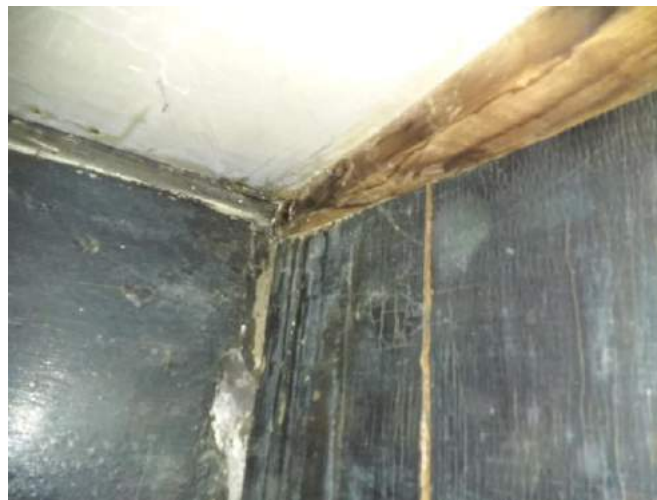
Comments: Access gained within radiator housing (no asbestos detected)

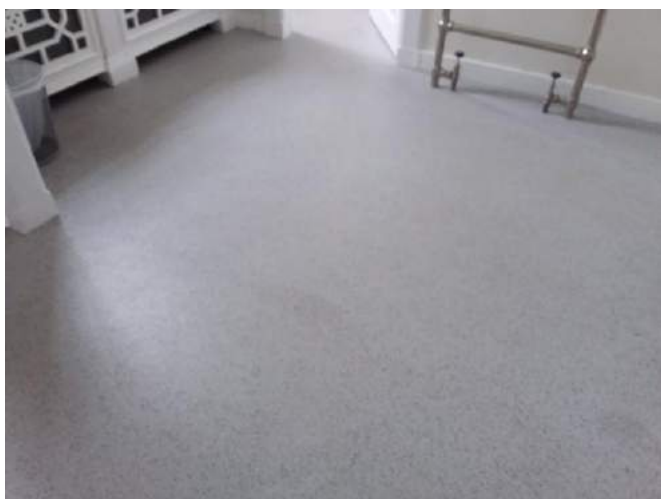
Comments: No access beneath modern vinyl floor covering without causing damage under management survey

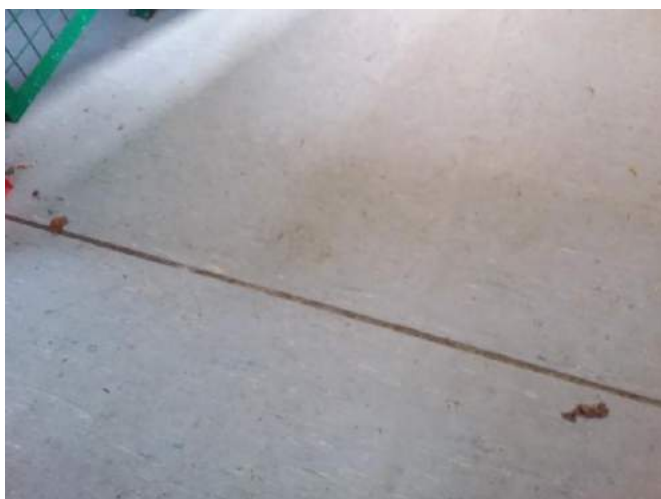
Comments: No access beneath modern vinyl floor covering without causing damage under management survey

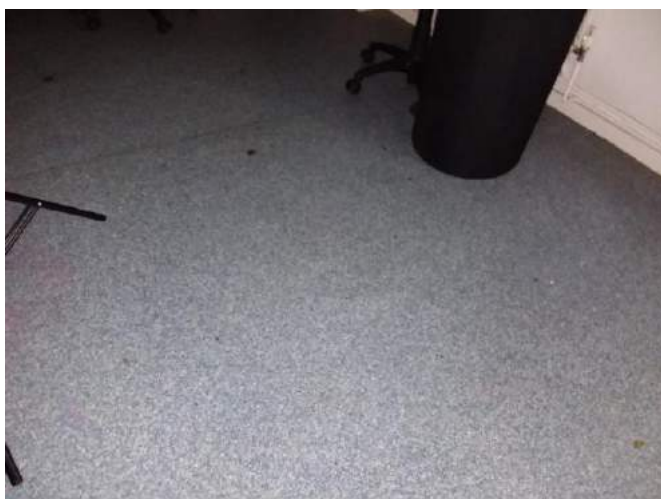
Comments: No access beneath modern vinyl floor covering without causing damage under management survey

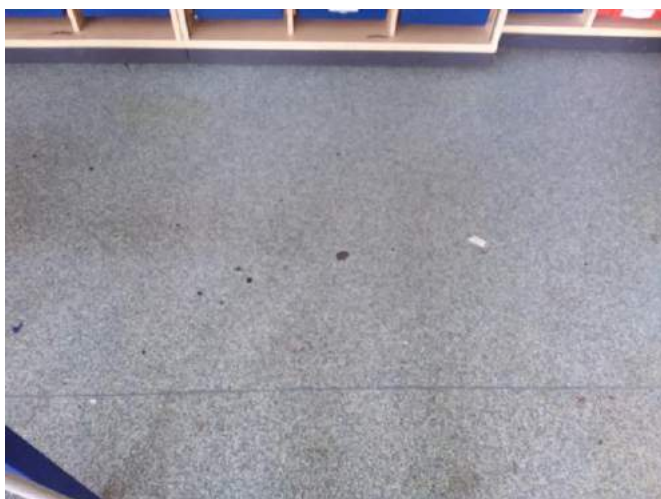
Comments: No access beneath modern vinyl floor covering without causing damage under management survey

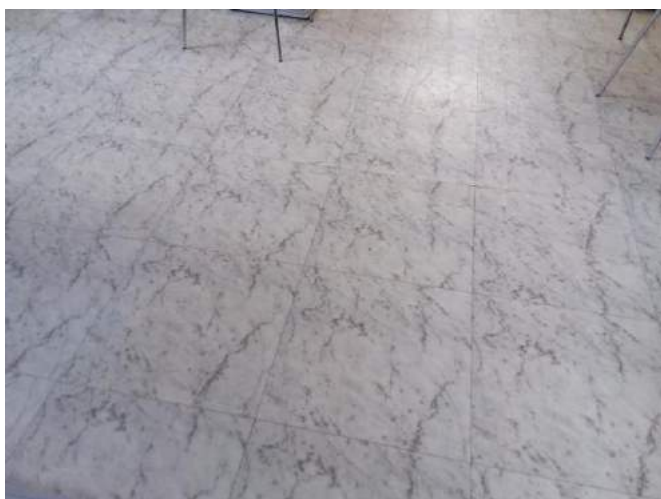
Comments: No access beneath modern vinyl floor covering without causing damage under management survey

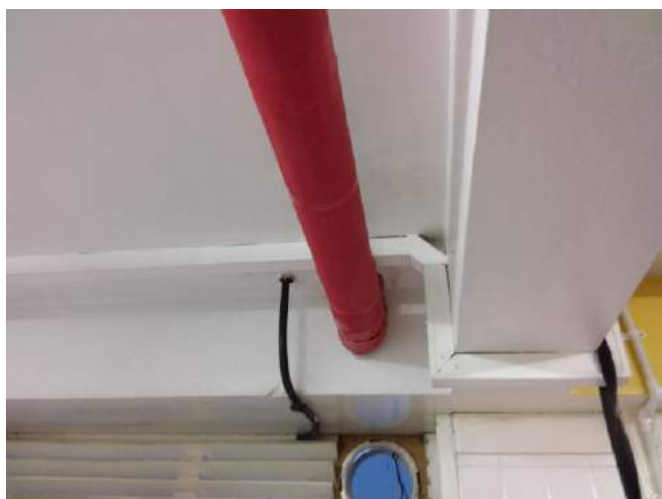
Comments: No access beyond MMMF insulation to pipework without causing significant damage under management survey

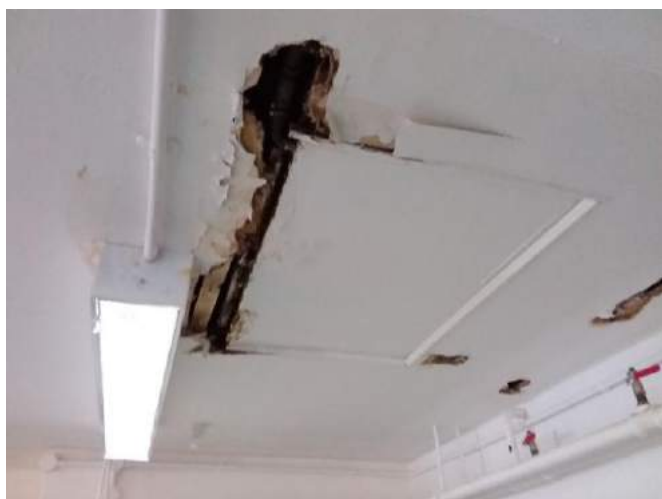
Comments: View of damaged lath and plaster ceiling (no asbestos detected)

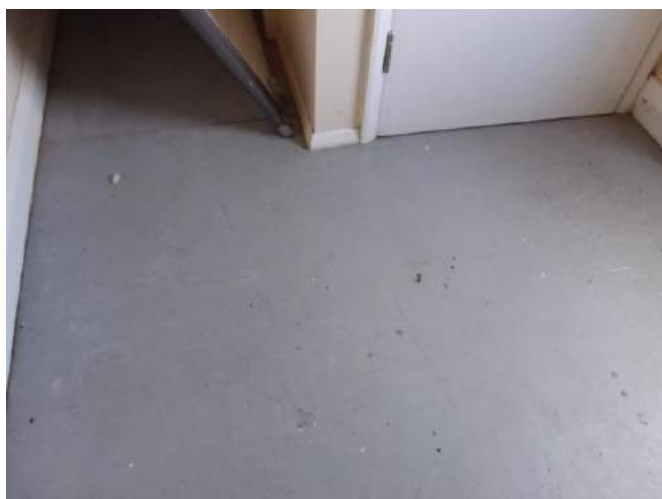
Comments: No access beneath modern vinyl floor covering without causing damage under management survey

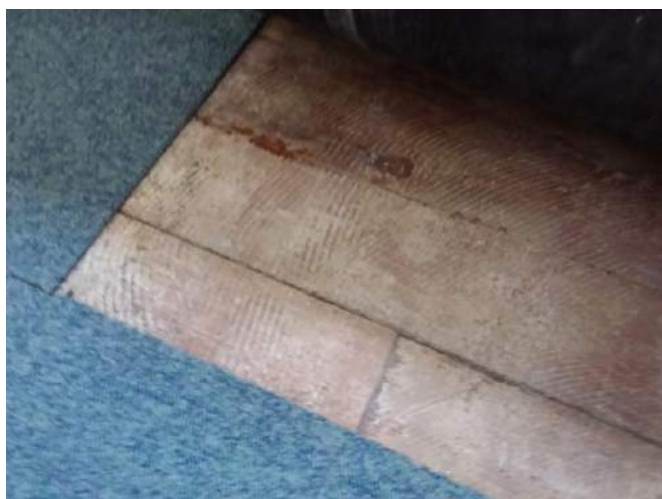
Comments: View of timber floor beneath carpet (no asbestos detected)
